## **Profile/Photo Observation Report**

Date: 09/15/2021 **PACP 7.0** Weather: Coding: Pipe Length (ft): 318.3 Owner: **City of Hobart** Pre Clean: **Heavy Cleaning** P.O.#: S. Bucklin PSR: P-504-053-052 YES502259 Surveyor:

Street: North Guyer Street Flow Control: Not Controlled

US MH: M-504-052 DS MH: M-504-053 Total Length Surveyed (ft): 318.3

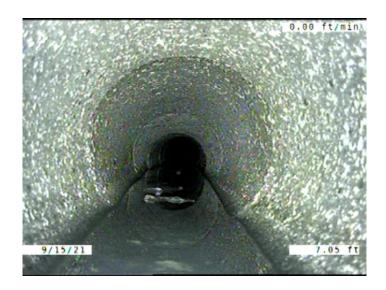
Code: **DSF**

Description: Deposits Settled Fine

Distance (ft): 7.0
Structural Grade: 0
O&M Grade: 2
Clock Start/From: 5
Clock To: 7

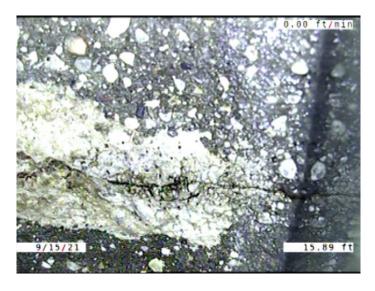
Code: CS

Description: Crack Spiral

Distance (ft): 15.9
Structural Grade: 2
O&M Grade: 0
Clock Start/From: 9
Clock To: 3
1st Value:
2nd Value:
Value Percent:
Continuous Index:

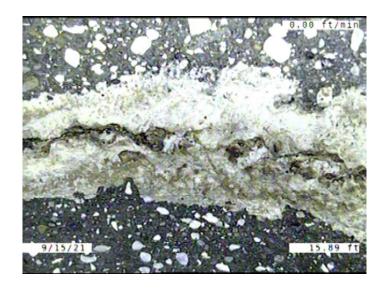
Code: DAE

Description: Deposits Attached Encrustation

Distance (ft): 15.9
Structural Grade: 0
O&M Grade: 2
Clock Start/From: 9
Clock To: 3

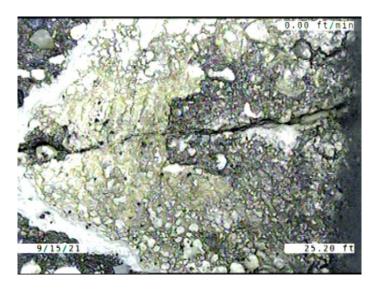
Code: CS

Description: Crack Spiral

Distance (ft): 25.2
Structural Grade: 2
O&M Grade: 0
Clock Start/From: 8
Clock To: 4
1st Value:
2nd Value:
Value Percent:

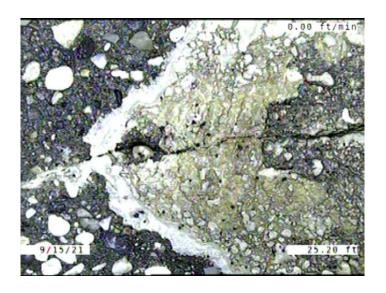
Code: DAE

Description: Deposits Attached Encrustation

Distance (ft): 25.2
Structural Grade: 0
O&M Grade: 2
Clock Start/From: 3
Clock To: 4

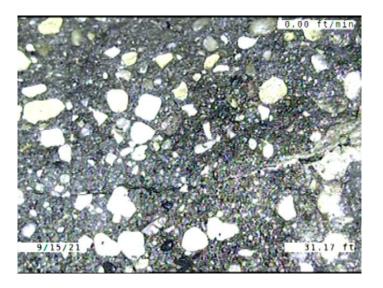
Code: CS

Description: Crack Spiral

Distance (ft): 31.2
Structural Grade: 2
O&M Grade: 0
Clock Start/From: 9
Clock To: 3
1st Value:
2nd Value:
Value Percent:
Continuous Index:

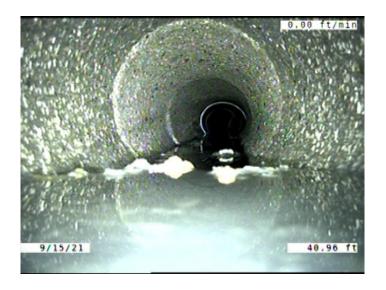
Code: OBZ

Description: Obstruction Other

Distance (ft): 41.0
Structural Grade: 0
O&M Grade: 2
Clock Start/From: 4
Clock To: 8

Remarks: UNKNOWN DEBRIS UNDER THE

**FLOW**

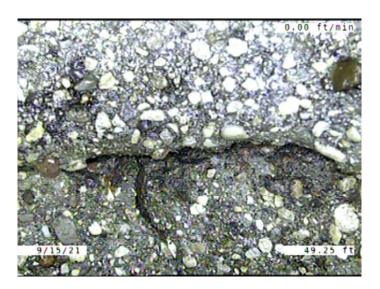
Code: **FM**

Description: Fracture Multiple

Distance (ft): 49.3
Structural Grade: 4
O&M Grade: 0
Clock Start/From: 7
Clock To: 5
1st Value:
2nd Value:
Value Percent:

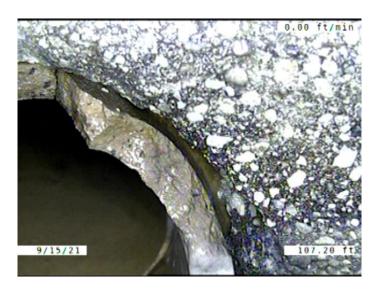
Code: B
Description: Broken

Distance (ft): 107.2
Structural Grade: 4
O&M Grade: 0
Clock Start/From: 12
Clock To: 2
1st Value:
2nd Value:
Value Percent:

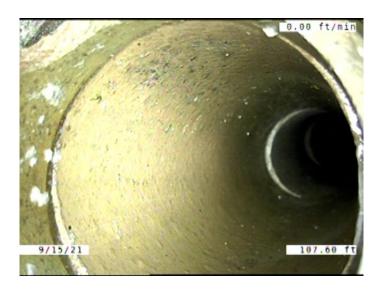
Code: **TBI**

Description: Tap Break-in Intruding

Distance (ft): 107.6
Structural Grade: 0
O&M Grade: 2
Clock Start/From: 1

Remarks: Broken near connection

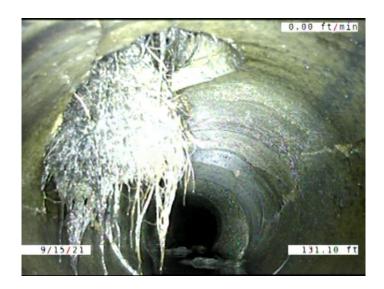
Code: RML

Description: Roots Medium Lateral

Distance (ft): 131.1
Structural Grade: 0
O&M Grade: 3
Clock Start/From: 9
Clock To: 11

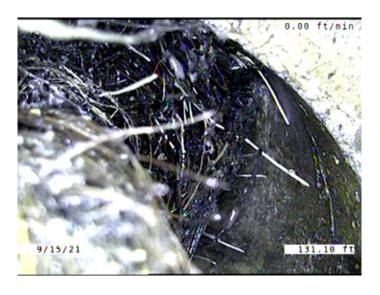
Code: **TFD**

Description: Tap Factory Defective

Distance (ft): 131.1
Structural Grade: 0
O&M Grade: 3
Clock Start/From: 11

Remarks: 100% PLUGGED WITH ROOTS

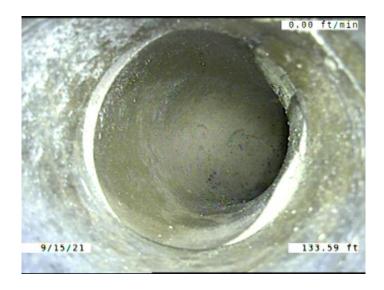
Code: **TFD**

Description: Tap Factory Defective

Distance (ft): 133.6
Structural Grade: 0
O&M Grade: 3
Clock Start/From: 1

Remarks: **Defective**

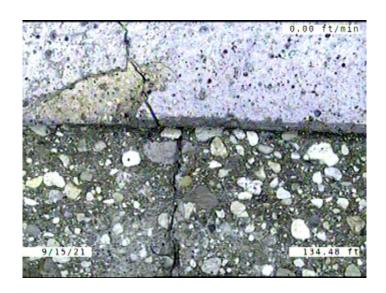
Code: FL

Description: Fracture Longitudinal

Distance (ft): 134.5
Structural Grade: 3
O&M Grade: 0
Clock Start/From: 12

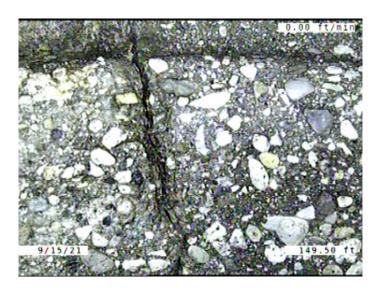
Code: FL

Description: Fracture Longitudinal

Distance (ft): 149.5
Structural Grade: 3
O&M Grade: 0
Clock Start/From: 9
Clock To:
1st Value:
2nd Value:

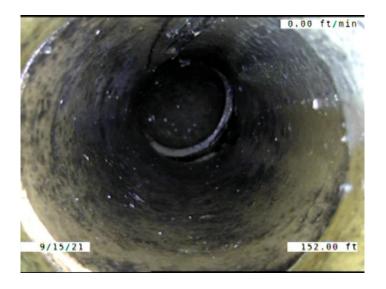
Code: TBI

Description: Tap Break-in Intruding

Distance (ft): 152.0
Structural Grade: 0
O&M Grade: 2
Clock Start/From: 12

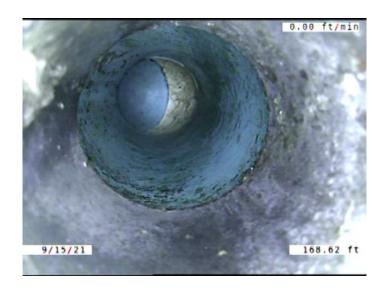
Code: **TFI**

Description: Tap Factory Intruding

Distance (ft): 168.6
Structural Grade: 0
O&M Grade: 2
Clock Start/From: 11

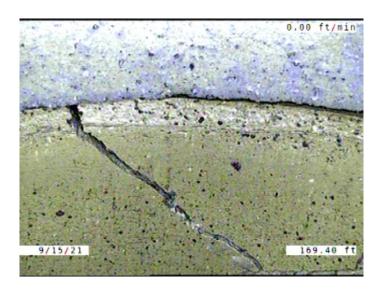
Code: **B**

Description: Broken

Distance (ft): 169.4
Structural Grade: 4

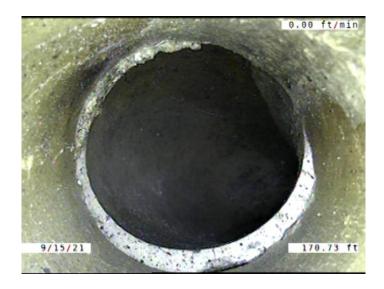
Code: **TFD**

Description: Tap Factory Defective

Distance (ft): 170.7
Structural Grade: 0
O&M Grade: 3
Clock Start/From: 1

Remarks: **Defective**

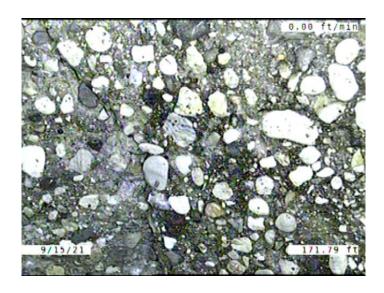
Code: CS

Description: Crack Spiral

Distance (ft): 171.8
Structural Grade: 2
O&M Grade: 0
Clock Start/From: 2
Clock To: 4

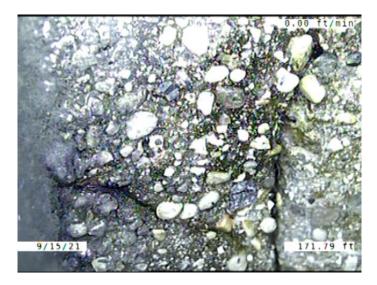
Code: FM

Description: Fracture Multiple

Distance (ft): 171.8
Structural Grade: 4
O&M Grade: 0
Clock Start/From: 7
Clock To: 9
1st Value:
2nd Value:

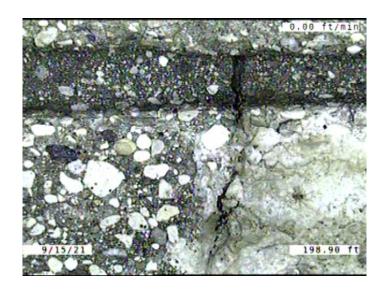
Code: **FM**

Description: Fracture Multiple

Distance (ft): 198.9
Structural Grade: 4
O&M Grade: 0
Clock Start/From: 10
Clock To: 3

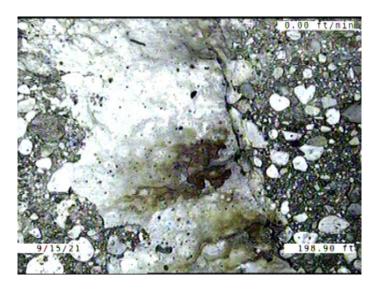
Code: DAE

Description: Deposits Attached Encrustation

Distance (ft): 198.9
Structural Grade: 0
O&M Grade: 2
Clock Start/From: 9
Clock To: 3
1st Value:

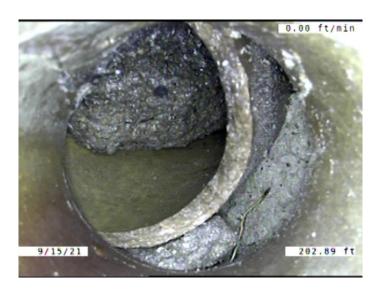
Code: **TFD**

Description: Tap Factory Defective

Distance (ft): 202.9
Structural Grade: 0
O&M Grade: 3
Clock Start/From: 11

Remarks: SOIL VISIBLE. FIRST JOINT BACK HAS

A LARGE OFFSET

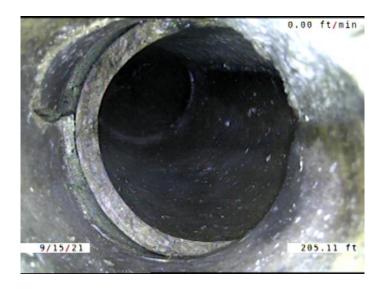
Code: **TFD**

Description: Tap Factory Defective

Distance (ft): 205.1
Structural Grade: 0
O&M Grade: 3
Clock Start/From: 1

Remarks: **Defective**

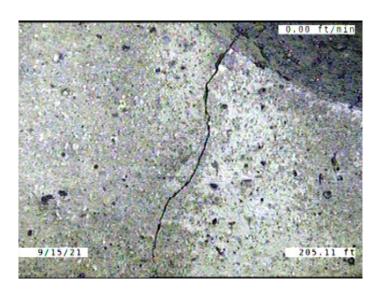
Code: CL

Description: Crack Longitudinal

Distance (ft): 205.1
Structural Grade: 2
O&M Grade: 0
Clock Start/From: 2
Clock To:
1st Value:

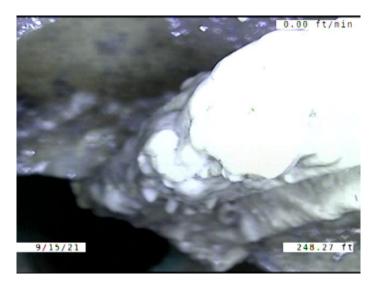
Code: DAE

Description: Deposits Attached Encrustation

Distance (ft): 248.3
Structural Grade: 0
O&M Grade: 2
Clock Start/From: 1

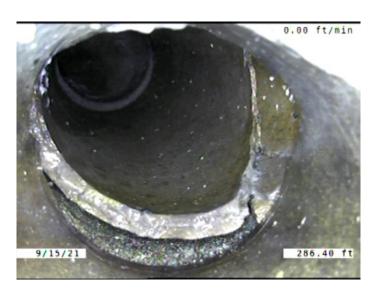
Code: **TFD**

Description: Tap Factory Defective

Distance (ft): 286.4
Structural Grade: 0

O&M Grade: 3

Remarks: **Defective**

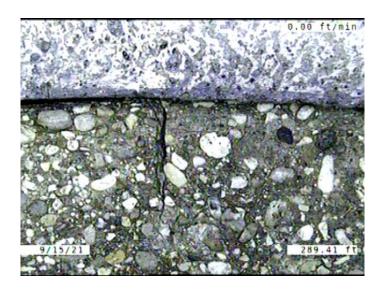
Code: FL

Description: Fracture Longitudinal

Distance (ft): 289.4
Structural Grade: 3
O&M Grade: 0
Clock Start/From: 11

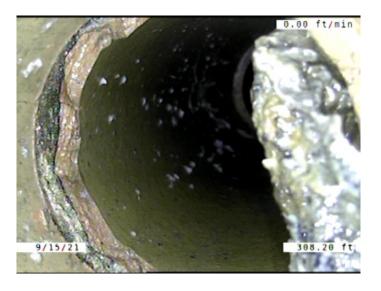
Code: TBI

Description: Tap Break-in Intruding

Distance (ft): 308.2
Structural Grade: 0
O&M Grade: 2
Clock Start/From: 1

Remarks: Broken near connection

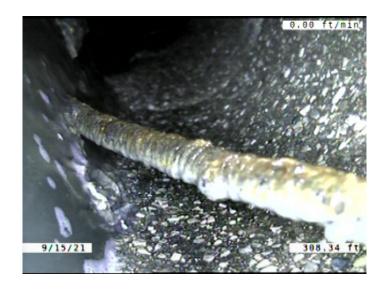
Code: OBZ

Description: Obstruction Other

Distance (ft): 308.3
Structural Grade: 0
O&M Grade: 2
Clock Start/From: 2
Clock To: 7

Value Percent: 5.000
Continuous Index: S01
Within 8" of Joint: YES
Remarks: STICK

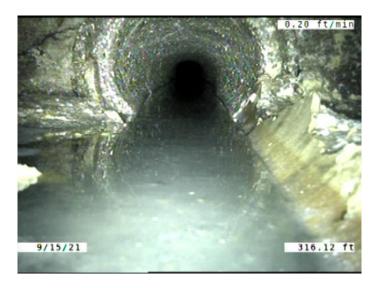
Code: OBZ

Description: Obstruction Other

Distance (ft): 316.1
Structural Grade: 0
O&M Grade: 2
Clock Start/From: 2
Clock To: 7
1st Value:
2nd Value:

Value Percent: 5.000
Continuous Index: F01
Within 8" of Joint: YES
Remarks: STICK

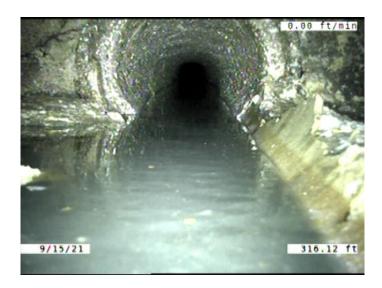
Code: **DSF**

Description: Deposits Settled Fine

Distance (ft): 316.1
Structural Grade: 0
O&M Grade: 2
Clock Start/From: 5
Clock To: 7
