Profile/Photo Observation Report

Date:	04/22/2018	Weather:		Coding:	PACP 6.0
Pipe Length (ft):	305.6	Owner:	NA	Pre Clean:	No Pre-Cleaning
P.O.#:		Surveyor:	Erik Redinger	PSR:	P-504-054-053
Customer:		Clean Date:	01/01/1900	Shape:	C

Street:	W HOME AVE	Flow Control:	Not Controlled
City:	Hobart, IN	Year Renewed:	
Location:	Light Highway	Tape/Media #:	
Purpose:	Routine Assessment	Dia/Height:	12"
Use:	Sanitary	Material:	VCP
Drain Area:	NA	Lining:	
Category:	NA		
Comment:	P_C at 46 ft roots. Flow direction wrong		
Location Details:		Direction of Survey:	Downstream
US MH:	M-504-053	DS MH:	M-504-054
		Total Length Surveyed (ft):	47.1

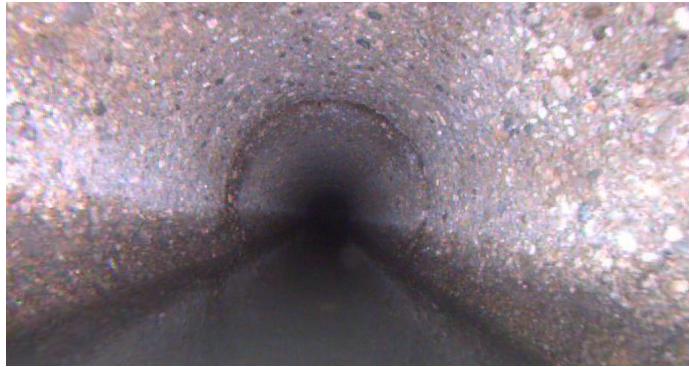
Code: **MWL**
Description: **Water Level**

Distance (ft): **.0**
Structural Grade: **0**
O&M Grade: **0**
Clock Start/From:
Clock To:
1st Value:
2nd Value:
Value Percent: **10.000**
Continuous Index:
Within 8" of Joint: **NO**
Remarks:

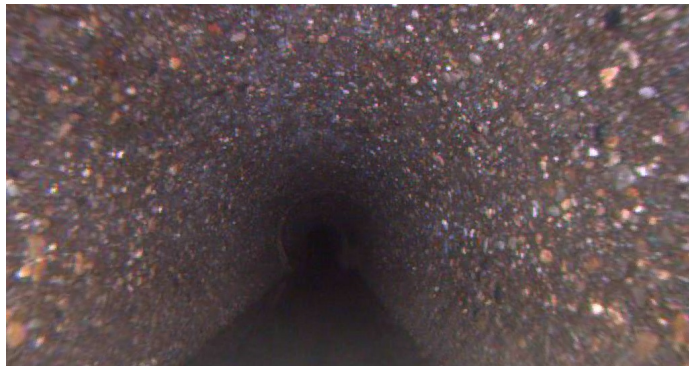
Code: **SAV**
Description: **Surface Aggregate Visible**

Distance (ft): **17.4**
Structural Grade: **3**
O&M Grade: **0**
Clock Start/From: **7**
Clock To: **5**
1st Value:
2nd Value:
Value Percent:
Continuous Index:
Within 8" of Joint:
Remarks:

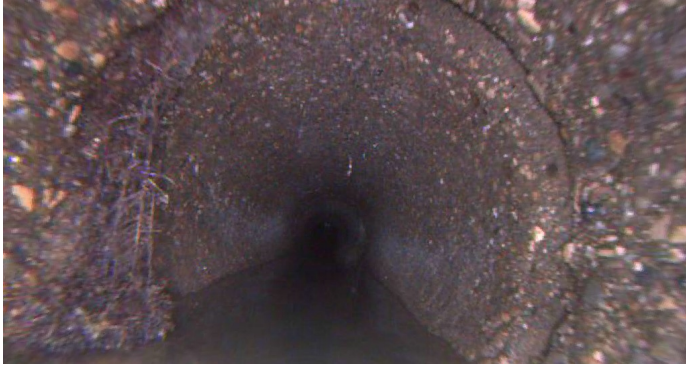
Code: **RFJ**
Description: **Roots Fine Joint**

Distance (ft): **28.6**
Structural Grade: **0**
O&M Grade: **1**
Clock Start/From: **7**
Clock To: **5**
1st Value:
2nd Value:
Value Percent:
Continuous Index: **S01**
Within 8" of Joint: **YES**
Remarks:

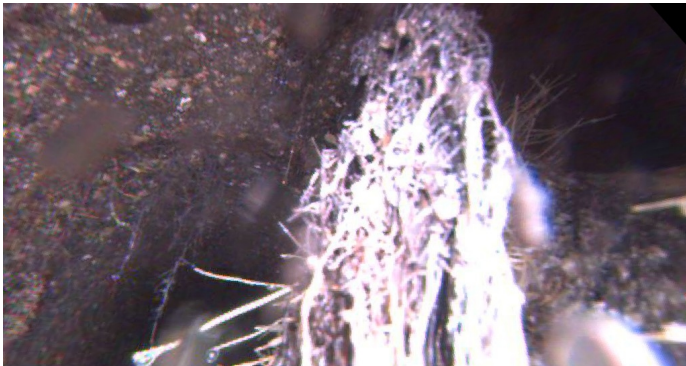
Code: **RFJ**
Description: **Roots Fine Joint**

Distance (ft): **46.3**
Structural Grade: **0**
O&M Grade: **1**
Clock Start/From: **7**
Clock To: **5**
1st Value:
2nd Value:
Value Percent:
Continuous Index: **F01**
Within 8" of Joint: **YES**
Remarks:

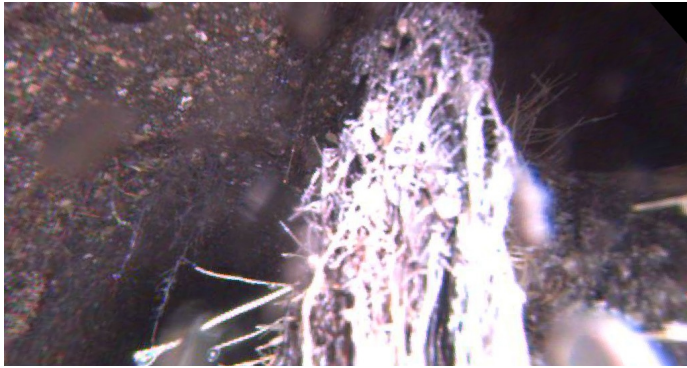
Code: **TFD**
Description: **Tap Factory Defective**

Distance (ft): **46.3**
Structural Grade: **0**
O&M Grade: **2**
Clock Start/From: **2**
Clock To:
1st Value: **4.000**
2nd Value:
Value Percent:
Continuous Index:
Within 8" of Joint:
Remarks: **RML**

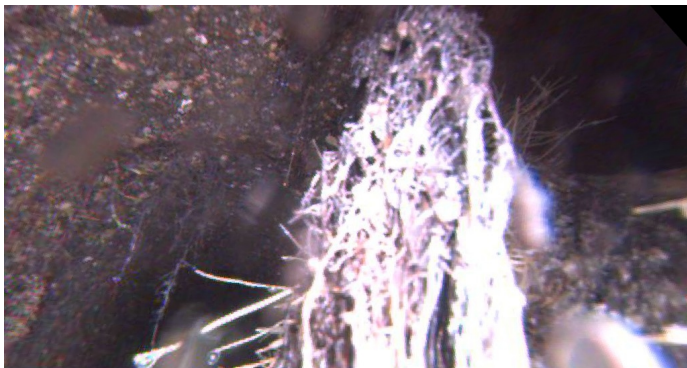
Code: **RML**
Description: **Roots Medium Lateral**

Distance (ft): **46.3**
Structural Grade: **0**
O&M Grade: **3**
Clock Start/From: **2**
Clock To:
1st Value:
2nd Value:
Value Percent: **10.000**
Continuous Index:
Within 8" of Joint: **NO**
Remarks:

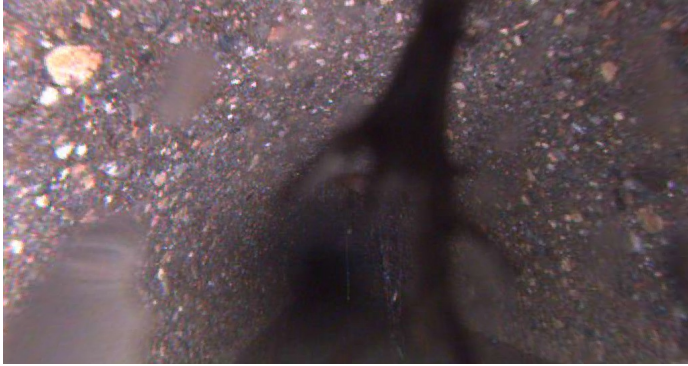
Code:	MSA
Description:	Abandoned Survey
Distance (ft):	47.1
Structural Grade:	0
O&M Grade:	0
Clock Start/From:	
Clock To:	
1st Value:	
2nd Value:	
Value Percent:	
Continuous Index:	
Within 8" of Joint:	NO
Remarks:	RML
