Profile/Photo Observation Report

Street:	FOXCROFT STREET	Flow Control:	Not Controlled
City:	Hobart, IN	Year Renewed:	
Location:	Light Highway	Tape/Media #:	
Purpose:	Routine Assessment	Dia/Height:	12"
Use:	Sanitary	Material:	VCP
Drain Area:	NA	Lining:	
Category:	NA		
Comment:	P_C at 46 ft roots. Flow direction wrong		
Location Details:		Direction of Survey:	Downstream
US MH:	M-504-053	DS MH:	M-504-054
		Total Length Surveyed (ft):	47.1

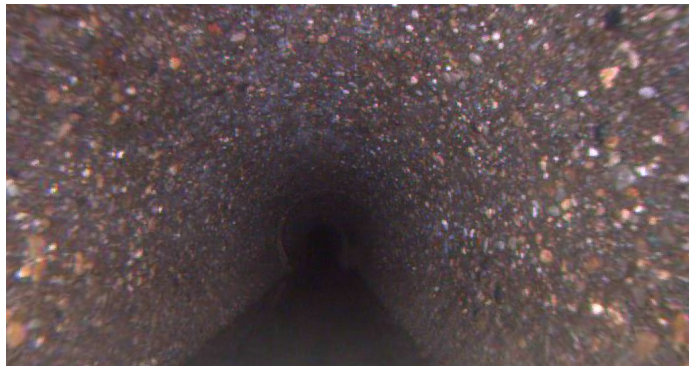
Code: **SAV**
Description: **Surface Aggregate Visible**

Distance (ft): **17.4**
Structural Grade: **3**
O&M Grade: **0**
Clock Start/From: **7**
Clock To: **5**
1st Value:
2nd Value:
Value Percent:
Continuous Index:
Within 8" of Joint:
Remarks:

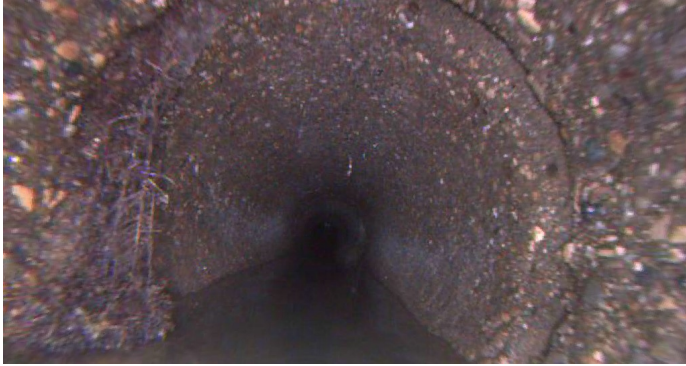
Code: **RFJ**
Description: **Roots Fine Joint**

Distance (ft): **28.6**
Structural Grade: **0**
O&M Grade: **1**
Clock Start/From: **7**
Clock To: **5**
1st Value:
2nd Value:
Value Percent:
Continuous Index: **S01**
Within 8" of Joint: **YES**
Remarks:

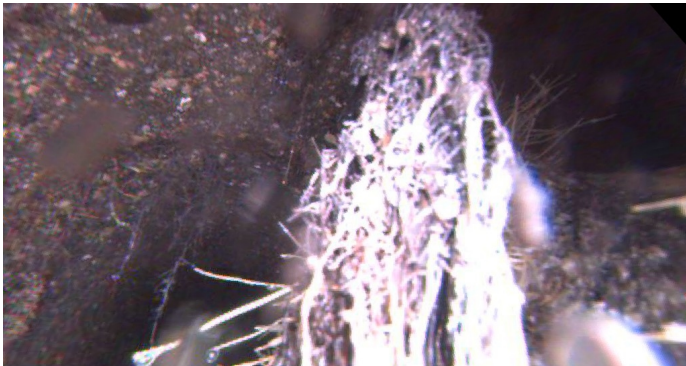
Code: **RFJ**
Description: **Roots Fine Joint**

Distance (ft): **46.3**
Structural Grade: **0**
O&M Grade: **1**
Clock Start/From: **7**
Clock To: **5**
1st Value:
2nd Value:
Value Percent:
Continuous Index: **F01**
Within 8" of Joint: **YES**
Remarks:

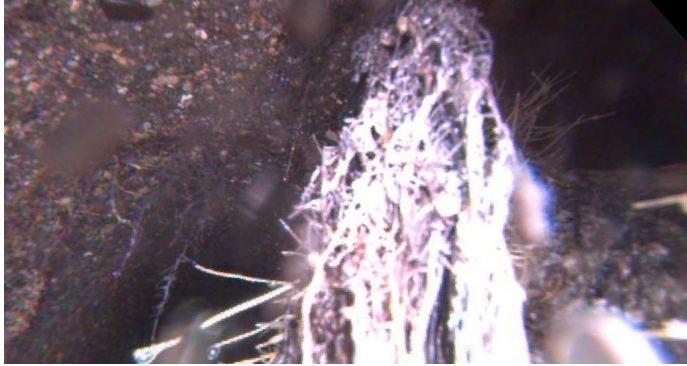
Code:	TFD
Description:	Tap Factory Defective
Distance (ft):	46.3
Structural Grade:	0
O&M Grade:	2
Clock Start/From:	2
Clock To:	
1st Value:	4.000
2nd Value:	
Value Percent:	
Continuous Index:	
Within 8" of Joint:	
Remarks:	RML

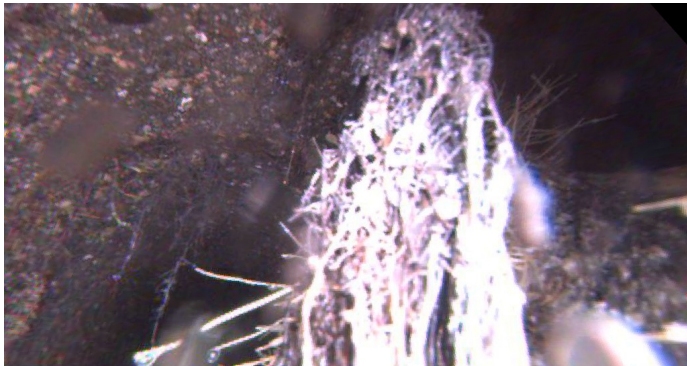
Code:	RML
Description:	Roots Medium Lateral
Distance (ft):	46.3
Structural Grade:	0
O&M Grade:	3
Clock Start/From:	2
Clock To:	
1st Value:	
2nd Value:	
Value Percent:	10.000
Continuous Index:	
Within 8" of Joint:	NO
Remarks:

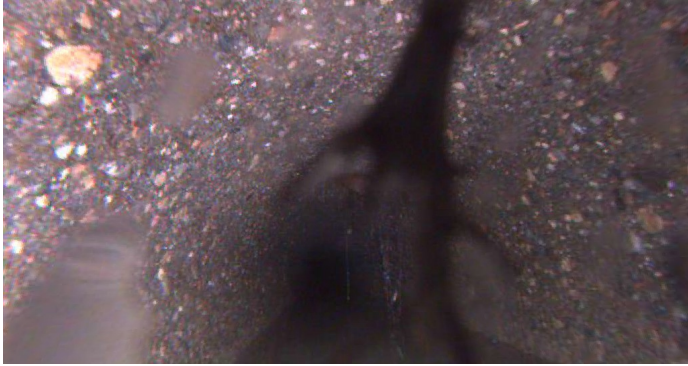
Code:	MSA
Description:	Abandoned Survey
Distance (ft):	47.1
Structural Grade:	0
O&M Grade:	0
Clock Start/From:	
Clock To:	
1st Value:	
2nd Value:	
Value Percent:	
Continuous Index:	
Within 8" of Joint:	NO
Remarks:	RML
