Profile/Photo Observation Report

Street:	W HOME AVE	Flow Control:	Not Controlled
City:	Hobart, IN	Year Renewed:	
Location:	Light Highway	Tape/Media #:	
Purpose:	Routine Assessment	Dia/Height:	12"
Use:	Sanitary	Material:	CP
Drain Area:	NA	Lining:	
Category:	NA		
Comment:	F_S_P_C at 10 ft grit / debris Flow direction wrong		
Location Details:		Direction of Survey:	Upstream
US MH:	M-504-053	DS MH:	M-504-054
		Total Length Surveyed (ft):	12.0

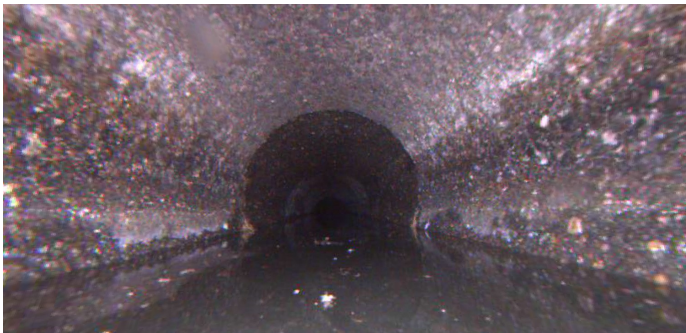
Code:	MWL
Description:	Water Level

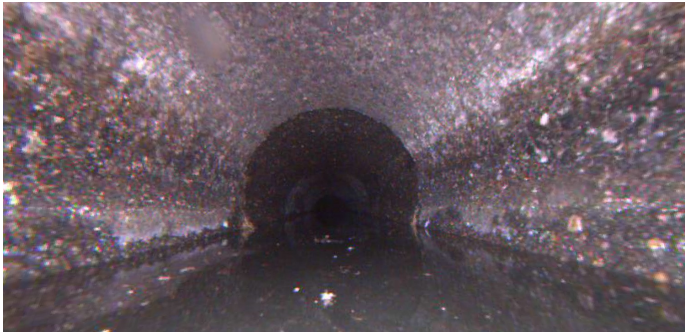
Code:	SAP
Description:	Surface Aggregate Projecting

Distance (ft):	.0
Structural Grade:	3
O&M Grade:	0
Clock Start/From:	8
Clock To:	4
1st Value:	
2nd Value:	
Value Percent:	
Continuous Index:	S01
Within 8" of Joint:	
Remarks:

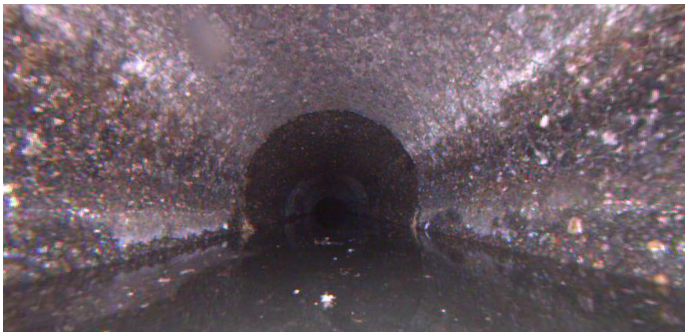
Code: **SSS**
Description: **Surface Spalling**

Distance (ft): **10.8**
Structural Grade: **2**
O&M Grade: **0**
Clock Start/From: **12**
Clock To:
1st Value:
2nd Value:
Value Percent:
Continuous Index:
Within 8" of Joint: **YES**
Remarks:

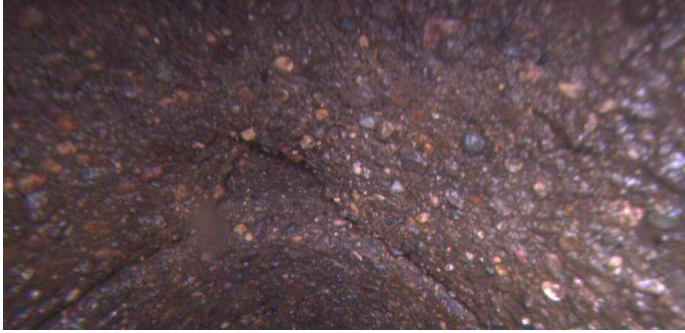
Code: **TBI**
Description: **Tap Break-in Intruding**

Distance (ft): **12.0**
Structural Grade: **0**
O&M Grade: **2**
Clock Start/From: **12**
Clock To:
1st Value: **4.000**
2nd Value: **1.000**
Value Percent:
Continuous Index:
Within 8" of Joint:
Remarks:

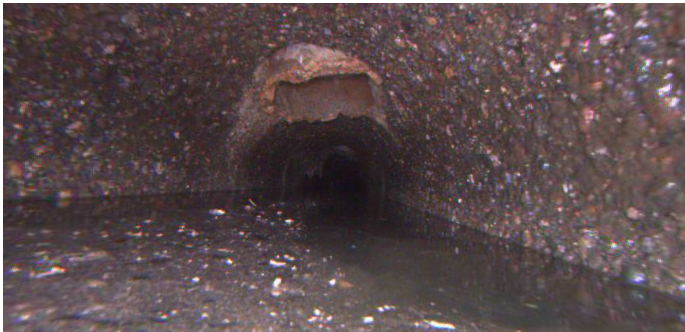
Code: **SAP**
Description: **Surface Aggregate Projecting**

Distance (ft): **12.0**
Structural Grade: **3**
O&M Grade: **0**
Clock Start/From: **8**
Clock To: **4**
1st Value:
2nd Value:
Value Percent:
Continuous Index: **F01**
Within 8" of Joint:
Remarks:

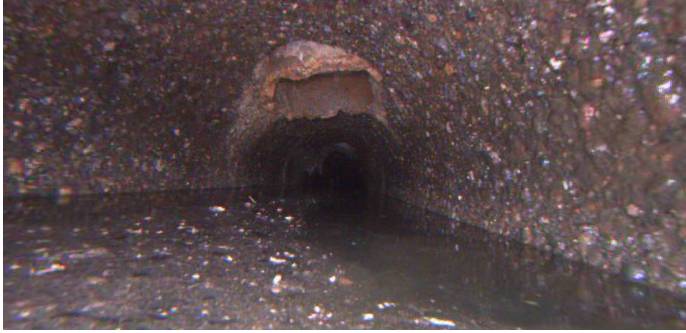
Code: **MSA**
Description: **Abandoned Survey**

Distance (ft): **12.0**
Structural Grade: **0**
O&M Grade: **0**
Clock Start/From:
Clock To:
1st Value:
2nd Value:
Value Percent:
Continuous Index:
Within 8" of Joint: **NO**
Remarks: **debris under water**
