Profile/Photo Observation Report

Date:	04/22/2018	Weather:		Coding:	PACP 6.0
Pipe Length (ft):	305.6	Owner:	NA	Pre Clean:	No Pre-Cleaning
P.O.#:		Surveyor:	Jen Costello	PSR:	P-504-054-053
Customer:		Clean Date:	01/01/1900	Shape:	C

Street:	FOXCROFT STREET	Flow Control:	Not Controlled
City:	Hobart, IN	Year Renewed:	
Location:	Light Highway	Tape/Media #:	
Purpose:	Routine Assessment	Dia/Height:	12"
Use:	Sanitary	Material:	CP
Drain Area:	NA	Lining:	
Category:	NA		
Comment:	F_S_P_C at 10 ft grit / debris Flow direction wrong		
Location Details:		Direction of Survey:	Upstream
US MH:	M-504-053	DS MH:	M-504-054
		Total Length Surveyed (ft):	12.0

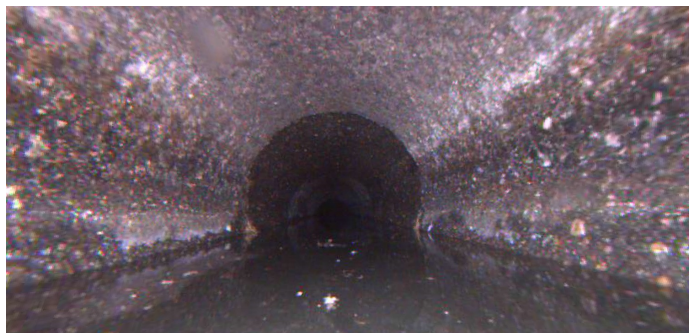
Code: **AMH**
 Description: **Manhole**

Distance (ft): **.0**
 Structural Grade: **0**
 O&M Grade: **0**
 Clock Start/From:
 Clock To:
 1st Value:
 2nd Value:
 Value Percent:
 Continuous Index:
 Within 8" of Joint: **NO**
 Remarks: **M-504-054**

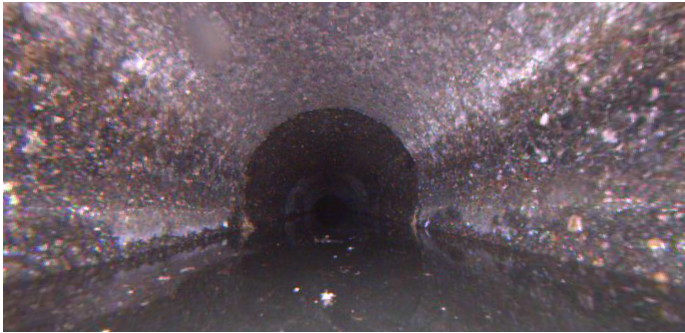
Code:	MWL
Description:	Water Level

Distance (ft):	.0
Structural Grade:	0
O&M Grade:	0
Clock Start/From:	
Clock To:	
1st Value:	
2nd Value:	
Value Percent:	40.000
Continuous Index:	
Within 8" of Joint:	NO
Remarks:

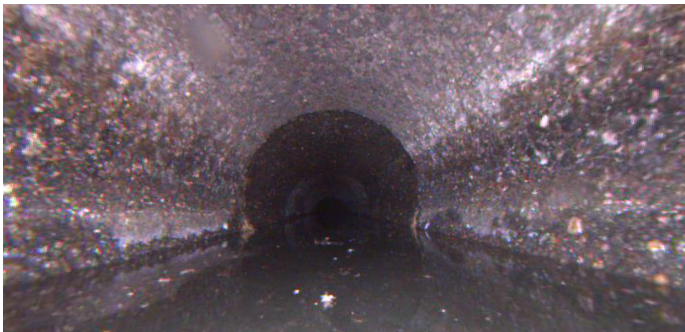
Code:	SAP
Description:	Surface Aggregate Projecting

Distance (ft):	.0
Structural Grade:	3
O&M Grade:	0
Clock Start/From:	8
Clock To:	4
1st Value:	
2nd Value:	
Value Percent:	
Continuous Index:	S01
Within 8" of Joint:	
Remarks:

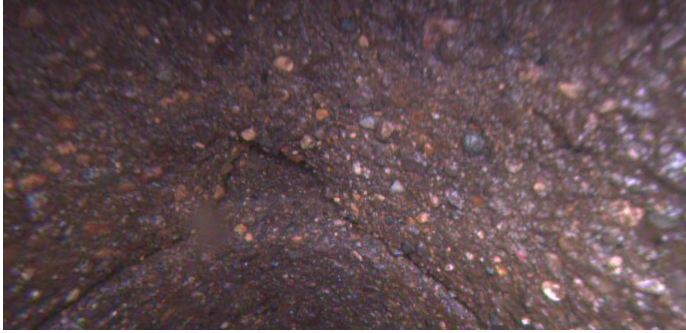
Code: **SSS**
Description: **Surface Spalling**

Distance (ft): **10.8**
Structural Grade: **2**
O&M Grade: **0**
Clock Start/From: **12**
Clock To:
1st Value:
2nd Value:
Value Percent:
Continuous Index:
Within 8" of Joint: **YES**
Remarks:

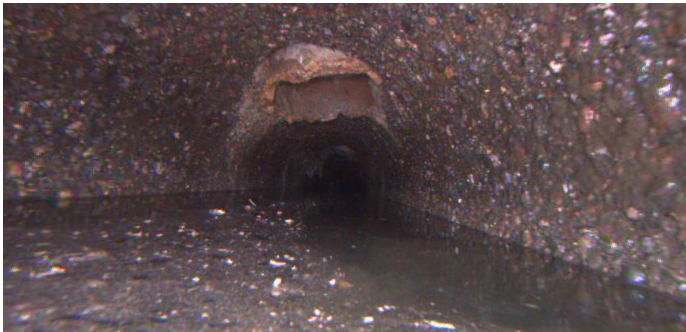
Code: **TBI**
Description: **Tap Break-in Intruding**

Distance (ft): **12.0**
Structural Grade: **0**
O&M Grade: **2**
Clock Start/From: **12**
Clock To:
1st Value: **4.000**
2nd Value: **1.000**
Value Percent:
Continuous Index:
Within 8" of Joint:
Remarks:

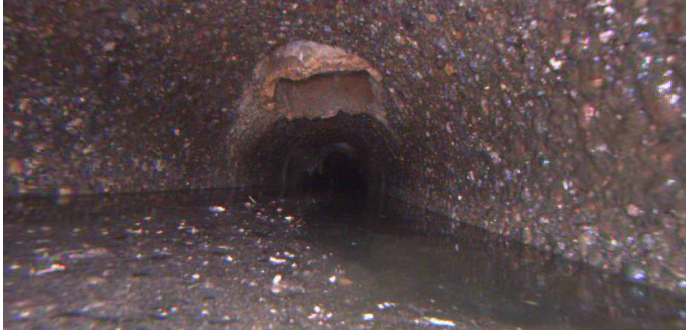
Code: **SAP**
Description: **Surface Aggregate Projecting**

Distance (ft): **12.0**
Structural Grade: **3**
O&M Grade: **0**
Clock Start/From: **8**
Clock To: **4**
1st Value:
2nd Value:
Value Percent:
Continuous Index: **F01**
Within 8" of Joint:
Remarks:

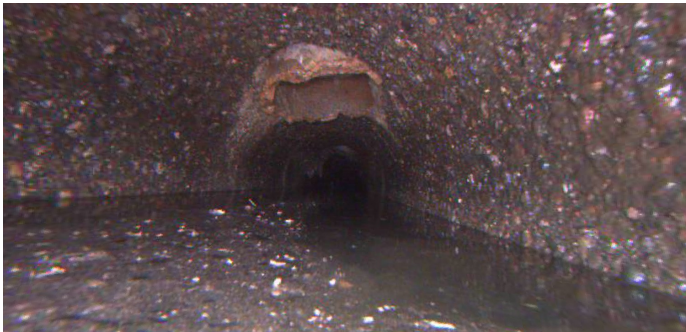
Code: **MSA**
Description: **Abandoned Survey**

Distance (ft): **12.0**
Structural Grade: **0**
O&M Grade: **0**
Clock Start/From:
Clock To:
1st Value:
2nd Value:
Value Percent:
Continuous Index:
Within 8" of Joint: **NO**
Remarks: **debris under water**
