Profile/Photo Observation Report

Date:	09/15/2021	Weather:		Coding:	PACP 7.0
Pipe Length (ft):	307.1	Owner:	City of Hobart	Pre Clean:	Light Cleaning
P.O.#:	YES502259	Surveyor:	S. Bucklin	PSR:	P-504-054-053
Customer:	City of Hobart	Clean Date:	09/10/2021	Shape:	C

Street:	North Guyer Street	Flow Control:	Not Controlled
City:	Hobart, IN	Year Renewed:	
Location:	Alley	Tape/Media #:	
Purpose:	Routine Assessment	Dia/Height:	10"
Use:	Sanitary Sewage Pipe	Material:	CP
Drain Area:		Lining:	None
Category:	NA		
Comment:			
Location Details:		Direction of Survey:	Downstream
US MH:	M-504-053	DS MH:	M-504-054
		Total Length Surveyed (ft):	307.1

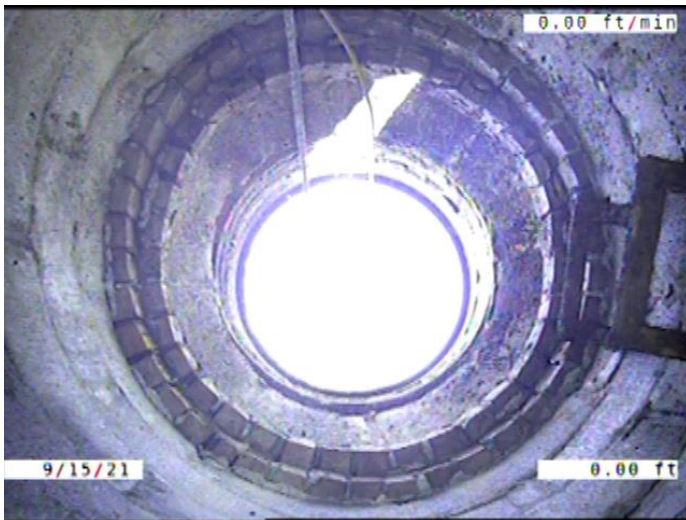
Code: **AMH**
Description: **Manhole**

Distance (ft): **.0**
Structural Grade: **0**
O&M Grade: **0**
Clock Start/From:
Clock To:
1st Value:
2nd Value:
Value Percent:
Continuous Index:
Within 8" of Joint: **NO**
Remarks: **M-504-053**

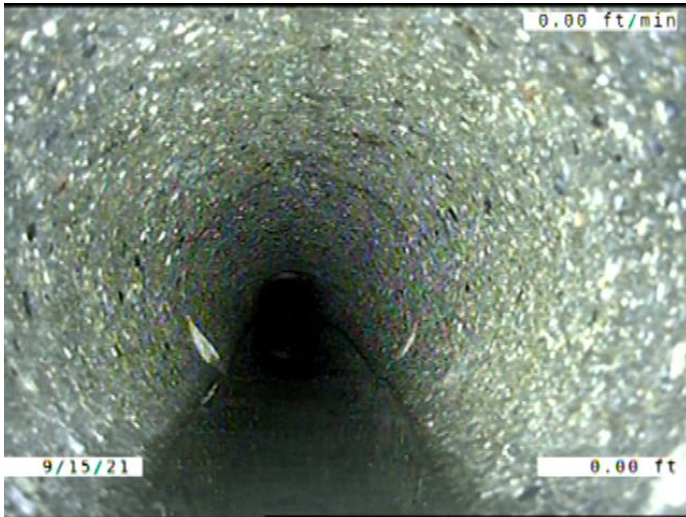
Code: **MWL**
 Description: **Miscellaneous Water Level**

Distance (ft): **.0**
 Structural Grade: **0**
 O&M Grade: **0**
 Clock Start/From:
 Clock To:
 1st Value:
 2nd Value:
 Value Percent: **10.000**
 Continuous Index:
 Within 8" of Joint: **NO**
 Remarks:

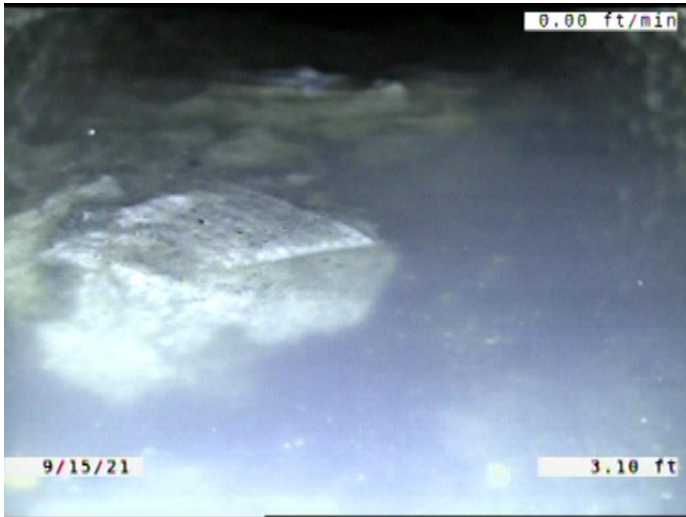
Code: **DSF**
 Description: **Deposits Settled Fine**

Distance (ft): **3.1**
 Structural Grade: **0**
 O&M Grade: **2**
 Clock Start/From: **5**
 Clock To: **7**
 1st Value:
 2nd Value:
 Value Percent: **5.000**
 Continuous Index: **S01**
 Within 8" of Joint: **YES**
 Remarks:

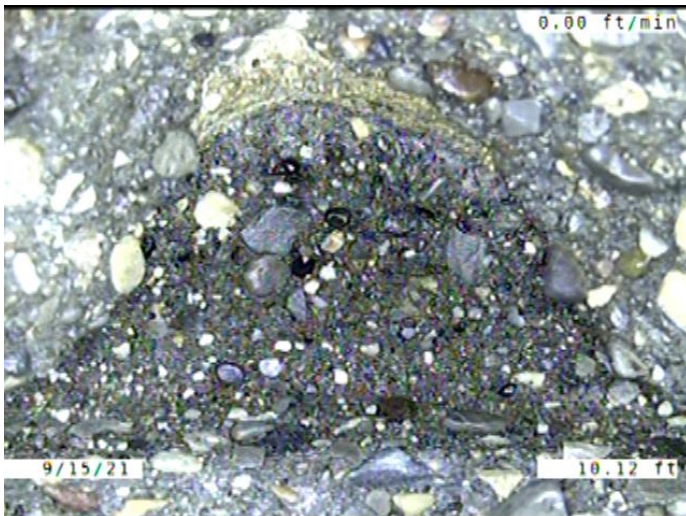
Code: **SMW**
 Description: **Surface Damage Missing Wall**

Distance (ft): **10.1**
 Structural Grade: **5**
 O&M Grade: **0**
 Clock Start/From: **11**
 Clock To: **12**
 1st Value:
 2nd Value:
 Value Percent:
 Continuous Index:
 Within 8" of Joint: **YES**
 Remarks: **INSIDE OF THE JOINT**

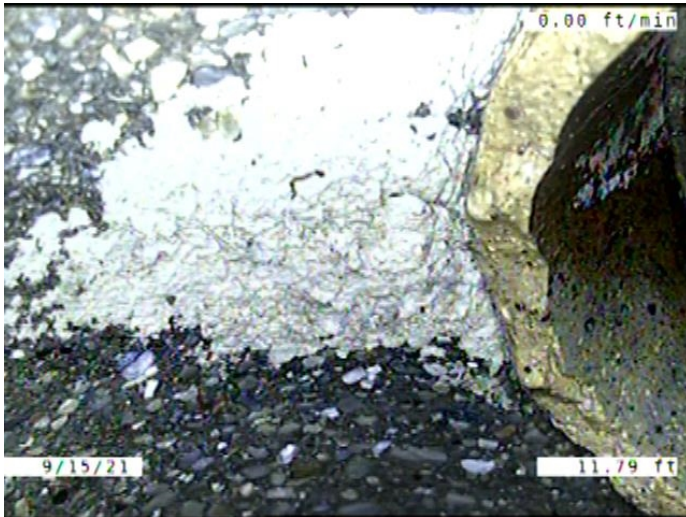
Code: **DAE**
 Description: **Deposits Attached Encrustation**

Distance (ft): **11.8**
 Structural Grade: **0**
 O&M Grade: **2**
 Clock Start/From: **10**
 Clock To: **2**
 1st Value:
 2nd Value:
 Value Percent: **5.000**
 Continuous Index:
 Within 8" of Joint: **YES**
 Remarks:

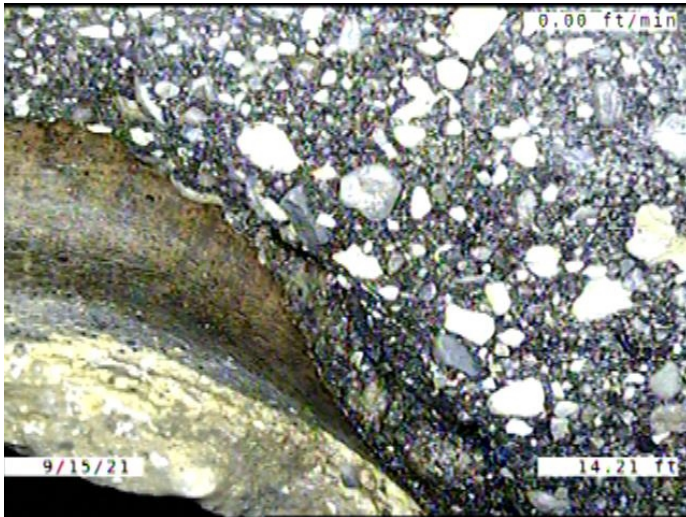
Code: **B**
Description: **Broken**

Distance (ft): **14.2**
Structural Grade: **4**
O&M Grade: **0**
Clock Start/From: **2**
Clock To:
1st Value:
2nd Value:
Value Percent:
Continuous Index:
Within 8" of Joint: **YES**
Remarks:

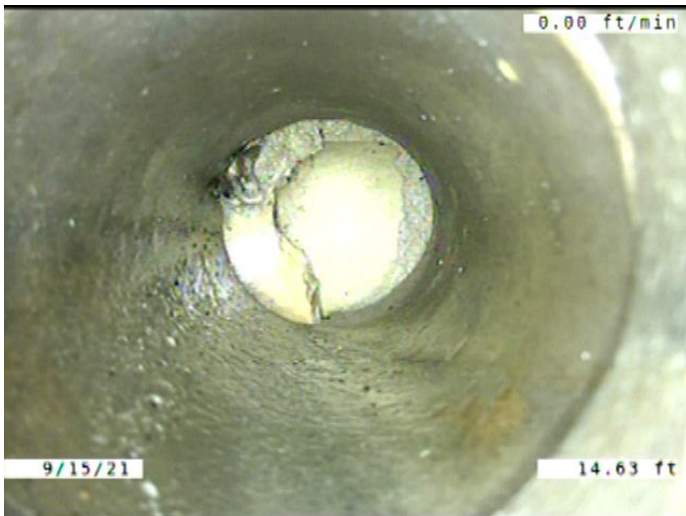
Code: **TBI**
Description: **Tap Break-in Intruding**

Distance (ft): **14.6**
Structural Grade: **0**
O&M Grade: **2**
Clock Start/From: **12**
Clock To:
1st Value: **4.000**
2nd Value: **1.000**
Value Percent:
Continuous Index:
Within 8" of Joint: **YES**
Remarks:

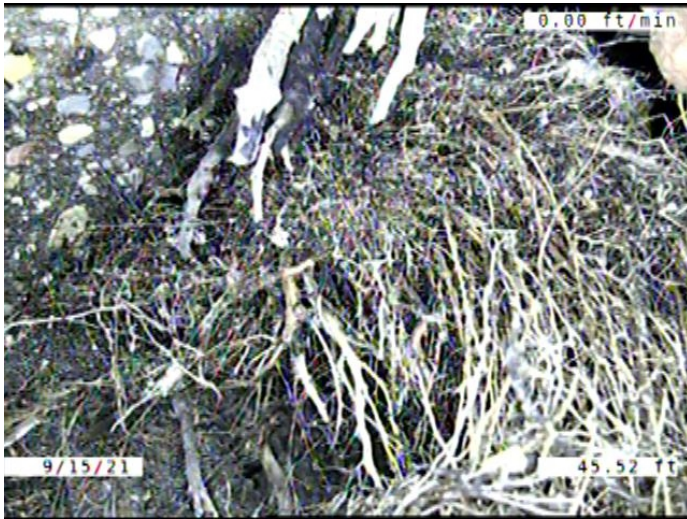
Code: **RML**
 Description: **Roots Medium Lateral**

Distance (ft): **45.5**
 Structural Grade: **0**
 O&M Grade: **3**
 Clock Start/From: **10**
 Clock To: **1**
 1st Value:
 2nd Value:
 Value Percent: **30.000**
 Continuous Index:
 Within 8" of Joint: **NO**
 Remarks:

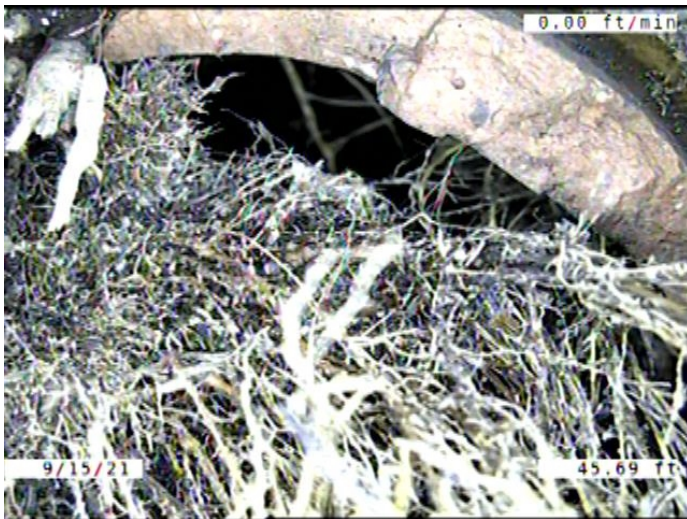
Code: **TBI**
 Description: **Tap Break-in Intruding**

Distance (ft): **45.7**
 Structural Grade: **0**
 O&M Grade: **2**
 Clock Start/From: **12**
 Clock To:
 1st Value: **4.000**
 2nd Value: **1.000**
 Value Percent:
 Continuous Index:
 Within 8" of Joint: **YES**
 Remarks:

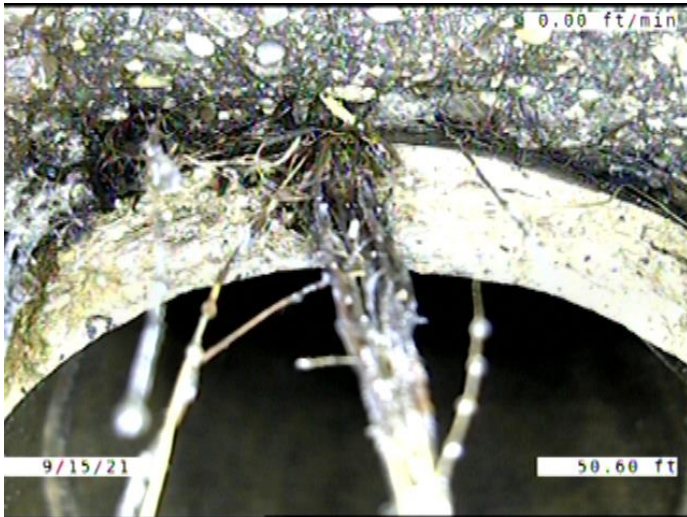
Code: **RFL**
 Description: **Roots Fine Lateral**

Distance (ft): **50.6**
 Structural Grade: **0**
 O&M Grade: **1**
 Clock Start/From: **11**
 Clock To: **1**
 1st Value:
 2nd Value:
 Value Percent:
 Continuous Index:
 Within 8" of Joint: **NO**
 Remarks:

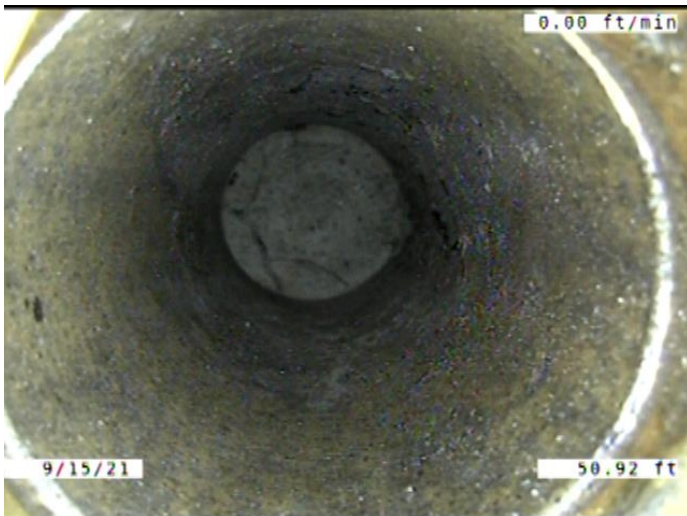
Code: **TBC**
 Description: **Tap Break-in Capped**

Distance (ft): **50.9**
 Structural Grade: **0**
 O&M Grade: **0**
 Clock Start/From: **12**
 Clock To:
 1st Value: **4.000**
 2nd Value:
 Value Percent:
 Continuous Index:
 Within 8" of Joint: **NO**
 Remarks:

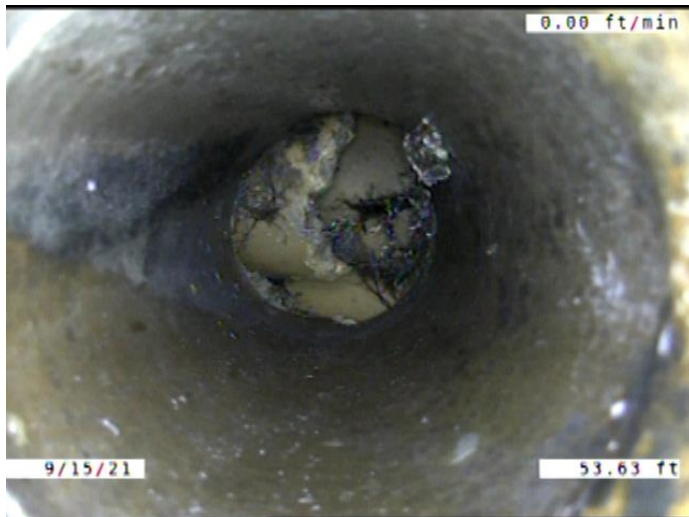
Code: **TBI**
 Description: **Tap Break-in Intruding**

Distance (ft): **53.6**
 Structural Grade: **0**
 O&M Grade: **2**
 Clock Start/From: **12**
 Clock To:
 1st Value: **4.000**
 2nd Value: **1.000**
 Value Percent:
 Continuous Index:
 Within 8" of Joint: **NO**
 Remarks:

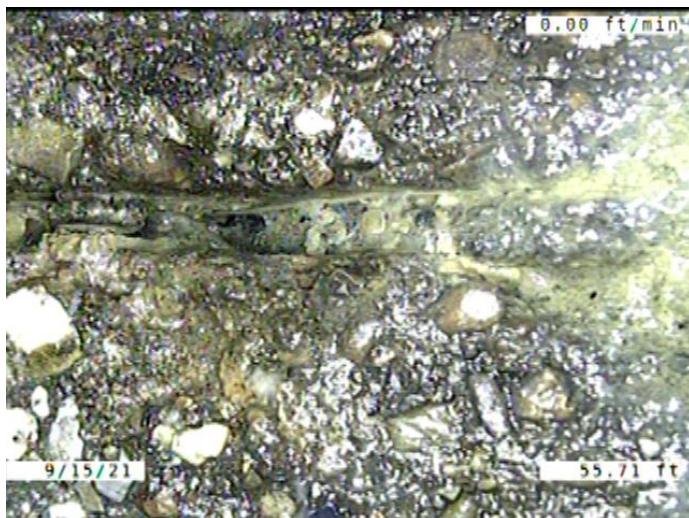
Code: **ISJ**
 Description: **Infiltration Stain Joint**

Distance (ft): **55.7**
 Structural Grade: **0**
 O&M Grade: **1**
 Clock Start/From: **7**
 Clock To: **8**
 1st Value:
 2nd Value:
 Value Percent:
 Continuous Index:
 Within 8" of Joint: **YES**
 Remarks:

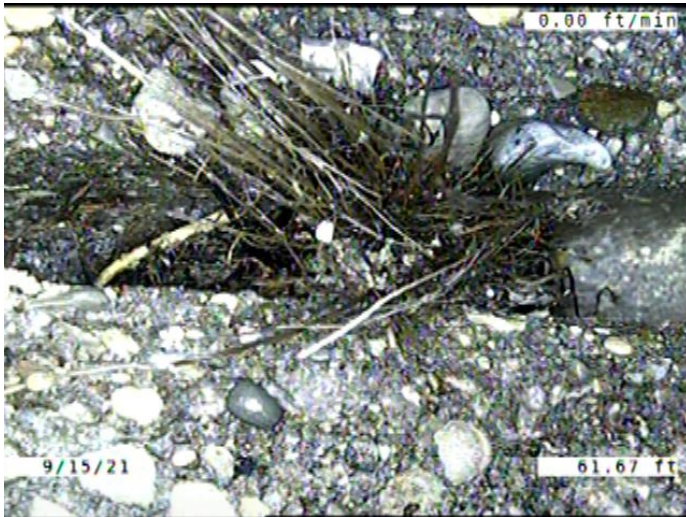
Code: **RFJ**
 Description: **Roots Fine Joint**

Distance (ft): **61.7**
 Structural Grade: **0**
 O&M Grade: **1**
 Clock Start/From: **3**
 Clock To:
 1st Value:
 2nd Value:
 Value Percent:
 Continuous Index:
 Within 8" of Joint: **YES**
 Remarks:

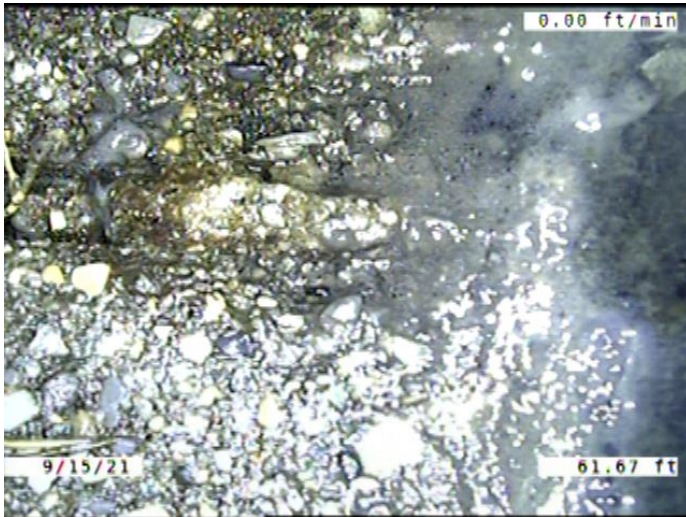
Code: **ISJ**
 Description: **Infiltration Stain Joint**

Distance (ft): **61.7**
 Structural Grade: **0**
 O&M Grade: **1**
 Clock Start/From: **7**
 Clock To:
 1st Value:
 2nd Value:
 Value Percent:
 Continuous Index:
 Within 8" of Joint: **YES**
 Remarks:

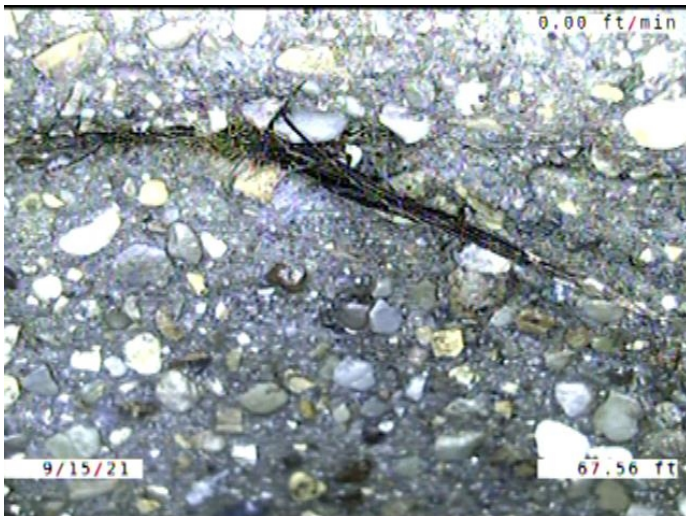
Code: **RFJ**
 Description: **Roots Fine Joint**

Distance (ft): **67.6**
 Structural Grade: **0**
 O&M Grade: **1**
 Clock Start/From: **11**
 Clock To: **3**
 1st Value:
 2nd Value:
 Value Percent:
 Continuous Index:
 Within 8" of Joint: **YES**
 Remarks:

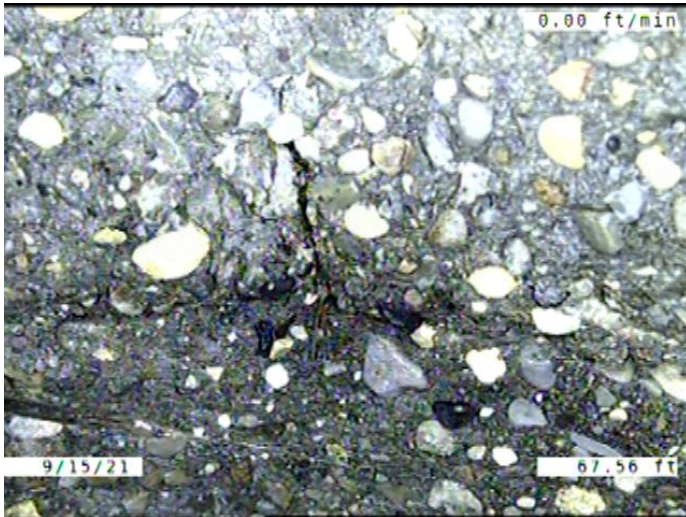
Code: **CL**
 Description: **Crack Longitudinal**

Distance (ft): **67.6**
 Structural Grade: **2**
 O&M Grade: **0**
 Clock Start/From: **3**
 Clock To:
 1st Value:
 2nd Value:
 Value Percent:
 Continuous Index:
 Within 8" of Joint: **YES**
 Remarks:

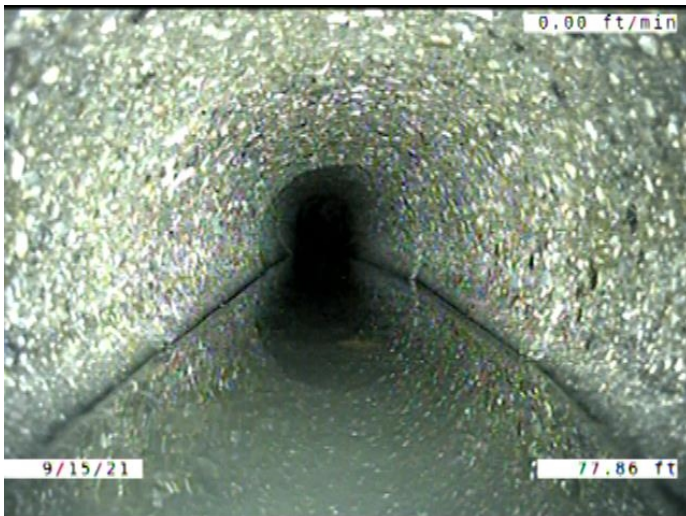
Code: **MWLS**
 Description: **Miscellaneous Water Level Sag**

Distance (ft): **77.9**
 Structural Grade: **2**
 O&M Grade: **0**
 Clock Start/From:
 Clock To:
 1st Value:
 2nd Value:
 Value Percent: **10.000**
 Continuous Index: **S02**
 Within 8" of Joint: **NO**
 Remarks:

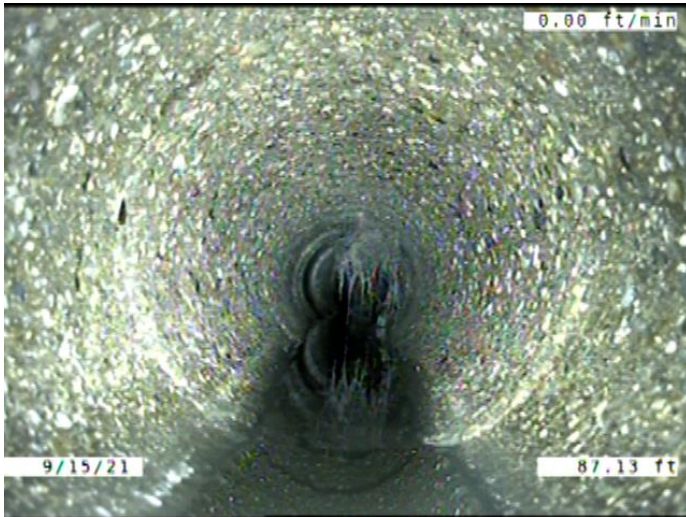
Code: **MWLS**
 Description: **Miscellaneous Water Level Sag**

Distance (ft): **87.1**
 Structural Grade: **2**
 O&M Grade: **0**
 Clock Start/From:
 Clock To:
 1st Value:
 2nd Value:
 Value Percent: **10.000**
 Continuous Index: **F02**
 Within 8" of Joint: **NO**
 Remarks:

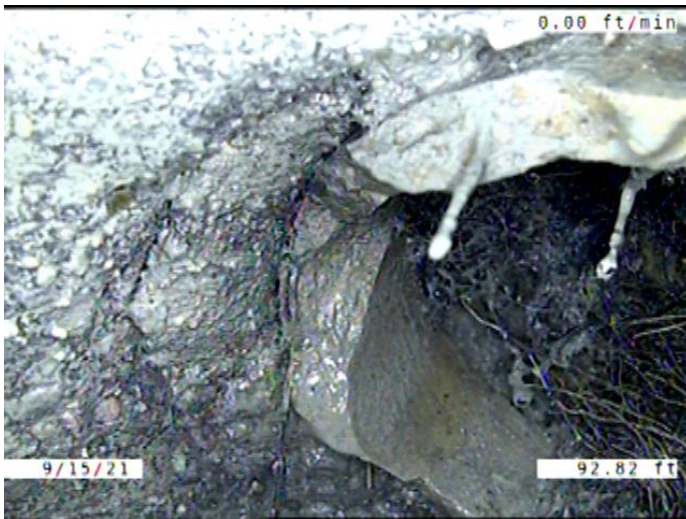
Code: **B**
 Description: **Broken**

Distance (ft): **92.8**
 Structural Grade: **4**
 O&M Grade: **0**
 Clock Start/From: **11**
 Clock To: **1**
 1st Value:
 2nd Value:
 Value Percent:
 Continuous Index:
 Within 8" of Joint: **YES**
 Remarks:

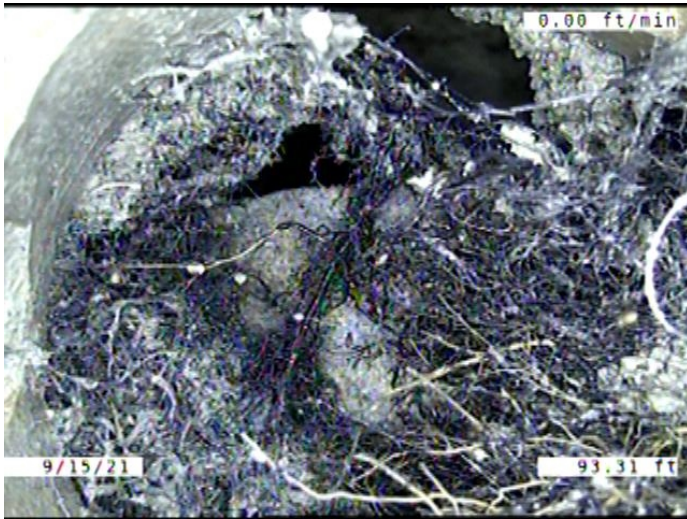
Code: **TBI**
 Description: **Tap Break-in Intruding**

Distance (ft): **93.3**
 Structural Grade: **0**
 O&M Grade: **2**
 Clock Start/From: **12**
 Clock To:
 1st Value: **4.000**
 2nd Value: **1.000**
 Value Percent:
 Continuous Index:
 Within 8" of Joint: **NO**
 Remarks:

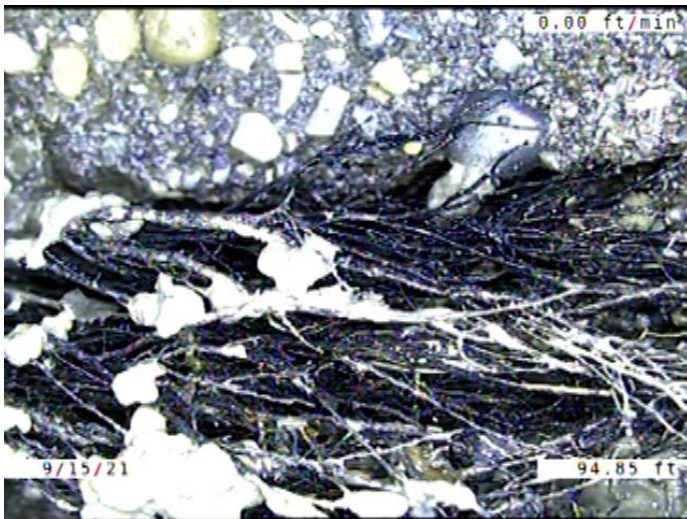
Code: **RFJ**
 Description: **Roots Fine Joint**

Distance (ft): **94.8**
 Structural Grade: **0**
 O&M Grade: **1**
 Clock Start/From: **2**
 Clock To: **4**
 1st Value:
 2nd Value:
 Value Percent:
 Continuous Index:
 Within 8" of Joint: **YES**
 Remarks:

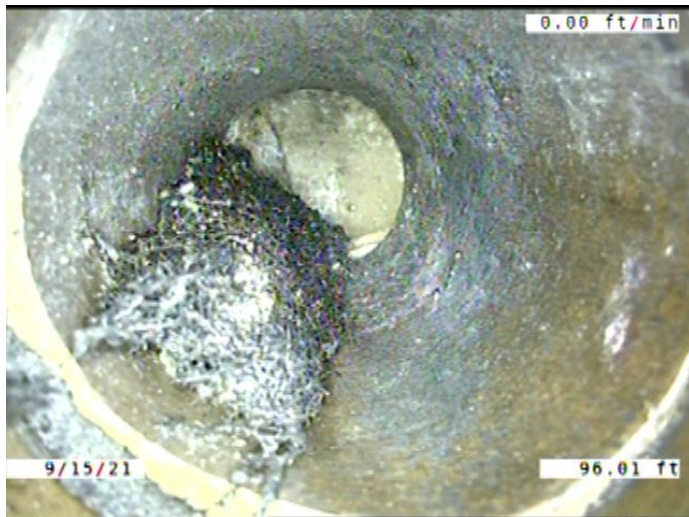
Code: **TBI**
 Description: **Tap Break-in Intruding**

Distance (ft): **96.0**
 Structural Grade: **0**
 O&M Grade: **2**
 Clock Start/From: **12**
 Clock To:
 1st Value: **4.000**
 2nd Value: **1.000**
 Value Percent:
 Continuous Index:
 Within 8" of Joint: **NO**
 Remarks:

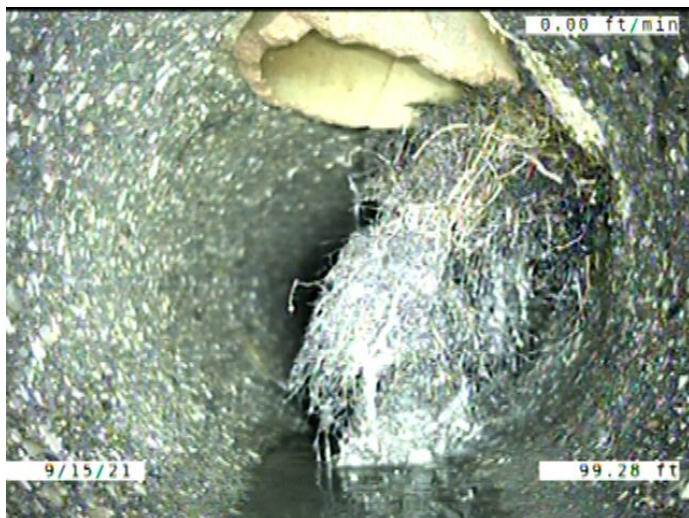
Code: **RML**
 Description: **Roots Medium Lateral**

Distance (ft): **99.3**
 Structural Grade: **0**
 O&M Grade: **3**
 Clock Start/From: **1**
 Clock To: **4**
 1st Value:
 2nd Value:
 Value Percent: **25.000**
 Continuous Index:
 Within 8" of Joint: **NO**
 Remarks:

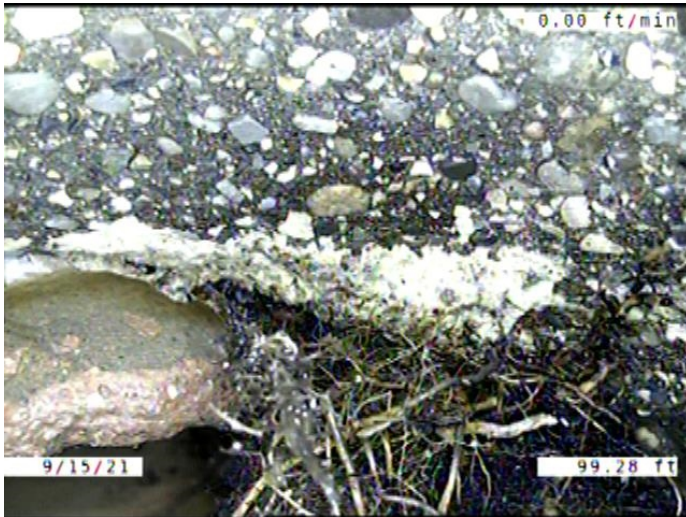
Code: **DAE**
 Description: **Deposits Attached Encrustation**

Distance (ft): **99.3**
 Structural Grade: **0**
 O&M Grade: **2**
 Clock Start/From: **1**
 Clock To: **3**
 1st Value:
 2nd Value:
 Value Percent: **5.000**
 Continuous Index:
 Within 8" of Joint: **NO**
 Remarks:

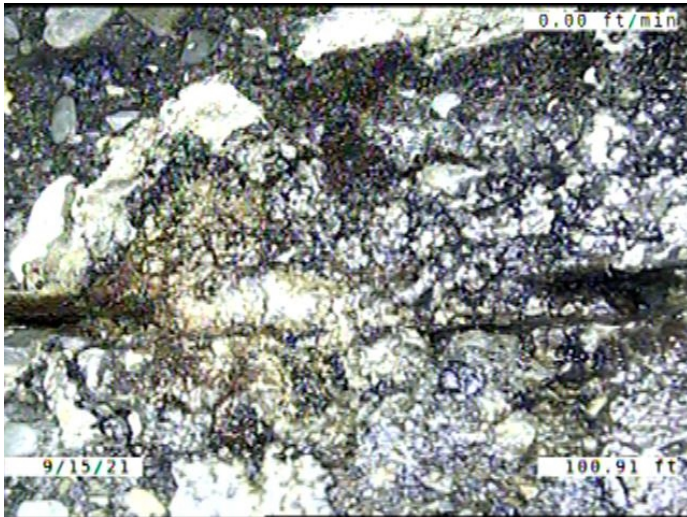
Code: **DAE**
 Description: **Deposits Attached Encrustation**

Distance (ft): **100.9**
 Structural Grade: **0**
 O&M Grade: **2**
 Clock Start/From: **3**
 Clock To: **9**
 1st Value:
 2nd Value:
 Value Percent: **5.000**
 Continuous Index: **S03**
 Within 8" of Joint: **YES**
 Remarks:

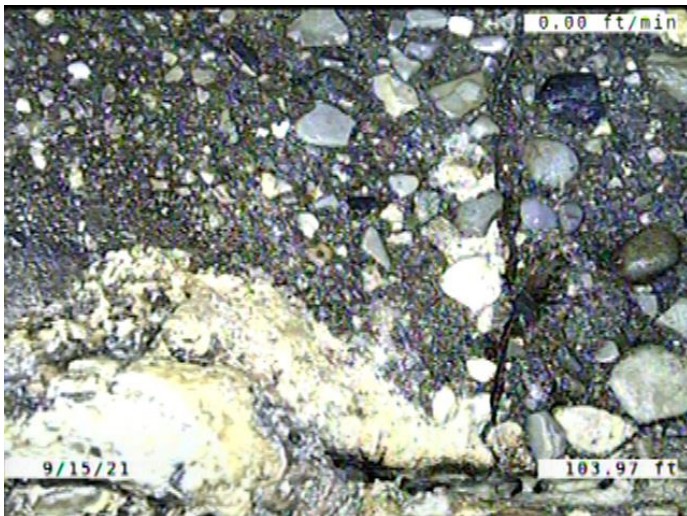
Code: **FM**
 Description: **Fracture Multiple**

Distance (ft): **104.0**
 Structural Grade: **4**
 O&M Grade: **0**
 Clock Start/From: **3**
 Clock To: **9**
 1st Value:
 2nd Value:
 Value Percent:
 Continuous Index:
 Within 8" of Joint: **YES**
 Remarks:

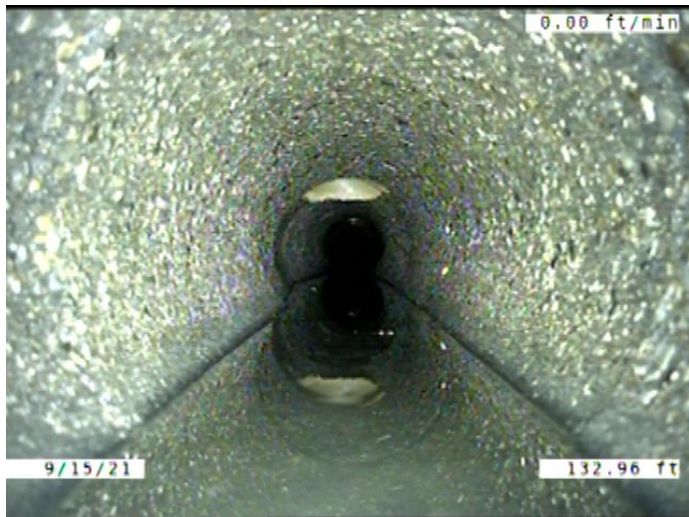
Code: **DAE**
 Description: **Deposits Attached Encrustation**

Distance (ft): **133.0**
 Structural Grade: **0**
 O&M Grade: **2**
 Clock Start/From: **3**
 Clock To: **9**
 1st Value:
 2nd Value:
 Value Percent: **5.000**
 Continuous Index: **F03**
 Within 8" of Joint: **YES**
 Remarks:

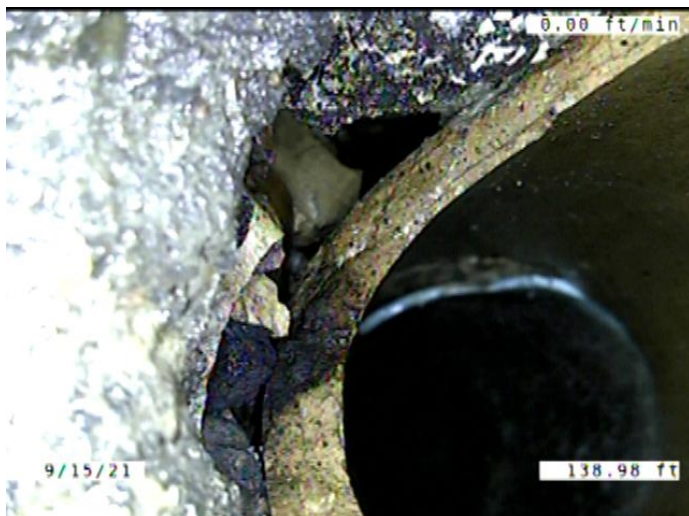
Code: **HVV**
 Description: **Hole Void Visible**

Distance (ft): **139.0**
 Structural Grade: **5**
 O&M Grade: **0**
 Clock Start/From: **11**
 Clock To:
 1st Value:
 2nd Value:
 Value Percent:
 Continuous Index:
 Within 8" of Joint: **NO**
 Remarks:

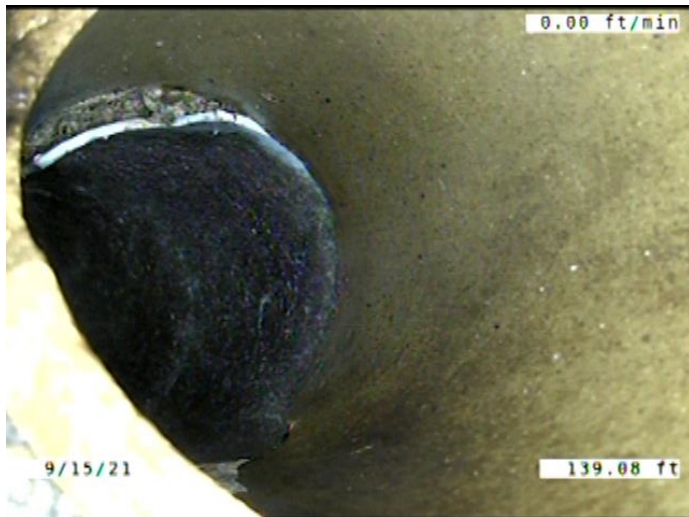
Code: **TB**
 Description: **Tap Break-in/Hammer**

Distance (ft): **139.1**
 Structural Grade: **0**
 O&M Grade: **0**
 Clock Start/From: **11**
 Clock To:
 1st Value: **4.000**
 2nd Value:
 Value Percent:
 Continuous Index:
 Within 8" of Joint: **NO**
 Remarks:

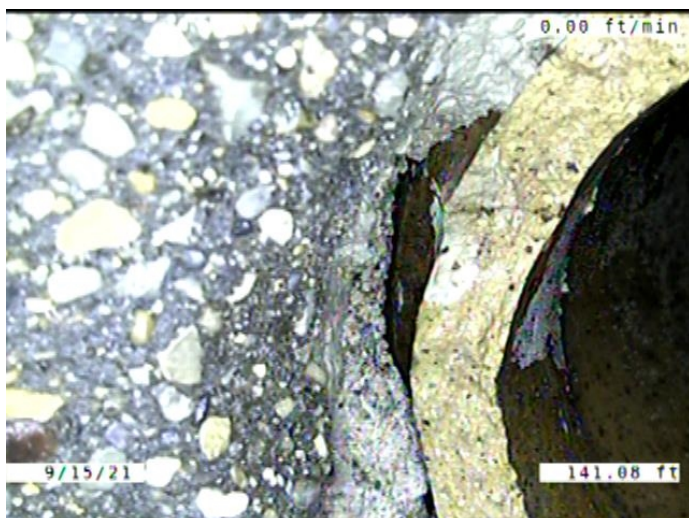
Code: **B**
 Description: **Broken**

Distance (ft): **141.1**
 Structural Grade: **4**
 O&M Grade: **0**
 Clock Start/From: **11**
 Clock To:
 1st Value:
 2nd Value:
 Value Percent:
 Continuous Index:
 Within 8" of Joint: **NO**
 Remarks:

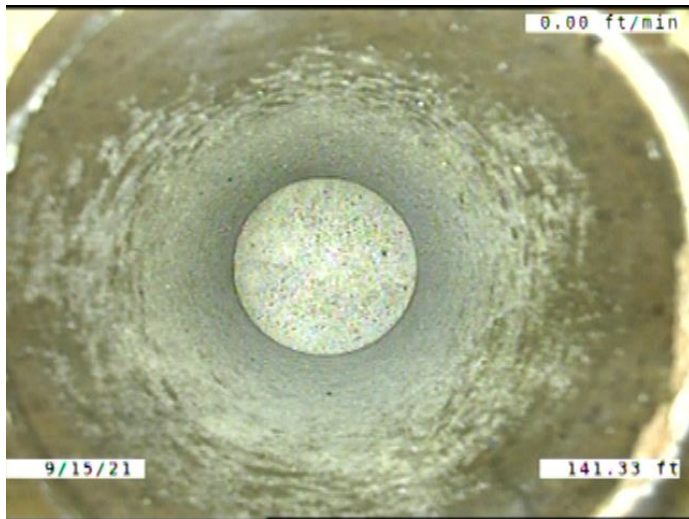
Code: **TBI**
 Description: **Tap Break-in Intruding**

Distance (ft): **141.3**
 Structural Grade: **0**
 O&M Grade: **2**
 Clock Start/From: **12**
 Clock To:
 1st Value: **4.000**
 2nd Value: **1.000**
 Value Percent:
 Continuous Index:
 Within 8" of Joint: **NO**
 Remarks:

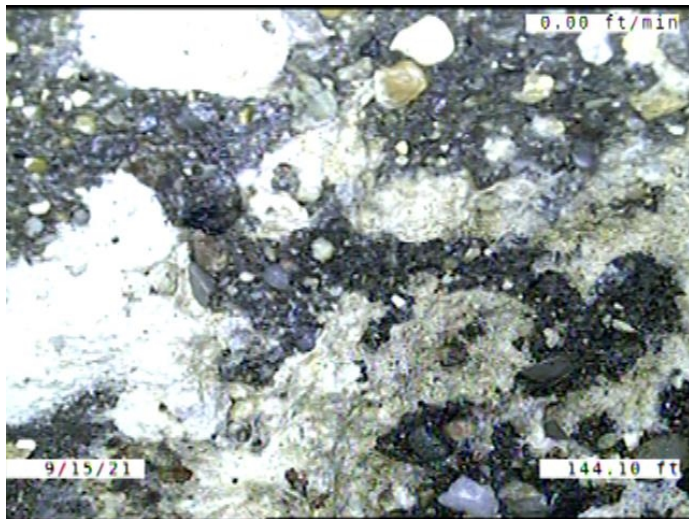
Code: **DAE**
 Description: **Deposits Attached Encrustation**

Distance (ft): **144.1**
 Structural Grade: **0**
 O&M Grade: **2**
 Clock Start/From: **10**
 Clock To: **12**
 1st Value:
 2nd Value:
 Value Percent: **5.000**
 Continuous Index:
 Within 8" of Joint: **NO**
 Remarks:

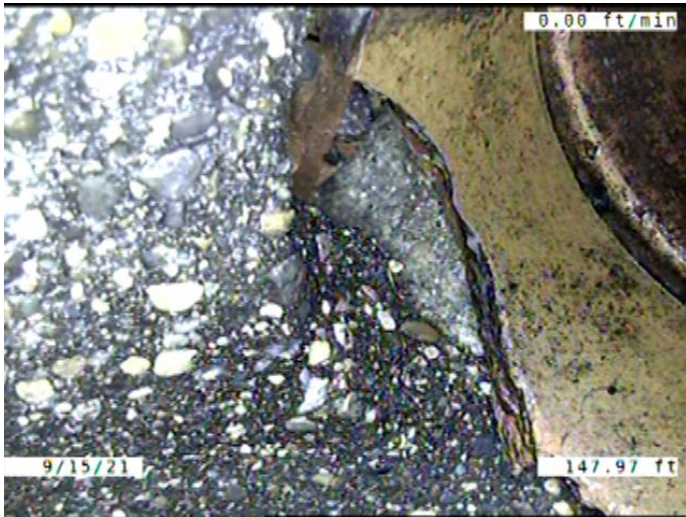
Code: **B**
 Description: **Broken**

Distance (ft): **148.0**
 Structural Grade: **4**
 O&M Grade: **0**
 Clock Start/From: **11**
 Clock To:
 1st Value:
 2nd Value:
 Value Percent:
 Continuous Index:
 Within 8" of Joint: **NO**
 Remarks:

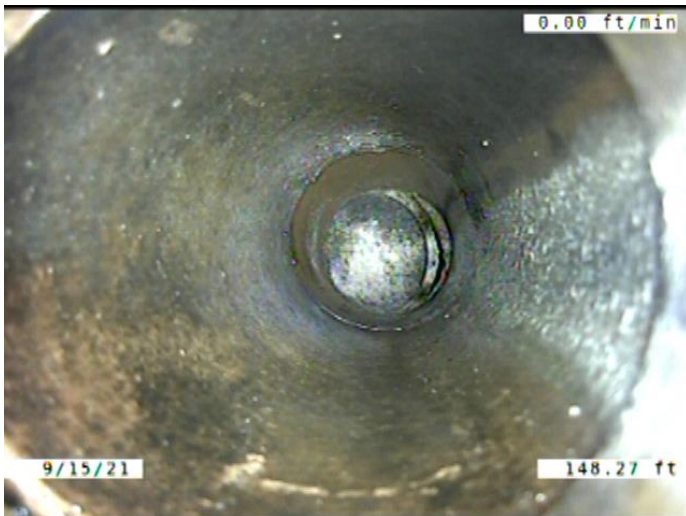
Code: **TBI**
 Description: **Tap Break-in Intruding**

Distance (ft): **148.3**
 Structural Grade: **0**
 O&M Grade: **2**
 Clock Start/From: **12**
 Clock To:
 1st Value: **4.000**
 2nd Value: **1.000**
 Value Percent:
 Continuous Index:
 Within 8" of Joint: **YES**
 Remarks:

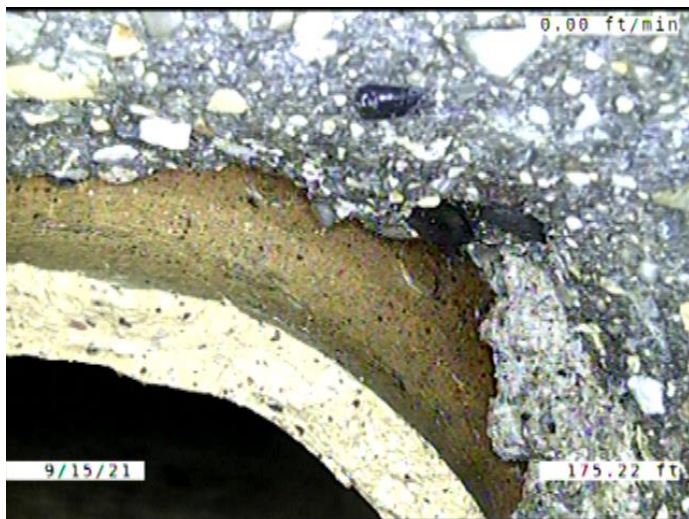
Code: **B**
 Description: **Broken**

Distance (ft): **175.2**
 Structural Grade: **4**
 O&M Grade: **0**
 Clock Start/From: **11**
 Clock To: **1**
 1st Value:
 2nd Value:
 Value Percent:
 Continuous Index:
 Within 8" of Joint: **NO**
 Remarks:

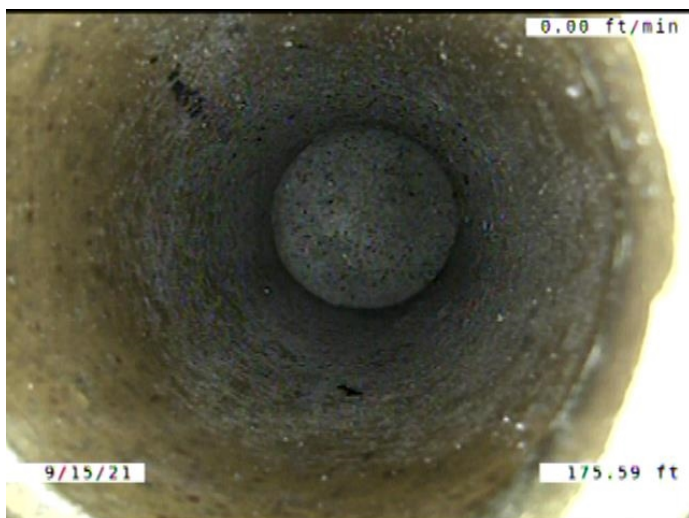
Code: **TBI**
 Description: **Tap Break-in Intruding**

Distance (ft): **175.6**
 Structural Grade: **0**
 O&M Grade: **2**
 Clock Start/From: **12**
 Clock To:
 1st Value: **4.000**
 2nd Value: **1.000**
 Value Percent:
 Continuous Index:
 Within 8" of Joint: **NO**
 Remarks:

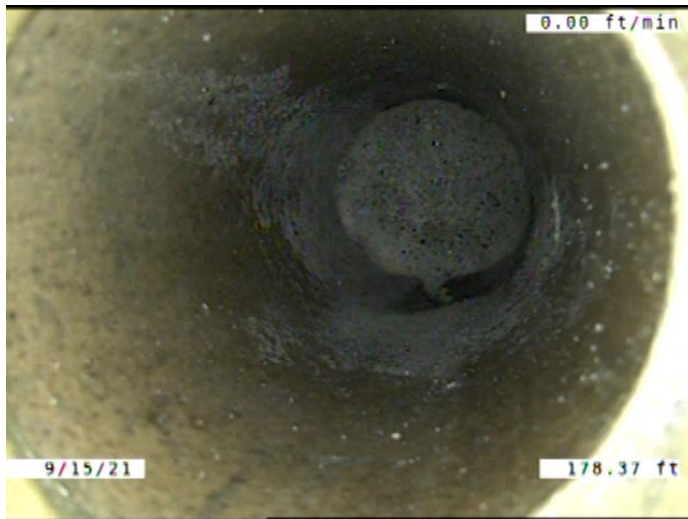
Code: **TBI**
Description: **Tap Break-in Intruding**

Distance (ft): **178.4**
Structural Grade: **0**
O&M Grade: **2**
Clock Start/From: **11**
Clock To:
1st Value: **4.000**
2nd Value: **1.000**
Value Percent:
Continuous Index:
Within 8" of Joint: **YES**
Remarks:

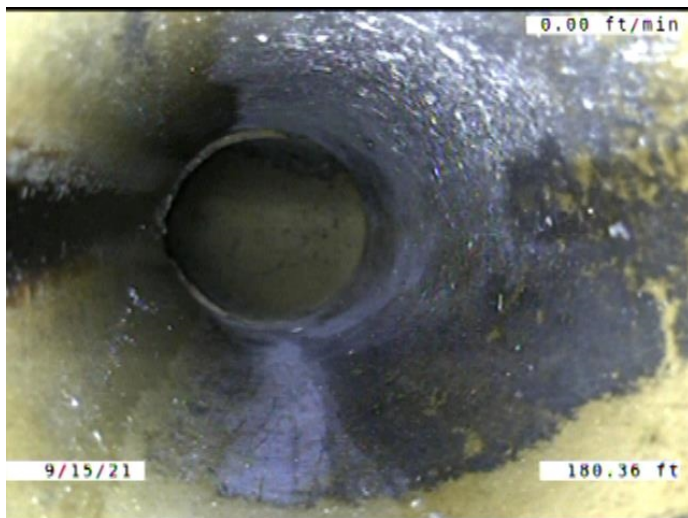
Code: **TBI**
Description: **Tap Break-in Intruding**

Distance (ft): **180.4**
Structural Grade: **0**
O&M Grade: **2**
Clock Start/From: **11**
Clock To:
1st Value: **4.000**
2nd Value: **1.000**
Value Percent:
Continuous Index:
Within 8" of Joint: **NO**
Remarks:

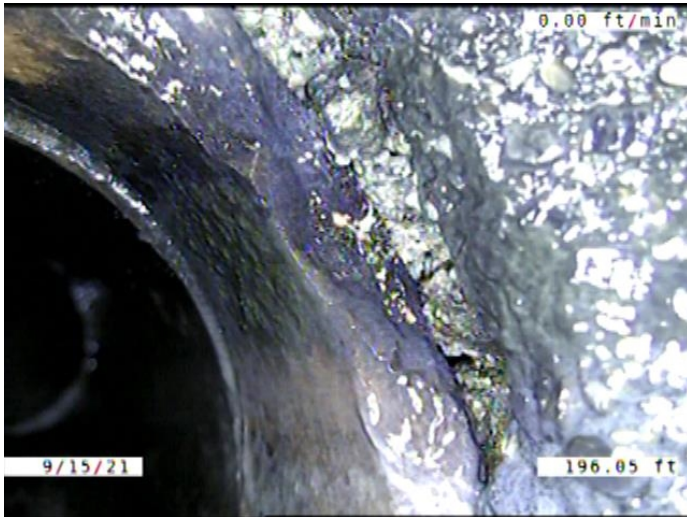
Code: **B**
 Description: **Broken**

Distance (ft): **196.1**
 Structural Grade: **4**
 O&M Grade: **0**
 Clock Start/From: **11**
 Clock To: **1**
 1st Value:
 2nd Value:
 Value Percent:
 Continuous Index:
 Within 8" of Joint: **NO**
 Remarks:

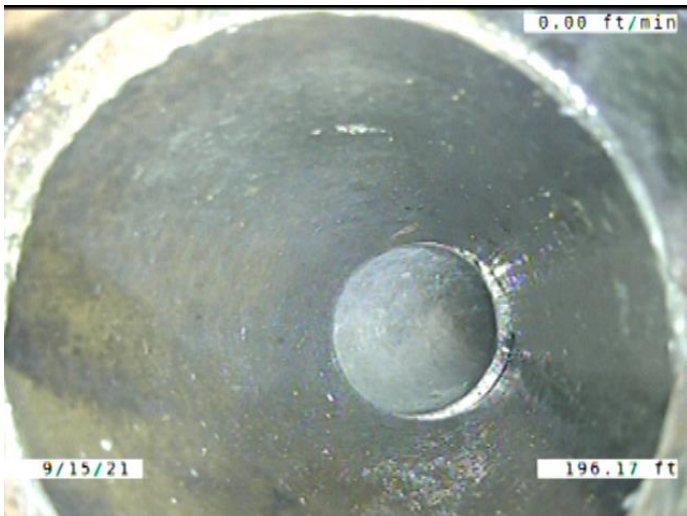
Code: **TBI**
 Description: **Tap Break-in Intruding**

Distance (ft): **196.2**
 Structural Grade: **0**
 O&M Grade: **2**
 Clock Start/From: **12**
 Clock To:
 1st Value: **4.000**
 2nd Value: **1.000**
 Value Percent:
 Continuous Index:
 Within 8" of Joint: **NO**
 Remarks:

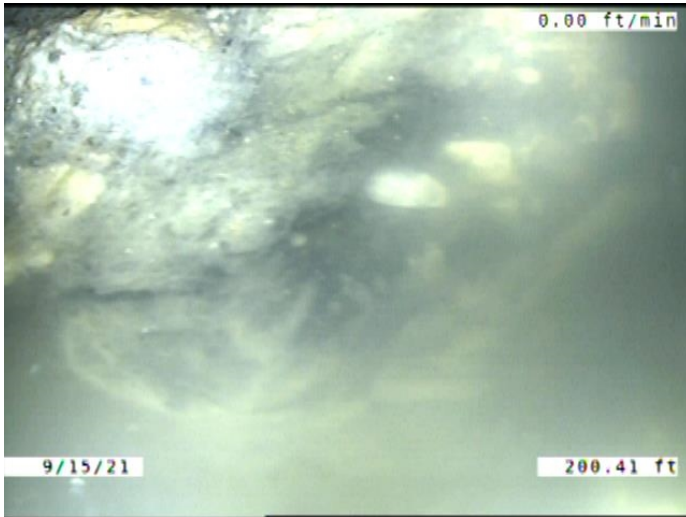
Code: **DAE**
Description: **Deposits Attached Encrustation**

Distance (ft): **200.4**
Structural Grade: **0**
O&M Grade: **2**
Clock Start/From: **6**
Clock To: **8**
1st Value:
2nd Value:
Value Percent: **5.000**
Continuous Index:
Within 8" of Joint: **YES**
Remarks:

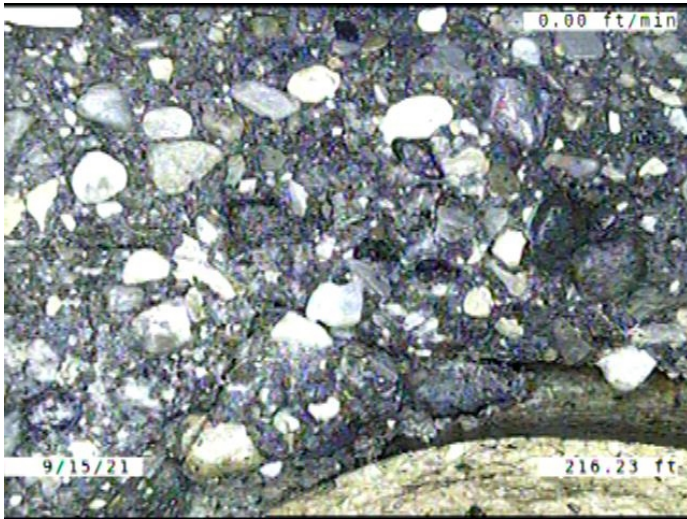
Code: **FM**
 Description: **Fracture Multiple**

Distance (ft): **216.2**
 Structural Grade: **4**
 O&M Grade: **0**
 Clock Start/From: **9**
 Clock To: **4**
 1st Value:
 2nd Value:
 Value Percent:
 Continuous Index:
 Within 8" of Joint: **NO**
 Remarks:

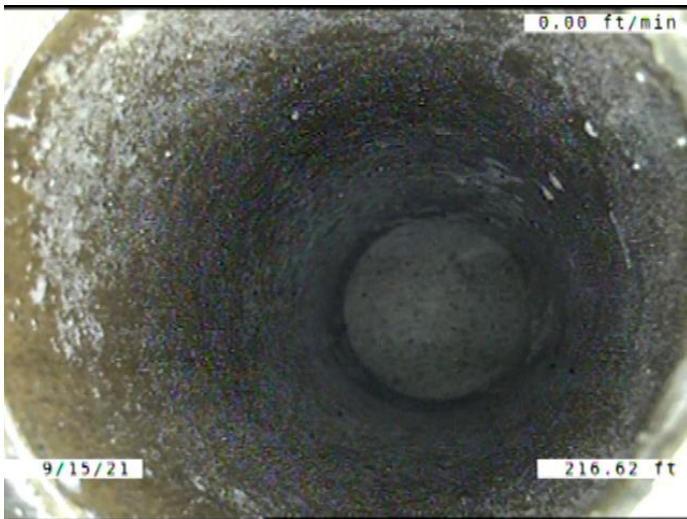
Code: **TBI**
 Description: **Tap Break-in Intruding**

Distance (ft): **216.6**
 Structural Grade: **0**
 O&M Grade: **2**
 Clock Start/From: **12**
 Clock To:
 1st Value: **4.000**
 2nd Value: **1.000**
 Value Percent:
 Continuous Index:
 Within 8" of Joint: **YES**
 Remarks:

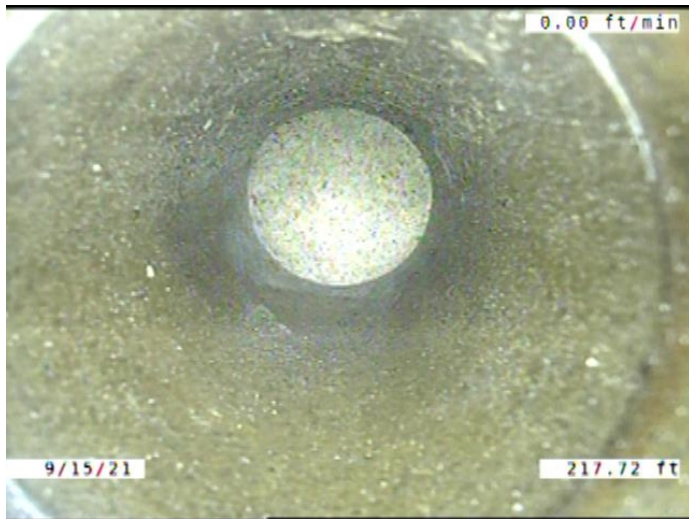
Code: **TBI**
 Description: **Tap Break-in Intruding**

Distance (ft): **217.7**
 Structural Grade: **0**
 O&M Grade: **2**
 Clock Start/From: **12**
 Clock To:
 1st Value: **4.000**
 2nd Value: **1.000**
 Value Percent:
 Continuous Index:
 Within 8" of Joint: **NO**
 Remarks: **LOOKS TO BE CAPPED**

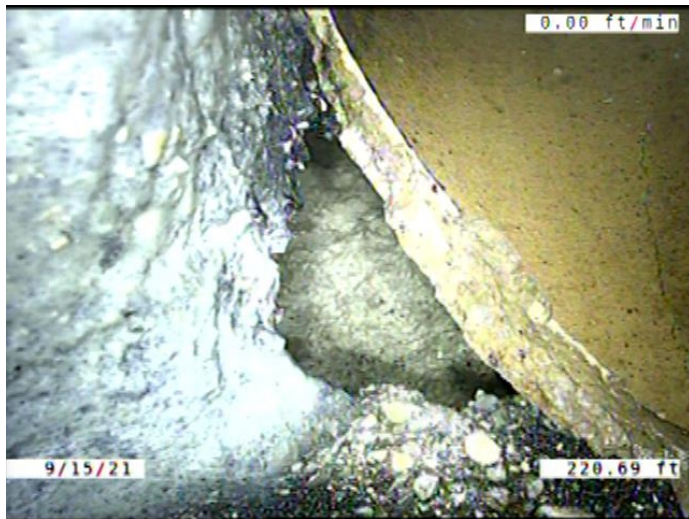
Code: **HSV**
 Description: **Hole Soil Visible**

Distance (ft): **220.7**
 Structural Grade: **5**
 O&M Grade: **0**
 Clock Start/From: **10**
 Clock To:
 1st Value:
 2nd Value:
 Value Percent:
 Continuous Index:
 Within 8" of Joint: **NO**
 Remarks:

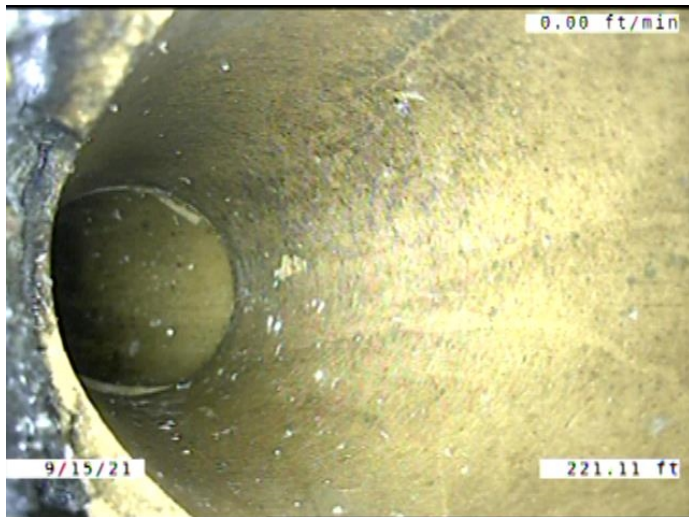
Code: **TBI**
 Description: **Tap Break-in Intruding**

Distance (ft): **221.1**
 Structural Grade: **0**
 O&M Grade: **2**
 Clock Start/From: **11**
 Clock To:
 1st Value: **4.000**
 2nd Value: **1.000**
 Value Percent:
 Continuous Index:
 Within 8" of Joint: **NO**
 Remarks:

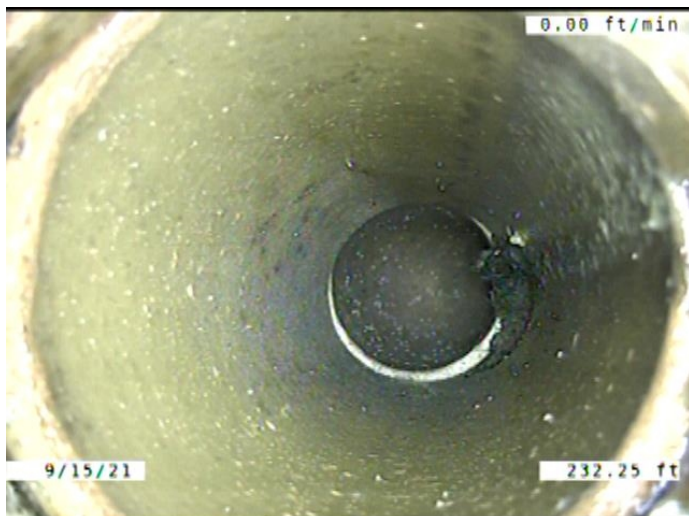
Code: **TBI**
 Description: **Tap Break-in Intruding**

Distance (ft): **232.3**
 Structural Grade: **0**
 O&M Grade: **2**
 Clock Start/From: **12**
 Clock To:
 1st Value: **4.000**
 2nd Value: **1.000**
 Value Percent:
 Continuous Index:
 Within 8" of Joint: **NO**
 Remarks:

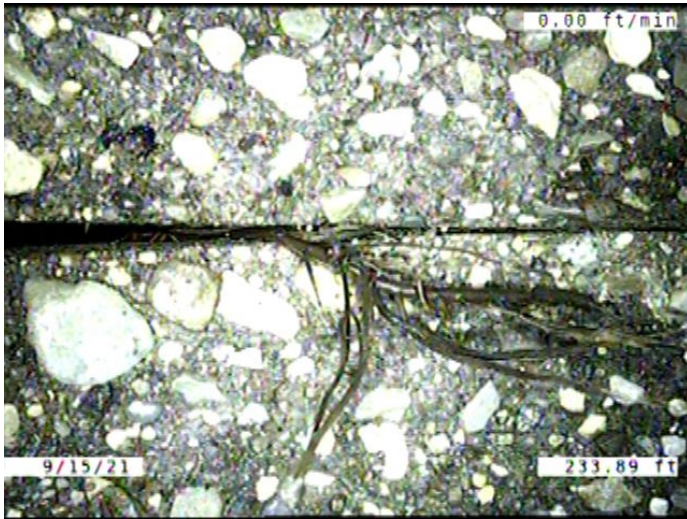
Code: **RFJ**
Description: **Roots Fine Joint**

Distance (ft): **233.9**
Structural Grade: **0**
O&M Grade: **1**
Clock Start/From: **10**
Clock To: **11**
1st Value:
2nd Value:
Value Percent:
Continuous Index:
Within 8" of Joint: **YES**
Remarks:

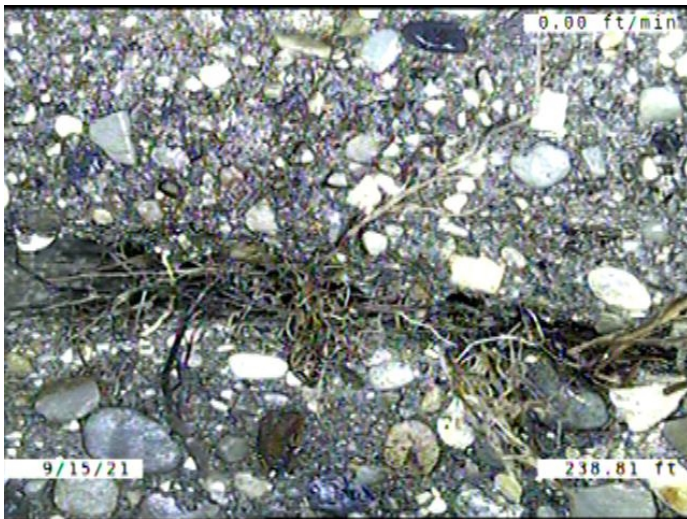
Code: **RFJ**
Description: **Roots Fine Joint**

Distance (ft): **238.8**
Structural Grade: **0**
O&M Grade: **1**
Clock Start/From: **1**
Clock To: **3**
1st Value:
2nd Value:
Value Percent:
Continuous Index:
Within 8" of Joint: **YES**
Remarks:

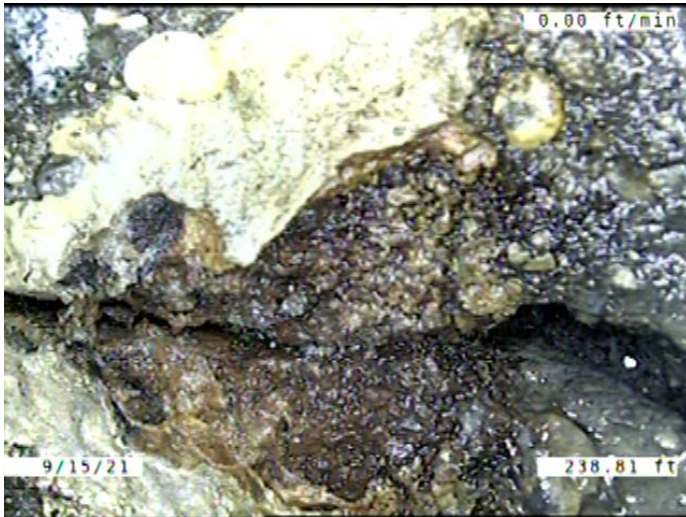
Code: **DAE**
 Description: **Deposits Attached Encrustation**

Distance (ft): **238.8**
 Structural Grade: **0**
 O&M Grade: **2**
 Clock Start/From: **3**
 Clock To: **4**
 1st Value:
 2nd Value:
 Value Percent: **5.000**
 Continuous Index:
 Within 8" of Joint: **YES**
 Remarks:

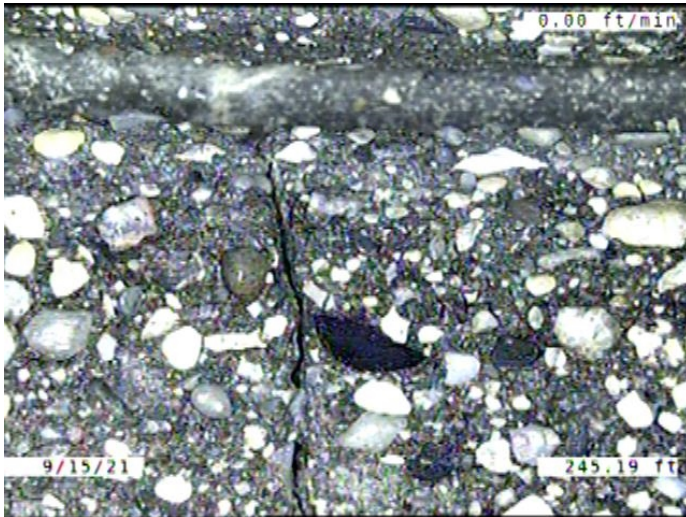
Code: **FS**
 Description: **Fracture Spiral**

Distance (ft): **245.2**
 Structural Grade: **3**
 O&M Grade: **0**
 Clock Start/From: **12**
 Clock To: **1**
 1st Value:
 2nd Value:
 Value Percent:
 Continuous Index:
 Within 8" of Joint: **YES**
 Remarks:

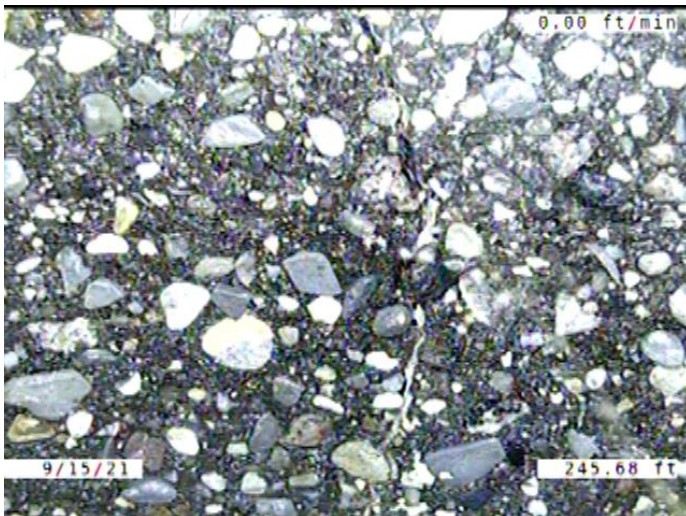
Code: **RFB**
 Description: **Roots Fine Barrel**

Distance (ft): **245.7**
 Structural Grade: **0**
 O&M Grade: **2**
 Clock Start/From: **12**
 Clock To:
 1st Value:
 2nd Value:
 Value Percent:
 Continuous Index:
 Within 8" of Joint: **NO**
 Remarks:
