Profile/Photo Observation Report

Date:	09/15/2021	Weather:		Coding:	PACP 7.0
Pipe Length (ft):	307.1	Owner:	City of Hobart	Pre Clean:	Light Cleaning
P.O.#:	YES502259	Surveyor:	S. Bucklin	PSR:	P-504-054-053
Customer:	City of Hobart	Clean Date:	09/10/2021	Shape:	C

Street:	North Guyer Street	Flow Control:	Not Controlled
City:	Hobart, IN	Year Renewed:	
Location:	Alley	Tape/Media #:	
Purpose:	Routine Assessment	Dia/Height:	10"
Use:	Sanitary Sewage Pipe	Material:	CP
Drain Area:		Lining:	None
Category:	NA		
Comment:			
Location Details:		Direction of Survey:	Downstream
US MH:	M-504-053	DS MH:	M-504-054
		Total Length Surveyed (ft):	307.1

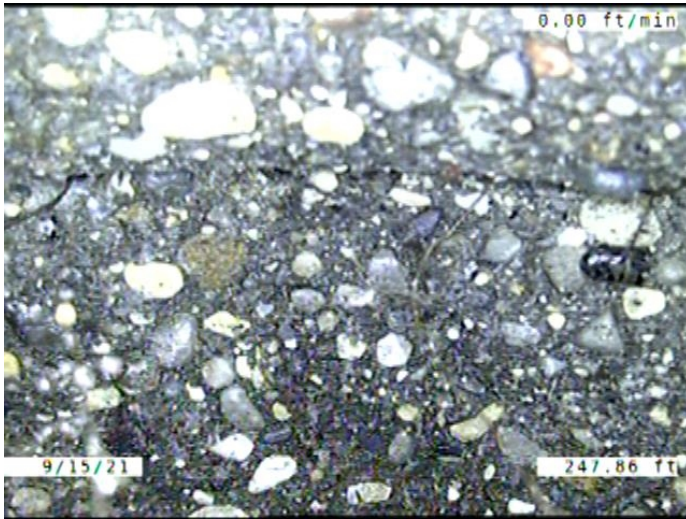
Code: **RFJ**
Description: **Roots Fine Joint**

Distance (ft): **247.9**
Structural Grade: **0**
O&M Grade: **1**
Clock Start/From: **12**
Clock To: **1**
1st Value:
2nd Value:
Value Percent:
Continuous Index:
Within 8" of Joint: **YES**
Remarks:

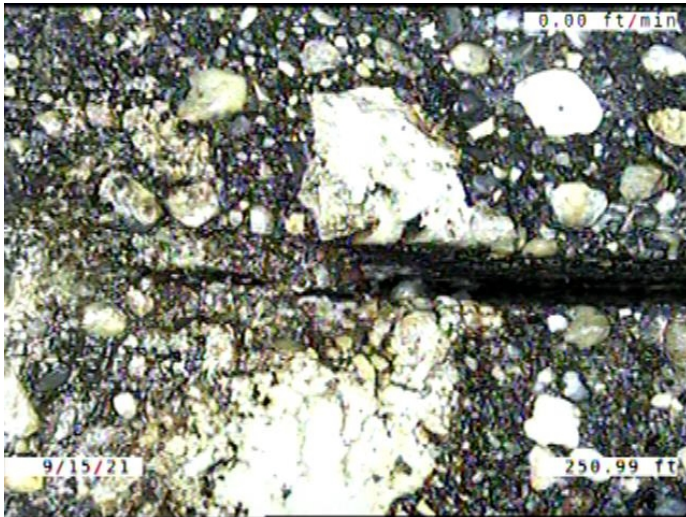
Code: **DAE**
 Description: **Deposits Attached Encrustation**

Distance (ft): **251.0**
 Structural Grade: **0**
 O&M Grade: **2**
 Clock Start/From: **3**
 Clock To: **4**
 1st Value:
 2nd Value:
 Value Percent: **5.000**
 Continuous Index:
 Within 8" of Joint: **YES**
 Remarks:

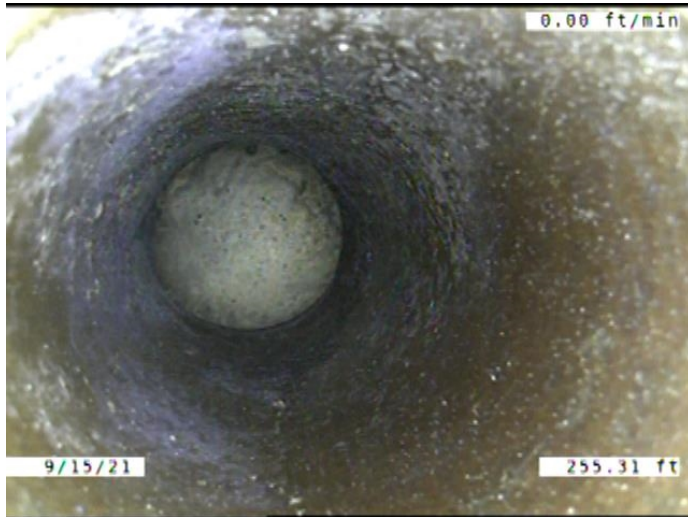
Code: **TBI**
Description: **Tap Break-in Intruding**

Distance (ft): **255.3**
Structural Grade: **0**
O&M Grade: **2**
Clock Start/From: **11**
Clock To:
1st Value: **4.000**
2nd Value: **1.000**
Value Percent:
Continuous Index:
Within 8" of Joint: **NO**
Remarks:

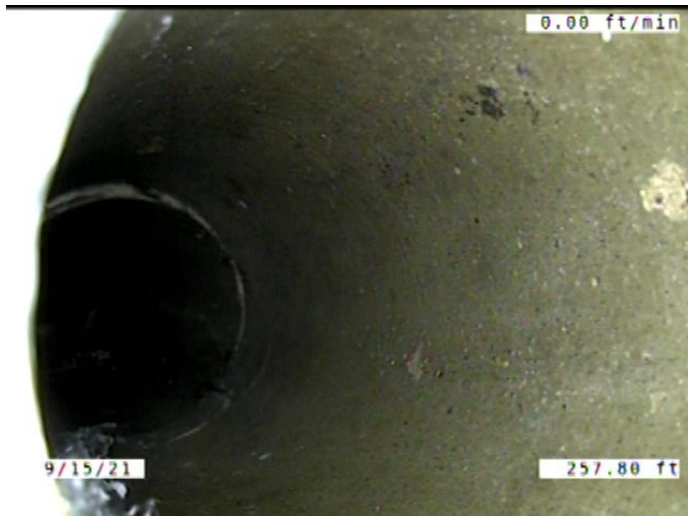
Code: **TBI**
Description: **Tap Break-in Intruding**

Distance (ft): **257.8**
Structural Grade: **0**
O&M Grade: **2**
Clock Start/From: **11**
Clock To:
1st Value: **4.000**
2nd Value: **1.000**
Value Percent:
Continuous Index:
Within 8" of Joint: **NO**
Remarks:

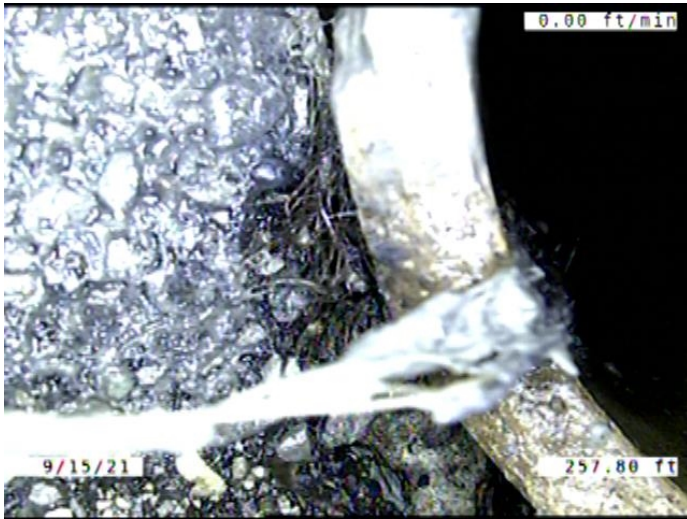
Code: **RFL**
Description: **Roots Fine Lateral**

Distance (ft): **257.8**
Structural Grade: **0**
O&M Grade: **1**
Clock Start/From: **10**
Clock To: **12**
1st Value:
2nd Value:
Value Percent:
Continuous Index:
Within 8" of Joint: **NO**
Remarks:

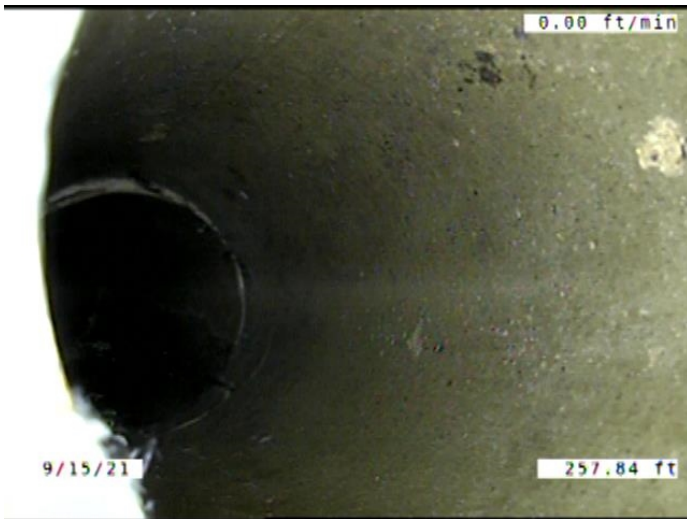
Code: **TBI**
Description: **Tap Break-in Intruding**

Distance (ft): **257.8**
Structural Grade: **0**
O&M Grade: **2**
Clock Start/From: **11**
Clock To:
1st Value: **4.000**
2nd Value: **1.000**
Value Percent:
Continuous Index:
Within 8" of Joint: **NO**
Remarks:
