Profile/Photo Observation Report

Street:	ALLEY BETWEEN N GUYER ST & N CA	Flow Control:	Not Controlled
City:	Hobart, IN	Year Renewed:	
Location:	Light Highway	Tape/Media #:	
Purpose:	Not Known	Dia/Height:	12"
Use:	Sanitary	Material:	CP
Drain Area:	NA	Lining:	
Category:	NA		
Comment:

Location Details:		Direction of Survey:	Downstream
US MH:	M-504-054	DS MH:	M-504-055
		Total Length Surveyed (ft):	78.6

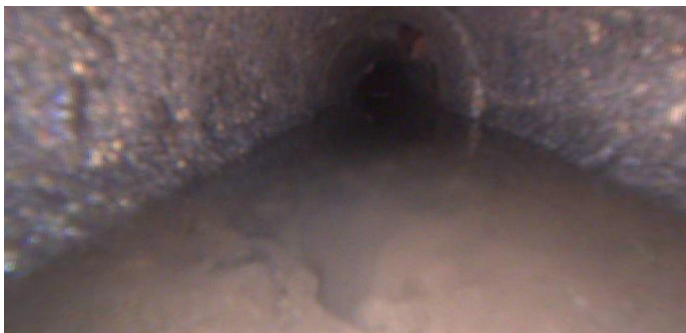
Code: **AMH**
Description: **Manhole**

Distance (ft): **.0**
Structural Grade: **0**
O&M Grade: **0**
Clock Start/From:
Clock To:
1st Value:
2nd Value:
Value Percent:
Continuous Index:
Within 8" of Joint: **NO**
Remarks: **M-504-054**

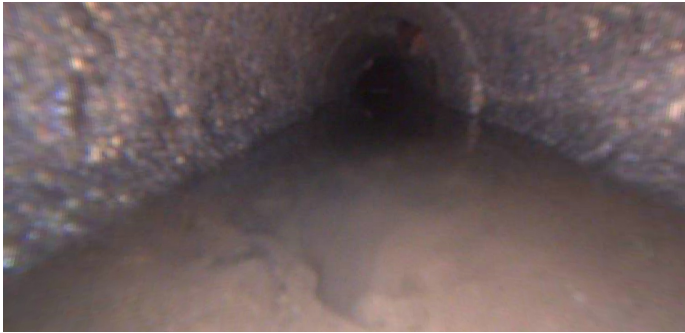
Code:	MWL
Description:	Water Level

Distance (ft):	.0
Structural Grade:	0
O&M Grade:	0
Clock Start/From:	
Clock To:	
1st Value:	
2nd Value:	
Value Percent:	5.000
Continuous Index:	
Within 8" of Joint:	NO
Remarks:

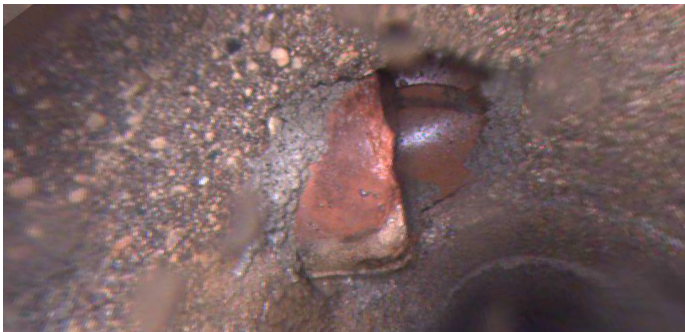
Code:	TB
Description:	Tap Break-in

Distance (ft):	4.2
Structural Grade:	0
O&M Grade:	0
Clock Start/From:	1
Clock To:	
1st Value:	4.000
2nd Value:	
Value Percent:	
Continuous Index:	
Within 8" of Joint:	
Remarks:

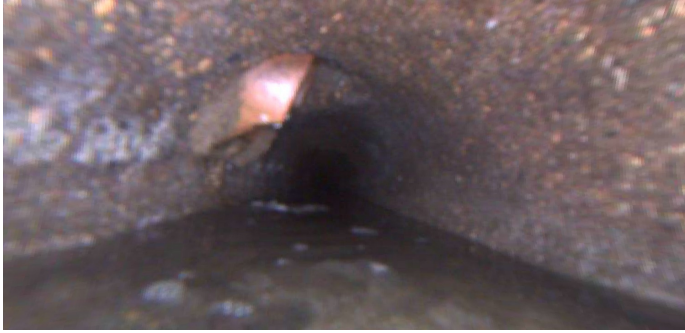
Code: **DSZ**
Description: **Deposits Settled Other**

Distance (ft): **5.4**
Structural Grade: **0**
O&M Grade: **2**
Clock Start/From: **6**
Clock To:
1st Value:
2nd Value:
Value Percent: **5.000**
Continuous Index: **S01**
Within 8" of Joint: **NO**
Remarks: **tissue/debris**

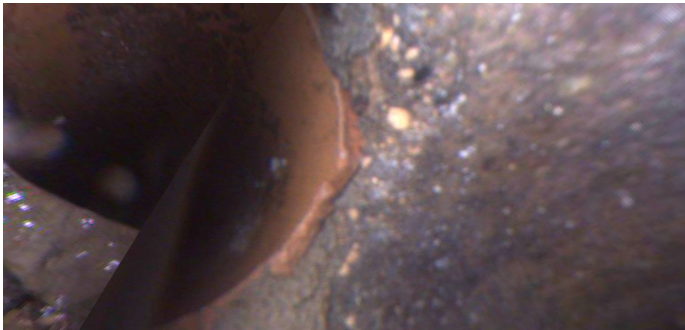
Code: **TB**
Description: **Tap Break-in**

Distance (ft): **6.6**
Structural Grade: **0**
O&M Grade: **0**
Clock Start/From: **11**
Clock To:
1st Value: **4.000**
2nd Value:
Value Percent:
Continuous Index:
Within 8" of Joint:
Remarks:

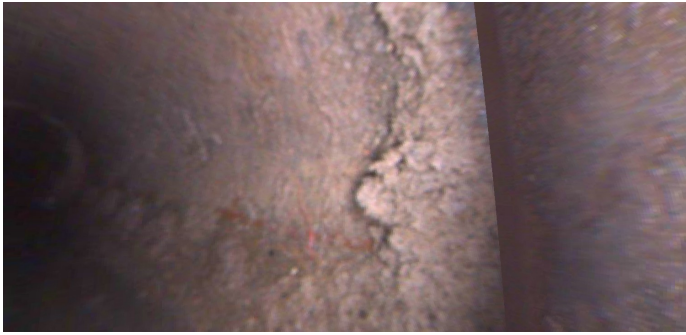
Code: **DAZ**
Description: **Deposits Attached Other**

Distance (ft): **24.3**
Structural Grade: **0**
O&M Grade: **2**
Clock Start/From: **7**
Clock To: **5**
1st Value:
2nd Value:
Value Percent: **5.000**
Continuous Index: **S02**
Within 8" of Joint: **YES**
Remarks:

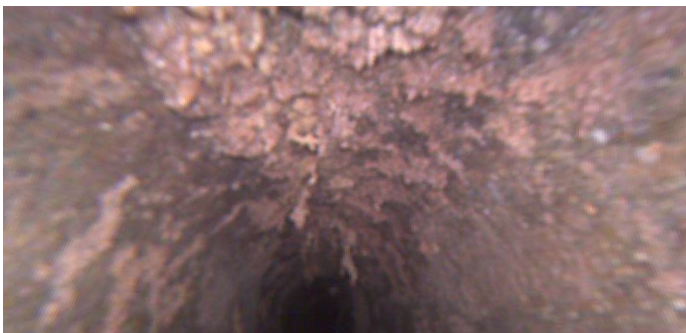
Code: **DAZ**
Description: **Deposits Attached Other**

Distance (ft): **33.9**
Structural Grade: **0**
O&M Grade: **2**
Clock Start/From: **12**
Clock To:
1st Value:
2nd Value:
Value Percent: **5.000**
Continuous Index: **S03**
Within 8" of Joint: **NO**
Remarks:

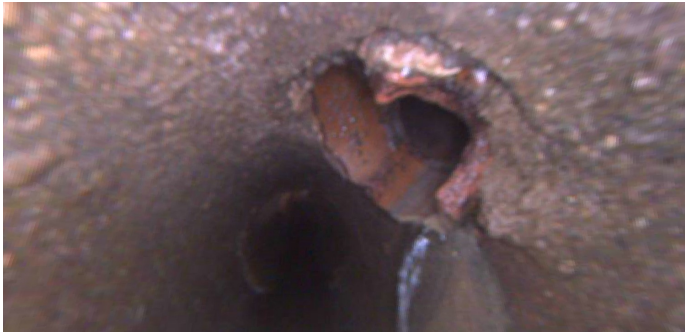
Code: **TBA**
Description: **Tap Break-in Active**

Distance (ft): **37.8**
Structural Grade: **0**
O&M Grade: **0**
Clock Start/From: **1**
Clock To:
1st Value: **4.000**
2nd Value:
Value Percent:
Continuous Index:
Within 8" of Joint:
Remarks:

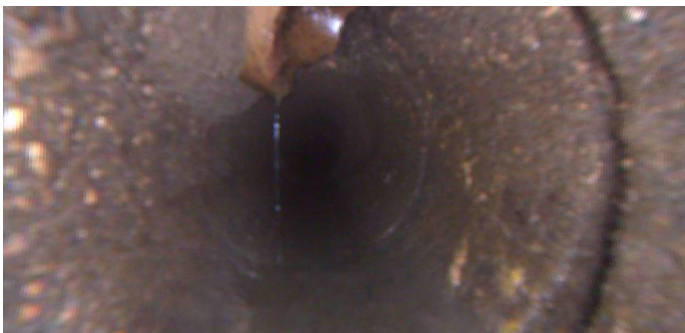
Code: **DAZ**
Description: **Deposits Attached Other**

Distance (ft): **39.8**
Structural Grade: **0**
O&M Grade: **2**
Clock Start/From: **12**
Clock To:
1st Value:
2nd Value:
Value Percent: **5.000**
Continuous Index: **F03**
Within 8" of Joint: **NO**
Remarks:

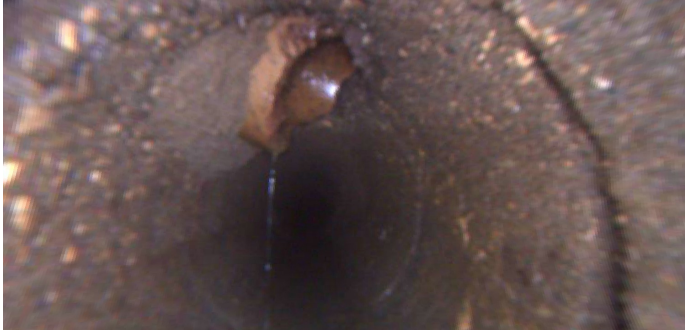
Code: **TB**
Description: **Tap Break-in**

Distance (ft): **39.8**
Structural Grade: **0**
O&M Grade: **0**
Clock Start/From: **12**
Clock To:
1st Value: **4.000**
2nd Value:
Value Percent:
Continuous Index:
Within 8" of Joint:
Remarks:

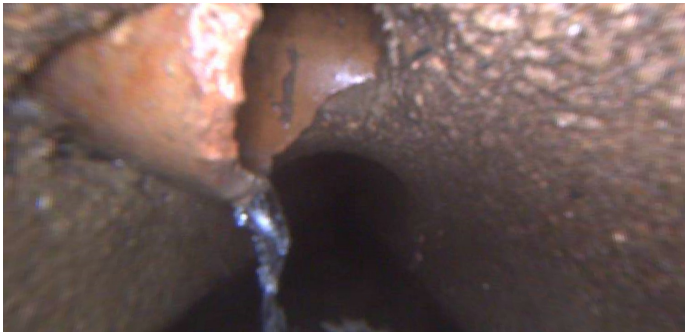
Code: **TBI**
Description: **Tap Break-in Intruding**

Distance (ft): **76.7**
Structural Grade: **0**
O&M Grade: **2**
Clock Start/From: **11**
Clock To:
1st Value: **4.000**
2nd Value: **2.500**
Value Percent:
Continuous Index:
Within 8" of Joint:
Remarks:

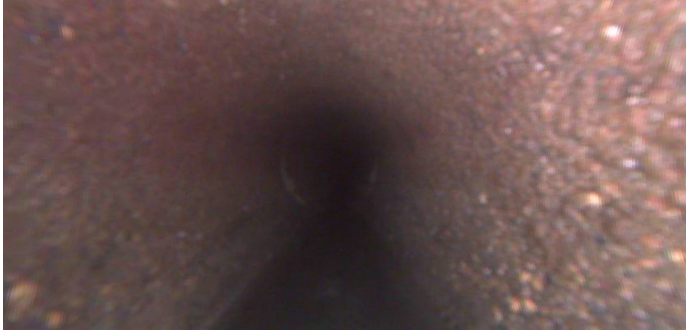
Code: **MSA**
Description: **Abandoned Survey**

Distance (ft): **78.6**
Structural Grade: **0**
O&M Grade: **0**
Clock Start/From:
Clock To:
1st Value:
2nd Value:
Value Percent:
Continuous Index:
Within 8" of Joint: **NO**
Remarks: **stuck on tbi?**

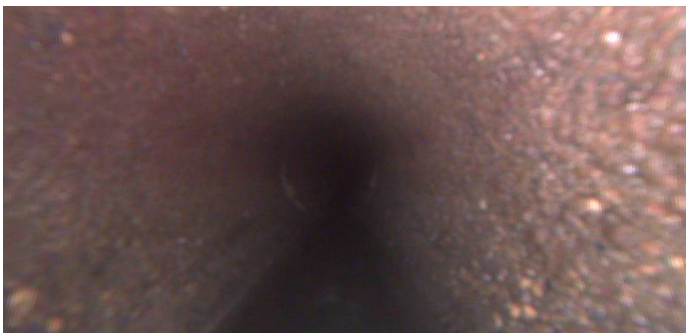
Code: **DAZ**
Description: **Deposits Attached Other**

Distance (ft): **78.6**
Structural Grade: **0**
O&M Grade: **2**
Clock Start/From: **7**
Clock To: **5**
1st Value:
2nd Value:
Value Percent: **5.000**
Continuous Index: **F02**
Within 8" of Joint: **YES**
Remarks:

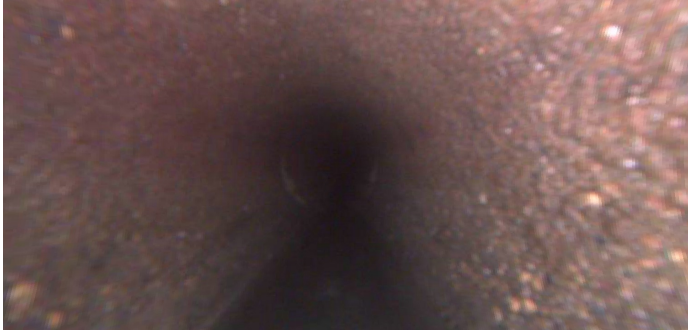
Code:	DSZ
Description:	Deposits Settled Other
Distance (ft):	78.6
Structural Grade:	0
O&M Grade:	2
Clock Start/From:	6
Clock To:	
1st Value:	
2nd Value:	
Value Percent:	5.000
Continuous Index:	F01
Within 8" of Joint:	NO
Remarks:	tissue/debris
