## Profile/Photo Observation Report

Street:	<b>Summerlin</b>	Flow Control:	<b>Not Controlled</b>
City:	<b>Hobart, IN</b>	Year Renewed:	
Location:	<b>Light Highway</b>	Tape/Media #:	
Purpose:	<b>Not Known</b>	Dia/Height:	<b>12"</b>
Use:	<b>Sanitary</b>	Material:	<b>CP</b>
Drain Area:	<b>NA</b>	Lining:	
Category:	<b>NA</b>		
Comment:

Location Details:		Direction of Survey:	<b>Downstream</b>
US MH:	<b>M-504-054</b>	DS MH:	<b>M-504-055</b>
		Total Length Surveyed (ft):	<b>78.6</b>

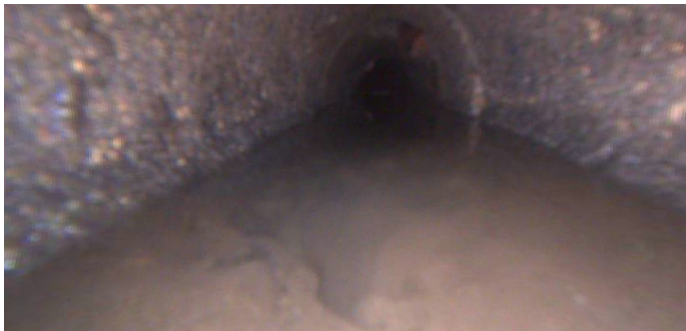
Code: **AMH**  
Description: **Manhole**

Distance (ft): **.0**  
Structural Grade: **0**  
O&M Grade: **0**  
Clock Start/From:  
Clock To:  
1st Value:  
2nd Value:  
Value Percent:  
Continuous Index:  
Within 8" of Joint: **NO**  
Remarks: **M-504-054**

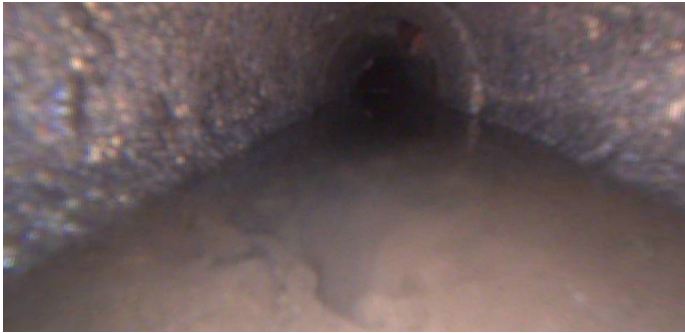
Code:	<b>MWL</b>
Description:	<b>Water Level</b>

Distance (ft):	<b>.0</b>
Structural Grade:	<b>0</b>
O&M Grade:	<b>0</b>
Clock Start/From:	
Clock To:	
1st Value:	
2nd Value:	
Value Percent:	<b>5.000</b>
Continuous Index:	
Within 8" of Joint:	<b>NO</b>
Remarks:

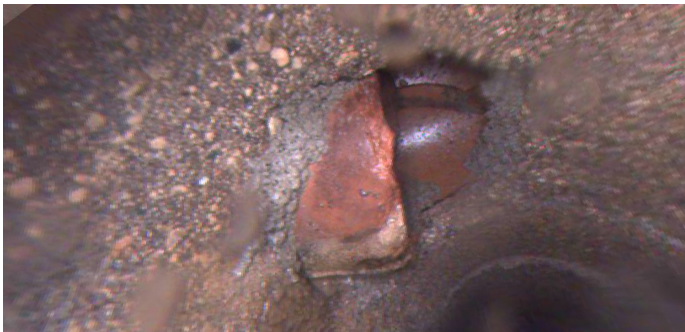
Code:	<b>TB</b>
Description:	<b>Tap Break-in</b>

Distance (ft):	<b>4.2</b>
Structural Grade:	<b>0</b>
O&M Grade:	<b>0</b>
Clock Start/From:	<b>1</b>
Clock To:	
1st Value:	<b>4.000</b>
2nd Value:	
Value Percent:	
Continuous Index:	
Within 8" of Joint:	
Remarks:

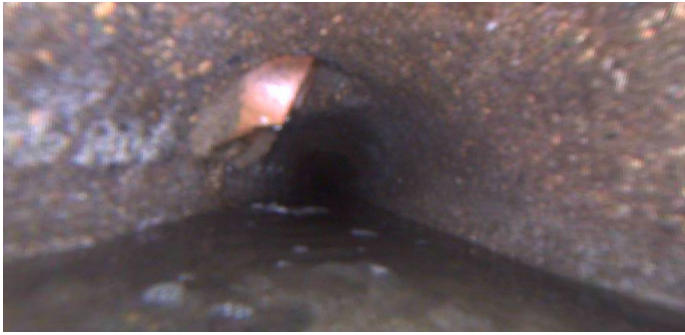
Code: **DSZ**  
Description: **Deposits Settled Other**

Distance (ft): **5.4**  
Structural Grade: **0**  
O&M Grade: **2**  
Clock Start/From: **6**  
Clock To:  
1st Value:  
2nd Value:  
Value Percent: **5.000**  
Continuous Index: **S01**  
Within 8" of Joint: **NO**  
Remarks: **tissue/debris**

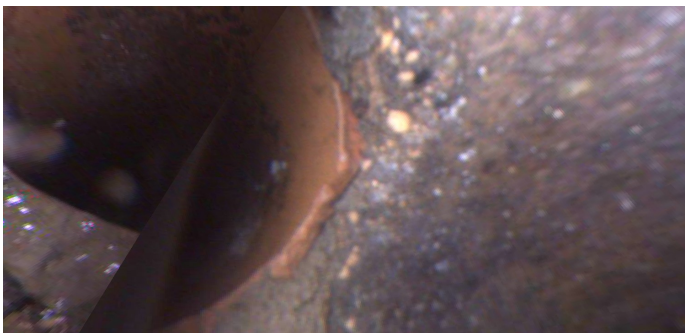
Code: **TB**  
Description: **Tap Break-in**

Distance (ft): **6.6**  
Structural Grade: **0**  
O&M Grade: **0**  
Clock Start/From: **11**  
Clock To:  
1st Value: **4.000**  
2nd Value:  
Value Percent:  
Continuous Index:  
Within 8" of Joint:  
Remarks:

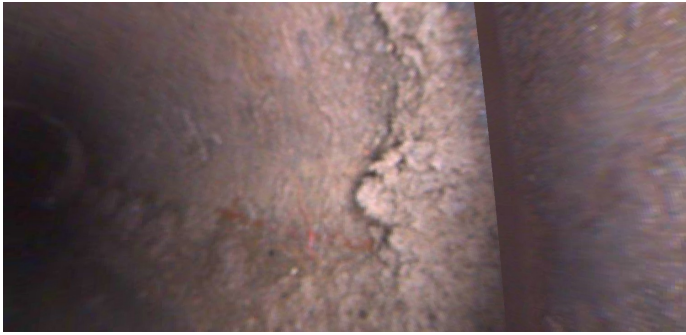
Code: **DAZ**  
Description: **Deposits Attached Other**

Distance (ft): **24.3**  
Structural Grade: **0**  
O&M Grade: **2**  
Clock Start/From: **7**  
Clock To: **5**  
1st Value:  
2nd Value:  
Value Percent: **5.000**  
Continuous Index: **S02**  
Within 8" of Joint: **YES**  
Remarks:

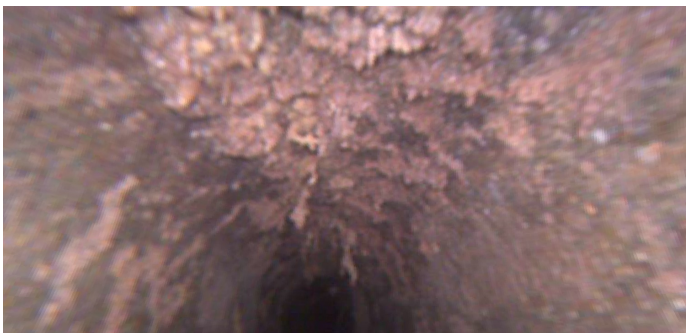
Code: **DAZ**  
Description: **Deposits Attached Other**

Distance (ft): **33.9**  
Structural Grade: **0**  
O&M Grade: **2**  
Clock Start/From: **12**  
Clock To:  
1st Value:  
2nd Value:  
Value Percent: **5.000**  
Continuous Index: **S03**  
Within 8" of Joint: **NO**  
Remarks:

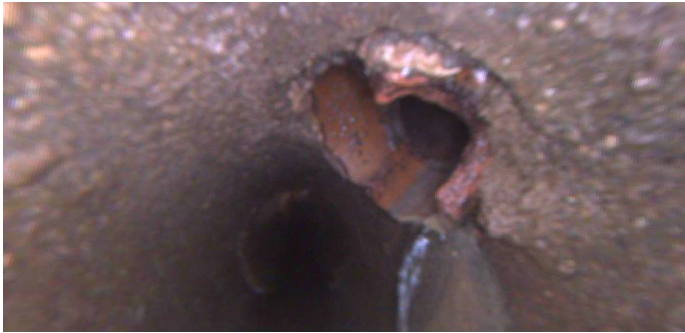
Code: **TBA**  
Description: **Tap Break-in Active**

Distance (ft): **37.8**  
Structural Grade: **0**  
O&M Grade: **0**  
Clock Start/From: **1**  
Clock To:  
1st Value: **4.000**  
2nd Value:  
Value Percent:  
Continuous Index:  
Within 8" of Joint:  
Remarks:

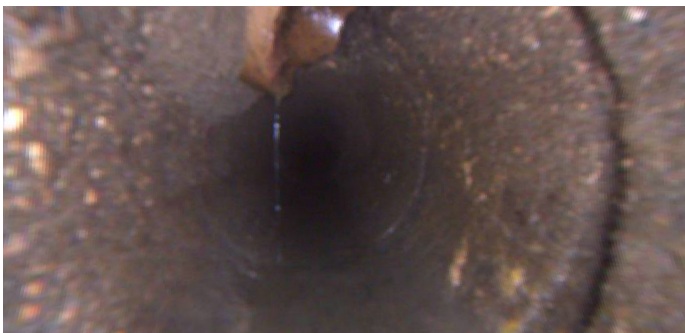
Code: **DAZ**  
Description: **Deposits Attached Other**

Distance (ft): **39.8**  
Structural Grade: **0**  
O&M Grade: **2**  
Clock Start/From: **12**  
Clock To:  
1st Value:  
2nd Value:  
Value Percent: **5.000**  
Continuous Index: **F03**  
Within 8" of Joint: **NO**  
Remarks:

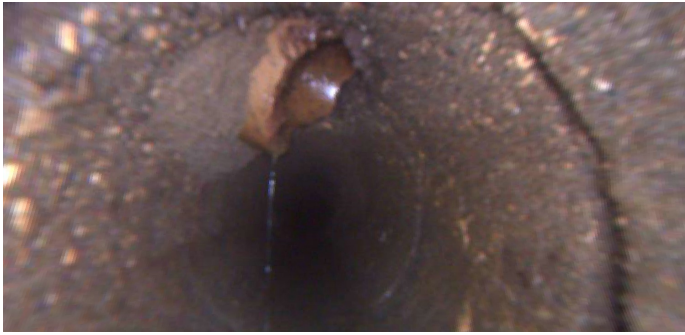
Code: **TB**  
Description: **Tap Break-in**

Distance (ft): **39.8**  
Structural Grade: **0**  
O&M Grade: **0**  
Clock Start/From: **12**  
Clock To:  
1st Value: **4.000**  
2nd Value:  
Value Percent:  
Continuous Index:  
Within 8" of Joint:  
Remarks:

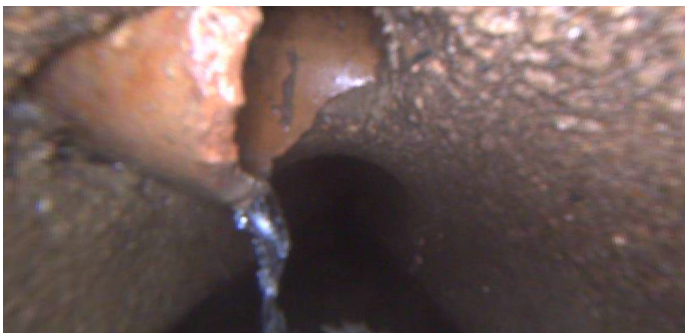
Code: **TBI**  
Description: **Tap Break-in Intruding**

Distance (ft): **76.7**  
Structural Grade: **0**  
O&M Grade: **2**  
Clock Start/From: **11**  
Clock To:  
1st Value: **4.000**  
2nd Value: **2.500**  
Value Percent:  
Continuous Index:  
Within 8" of Joint:  
Remarks:

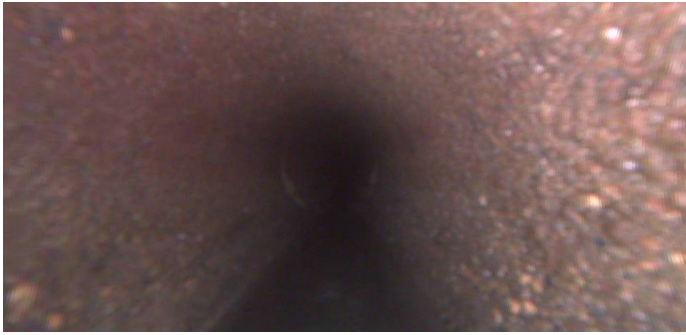
Code: **MSA**  
Description: **Abandoned Survey**

Distance (ft): **78.6**  
Structural Grade: **0**  
O&M Grade: **0**  
Clock Start/From:  
Clock To:  
1st Value:  
2nd Value:  
Value Percent:  
Continuous Index:  
Within 8" of Joint: **NO**  
Remarks: **stuck on tbi?**

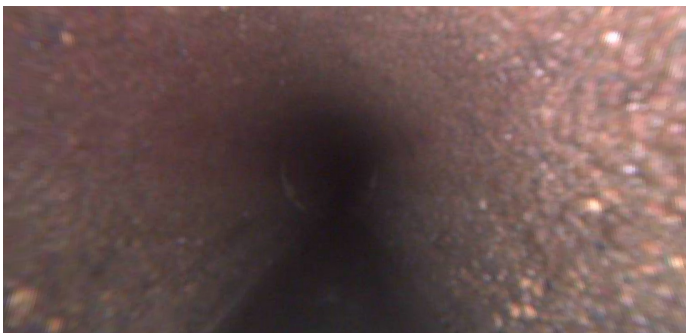
Code: **DAZ**  
Description: **Deposits Attached Other**

Distance (ft): **78.6**  
Structural Grade: **0**  
O&M Grade: **2**  
Clock Start/From: **7**  
Clock To: **5**  
1st Value:  
2nd Value:  
Value Percent: **5.000**  
Continuous Index: **F02**  
Within 8" of Joint: **YES**  
Remarks:

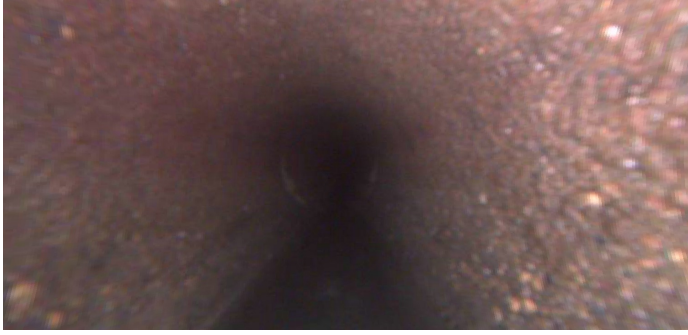
Code:	<b>DSZ</b>
Description:	<b>Deposits Settled Other</b>
Distance (ft):	<b>78.6</b>
Structural Grade:	<b>0</b>
O&M Grade:	<b>2</b>
Clock Start/From:	<b>6</b>
Clock To:	
1st Value:	
2nd Value:	
Value Percent:	<b>5.000</b>
Continuous Index:	<b>F01</b>
Within 8" of Joint:	<b>NO</b>
Remarks:	<b>tissue/debris</b>
