Profile/Ph	oto Observation	n Report				RedZon
Date:	04/19/2018	Weather:		Co	ding: P	PACP 6.0
Pipe Length (ft): 304.1	Owner:	NA	Pre	e Clean: 🛛 🛚	lot Known
P.O.#:		Surveyor:	Jen Costello	PSI	R: P	-504-055-054
Customer:		Clean Date:	01/01/1900	Sha	ape: C	2
Street:	ALLEY BETWEEN M	N GUYER ST & N C	A Flow Control:	Not	t Controlled	
City:	Hobart, IN		Year Renewed:			
Location:	Light Highway		Tape/Media #:			
Purpose:	Not Known		Dia/Height:	12"	ı	
Use:	Sanitary		Material:	СР		
Drain Area:	NA		Lining:			
Category:	NA					
Comment:						
Location Detai	ls:		Direction of Sur	rvey: Do	wnstream	
US MH:	M-504-054	DS MH:	M-504-055	Total Length S	Surveyed (ft):	5.4
0&M Index:	0.00	O&M Quick:	00	00 O&M	Rating:	0.00
tructural Index:	3.00	Structural Qu	uick: 31	00 Struct	ural Rating:	3.00
Overall Index:	3.00	Overall Quick		00 Overa	II Rating:	3.00

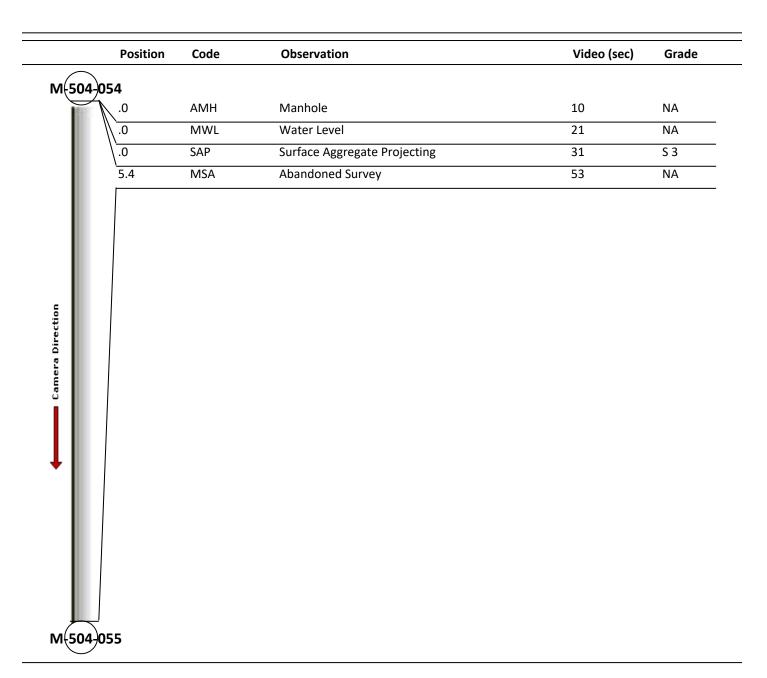
Code:	SAP
Description:	Surface Aggregate Projecting

Distance (ft):	.0
Structural Grade:	3
O&M Grade:	0
Clock Start/From:	8
Clock To:	4
1st Value:	
2nd Value:	
Value Percent:	
Continuous Index:	
Within 8" of Joint:	
Remarks:
