## Profile/Photo Observation Report

Street:	<b>Summerlin</b>	Flow Control:	<b>Not Controlled</b>
City:	<b>Hobart, IN</b>	Year Renewed:	
Location:	<b>Light Highway</b>	Tape/Media #:	
Purpose:	<b>Not Known</b>	Dia/Height:	<b>12"</b>
Use:	<b>Sanitary</b>	Material:	<b>CP</b>
Drain Area:	<b>NA</b>	Lining:	
Category:	<b>NA</b>		
Comment:

Location Details:		Direction of Survey:	<b>Downstream</b>
US MH:	<b>M-504-054</b>	DS MH:	<b>M-504-055</b>
		Total Length Surveyed (ft):	<b>5.4</b>

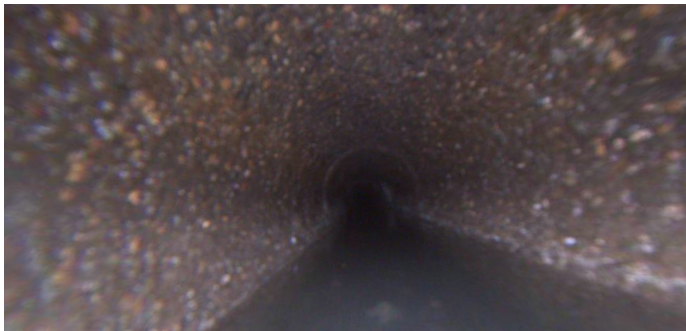
Code: **AMH**  
Description: **Manhole**

Distance (ft): **.0**  
Structural Grade: **0**  
O&M Grade: **0**  
Clock Start/From:  
Clock To:  
1st Value:  
2nd Value:  
Value Percent:  
Continuous Index:  
Within 8" of Joint: **NO**  
Remarks: **M-504-054**

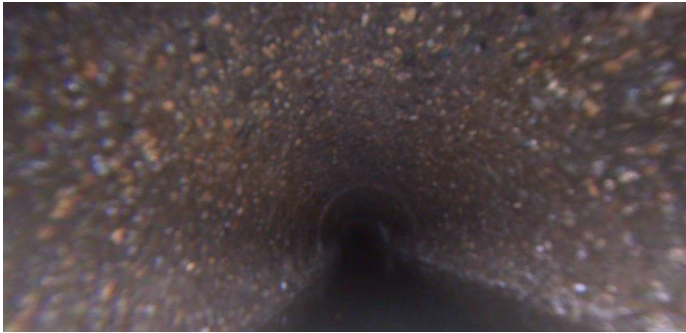
Code:	<b>MWL</b>
Description:	<b>Water Level</b>

Distance (ft):	<b>.0</b>
Structural Grade:	<b>0</b>
O&M Grade:	<b>0</b>
Clock Start/From:	
Clock To:	
1st Value:	
2nd Value:	
Value Percent:	<b>20.000</b>
Continuous Index:	
Within 8" of Joint:	<b>NO</b>
Remarks:

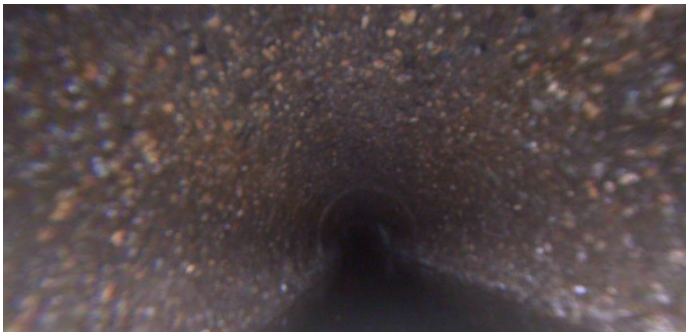
Code:	<b>SAP</b>
Description:	<b>Surface Aggregate Projecting</b>

Distance (ft):	<b>.0</b>
Structural Grade:	<b>3</b>
O&M Grade:	<b>0</b>
Clock Start/From:	<b>8</b>
Clock To:	<b>4</b>
1st Value:	
2nd Value:	
Value Percent:	
Continuous Index:	
Within 8" of Joint:	
Remarks:

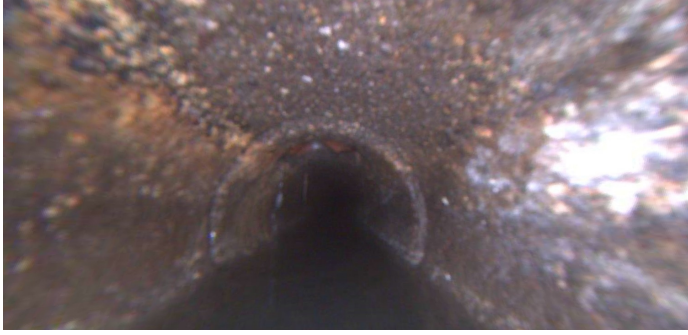
Code:	<b>MSA</b>
Description:	<b>Abandoned Survey</b>
Distance (ft):	<b>5.4</b>
Structural Grade:	<b>0</b>
O&M Grade:	<b>0</b>
Clock Start/From:	
Clock To:	
1st Value:	
2nd Value:	
Value Percent:	
Continuous Index:	
Within 8" of Joint:	<b>NO</b>
Remarks:	<b>debris under water</b>
