Profile/Photo Observation Report

Date:	04/19/2018	Weather:		Coding:	PACP 6.0
Pipe Length (ft):	304.1	Owner:	NA	Pre Clean:	Not Known
P.O.#:		Surveyor:	Byrd Fitzgerald	PSR:	P-504-055-054
Customer:		Clean Date:	01/01/1900	Shape:	C

Street:	ALLEY BETWEEN N GUYER ST & N CA	Flow Control:	Not Controlled
City:	Hobart, IN	Year Renewed:	
Location:	Light Highway	Tape/Media #:	
Purpose:	Not Known	Dia/Height:	12"
Use:	Sanitary	Material:	CP
Drain Area:	NA	Lining:	
Category:	NA		
Comment:

Location Details:		Direction of Survey:	Upstream
US MH:	M-504-054	DS MH:	M-504-055
		Total Length Surveyed (ft):	83.9

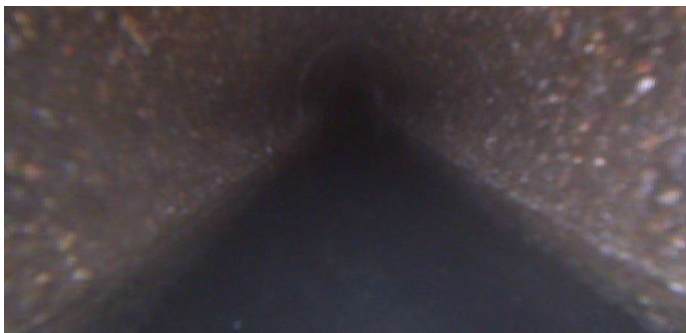
Code: **AMH**
Description: **Manhole**

Distance (ft): **.0**
Structural Grade: **0**
O&M Grade: **0**
Clock Start/From:
Clock To:
1st Value:
2nd Value:
Value Percent:
Continuous Index:
Within 8" of Joint: **NO**
Remarks: **M-504-054**

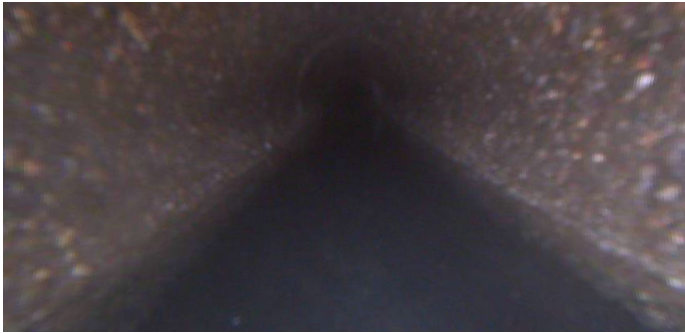
Code:	MWL
Description:	Water Level

Distance (ft):	.0
Structural Grade:	0
O&M Grade:	0
Clock Start/From:	
Clock To:	
1st Value:	
2nd Value:	
Value Percent:	5.000
Continuous Index:	
Within 8" of Joint:	NO
Remarks:

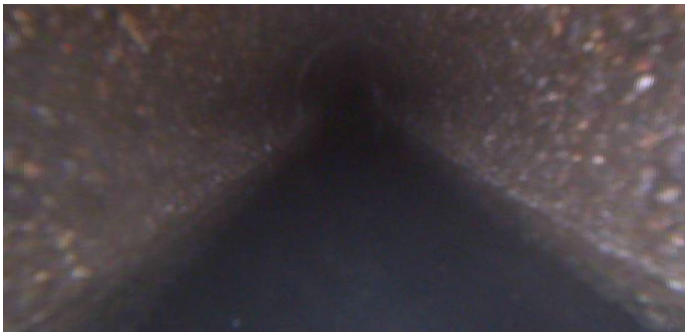
Code:	SAV
Description:	Surface Aggregate Visible

Distance (ft):	.0
Structural Grade:	3
O&M Grade:	0
Clock Start/From:	7
Clock To:	5
1st Value:	
2nd Value:	
Value Percent:	
Continuous Index:	S01
Within 8" of Joint:	
Remarks:

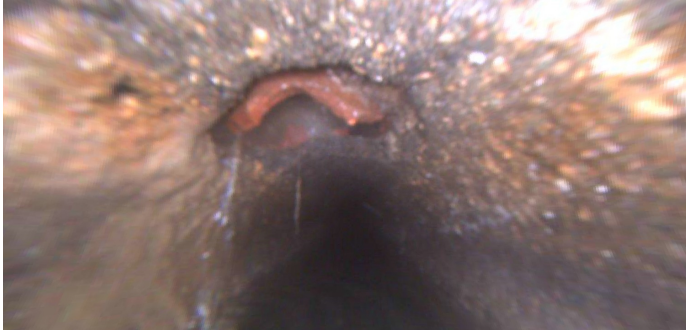
Code: **TB**
Description: **Tap Break-in**

Distance (ft): **6.1**
Structural Grade: **0**
O&M Grade: **0**
Clock Start/From: **12**
Clock To:
1st Value: **4.000**
2nd Value:
Value Percent:
Continuous Index:
Within 8" of Joint:
Remarks:

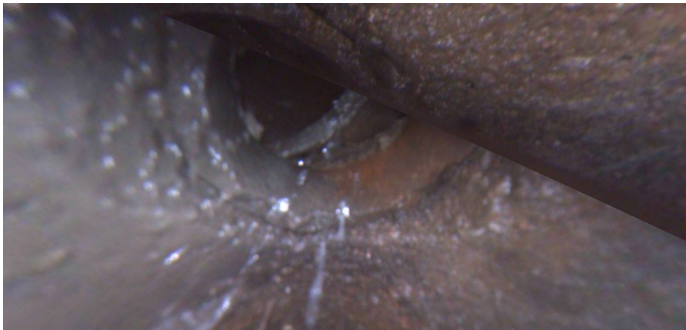
Code: **TFA**
Description: **Tap Factory Active**

Distance (ft): **20.7**
Structural Grade: **0**
O&M Grade: **0**
Clock Start/From: **12**
Clock To:
1st Value: **4.000**
2nd Value:
Value Percent:
Continuous Index:
Within 8" of Joint:
Remarks:

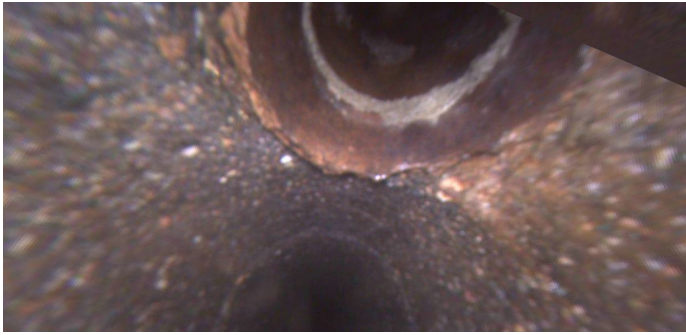
Code: **TB**
Description: **Tap Break-in**

Distance (ft): **23.7**
Structural Grade: **0**
O&M Grade: **0**
Clock Start/From: **1**
Clock To:
1st Value: **4.000**
2nd Value:
Value Percent:
Continuous Index:
Within 8" of Joint:
Remarks:

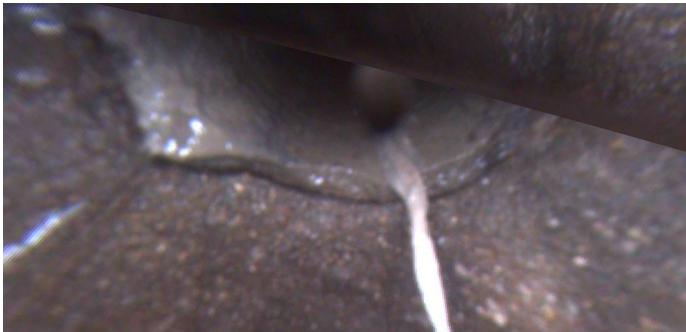
Code: **TFA**
Description: **Tap Factory Active**

Distance (ft): **44.5**
Structural Grade: **0**
O&M Grade: **0**
Clock Start/From: **12**
Clock To:
1st Value: **6.000**
2nd Value:
Value Percent:
Continuous Index:
Within 8" of Joint:
Remarks:

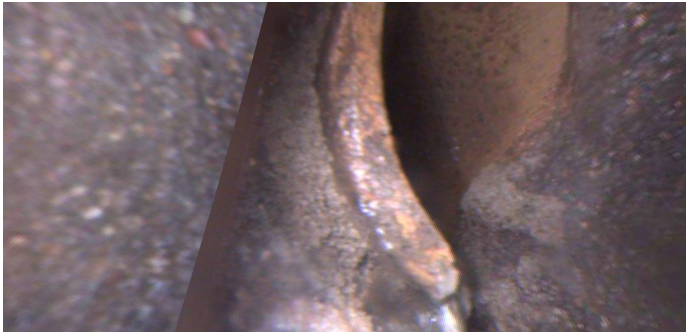
Code: **TBD**
Description: **Tap Break-in Defective**

Distance (ft): **61.4**
Structural Grade: **0**
O&M Grade: **3**
Clock Start/From: **3**
Clock To:
1st Value: **4.000**
2nd Value:
Value Percent:
Continuous Index:
Within 8" of Joint:
Remarks: **broken**

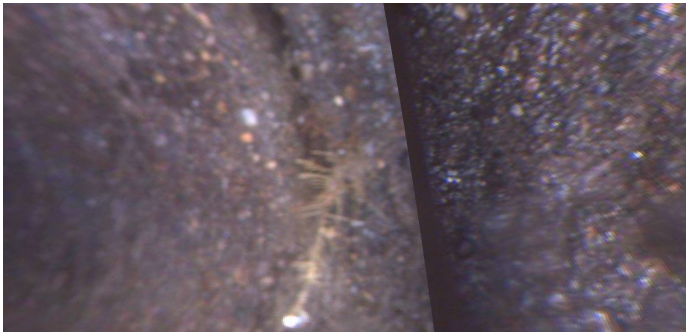
Code: **RFJ**
Description: **Roots Fine Joint**

Distance (ft): **74.7**
Structural Grade: **0**
O&M Grade: **1**
Clock Start/From: **3**
Clock To:
1st Value:
2nd Value:
Value Percent:
Continuous Index:
Within 8" of Joint: **YES**
Remarks:

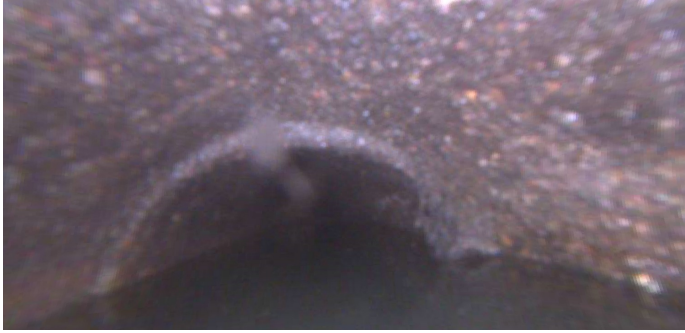
Code: **MWL**
Description: **Water Level**

Distance (ft): **80.8**
Structural Grade: **0**
O&M Grade: **0**
Clock Start/From:
Clock To:
1st Value:
2nd Value:
Value Percent: **50.000**
Continuous Index:
Within 8" of Joint: **NO**
Remarks:

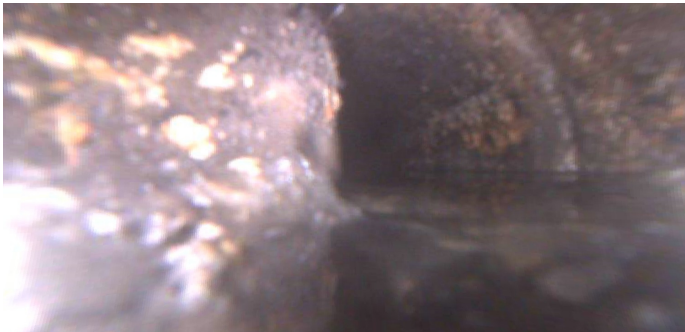
Code: **RBB**
Description: **Roots Ball Barrel**

Distance (ft): **83.9**
Structural Grade: **0**
O&M Grade: **5**
Clock Start/From: **9**
Clock To: **12**
1st Value:
2nd Value:
Value Percent: **55.000**
Continuous Index:
Within 8" of Joint: **NO**
Remarks: **rbb is also underwater**

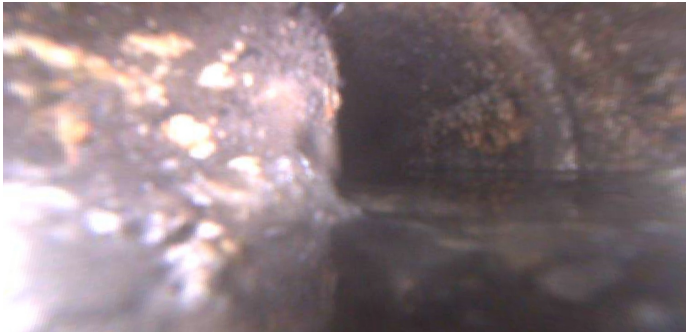
Code: **SAV**
Description: **Surface Aggregate Visible**

Distance (ft): **83.9**
Structural Grade: **3**
O&M Grade: **0**
Clock Start/From: **7**
Clock To: **5**
1st Value:
2nd Value:
Value Percent:
Continuous Index: **F01**
Within 8" of Joint:
Remarks:

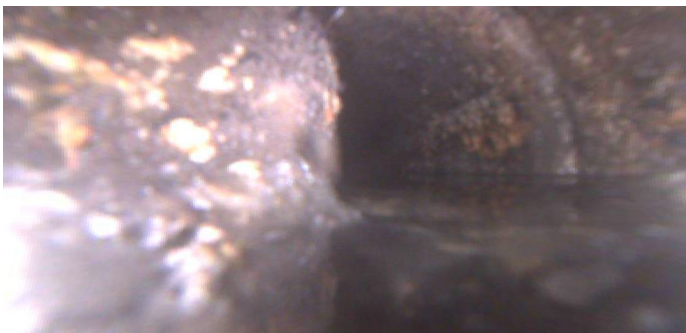
Code: **MSA**
Description: **Abandoned Survey**

Distance (ft): **83.9**
Structural Grade: **0**
O&M Grade: **0**
Clock Start/From:
Clock To:
1st Value:
2nd Value:
Value Percent:
Continuous Index:
Within 8" of Joint: **NO**
Remarks: **rbb**
