Profile/Photo Observation Report

Date:	04/19/2018	Weather:		Coding:	PACP 6.0
Pipe Length (ft):	304.1	Owner:	NA	Pre Clean:	Not Known
P.O.#:		Surveyor:	Byrd Fitzgerald	PSR:	P-504-055-054
Customer:		Clean Date:	01/01/1900	Shape:	C

Street:	Summerlin	Flow Control:	Not Controlled
City:	Hobart, IN	Year Renewed:	
Location:	Light Highway	Tape/Media #:	
Purpose:	Not Known	Dia/Height:	12"
Use:	Sanitary	Material:	CP
Drain Area:	NA	Lining:	
Category:	NA		
Comment:

Location Details:		Direction of Survey:	Upstream
US MH:	M-504-054	DS MH:	M-504-055
		Total Length Surveyed (ft):	83.9

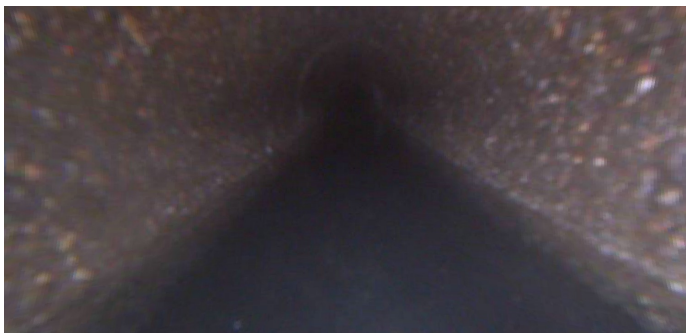
Code: **AMH**
Description: **Manhole**

Distance (ft): **.0**
Structural Grade: **0**
O&M Grade: **0**
Clock Start/From:
Clock To:
1st Value:
2nd Value:
Value Percent:
Continuous Index:
Within 8" of Joint: **NO**
Remarks: **M-504-054**

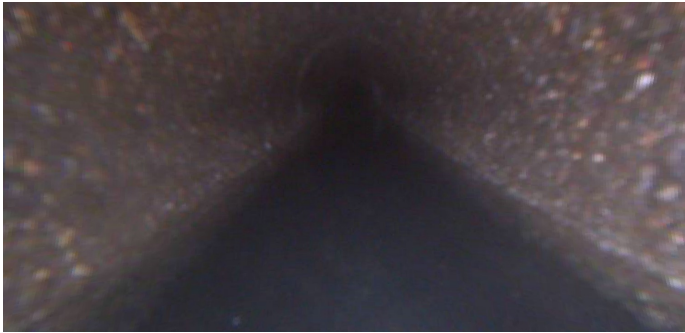
Code:	MWL
Description:	Water Level

Distance (ft):	.0
Structural Grade:	0
O&M Grade:	0
Clock Start/From:	
Clock To:	
1st Value:	
2nd Value:	
Value Percent:	5.000
Continuous Index:	
Within 8" of Joint:	NO
Remarks:

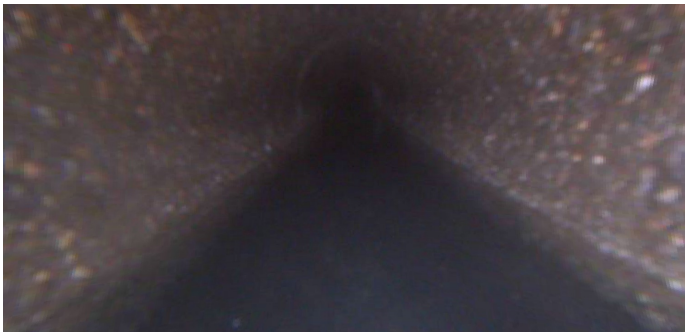
Code:	SAV
Description:	Surface Aggregate Visible

Distance (ft):	.0
Structural Grade:	3
O&M Grade:	0
Clock Start/From:	7
Clock To:	5
1st Value:	
2nd Value:	
Value Percent:	
Continuous Index:	S01
Within 8" of Joint:	
Remarks:

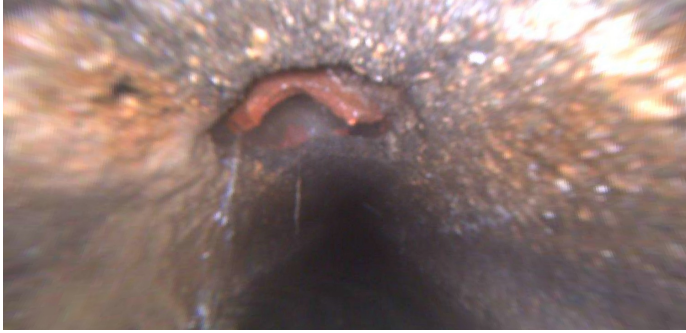
Code: **TB**
Description: **Tap Break-in**

Distance (ft): **6.1**
Structural Grade: **0**
O&M Grade: **0**
Clock Start/From: **12**
Clock To:
1st Value: **4.000**
2nd Value:
Value Percent:
Continuous Index:
Within 8" of Joint:
Remarks:

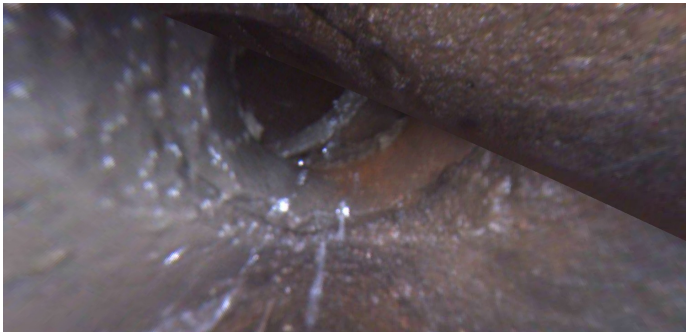
Code: **TFA**
Description: **Tap Factory Active**

Distance (ft): **20.7**
Structural Grade: **0**
O&M Grade: **0**
Clock Start/From: **12**
Clock To:
1st Value: **4.000**
2nd Value:
Value Percent:
Continuous Index:
Within 8" of Joint:
Remarks:

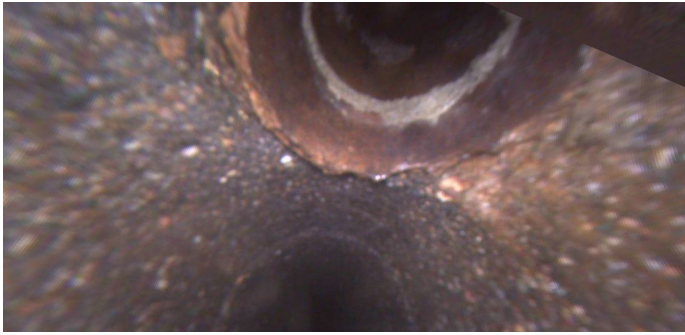
Code: **TB**
Description: **Tap Break-in**

Distance (ft): **23.7**
Structural Grade: **0**
O&M Grade: **0**
Clock Start/From: **1**
Clock To:
1st Value: **4.000**
2nd Value:
Value Percent:
Continuous Index:
Within 8" of Joint:
Remarks:

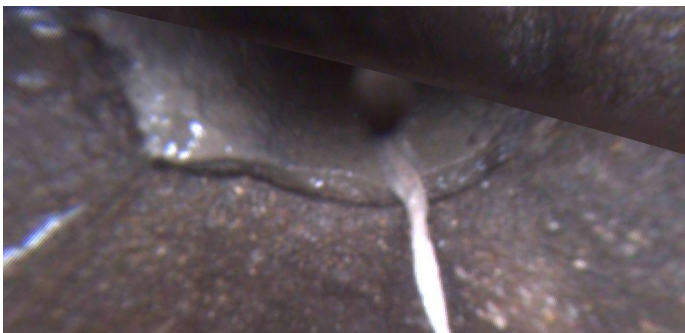
Code: **TFA**
Description: **Tap Factory Active**

Distance (ft): **44.5**
Structural Grade: **0**
O&M Grade: **0**
Clock Start/From: **12**
Clock To:
1st Value: **6.000**
2nd Value:
Value Percent:
Continuous Index:
Within 8" of Joint:
Remarks:

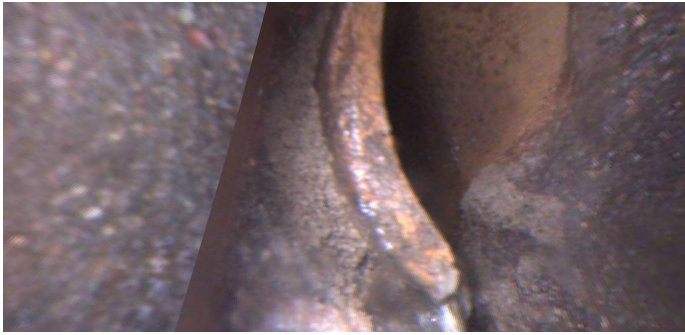
Code: **TBD**
Description: **Tap Break-in Defective**

Distance (ft): **61.4**
Structural Grade: **0**
O&M Grade: **3**
Clock Start/From: **3**
Clock To:
1st Value: **4.000**
2nd Value:
Value Percent:
Continuous Index:
Within 8" of Joint:
Remarks: **broken**

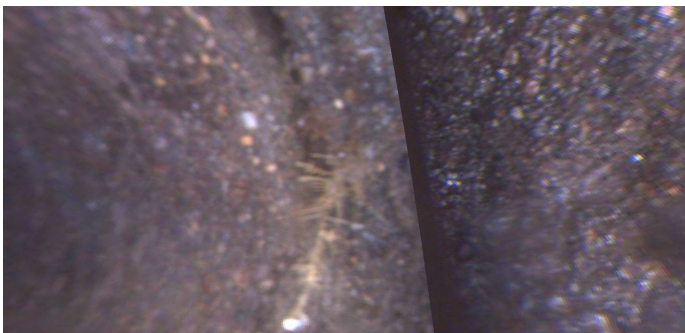
Code: **RFJ**
Description: **Roots Fine Joint**

Distance (ft): **74.7**
Structural Grade: **0**
O&M Grade: **1**
Clock Start/From: **3**
Clock To:
1st Value:
2nd Value:
Value Percent:
Continuous Index:
Within 8" of Joint: **YES**
Remarks:

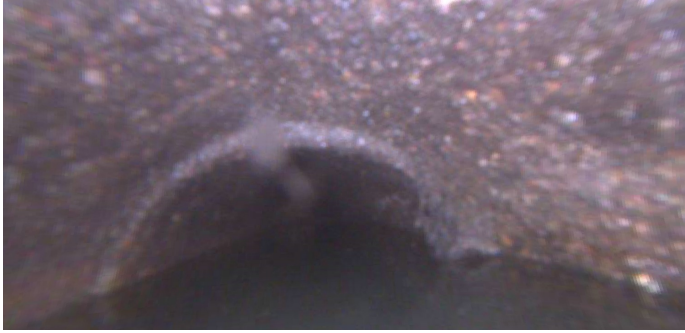
Code: **MWL**
Description: **Water Level**

Distance (ft): **80.8**
Structural Grade: **0**
O&M Grade: **0**
Clock Start/From:
Clock To:
1st Value:
2nd Value:
Value Percent: **50.000**
Continuous Index:
Within 8" of Joint: **NO**
Remarks:

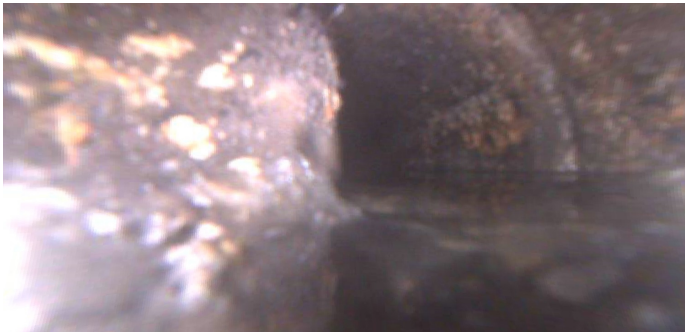
Code: **RBB**
Description: **Roots Ball Barrel**

Distance (ft): **83.9**
Structural Grade: **0**
O&M Grade: **5**
Clock Start/From: **9**
Clock To: **12**
1st Value:
2nd Value:
Value Percent: **55.000**
Continuous Index:
Within 8" of Joint: **NO**
Remarks: **rbb is also underwater**

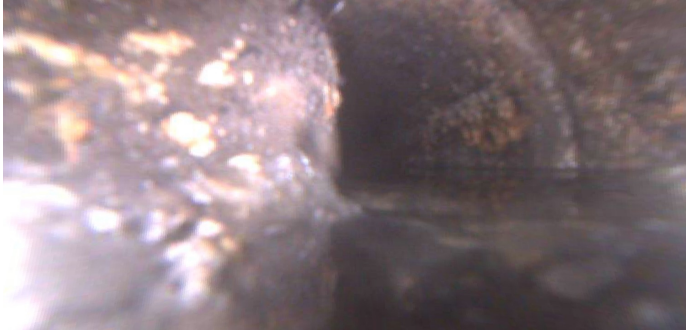
Code: **SAV**
Description: **Surface Aggregate Visible**

Distance (ft): **83.9**
Structural Grade: **3**
O&M Grade: **0**
Clock Start/From: **7**
Clock To: **5**
1st Value:
2nd Value:
Value Percent:
Continuous Index: **F01**
Within 8" of Joint:
Remarks:

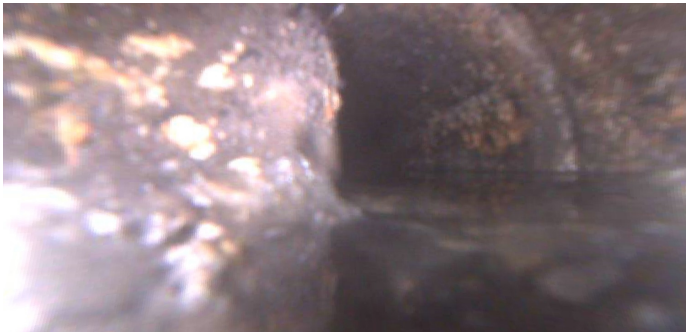
Code: **MSA**
Description: **Abandoned Survey**

Distance (ft): **83.9**
Structural Grade: **0**
O&M Grade: **0**
Clock Start/From:
Clock To:
1st Value:
2nd Value:
Value Percent:
Continuous Index:
Within 8" of Joint: **NO**
Remarks: **rbb**
