Profile/Photo Observation Report

Date: 09/15/2021 Weather: **PACP 7.0** Coding: Pipe Length (ft): 298.9 Owner: **City of Hobart** Pre Clean: **Heavy Cleaning** P.O.#: S. Bucklin PSR: P-504-055-054 YES502259 Surveyor:

Street: North Guyer Street Flow Control: Not Controlled

US MH: M-504-054 DS MH: M-504-055 Total Length Surveyed (ft): 298.9

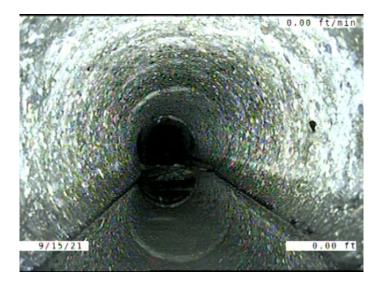
Code: DSF
Description: Deposits Settled Fine

Distance (ft): .0
Structural Grade: 0
O&M Grade: 2
Clock Start/From: 5
Clock To: 7

Value Percent: 5.000
Continuous Index: S01
Within 8" of Joint: YES

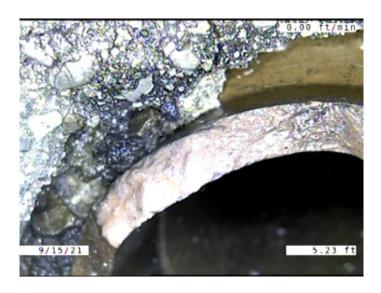
Code: B
Description: Broken

Distance (ft): 5.0
Structural Grade: 4
O&M Grade: 0
Clock Start/From: 10
Clock To: 12
1st Value:
2nd Value:
Value Percent:
Continuous Index:

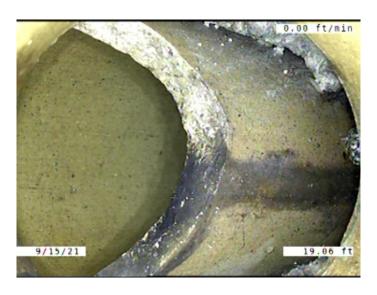
Code: **TBD**

Description: Tap Break-in/Hammer Defective

Distance (ft): 19.1
Structural Grade: 0

O&M Grade: 3

Remarks: **Defective**

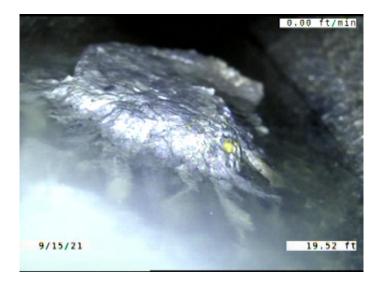
Code: OBB

Description: Obstruction Brick or Masonry

Distance (ft): 19.5
Structural Grade: 0
O&M Grade: 2
Clock Start/From: 6

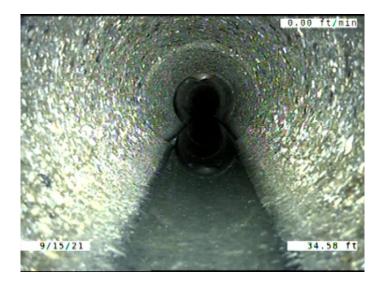
Code: **MWLS**

Description: **Miscellaneous Water Level Sag**

Distance (ft): 34.6 Structural Grade: 2 0 O&M Grade:

Value Percent: 5.000 Continuous Index: **S02** Within 8" of Joint: NO

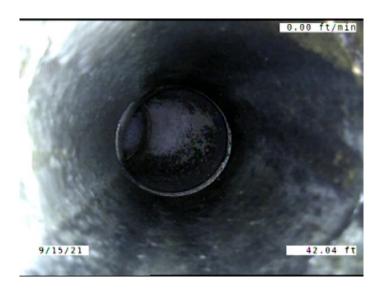
Code: TBI

Description: **Tap Break-in Intruding**

Distance (ft): 42.0 Structural Grade: 0 O&M Grade: 2 Clock Start/From: 12

1st Value: 4.000 2nd Value: 1.000

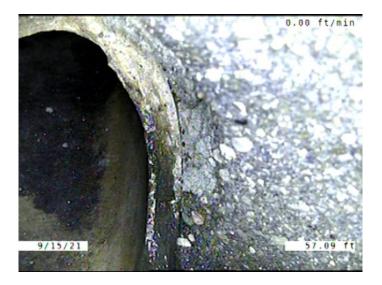
Code: Description: Broken

Distance (ft): 57.1 Structural Grade: 4 O&M Grade: 0 Clock Start/From: 2

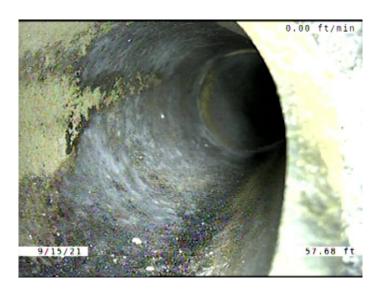
TBI Code:

Description: **Tap Break-in Intruding**

Distance (ft): 57.7 Structural Grade: 0 O&M Grade: 2 Clock Start/From: 1

1st Value: 4.000 2nd Value: 2.000

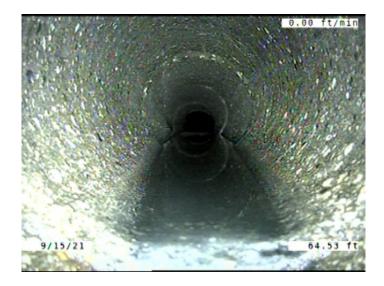
Code: MWLS

Description: Miscellaneous Water Level Sag

Distance (ft): 64.5
Structural Grade: 2
O&M Grade: 0

Value Percent: 5.000
Continuous Index: F02
Within 8" of Joint: NO

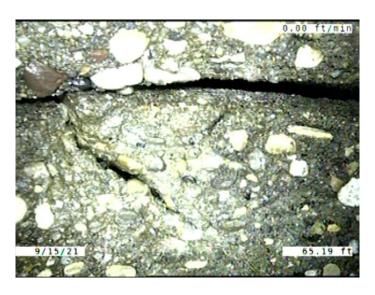
Code: FL

Description: Fracture Longitudinal

Distance (ft): 65.2
Structural Grade: 3
O&M Grade: 0
Clock Start/From: 8
Clock To:
1st Value:
2nd Value:

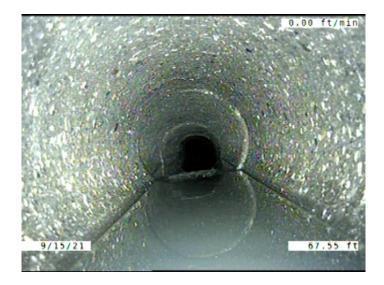
Code: **MWLS**

Description: **Miscellaneous Water Level Sag**

Distance (ft): 67.6 Structural Grade: 2 0 O&M Grade:

Value Percent: 10.000 Continuous Index: **S03** Within 8" of Joint: NO

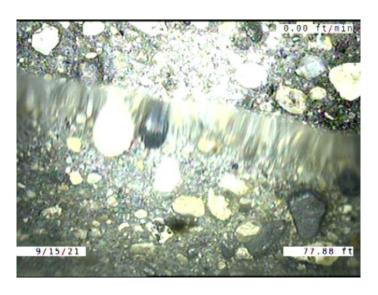
MCU Code:

Description: **Miscellaneous Camera Underwater**

77.9 Distance (ft): Structural Grade: 0 O&M Grade:

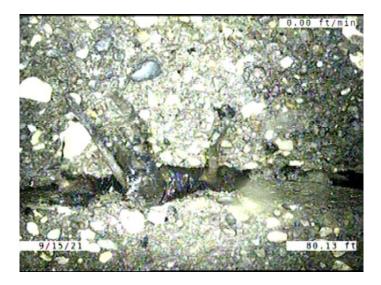
Code: RFJ

Description: Roots Fine Joint

Distance (ft): 80.1
Structural Grade: 0

O&M Grade: 1

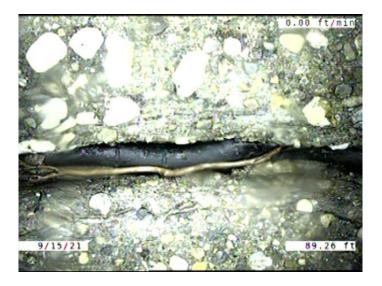
Code: RFJ

Description: **Roots Fine Joint**

Distance (ft): 89.3 Structural Grade: 0 O&M Grade: 1 Clock Start/From: 9 Clock To: 1

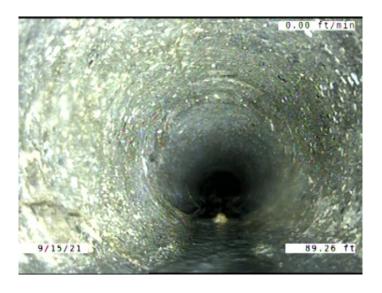
Code: **MWLS**

Description: **Miscellaneous Water Level Sag**

Distance (ft): 89.3 Structural Grade: 2 O&M Grade: 0

10.000 Value Percent: Continuous Index: F03 Within 8" of Joint: NO

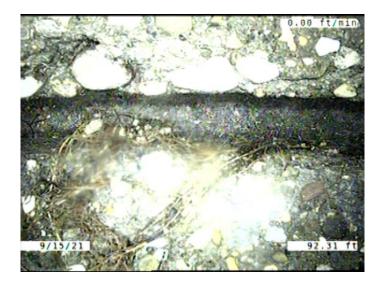
Code: RFJ

Description: Roots Fine Joint

Distance (ft): 92.3
Structural Grade: 0

O&M Grade: 1

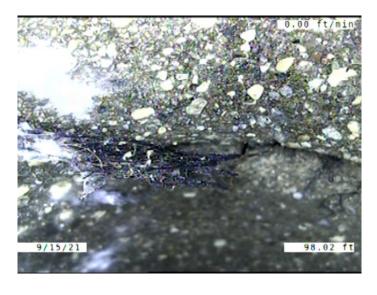
Code: RFJ

Description: Roots Fine Joint

Distance (ft): 98.0 Structural Grade: 0 O&M Grade: 1 Clock Start/From: 8 Clock To: 9 1st Value: 2nd Value: Value Percent: Continuous Index: Within 8" of Joint: YES

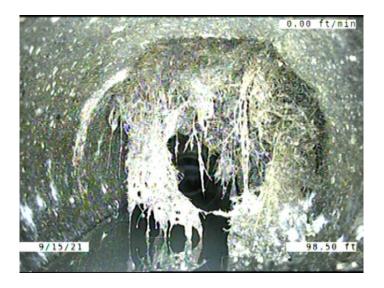
Code: RMB

Description: Roots Medium Barrel

Distance (ft): 98.4
Structural Grade: 0

O&M Grade: 4

Value Percent: 40.000

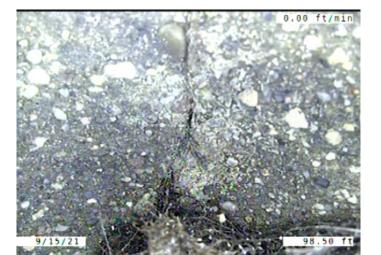
Code: **B**

Description: Broken

Distance (ft): 98.5
Structural Grade: 4
O&M Grade: 0
Clock Start/From: 12

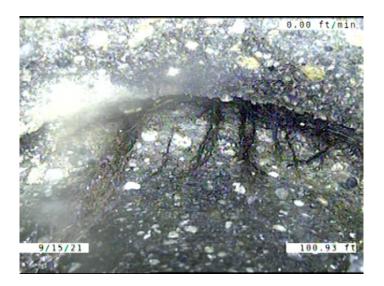
Code: RFJ

Description: Roots Fine Joint

Distance (ft): 100.9
Structural Grade: 0
O&M Grade: 1
Clock Start/From: 10
Clock To: 2

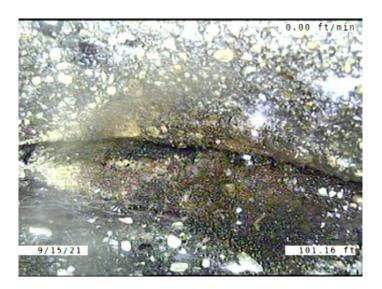
Code: ISJ

Description: Infiltration Stain Joint

Distance (ft): 101.2
Structural Grade: 0
O&M Grade: 1
Clock Start/From: 2
Clock To: 4
1st Value:
2nd Value:

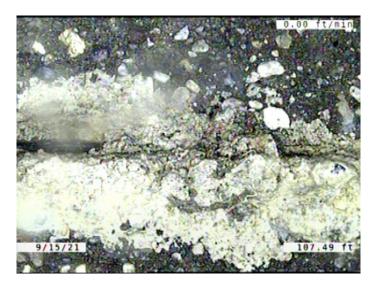
Code: DAE

Description: **Deposits Attached Encrustation**

Distance (ft): 107.5 Structural Grade: 0 O&M Grade: 2 Clock Start/From: 10 2 Clock To: 1st Value:

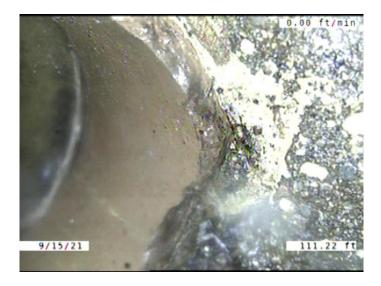
Code: B
Description: Broken

Distance (ft): 111.2
Structural Grade: 4

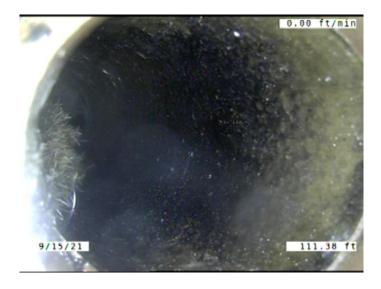
Code: TBI

Description: Tap Break-in Intruding

Distance (ft): 111.4
Structural Grade: 0
O&M Grade: 2
Clock Start/From: 11

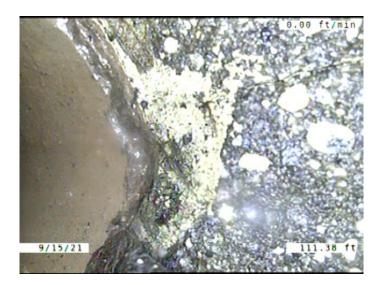
Code: DAE

Description: Deposits Attached Encrustation

Distance (ft): 111.4
Structural Grade: 0
O&M Grade: 2
Clock Start/From: 12

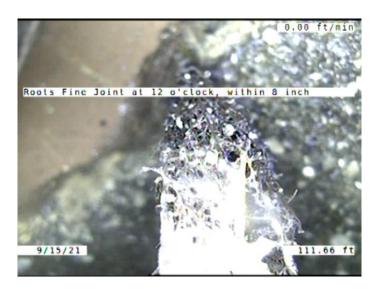
Code: RFJ

Description: Roots Fine Joint

Distance (ft): 111.7
Structural Grade: 0
O&M Grade: 1
Clock Start/From: 12

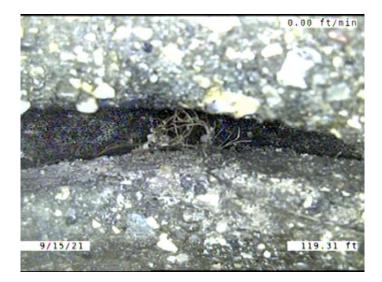
Code: RFJ

Description: **Roots Fine Joint**

Distance (ft): 119.3 Structural Grade: 0 O&M Grade: 1 Clock Start/From: 2

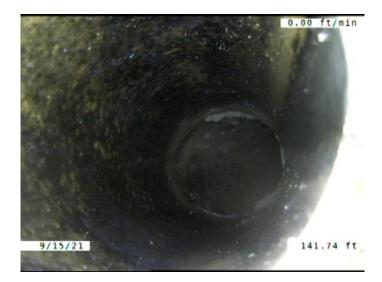
Code: TBI

Description: **Tap Break-in Intruding**

Distance (ft): 141.7 Structural Grade: 0 O&M Grade: 2 Clock Start/From: 1

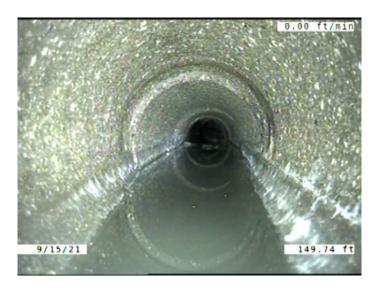
Code: **MWLS**

Description: **Miscellaneous Water Level Sag**

Distance (ft): 149.7 Structural Grade: 2 O&M Grade: 0

Value Percent: 15.000 Continuous Index: **S04** Within 8" of Joint: NO

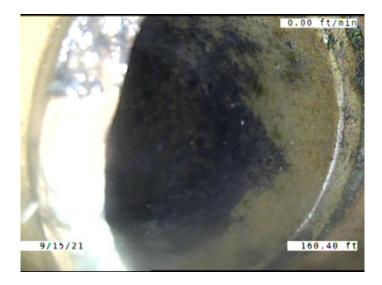
Code: TBI

Description: **Tap Break-in Intruding**

Distance (ft): 160.3 Structural Grade: 0 2 O&M Grade: Clock Start/From: 12

Remarks: **CONTSTANTLY RUNNING WATER**

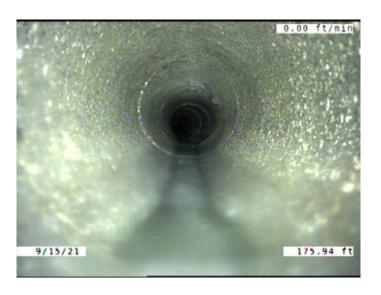
Code: **MWLS**

Description: **Miscellaneous Water Level Sag**

Distance (ft): 175.9 Structural Grade: 2 O&M Grade: 0

Value Percent: 15.000 Continuous Index: F04 Within 8" of Joint: NO

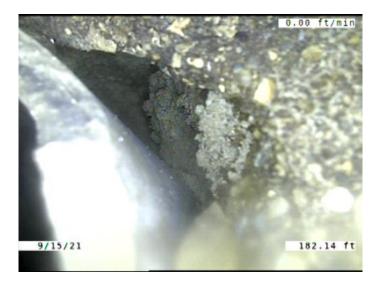
Code: BSV

Description: Broken Soil Visible

Distance (ft): 181.8
Structural Grade: 5
O&M Grade: 0
Clock Start/From: 12
Clock To: 3

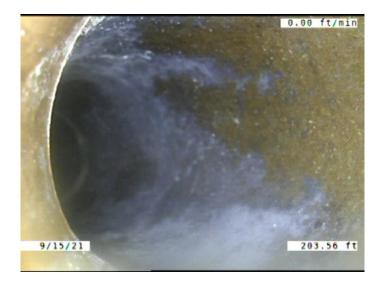
Code: TBI

Description: **Tap Break-in Intruding**

Distance (ft): 203.6 Structural Grade: 0 2 O&M Grade: Clock Start/From: 11

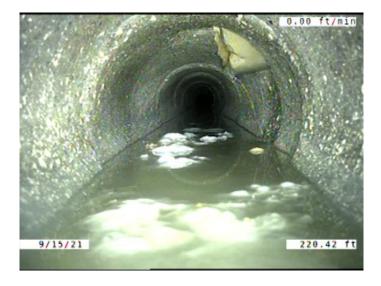
Code: **MWLS**

Description: **Miscellaneous Water Level Sag**

Distance (ft): 220.4 Structural Grade: 2 O&M Grade: 0

Value Percent: 10.000 Continuous Index: **S05** Within 8" of Joint: NO

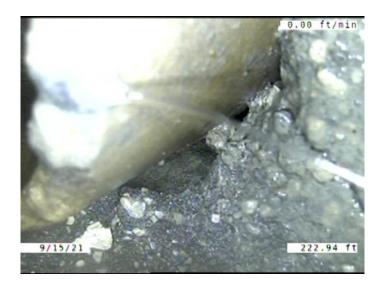
Code: **FM**

Description: Fracture Multiple

Distance (ft): 222.5
Structural Grade: 4
O&M Grade: 0
Clock Start/From: 11
Clock To: 3

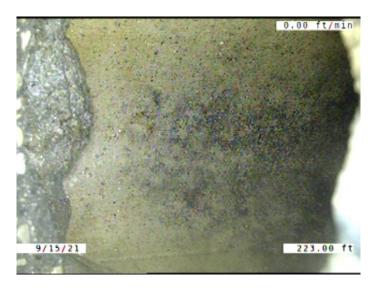
Code: TBI

Description: Tap Break-in Intruding

Distance (ft): 222.9
Structural Grade: 0
O&M Grade: 2
Clock Start/From: 1

Remarks: ACTIVITY

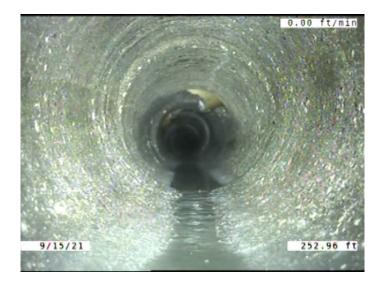
Code: MWLS

Description: Miscellaneous Water Level Sag

Distance (ft): 253.0 Structural Grade: 2

Value Percent: 10.000
Continuous Index: F05
Within 8" of Joint: NO

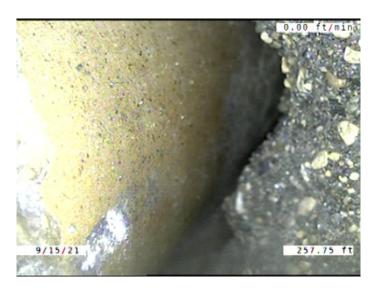
Code: **HVV**

Description: Hole Void Visible

Distance (ft): 257.7
Structural Grade: 5
O&M Grade: 0
Clock Start/From: 2

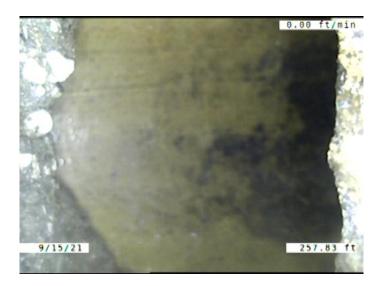
Code: **TBI**

Description: Tap Break-in Intruding

Distance (ft): 257.8
Structural Grade: 0
O&M Grade: 2
Clock Start/From: 1

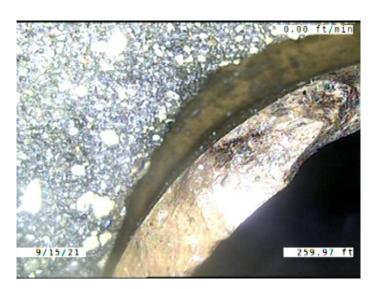
Code: B
Description: Broken

Distance (ft): 260.0
Structural Grade: 4

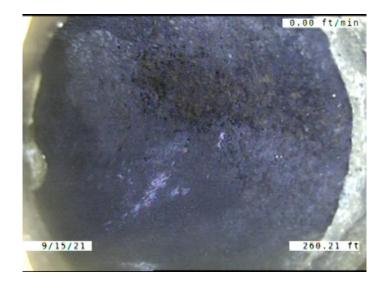
Code: **TBI**

Description: Tap Break-in Intruding

Distance (ft): 260.2
Structural Grade: 0
O&M Grade: 2
Clock Start/From: 11

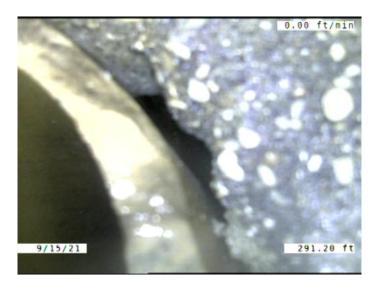
Code: **HVV**

Description: Hole Void Visible

Distance (ft): 291.2
Structural Grade: 5

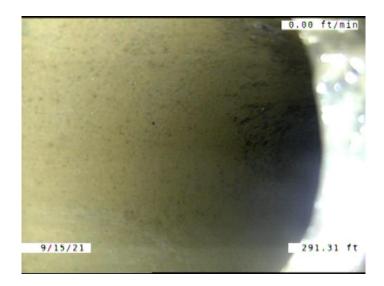
Code: TBI

Description: **Tap Break-in Intruding**

Distance (ft): 291.3 Structural Grade: 0 O&M Grade: 2 Clock Start/From: 1

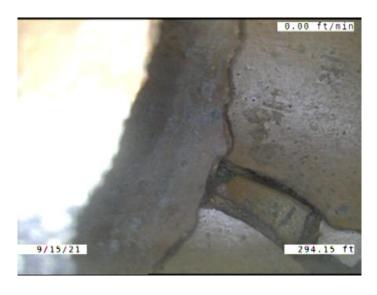
Code: TBI

Description: **Tap Break-in Intruding**

Distance (ft): 294.2 Structural Grade: 0 O&M Grade: 2 Clock Start/From: 11

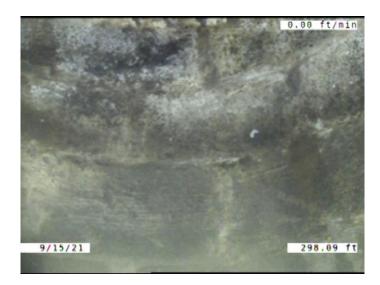
Code: **DSF**

Description: Deposits Settled Fine

Distance (ft): 298.1
Structural Grade: 0
O&M Grade: 2
Clock Start/From: 5
Clock To: 7

Value Percent: 5.000
Continuous Index: F01
Within 8" of Joint: YES
