# Profile/Photo Observation Report

| Street: | North Guyer Street | Flow Control: | Not Controlled |
| US MH: | M-504-054 | DS MH: | M-504-055 |

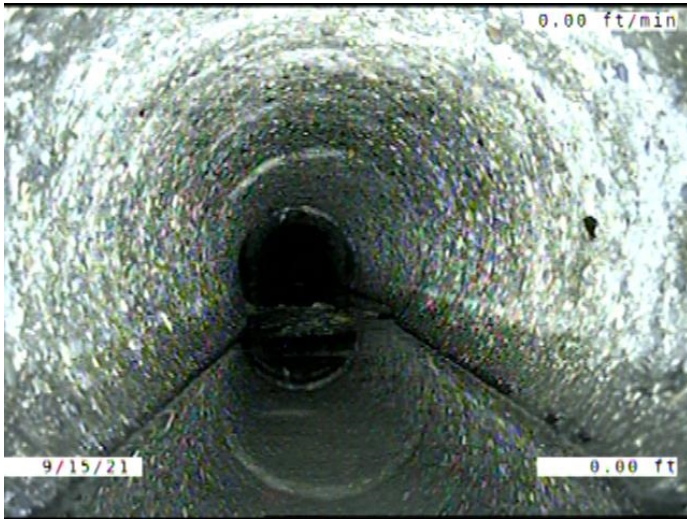
| Position | Code | Observation | Video (sec) | Grade |
|---|---|---|---|---|
| .0 | DSF(S01) | Deposits Settled Fine | 85 | M 2 |

Code: **DSF**  
 Description: **Deposits Settled Fine**

Distance (ft): **.0**  
 Structural Grade: **0**  
 O&M Grade: **2**  
 Clock Start/From: **5**  
 Clock To: **7**  
 1st Value:  
 2nd Value:  
 Value Percent: **5.000**  
 Continuous Index: **S01**  
 Within 8" of Joint: **YES**  
 Remarks:

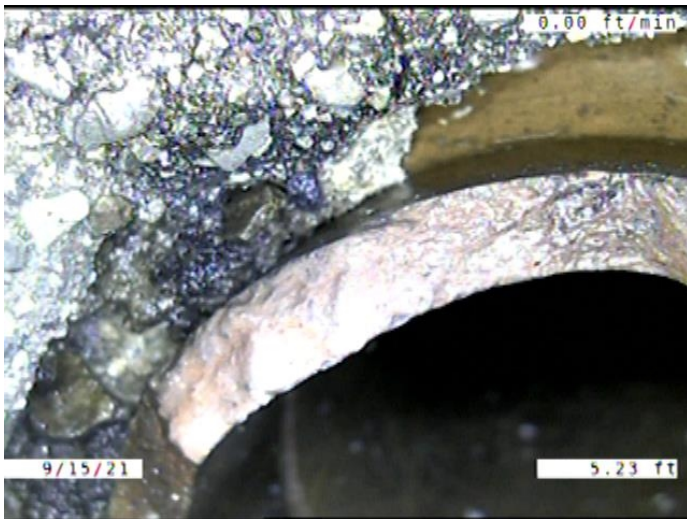
| Position | Code | Observation | Video (sec) | Grade |
|---|---|---|---|---|
| 5.0 | B | Broken | 160 | S 4 |

Code: **B**  
 Description: **Broken**

Distance (ft): **5.0**  
 Structural Grade: **4**  
 O&M Grade: **0**  
 Clock Start/From: **10**  
 Clock To: **12**  
 1st Value:  
 2nd Value:  
 Value Percent:  
 Continuous Index:  
 Within 8" of Joint: **YES**  
 Remarks:

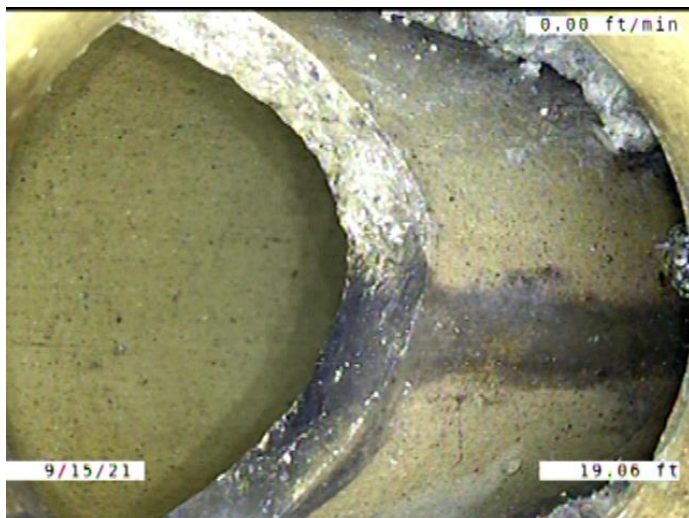
| Position | Code | Observation | Video (sec) | Grade |
|---|---|---|---|---|
| 19.1 | TBD | Tap Break-in/Hammer Defective | 358 | M 3 |

Code: **TBD**  
 Description: **Tap Break-in/Hammer Defective**

Distance (ft): **19.1**  
 Structural Grade: **0**  
 O&M Grade: **3**  
 Clock Start/From: **12**  
 Clock To:  
 1st Value: **4.000**  
 2nd Value:  
 Value Percent:  
 Continuous Index:  
 Within 8" of Joint: **YES**  
 Remarks: **Defective**

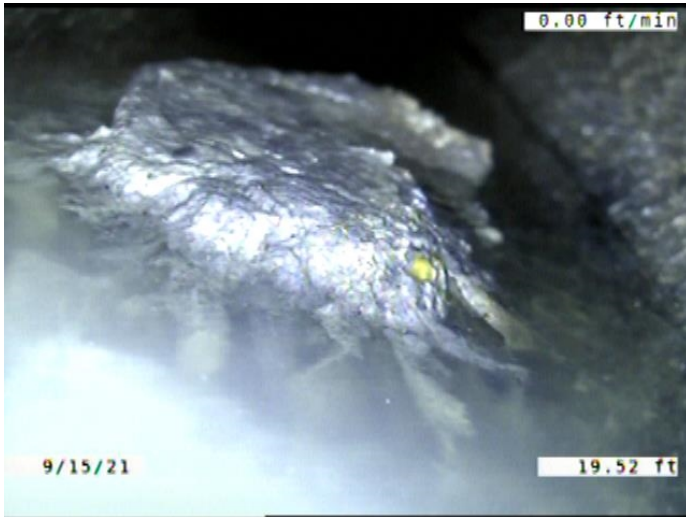
| Position | Code | Observation | Video (sec) | Grade |
|---|---|---|---|---|
| 19.5 | OBB | Obstruction Brick or Masonry | 405 | M 2 |

Code: **OBB**  
Description: **Obstruction Brick or Masonry**

Distance (ft): **19.5**  
Structural Grade: **0**  
O&M Grade: **2**  
Clock Start/From: **6**  
Clock To:  
1st Value:  
2nd Value:  
Value Percent: **10.000**  
Continuous Index:  
Within 8" of Joint: **NO**  
Remarks:

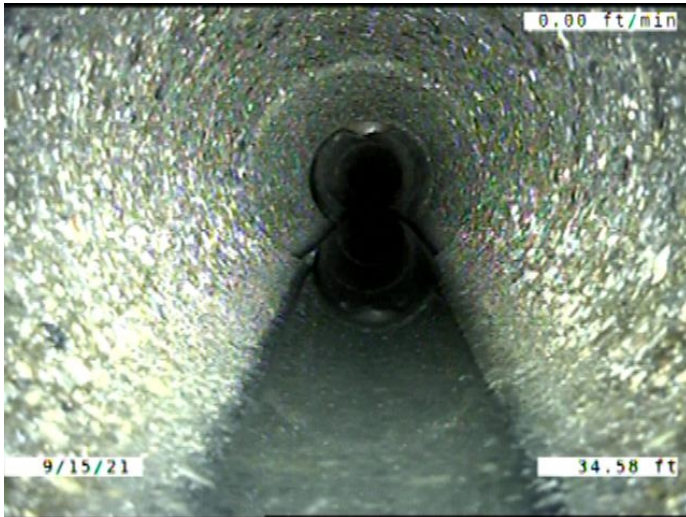
| Position | Code | Observation | Video (sec) | Grade |
|---|---|---|---|---|
| 34.6 | MWLS(S02) | Miscellaneous Water Level Sag | 506 | S 2 |

Code: **MWLS**  
 Description: **Miscellaneous Water Level Sag**

Distance (ft): **34.6**  
 Structural Grade: **2**  
 O&M Grade: **0**  
 Clock Start/From:  
 Clock To:  
 1st Value:  
 2nd Value:  
 Value Percent: **5.000**  
 Continuous Index: **S02**  
 Within 8" of Joint: **NO**  
 Remarks:

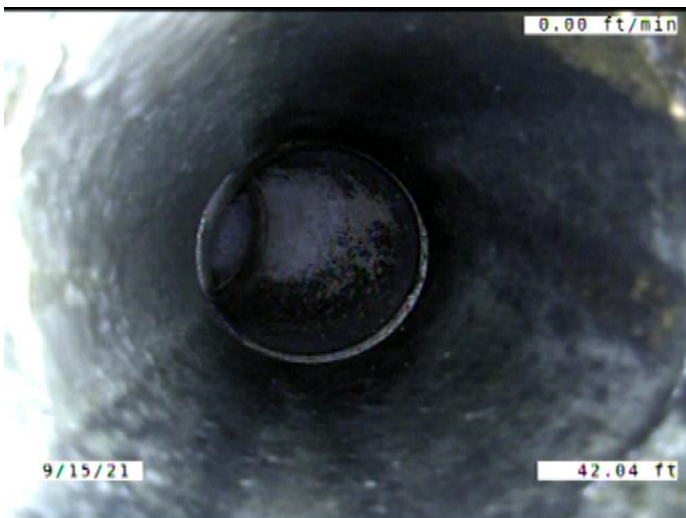
| Position | Code | Observation | Video (sec) | Grade |
|---|---|---|---|---|
| 42.0 | TBI | Tap Break-in Intruding | 589 | M 2 |

Code: **TBI**  
 Description: **Tap Break-in Intruding**

Distance (ft): **42.0**  
 Structural Grade: **0**  
 O&M Grade: **2**  
 Clock Start/From: **12**  
 Clock To:  
 1st Value: **4.000**  
 2nd Value: **1.000**  
 Value Percent:  
 Continuous Index:  
 Within 8" of Joint: **YES**  
 Remarks:

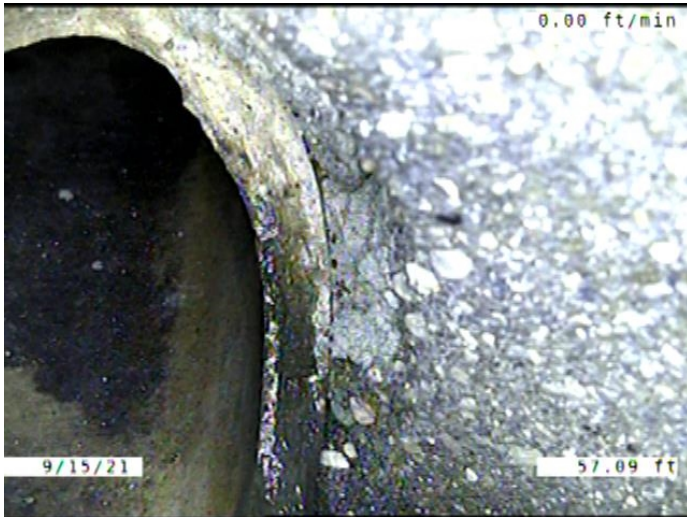
| Position | Code | Observation | Video (sec) | Grade |
|---|---|---|---|---|
| 57.1 | B | Broken | 690 | S 4 |

Code: **B**  
 Description: **Broken**

Distance (ft): **57.1**  
 Structural Grade: **4**  
 O&M Grade: **0**  
 Clock Start/From: **2**  
 Clock To:  
 1st Value:  
 2nd Value:  
 Value Percent:  
 Continuous Index:  
 Within 8" of Joint: **NO**  
 Remarks:

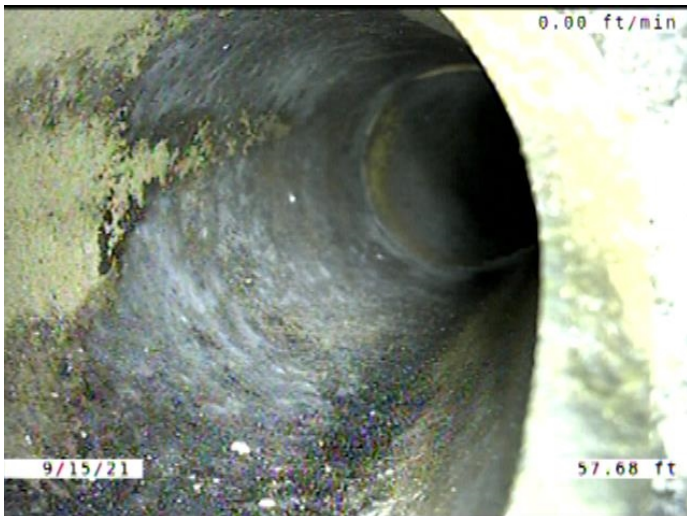
| Position | Code | Observation | Video (sec) | Grade |
|---|---|---|---|---|
| 57.7 | TBI | Tap Break-in Intruding | 835 | M 2 |

Code: **TBI**  
 Description: **Tap Break-in Intruding**

Distance (ft): **57.7**  
 Structural Grade: **0**  
 O&M Grade: **2**  
 Clock Start/From: **1**  
 Clock To:  
 1st Value: **4.000**  
 2nd Value: **2.000**  
 Value Percent:  
 Continuous Index:  
 Within 8" of Joint: **NO**  
 Remarks:

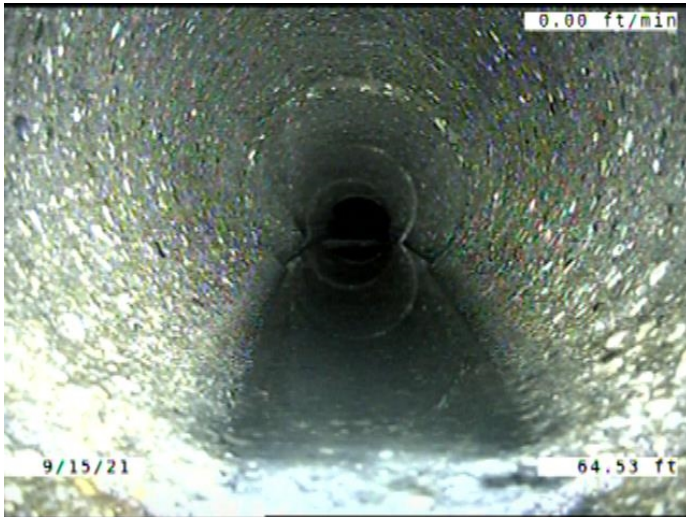
| Position | Code | Observation | Video (sec) | Grade |
|---|---|---|---|---|
| 64.5 | MWLS(F02) | Miscellaneous Water Level Sag | 889 | S 2 |

Code: **MWLS**  
 Description: **Miscellaneous Water Level Sag**

Distance (ft): **64.5**  
 Structural Grade: **2**  
 O&M Grade: **0**  
 Clock Start/From:  
 Clock To:  
 1st Value:  
 2nd Value:  
 Value Percent: **5.000**  
 Continuous Index: **F02**  
 Within 8" of Joint: **NO**  
 Remarks:

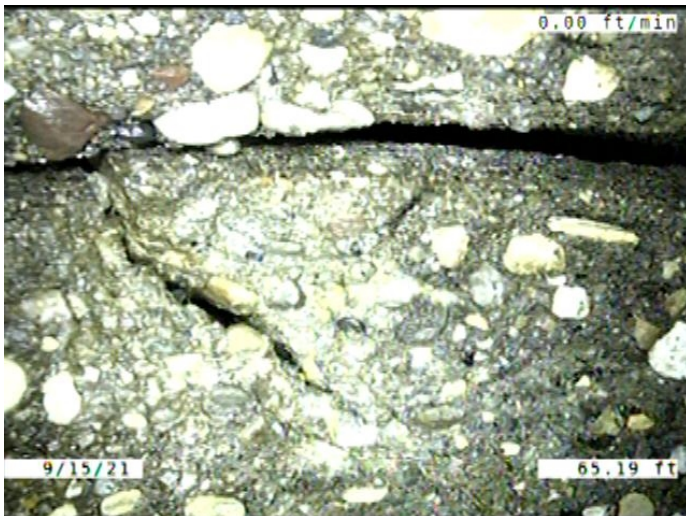
| Position | Code | Observation | Video (sec) | Grade |
|---|---|---|---|---|
| 65.2 | FL | Fracture Longitudinal | 969 | S 3 |

Code: **FL**  
 Description: **Fracture Longitudinal**

Distance (ft): **65.2**  
 Structural Grade: **3**  
 O&M Grade: **0**  
 Clock Start/From: **8**  
 Clock To:  
 1st Value:  
 2nd Value:  
 Value Percent:  
 Continuous Index:  
 Within 8" of Joint: **YES**  
 Remarks:

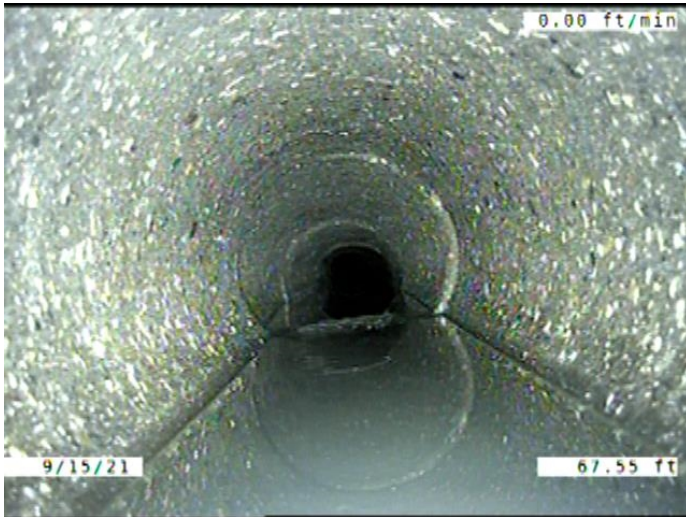
| Position | Code | Observation | Video (sec) | Grade |
|---|---|---|---|---|
| 67.6 | MWLS(S03) | Miscellaneous Water Level Sag | 1011 | S 2 |

Code: **MWLS**  
 Description: **Miscellaneous Water Level Sag**

Distance (ft): **67.6**  
 Structural Grade: **2**  
 O&M Grade: **0**  
 Clock Start/From:  
 Clock To:  
 1st Value:  
 2nd Value:  
 Value Percent: **10.000**  
 Continuous Index: **S03**  
 Within 8" of Joint: **NO**  
 Remarks:

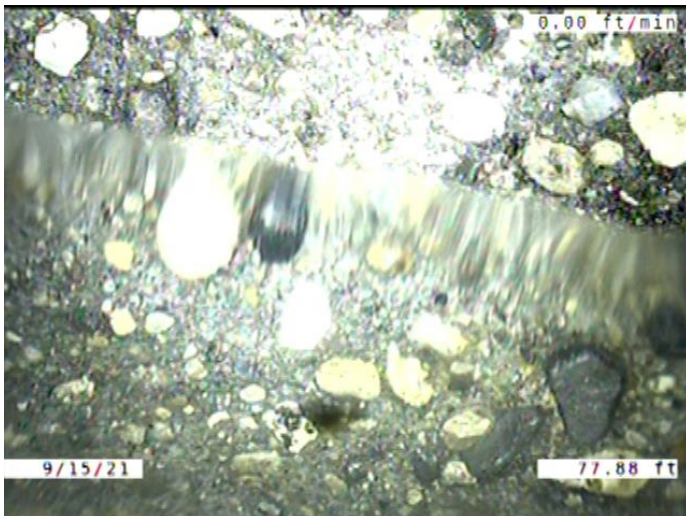
| Position | Code | Observation | Video (sec) | Grade |
|---|---|---|---|---|
| 77.9 | MCU | Miscellaneous Camera Underwater | 1108 | M 4 |

Code: **MCU**  
 Description: **Miscellaneous Camera Underwater**

Distance (ft): **77.9**  
 Structural Grade: **0**  
 O&M Grade: **4**  
 Clock Start/From:  
 Clock To:  
 1st Value:  
 2nd Value:  
 Value Percent:  
 Continuous Index:  
 Within 8" of Joint: **NO**  
 Remarks:

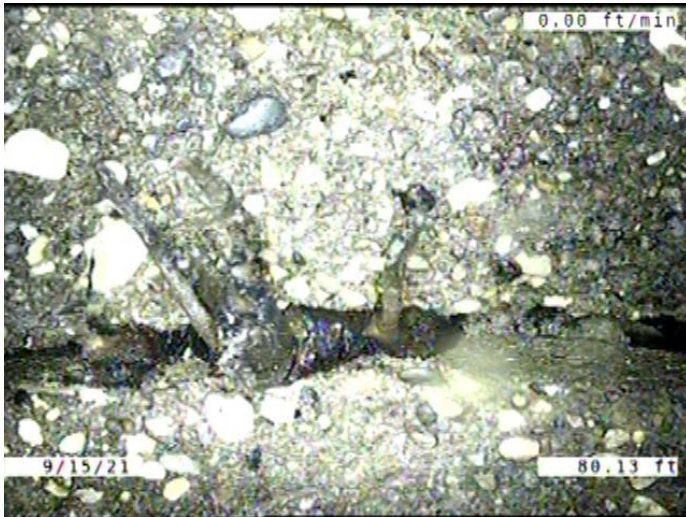
| Position | Code | Observation | Video (sec) | Grade |
|---|---|---|---|---|
| 80.1 | RFJ | Roots Fine Joint | 1176 | M 1 |

Code: **RFJ**  
Description: **Roots Fine Joint**

Distance (ft): **80.1**  
Structural Grade: **0**  
O&M Grade: **1**  
Clock Start/From: **10**  
Clock To:  
1st Value:  
2nd Value:  
Value Percent:  
Continuous Index:  
Within 8" of Joint: **YES**  
Remarks:

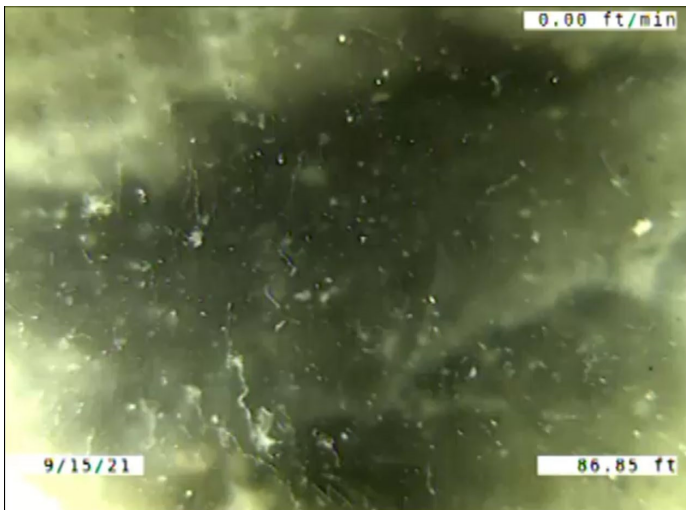
| Position | Code | Observation | Video (sec) | Grade |
|---|---|---|---|---|
| 86.9 | MCU | Miscellaneous Camera Underwater | 1298 | M 4 |

Code: **MCU**  
Description: **Miscellaneous Camera Underwater**

Distance (ft): **86.9**  
Structural Grade: **0**  
O&M Grade: **4**  
Clock Start/From:  
Clock To:  
1st Value:  
2nd Value:  
Value Percent:  
Continuous Index:  
Within 8" of Joint: **NO**  
Remarks: **Out at 87.4**

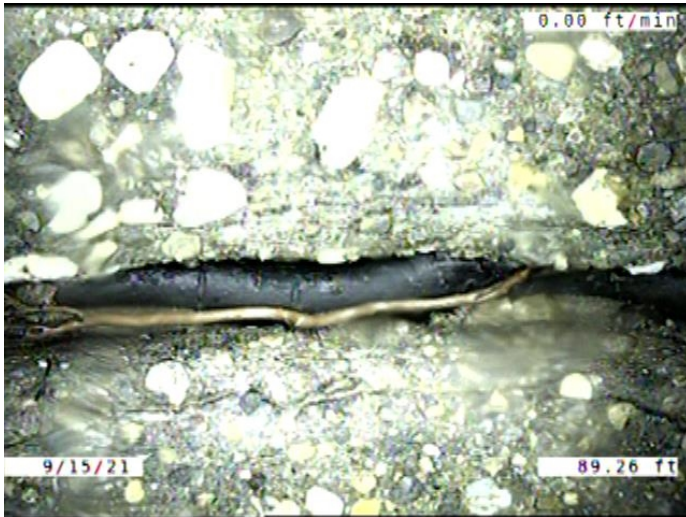
| Position | Code | Observation | Video (sec) | Grade |
|---|---|---|---|---|
| 89.3 | RFJ | Roots Fine Joint | 1384 | M 1 |

Code: **RFJ**  
 Description: **Roots Fine Joint**

Distance (ft): **89.3**  
 Structural Grade: **0**  
 O&M Grade: **1**  
 Clock Start/From: **9**  
 Clock To: **1**  
 1st Value:  
 2nd Value:  
 Value Percent:  
 Continuous Index:  
 Within 8" of Joint: **YES**  
 Remarks:

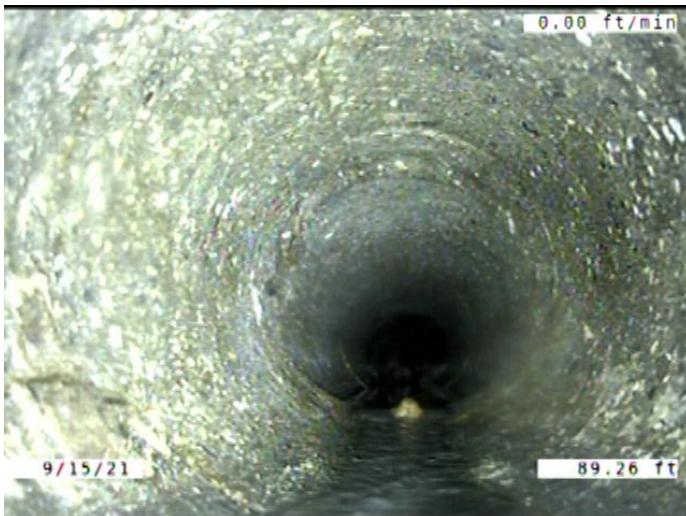
| 89.3 | MWLS(F03) | Miscellaneous Water Level Sag | 1403 | S 2 |

Code: **MWLS**  
 Description: **Miscellaneous Water Level Sag**

Distance (ft): **89.3**  
 Structural Grade: **2**  
 O&M Grade: **0**  
 Clock Start/From:  
 Clock To:  
 1st Value:  
 2nd Value:  
 Value Percent: **10.000**  
 Continuous Index: **F03**  
 Within 8" of Joint: **NO**  
 Remarks:

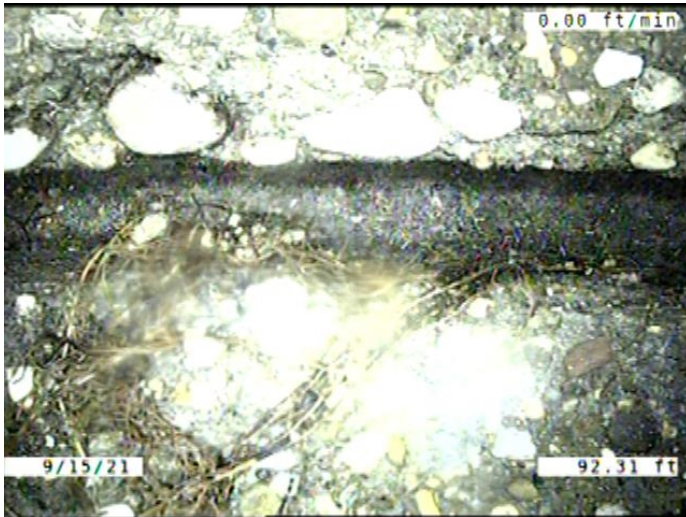
| 92.3 | RFJ | Roots Fine Joint | 1475 | M 1 |

Code: **RFJ**  
 Description: **Roots Fine Joint**

Distance (ft): **92.3**  
 Structural Grade: **0**  
 O&M Grade: **1**  
 Clock Start/From: **10**  
 Clock To: **12**  
 1st Value:  
 2nd Value:  
 Value Percent:  
 Continuous Index:  
 Within 8" of Joint: **YES**  
 Remarks:

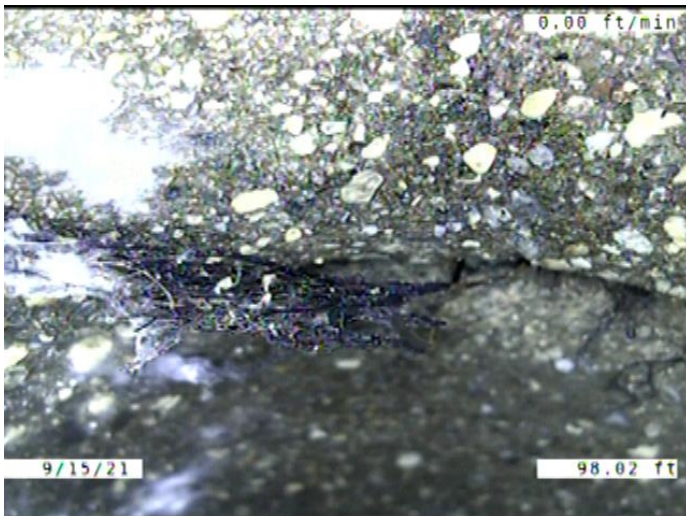
| 98.0 | RFJ | Roots Fine Joint | 1551 | M 1 |

Code: **RFJ**  
 Description: **Roots Fine Joint**

Distance (ft): **98.0**  
 Structural Grade: **0**  
 O&M Grade: **1**  
 Clock Start/From: **8**  
 Clock To: **9**  
 1st Value:  
 2nd Value:  
 Value Percent:  
 Continuous Index:  
 Within 8" of Joint: **YES**  
 Remarks:

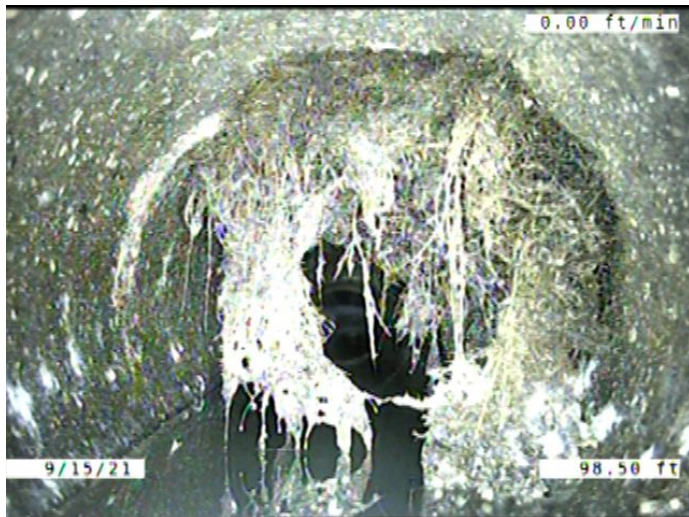
| 98.4 | RMB | Roots Medium Barrel | 1621 | M 4 |

Code: **RMB**  
 Description: **Roots Medium Barrel**

Distance (ft): **98.4**  
 Structural Grade: **0**  
 O&M Grade: **4**  
 Clock Start/From: **11**  
 Clock To: **5**  
 1st Value:  
 2nd Value:  
 Value Percent: **40.000**  
 Continuous Index:  
 Within 8" of Joint: **NO**  
 Remarks:

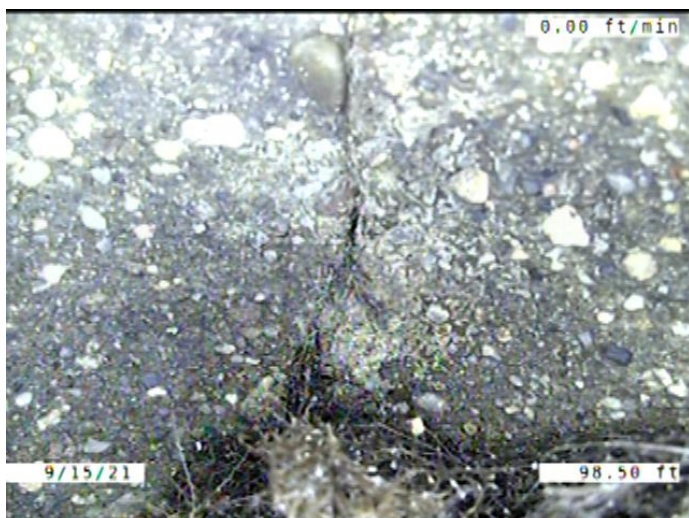
| 98.5 | B | Broken | 1701 | S 4 |

Code: **B**  
 Description: **Broken**

Distance (ft): **98.5**  
 Structural Grade: **4**  
 O&M Grade: **0**  
 Clock Start/From: **12**  
 Clock To: **2**  
 1st Value:  
 2nd Value:  
 Value Percent:  
 Continuous Index:  
 Within 8" of Joint: **YES**  
 Remarks:

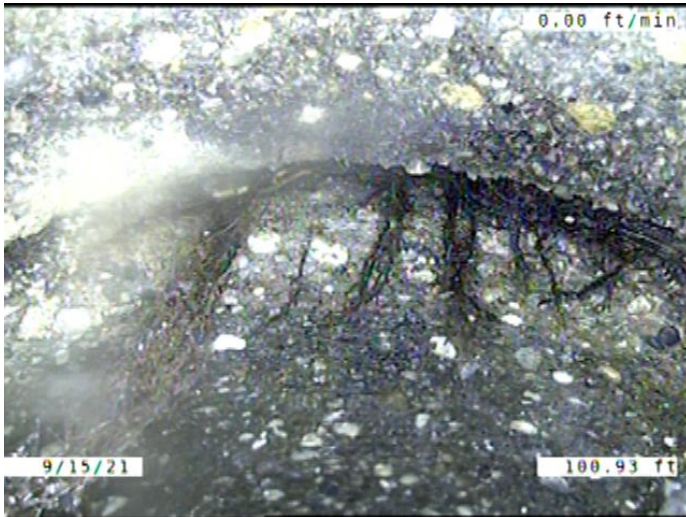
| 100.9 | RFJ | Roots Fine Joint | 1781 | M 1 |

Code: **RFJ**  
 Description: **Roots Fine Joint**

Distance (ft): **100.9**  
 Structural Grade: **0**  
 O&M Grade: **1**  
 Clock Start/From: **10**  
 Clock To: **2**  
 1st Value:  
 2nd Value:  
 Value Percent:  
 Continuous Index:  
 Within 8" of Joint: **YES**  
 Remarks:

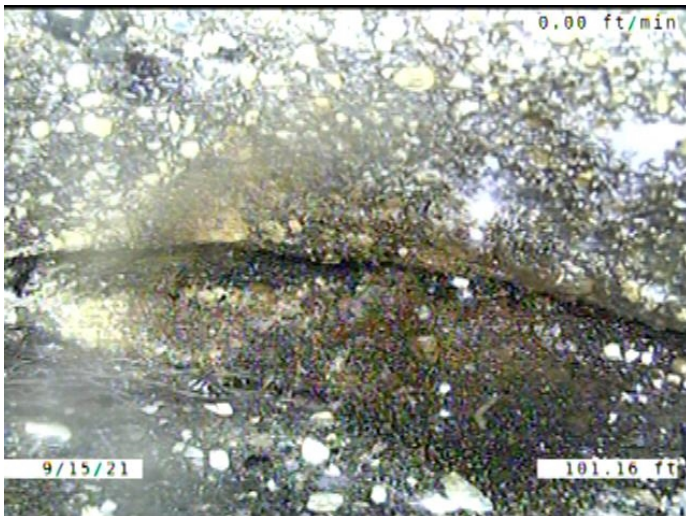
| 101.2 | ISJ | Infiltration Stain Joint | 1807 | M 1 |

Code: **ISJ**  
 Description: **Infiltration Stain Joint**

Distance (ft): **101.2**  
 Structural Grade: **0**  
 O&M Grade: **1**  
 Clock Start/From: **2**  
 Clock To: **4**  
 1st Value:  
 2nd Value:  
 Value Percent:  
 Continuous Index:  
 Within 8" of Joint: **YES**  
 Remarks:

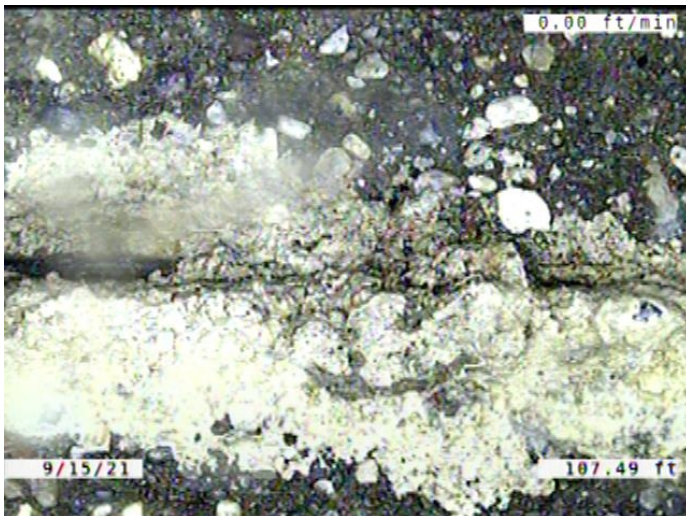
| 107.5 | DAE | Deposits Attached Encrustation | 1925 | M 2 |

Code: **DAE**  
 Description: **Deposits Attached Encrustation**

Distance (ft): **107.5**  
 Structural Grade: **0**  
 O&M Grade: **2**  
 Clock Start/From: **10**  
 Clock To: **2**  
 1st Value:  
 2nd Value:  
 Value Percent: **5.000**  
 Continuous Index:  
 Within 8" of Joint: **YES**  
 Remarks:

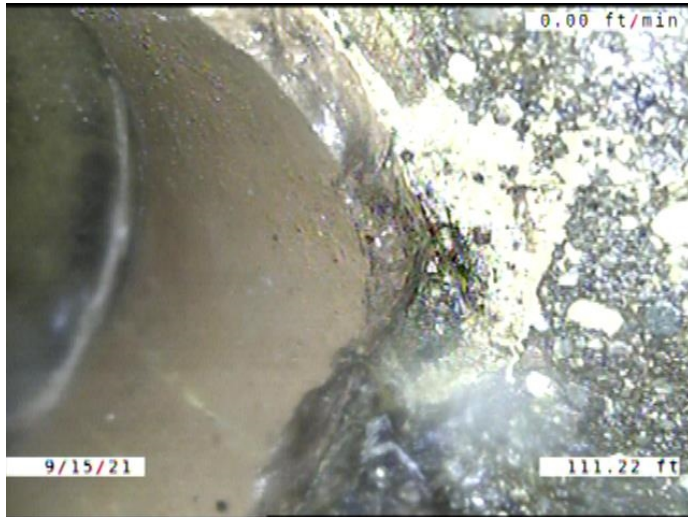
| 111.2 | B | Broken | 2038 | S 4 |

Code: **B**  
Description: **Broken**

Distance (ft): **111.2**  
Structural Grade: **4**  
O&M Grade: **0**  
Clock Start/From: **10**  
Clock To: **1**  
1st Value:  
2nd Value:  
Value Percent:  
Continuous Index:  
Within 8" of Joint: **NO**  
Remarks:

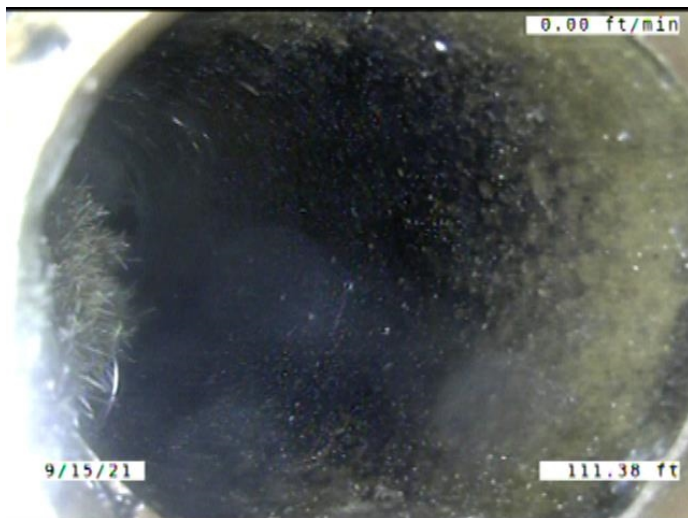
| 111.4 | TBI | Tap Break-in Intruding | 2087 | M 2 |

Code: **TBI**  
Description: **Tap Break-in Intruding**

Distance (ft): **111.4**  
Structural Grade: **0**  
O&M Grade: **2**  
Clock Start/From: **11**  
Clock To:  
1st Value: **4.000**  
2nd Value: **1.000**  
Value Percent:  
Continuous Index:  
Within 8" of Joint: **NO**  
Remarks:

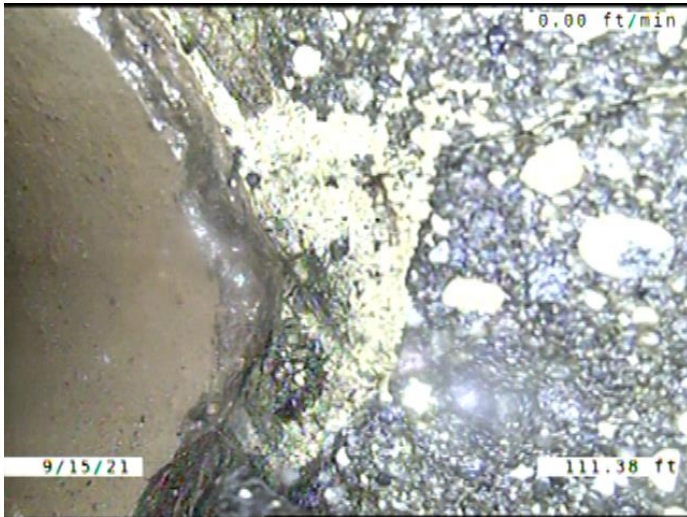
| 111.4 | DAE | Deposits Attached Encrustation | 2103 | M 2 |

Code: **DAE**  
 Description: **Deposits Attached Encrustation**

Distance (ft): **111.4**  
 Structural Grade: **0**  
 O&M Grade: **2**  
 Clock Start/From: **12**  
 Clock To:  
 1st Value:  
 2nd Value:  
 Value Percent: **5.000**  
 Continuous Index:  
 Within 8" of Joint: **NO**  
 Remarks:

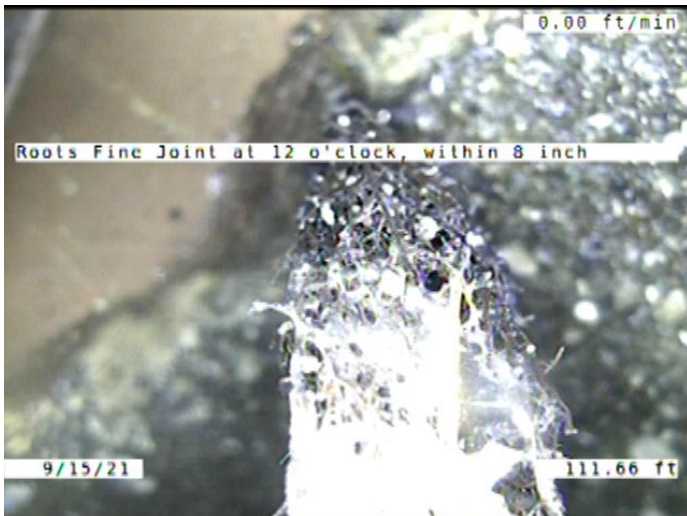
| 111.7 | RFJ | Roots Fine Joint | 2143 | M 1 |

Code: **RFJ**  
 Description: **Roots Fine Joint**

Distance (ft): **111.7**  
 Structural Grade: **0**  
 O&M Grade: **1**  
 Clock Start/From: **12**  
 Clock To:  
 1st Value:  
 2nd Value:  
 Value Percent:  
 Continuous Index:  
 Within 8" of Joint: **YES**  
 Remarks:

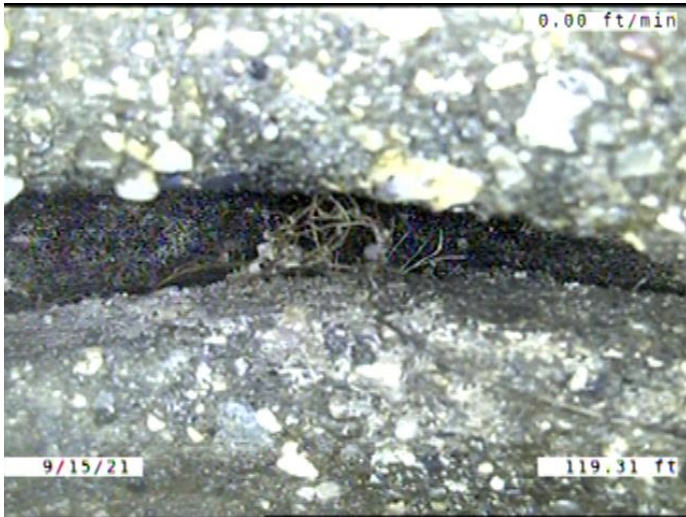
| 119.3 | RFJ | Roots Fine Joint | 2315 | M 1 |

Code: **RFJ**  
 Description: **Roots Fine Joint**

Distance (ft): **119.3**  
 Structural Grade: **0**  
 O&M Grade: **1**  
 Clock Start/From: **2**  
 Clock To:  
 1st Value:  
 2nd Value:  
 Value Percent:  
 Continuous Index:  
 Within 8" of Joint: **YES**  
 Remarks:

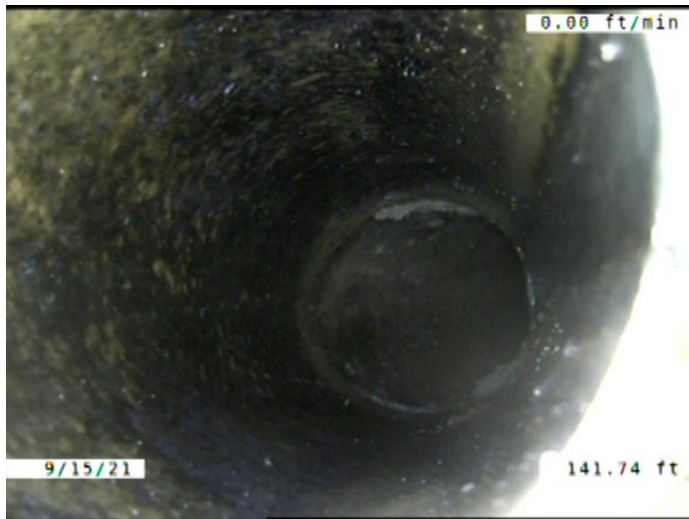
| 141.7 | TBI | Tap Break-in Intruding | 2609 | M 2 |

Code: **TBI**  
 Description: **Tap Break-in Intruding**

Distance (ft): **141.7**  
 Structural Grade: **0**  
 O&M Grade: **2**  
 Clock Start/From: **1**  
 Clock To:  
 1st Value: **4.000**  
 2nd Value: **1.000**  
 Value Percent:  
 Continuous Index:  
 Within 8" of Joint: **NO**  
 Remarks:

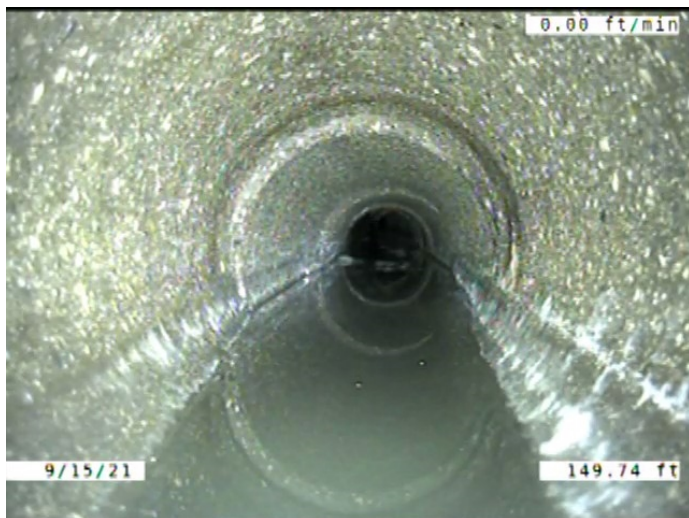
| 149.7 | MWLS(S04) | Miscellaneous Water Level Sag | 2679 | S 2 |

Code: **MWLS**  
 Description: **Miscellaneous Water Level Sag**

Distance (ft): **149.7**  
 Structural Grade: **2**  
 O&M Grade: **0**  
 Clock Start/From:  
 Clock To:  
 1st Value:  
 2nd Value:  
 Value Percent: **15.000**  
 Continuous Index: **S04**  
 Within 8" of Joint: **NO**  
 Remarks:

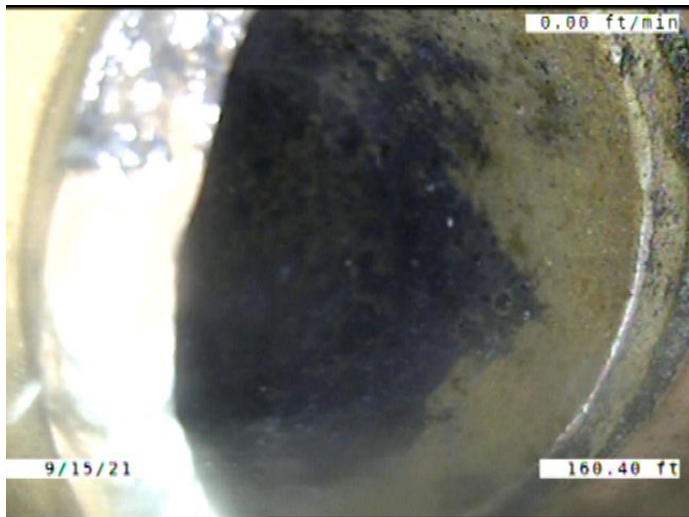
| 160.3 | TBI | Tap Break-in Intruding | 2840 | M 2 |

Code: **TBI**  
 Description: **Tap Break-in Intruding**

Distance (ft): **160.3**  
 Structural Grade: **0**  
 O&M Grade: **2**  
 Clock Start/From: **12**  
 Clock To:  
 1st Value: **4.000**  
 2nd Value: **2.000**  
 Value Percent:  
 Continuous Index:  
 Within 8" of Joint: **NO**  
 Remarks: **CONSTANTLY RUNNING WATER**

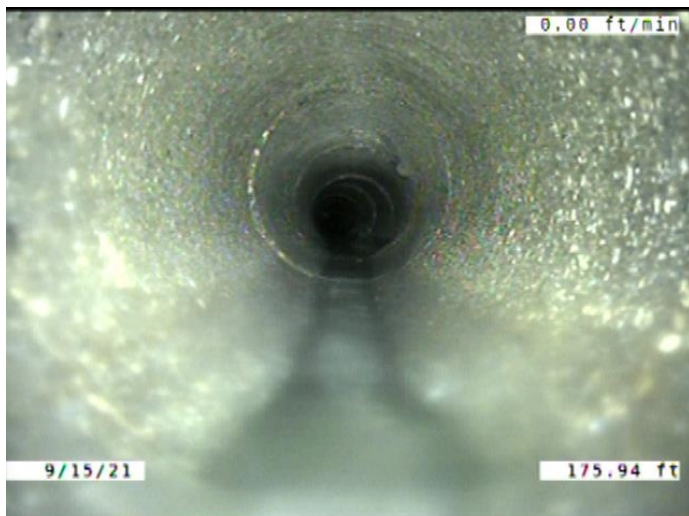
| 175.9 | MWLS(F04) | Miscellaneous Water Level Sag | 3059 | S 2 |

Code: **MWLS**  
 Description: **Miscellaneous Water Level Sag**

Distance (ft): **175.9**  
 Structural Grade: **2**  
 O&M Grade: **0**  
 Clock Start/From:  
 Clock To:  
 1st Value:  
 2nd Value:  
 Value Percent: **15.000**  
 Continuous Index: **F04**  
 Within 8" of Joint: **NO**  
 Remarks:

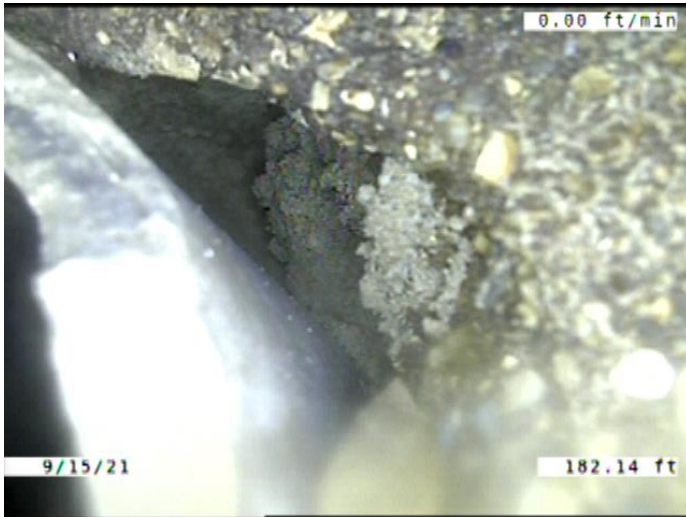
| 181.8 | BSV | Broken Soil Visible | 3115 | S 5 |

Code: **BSV**  
 Description: **Broken Soil Visible**

Distance (ft): **181.8**  
 Structural Grade: **5**  
 O&M Grade: **0**  
 Clock Start/From: **12**  
 Clock To: **3**  
 1st Value:  
 2nd Value:  
 Value Percent:  
 Continuous Index:  
 Within 8" of Joint: **NO**  
 Remarks:

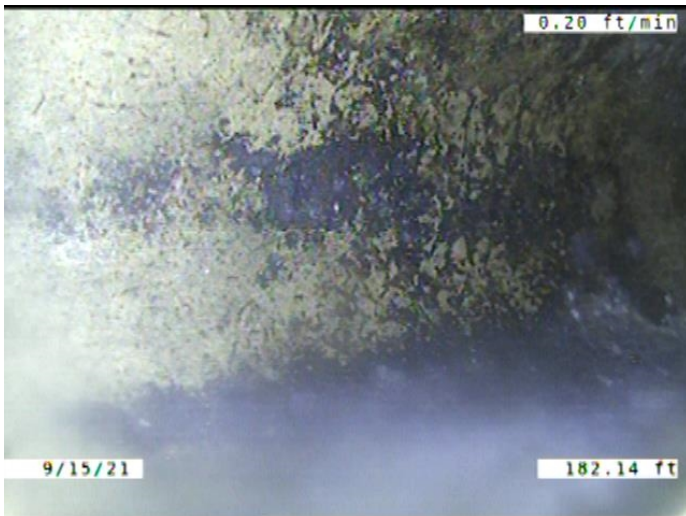
| 182.1 | TBI | Tap Break-in Intruding | 3145 | M 2 |

Code: **TBI**  
 Description: **Tap Break-in Intruding**

Distance (ft): **182.1**  
 Structural Grade: **0**  
 O&M Grade: **2**  
 Clock Start/From: **1**  
 Clock To:  
 1st Value: **4.000**  
 2nd Value: **1.000**  
 Value Percent:  
 Continuous Index:  
 Within 8" of Joint: **NO**  
 Remarks:

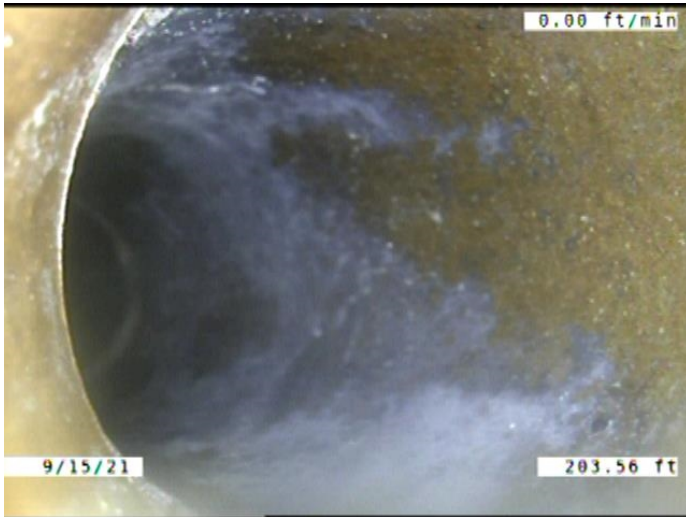
| 203.6 | TBI | Tap Break-in Intruding | 3327 | M 2 |

Code: **TBI**  
 Description: **Tap Break-in Intruding**

Distance (ft): **203.6**  
 Structural Grade: **0**  
 O&M Grade: **2**  
 Clock Start/From: **11**  
 Clock To:  
 1st Value: **4.000**  
 2nd Value: **3.000**  
 Value Percent:  
 Continuous Index:  
 Within 8" of Joint: **NO**  
 Remarks:

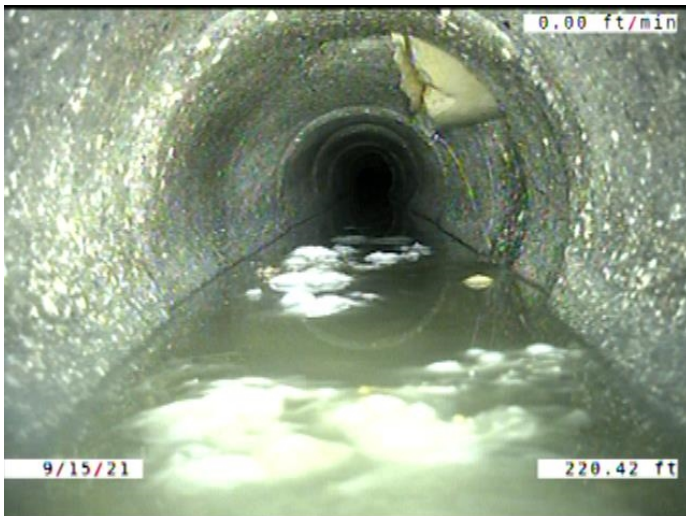
| 220.4 | MWLS(S05) | Miscellaneous Water Level Sag | 3439 | S 2 |

Code: **MWLS**  
 Description: **Miscellaneous Water Level Sag**

Distance (ft): **220.4**  
 Structural Grade: **2**  
 O&M Grade: **0**  
 Clock Start/From:  
 Clock To:  
 1st Value:  
 2nd Value:  
 Value Percent: **10.000**  
 Continuous Index: **S05**  
 Within 8" of Joint: **NO**  
 Remarks:

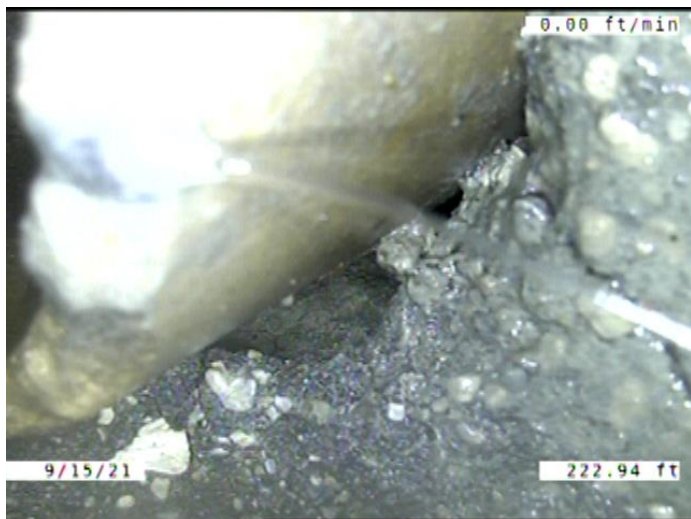
| 222.5 | FM | Fracture Multiple | 3510 | S 4 |

Code: **FM**  
 Description: **Fracture Multiple**

Distance (ft): **222.5**  
 Structural Grade: **4**  
 O&M Grade: **0**  
 Clock Start/From: **11**  
 Clock To: **3**  
 1st Value:  
 2nd Value:  
 Value Percent:  
 Continuous Index:  
 Within 8" of Joint: **NO**  
 Remarks:

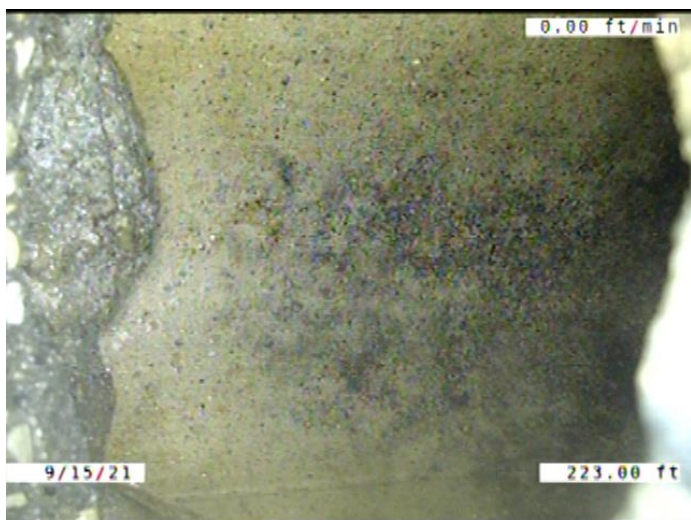
| 222.9 | TBI | Tap Break-in Intruding | 3545 | M 2 |

Code: **TBI**  
 Description: **Tap Break-in Intruding**

Distance (ft): **222.9**  
 Structural Grade: **0**  
 O&M Grade: **2**  
 Clock Start/From: **1**  
 Clock To:  
 1st Value: **4.000**  
 2nd Value: **2.000**  
 Value Percent:  
 Continuous Index:  
 Within 8" of Joint: **NO**  
 Remarks: **ACTIVITY**

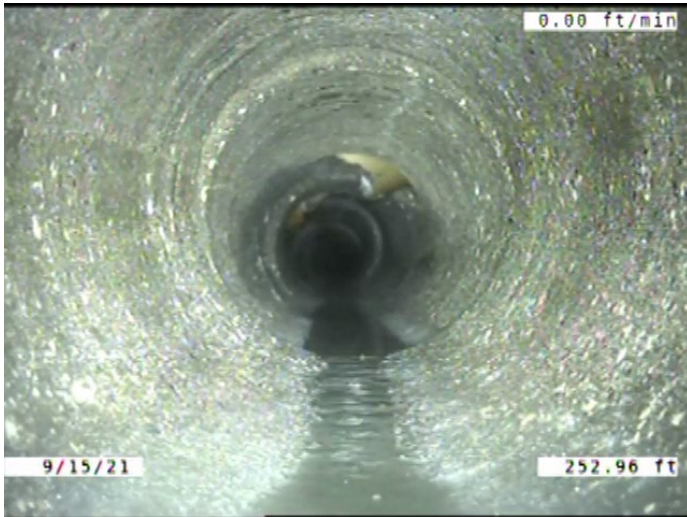
| 253.0 | MWLS(F05) | Miscellaneous Water Level Sag | 3719 | S 2 |

Code: **MWLS**  
 Description: **Miscellaneous Water Level Sag**

Distance (ft): **253.0**  
 Structural Grade: **2**  
 O&M Grade: **0**  
 Clock Start/From:  
 Clock To:  
 1st Value:  
 2nd Value:  
 Value Percent: **10.000**  
 Continuous Index: **F05**  
 Within 8" of Joint: **NO**  
 Remarks:

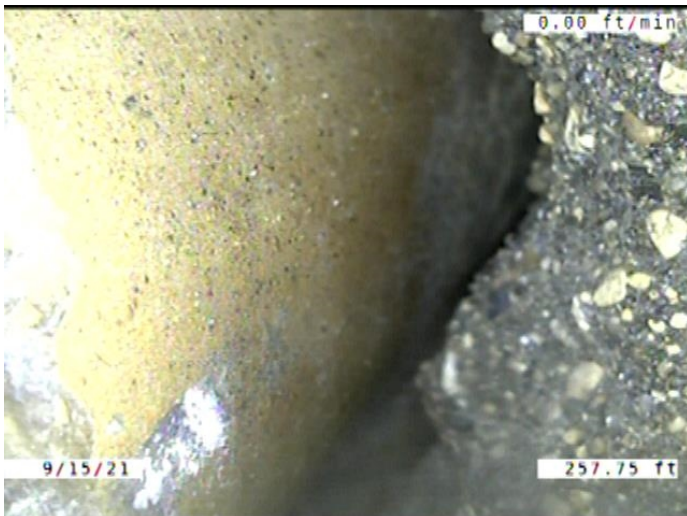
| 257.7 | HVV | Hole Void Visible | 3817 | S 5 |

Code: **HVV**  
 Description: **Hole Void Visible**

Distance (ft): **257.7**  
 Structural Grade: **5**  
 O&M Grade: **0**  
 Clock Start/From: **2**  
 Clock To:  
 1st Value:  
 2nd Value:  
 Value Percent:  
 Continuous Index:  
 Within 8" of Joint: **NO**  
 Remarks:

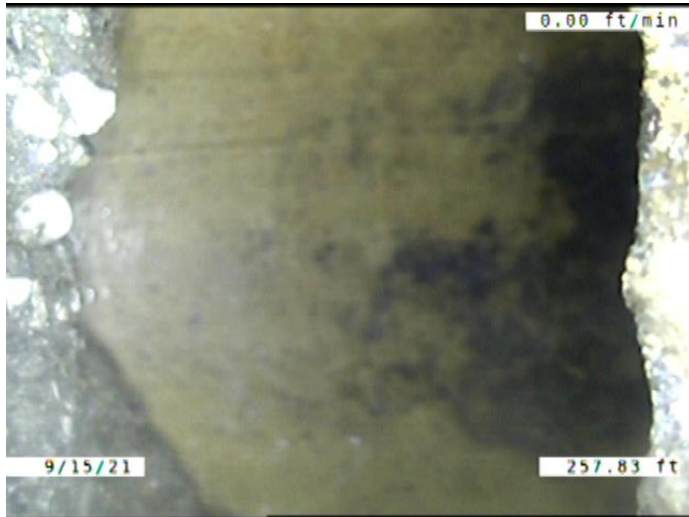
| 257.8 | TBI | Tap Break-in Intruding | 3905 | M 2 |

Code: **TBI**  
 Description: **Tap Break-in Intruding**

Distance (ft): **257.8**  
 Structural Grade: **0**  
 O&M Grade: **2**  
 Clock Start/From: **1**  
 Clock To:  
 1st Value: **4.000**  
 2nd Value: **2.000**  
 Value Percent:  
 Continuous Index:  
 Within 8" of Joint: **NO**  
 Remarks:

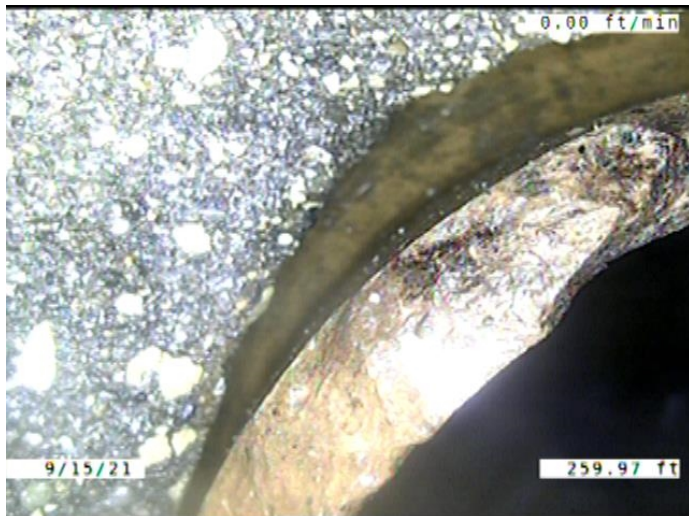
| 260.0 | B | Broken | 3973 | S 4 |

Code: **B**  
 Description: **Broken**

Distance (ft): **260.0**  
 Structural Grade: **4**  
 O&M Grade: **0**  
 Clock Start/From: **11**  
 Clock To: **12**  
 1st Value:  
 2nd Value:  
 Value Percent:  
 Continuous Index:  
 Within 8" of Joint: **NO**  
 Remarks:

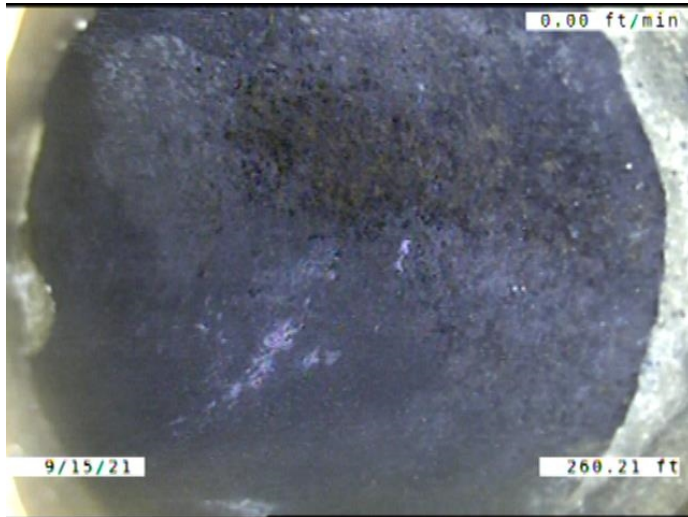
| 260.2 | TBI | Tap Break-in Intruding | 3997 | M 2 |

Code: **TBI**  
Description: **Tap Break-in Intruding**

Distance (ft): **260.2**  
Structural Grade: **0**  
O&M Grade: **2**  
Clock Start/From: **11**  
Clock To:  
1st Value: **4.000**  
2nd Value: **1.000**  
Value Percent:  
Continuous Index:  
Within 8" of Joint: **NO**  
Remarks:

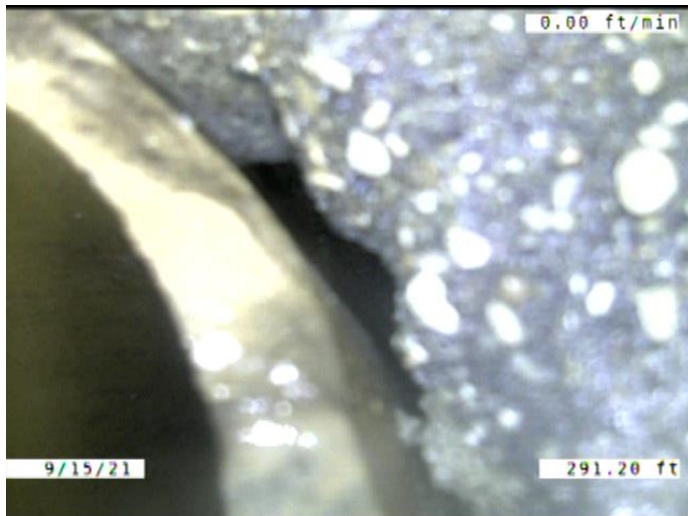
| 291.2 | HVV | Hole Void Visible | 4212 | S 5 |

Code: **HVV**  
Description: **Hole Void Visible**

Distance (ft): **291.2**  
Structural Grade: **5**  
O&M Grade: **0**  
Clock Start/From: **3**  
Clock To:  
1st Value:  
2nd Value:  
Value Percent:  
Continuous Index:  
Within 8" of Joint: **NO**  
Remarks:

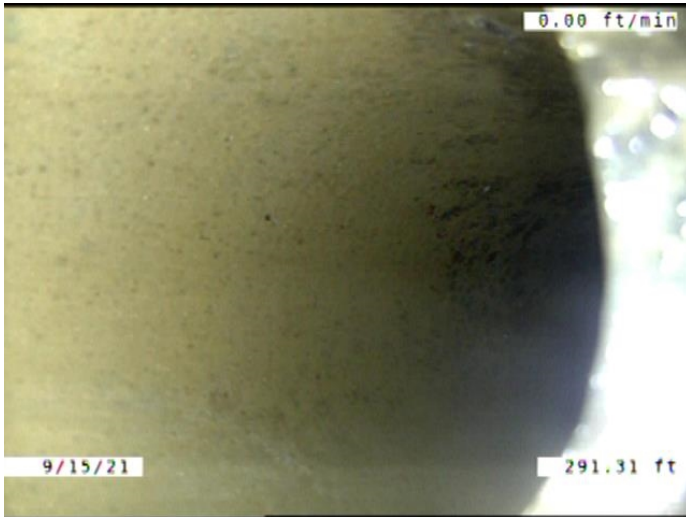
| 291.3 | TBI | Tap Break-in Intruding | 4288 | M 2 |

Code: **TBI**  
Description: **Tap Break-in Intruding**

Distance (ft): **291.3**  
Structural Grade: **0**  
O&M Grade: **2**  
Clock Start/From: **1**  
Clock To:  
1st Value: **4.000**  
2nd Value: **2.000**  
Value Percent:  
Continuous Index:  
Within 8" of Joint: **NO**  
Remarks:

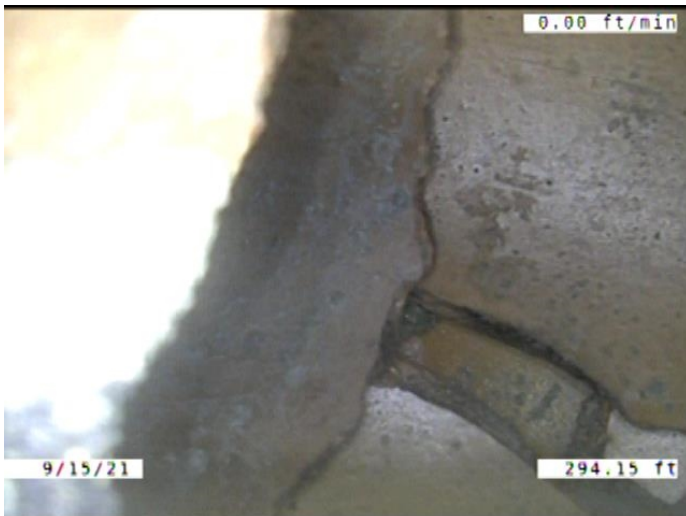
| 294.2 | TBI | Tap Break-in Intruding | 4368 | M 2 |

Code: **TBI**  
Description: **Tap Break-in Intruding**

Distance (ft): **294.2**  
Structural Grade: **0**  
O&M Grade: **2**  
Clock Start/From: **11**  
Clock To:  
1st Value: **4.000**  
2nd Value: **3.000**  
Value Percent:  
Continuous Index:  
Within 8" of Joint: **NO**  
Remarks:

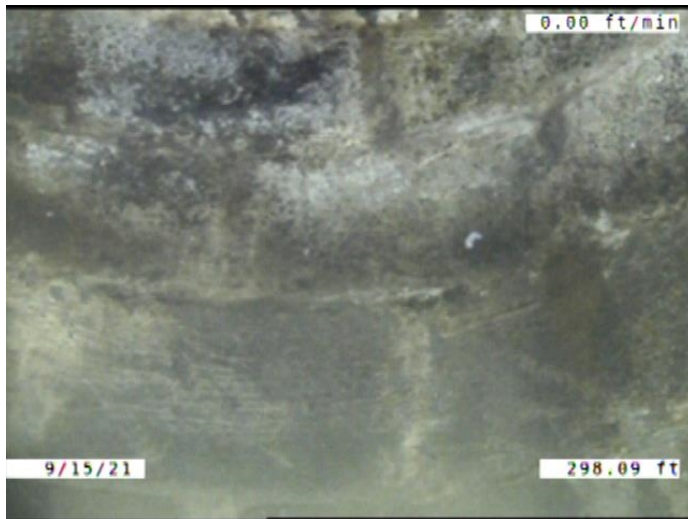
| 298.1 | DSF(F01) | Deposits Settled Fine | 4429 | M 2 |

Code: **DSF**  
 Description: **Deposits Settled Fine**

Distance (ft): **298.1**  
 Structural Grade: **0**  
 O&M Grade: **2**  
 Clock Start/From: **5**  
 Clock To: **7**  
 1st Value:  
 2nd Value:  
 Value Percent: **5.000**  
 Continuous Index: **F01**  
 Within 8" of Joint: **YES**  
 Remarks:
