Profile/Photo Observation Report

Date:	04/22/2018	Weather:		Coding:	PACP 6.0
Pipe Length (ft):	329.6	Owner:	NA	Pre Clean:	No Pre-Cleaning
P.O.#:		Surveyor:	Erik Redinger	PSR:	P-504-057-056
Customer:		Clean Date:	01/01/1900	Shape:	C

Street:	W HOME AVE	Flow Control:	Not Controlled
City:	Hobart, IN	Year Renewed:	
Location:	Light Highway	Tape/Media #:	
Purpose:	Routine Assessment	Dia/Height:	12"
Use:	Sanitary	Material:	VCP
Drain Area:	NA	Lining:	
Category:	NA		
Comment:	P_C at 38 ft debris . Flow direction wrong		
Location Details:		Direction of Survey:	Upstream
US MH:	M-504-056	DS MH:	M-504-057
		Total Length Surveyed (ft):	39.4

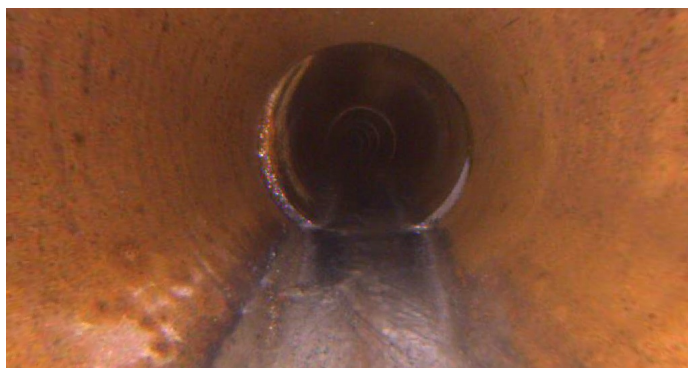
Code: **AMH**
 Description: **Manhole**

Distance (ft): **.0**
 Structural Grade: **0**
 O&M Grade: **0**
 Clock Start/From:
 Clock To:
 1st Value:
 2nd Value:
 Value Percent:
 Continuous Index:
 Within 8" of Joint: **NO**
 Remarks: **M-504-057**

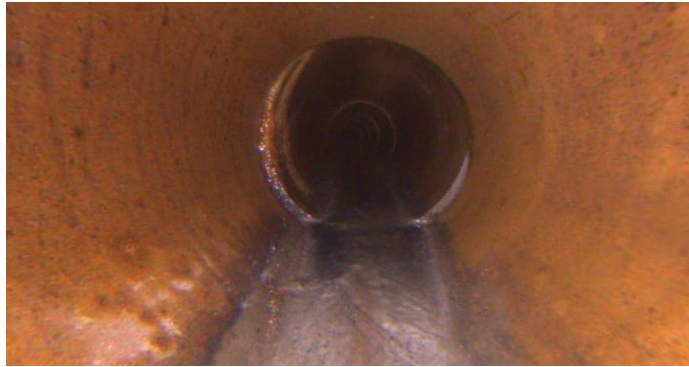
Code: **MWL**
Description: **Water Level**

Distance (ft): **.0**
Structural Grade: **0**
O&M Grade: **0**
Clock Start/From:
Clock To:
1st Value:
2nd Value:
Value Percent: **10.000**
Continuous Index:
Within 8" of Joint: **NO**
Remarks:

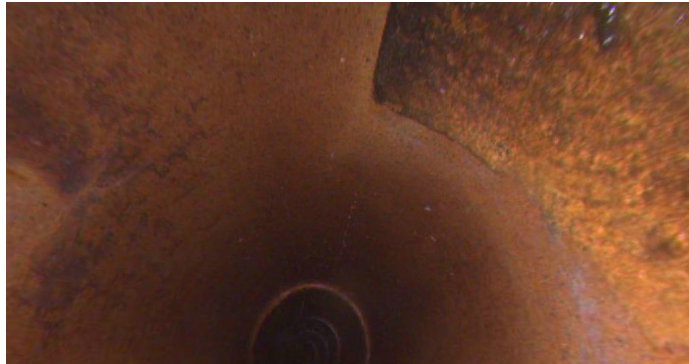
Code: **CL**
Description: **Crack Longitudinal**

Distance (ft): **2.5**
Structural Grade: **2**
O&M Grade: **0**
Clock Start/From: **1**
Clock To:
1st Value:
2nd Value:
Value Percent:
Continuous Index:
Within 8" of Joint:
Remarks:

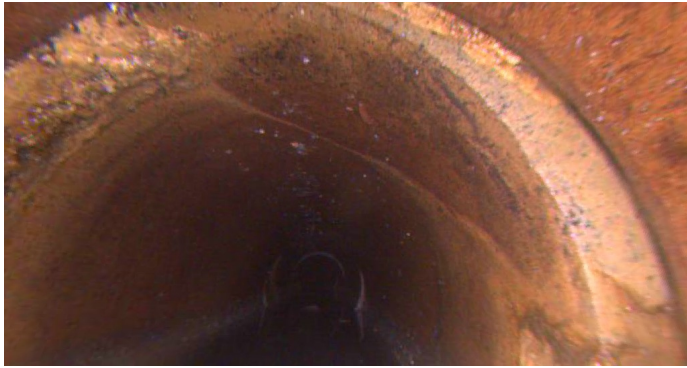
Code: **CS**
Description: **Crack Spiral**

Distance (ft): **13.9**
Structural Grade: **2**
O&M Grade: **0**
Clock Start/From: **10**
Clock To: **4**
1st Value:
2nd Value:
Value Percent:
Continuous Index:
Within 8" of Joint: **YES**
Remarks:

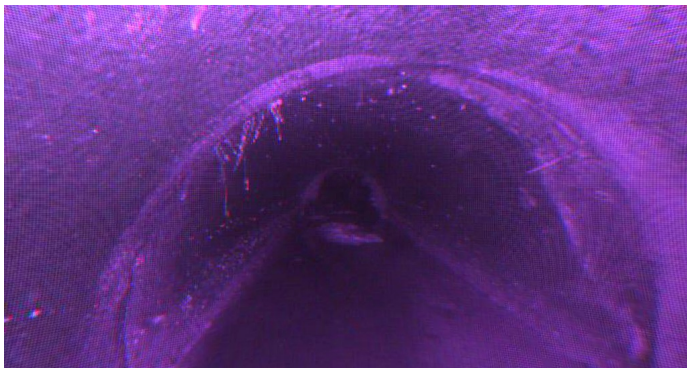
Code: **RFJ**
Description: **Roots Fine Joint**

Distance (ft): **30.8**
Structural Grade: **0**
O&M Grade: **1**
Clock Start/From: **7**
Clock To: **5**
1st Value:
2nd Value:
Value Percent:
Continuous Index:
Within 8" of Joint: **YES**
Remarks:

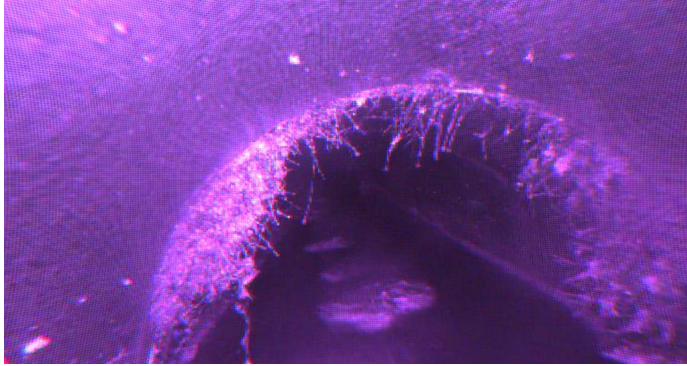
Code: **RFJ**
Description: **Roots Fine Joint**

Distance (ft): **33.8**
Structural Grade: **0**
O&M Grade: **1**
Clock Start/From: **7**
Clock To: **5**
1st Value:
2nd Value:
Value Percent:
Continuous Index:
Within 8" of Joint: **YES**
Remarks:

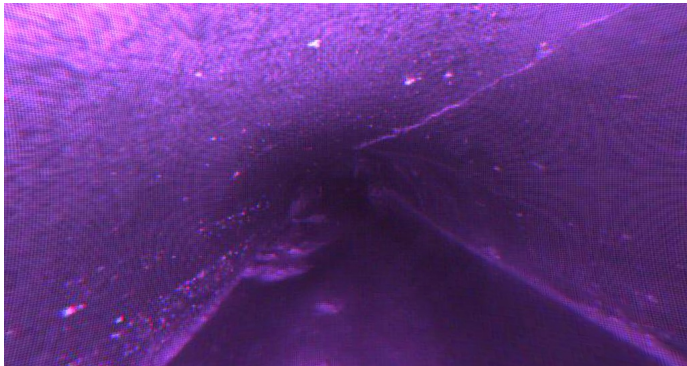
Code: **CM**
Description: **Crack Multiple**

Distance (ft): **35.2**
Structural Grade: **3**
O&M Grade: **0**
Clock Start/From: **12**
Clock To: **5**
1st Value:
2nd Value:
Value Percent:
Continuous Index:
Within 8" of Joint:
Remarks:

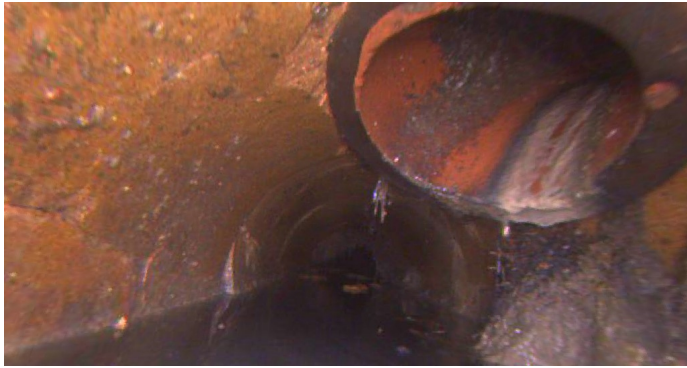
Code: **TBD**
Description: **Tap Break-in Defective**

Distance (ft): **39.0**
Structural Grade: **0**
O&M Grade: **3**
Clock Start/From: **2**
Clock To:
1st Value: **4.000**
2nd Value:
Value Percent:
Continuous Index:
Within 8" of Joint:
Remarks: **Roots**

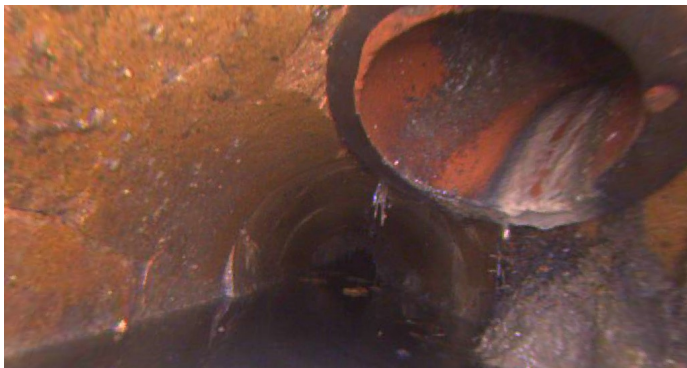
Code: **RFL**
Description: **Roots Fine Lateral**

Distance (ft): **39.0**
Structural Grade: **0**
O&M Grade: **1**
Clock Start/From: **2**
Clock To:
1st Value:
2nd Value:
Value Percent:
Continuous Index:
Within 8" of Joint: **NO**
Remarks:

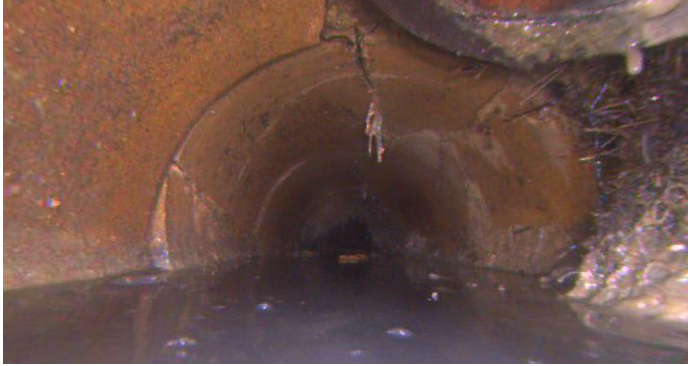
Code:	MSA
Description:	Abandoned Survey
Distance (ft):	39.4
Structural Grade:	0
O&M Grade:	0
Clock Start/From:	
Clock To:	
1st Value:	
2nd Value:	
Value Percent:	
Continuous Index:	
Within 8" of Joint:	NO
Remarks:	TBD
