## Profile/Photo Observation Report

Date:	<b>04/22/2018</b>	Weather:		Coding:	<b>PACP 6.0</b>
Pipe Length (ft):	<b>329.6</b>	Owner:	<b>NA</b>	Pre Clean:	<b>No Pre-Cleaning</b>
P.O.#:		Surveyor:	<b>Erik Redinger</b>	PSR:	<b>P-504-057-056</b>
Customer:		Clean Date:	<b>01/01/1900</b>	Shape:	<b>C</b>

Street:	<b>FOXCROFT STREET</b>	Flow Control:	<b>Not Controlled</b>
City:	<b>Hobart, IN</b>	Year Renewed:	
Location:	<b>Light Highway</b>	Tape/Media #:	
Purpose:	<b>Routine Assessment</b>	Dia/Height:	<b>12"</b>
Use:	<b>Sanitary</b>	Material:	<b>VCP</b>
Drain Area:	<b>NA</b>	Lining:	
Category:	<b>NA</b>		
Comment:	<b>P_C at 38 ft debris . Flow direction wrong</b>		
Location Details:		Direction of Survey:	<b>Upstream</b>
US MH:	<b>M-504-056</b>	DS MH:	<b>M-504-057</b>
		Total Length Surveyed (ft):	<b>39.4</b>

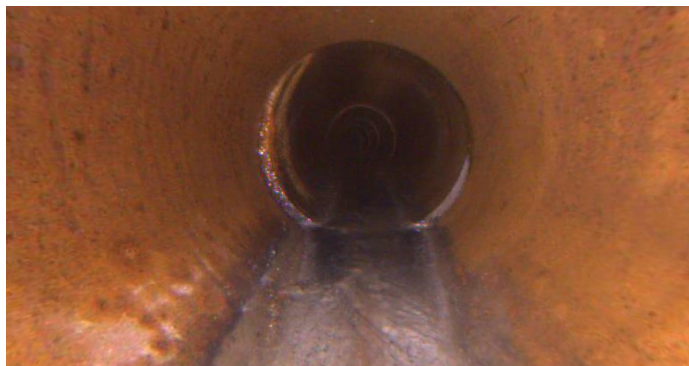
Code: **AMH**  
 Description: **Manhole**

Distance (ft): **.0**  
 Structural Grade: **0**  
 O&M Grade: **0**  
 Clock Start/From:  
 Clock To:  
 1st Value:  
 2nd Value:  
 Value Percent:  
 Continuous Index:  
 Within 8" of Joint: **NO**  
 Remarks: **M-504-057**

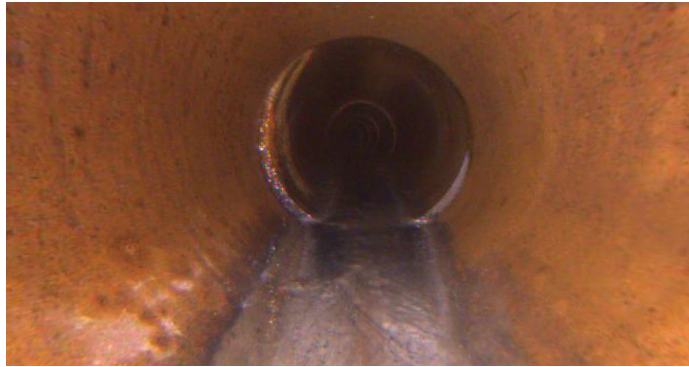
Code: **MWL**  
Description: **Water Level**

Distance (ft): **.0**  
Structural Grade: **0**  
O&M Grade: **0**  
Clock Start/From:  
Clock To:  
1st Value:  
2nd Value:  
Value Percent: **10.000**  
Continuous Index:  
Within 8" of Joint: **NO**  
Remarks:

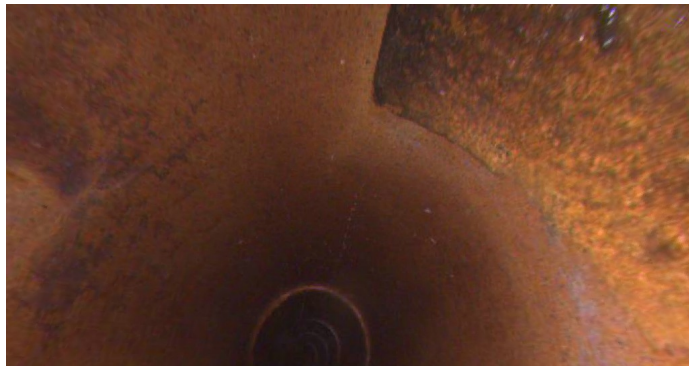
Code: **CL**  
Description: **Crack Longitudinal**

Distance (ft): **2.5**  
Structural Grade: **2**  
O&M Grade: **0**  
Clock Start/From: **1**  
Clock To:  
1st Value:  
2nd Value:  
Value Percent:  
Continuous Index:  
Within 8" of Joint:  
Remarks:

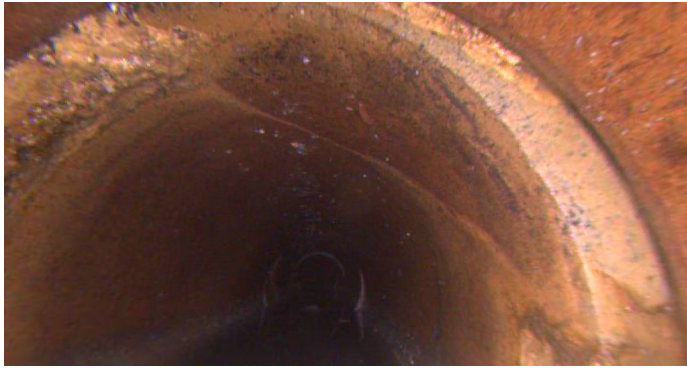
Code: **CS**  
Description: **Crack Spiral**

Distance (ft): **13.9**  
Structural Grade: **2**  
O&M Grade: **0**  
Clock Start/From: **10**  
Clock To: **4**  
1st Value:  
2nd Value:  
Value Percent:  
Continuous Index:  
Within 8" of Joint: **YES**  
Remarks:

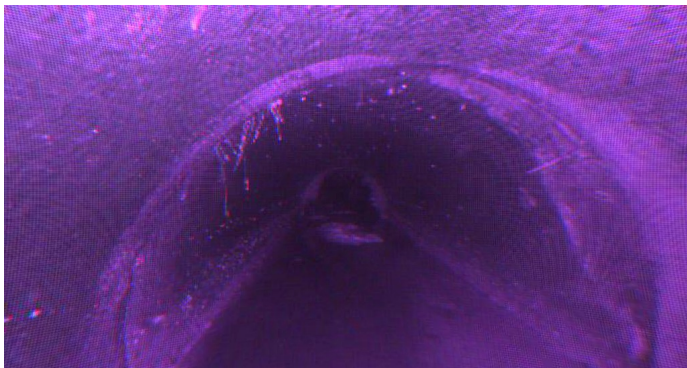
Code: **RFJ**  
Description: **Roots Fine Joint**

Distance (ft): **30.8**  
Structural Grade: **0**  
O&M Grade: **1**  
Clock Start/From: **7**  
Clock To: **5**  
1st Value:  
2nd Value:  
Value Percent:  
Continuous Index:  
Within 8" of Joint: **YES**  
Remarks:

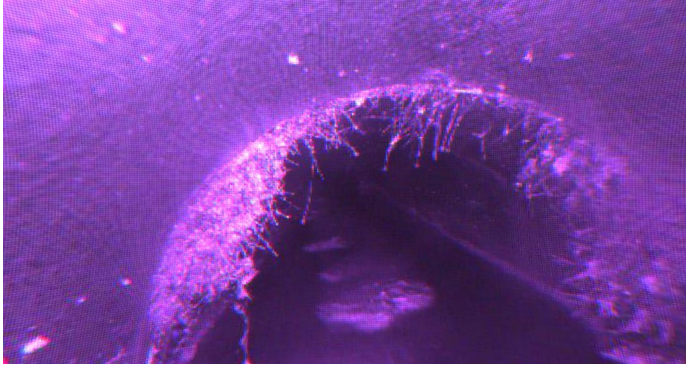
Code: **RFJ**  
Description: **Roots Fine Joint**

Distance (ft): **33.8**  
Structural Grade: **0**  
O&M Grade: **1**  
Clock Start/From: **7**  
Clock To: **5**  
1st Value:  
2nd Value:  
Value Percent:  
Continuous Index:  
Within 8" of Joint: **YES**  
Remarks:

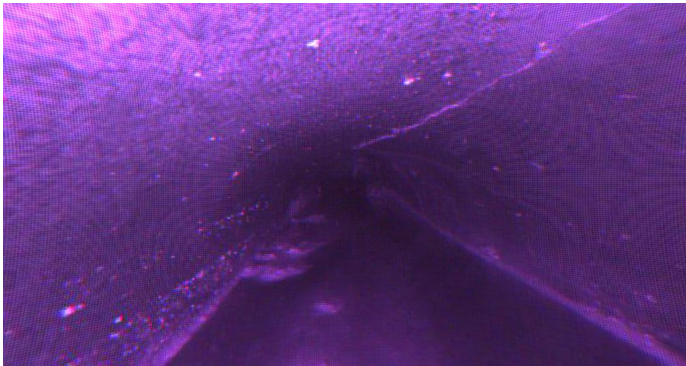
Code: **CM**  
Description: **Crack Multiple**

Distance (ft): **35.2**  
Structural Grade: **3**  
O&M Grade: **0**  
Clock Start/From: **12**  
Clock To: **5**  
1st Value:  
2nd Value:  
Value Percent:  
Continuous Index:  
Within 8" of Joint:  
Remarks:

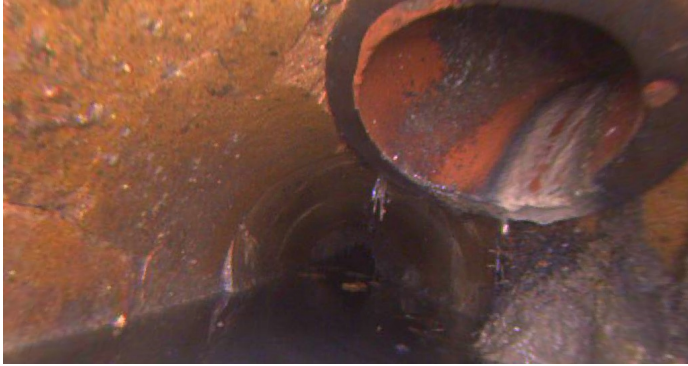
Code: **TBD**  
Description: **Tap Break-in Defective**

Distance (ft): **39.0**  
Structural Grade: **0**  
O&M Grade: **3**  
Clock Start/From: **2**  
Clock To:  
1st Value: **4.000**  
2nd Value:  
Value Percent:  
Continuous Index:  
Within 8" of Joint:  
Remarks: **Roots**

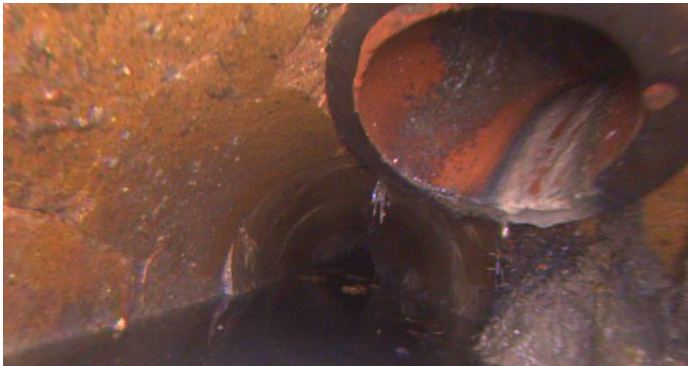
Code: **RFL**  
Description: **Roots Fine Lateral**

Distance (ft): **39.0**  
Structural Grade: **0**  
O&M Grade: **1**  
Clock Start/From: **2**  
Clock To:  
1st Value:  
2nd Value:  
Value Percent:  
Continuous Index:  
Within 8" of Joint: **NO**  
Remarks:

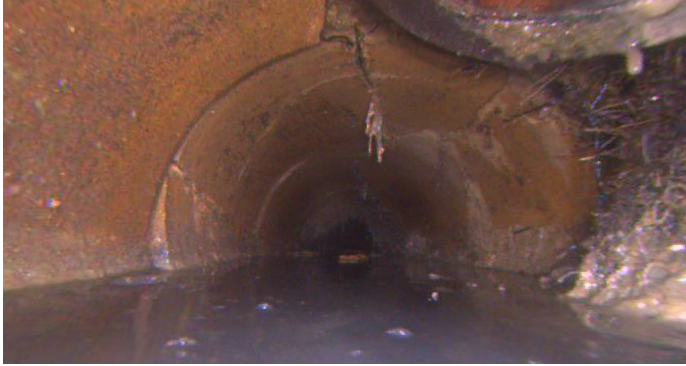
Code:	<b>MSA</b>
Description:	<b>Abandoned Survey</b>
Distance (ft):	<b>39.4</b>
Structural Grade:	<b>0</b>
O&M Grade:	<b>0</b>
Clock Start/From:	
Clock To:	
1st Value:	
2nd Value:	
Value Percent:	
Continuous Index:	
Within 8" of Joint:	<b>NO</b>
Remarks:	<b>TBD</b>
