Profile/Photo Observation Report

Street:	W HOME AVE	Flow Control:	Not Controlled
City:	Hobart, IN	Year Renewed:	
Location:	Light Highway	Tape/Media #:	
Purpose:	Routine Assessment	Dia/Height:	12"
Use:	Sanitary	Material:	VCP
Drain Area:	NA	Lining:	
Category:	NA		
Comment:	F_S_P_C at 8 ft grit/debris . Flow direction wrong		
Location Details:		Direction of Survey:	Downstream
US MH:	M-504-056	DS MH:	M-504-057
		Total Length Surveyed (ft):	9.7

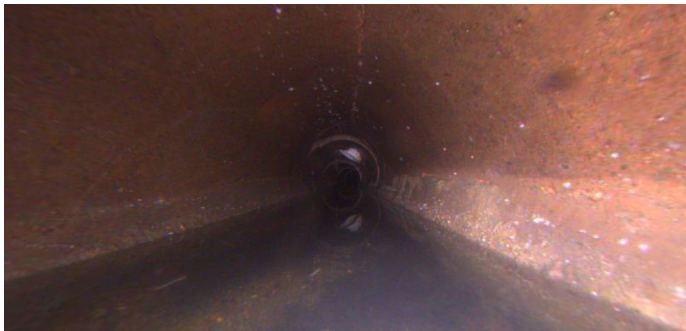
Code: **AMH**
Description: **Manhole**

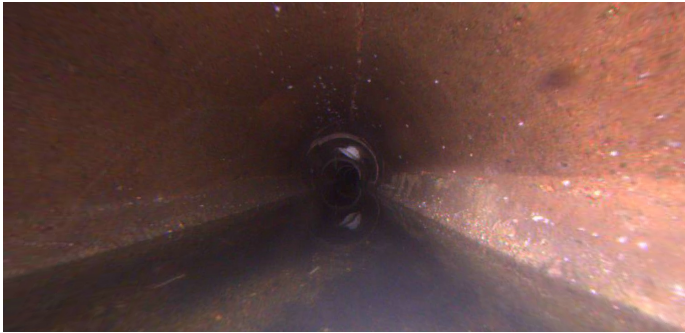
Code:	MWL
Description:	Water Level

Distance (ft):	.0
Structural Grade:	0
O&M Grade:	0
Clock Start/From:	
Clock To:	
1st Value:	
2nd Value:	
Value Percent:	20.000
Continuous Index:	
Within 8" of Joint:	NO
Remarks:

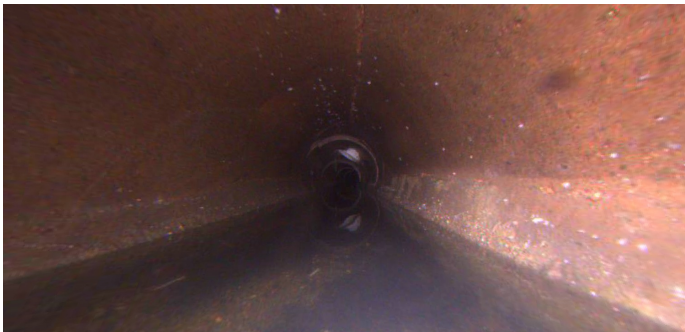
Code:	FL
Description:	Fracture Longitudinal

Distance (ft):	.0
Structural Grade:	3
O&M Grade:	0
Clock Start/From:	12
Clock To:	
1st Value:	
2nd Value:	
Value Percent:	
Continuous Index:	
Within 8" of Joint:	
Remarks:

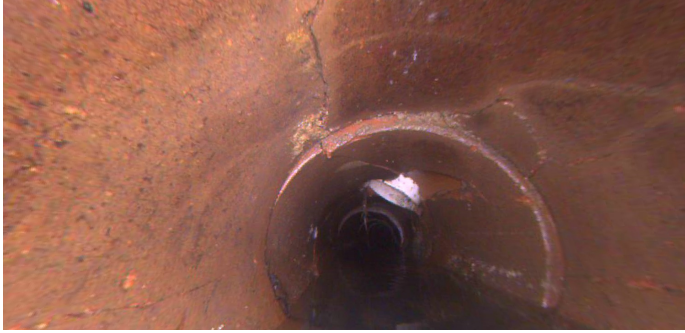
Code: **FM**
Description: **Fracture Multiple**

Distance (ft): **3.2**
Structural Grade: **4**
O&M Grade: **0**
Clock Start/From: **8**
Clock To: **4**
1st Value:
2nd Value:
Value Percent:
Continuous Index: **S01**
Within 8" of Joint: **YES**
Remarks:

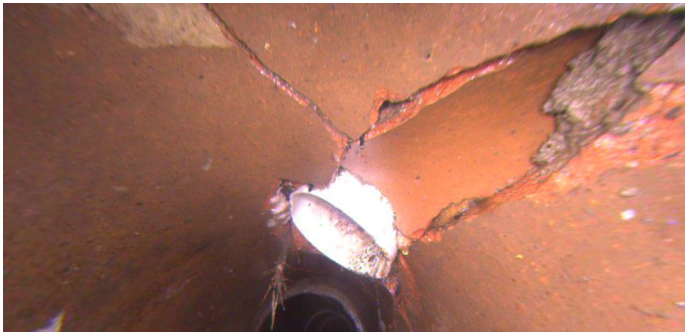
Code: **BSV**
Description: **Broken Soil Visible**

Distance (ft): **4.3**
Structural Grade: **5**
O&M Grade: **0**
Clock Start/From: **1**
Clock To: **2**
1st Value:
2nd Value:
Value Percent:
Continuous Index:
Within 8" of Joint:
Remarks:

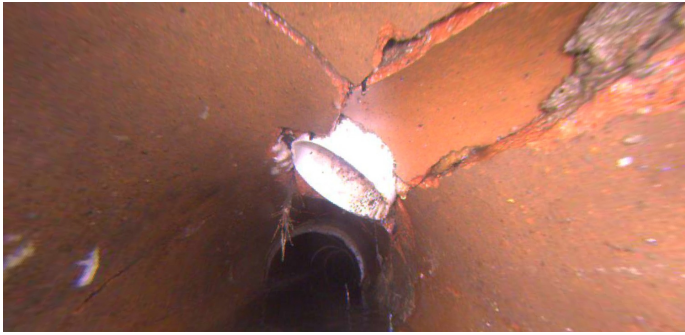
Code: **FM**
Description: **Fracture Multiple**

Distance (ft): **4.3**
Structural Grade: **4**
O&M Grade: **0**
Clock Start/From: **8**
Clock To: **4**
1st Value:
2nd Value:
Value Percent:
Continuous Index:
Within 8" of Joint:
Remarks:

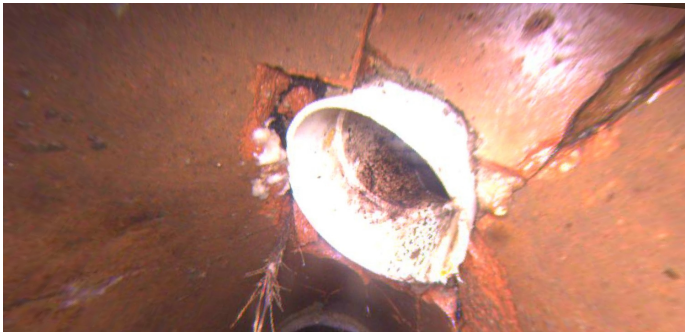
Code: **TBI**
Description: **Tap Break-in Intruding**

Distance (ft): **4.7**
Structural Grade: **0**
O&M Grade: **2**
Clock Start/From: **1**
Clock To:
1st Value: **4.000**
2nd Value: **1.000**
Value Percent:
Continuous Index:
Within 8" of Joint:
Remarks: **RFC**

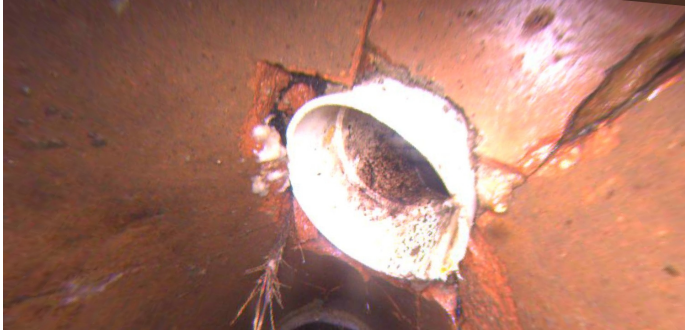
Code: **RFC**
Description: **Roots Fine Connection**

Distance (ft): **4.7**
Structural Grade: **0**
O&M Grade: **1**
Clock Start/From: **12**
Clock To:
1st Value:
2nd Value:
Value Percent:
Continuous Index:
Within 8" of Joint: **NO**
Remarks:

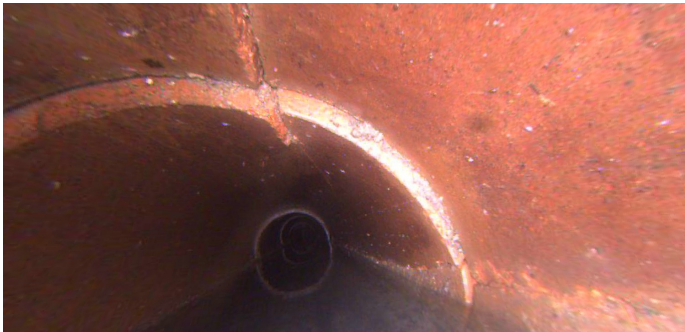
Code: **FM**
Description: **Fracture Multiple**

Distance (ft): **9.7**
Structural Grade: **4**
O&M Grade: **0**
Clock Start/From: **8**
Clock To: **4**
1st Value:
2nd Value:
Value Percent:
Continuous Index: **F01**
Within 8" of Joint: **YES**
Remarks:

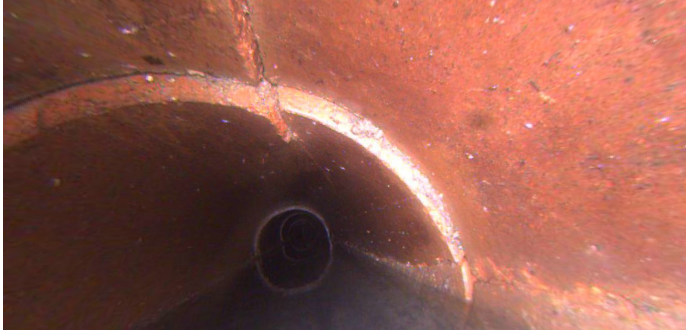
Code: **MGO**
Description: **General Observation**

Distance (ft): **9.7**
Structural Grade: **0**
O&M Grade: **0**
Clock Start/From:
Clock To:
1st Value:
2nd Value:
Value Percent:
Continuous Index:
Within 8" of Joint: **NO**
Remarks: **END SURVEY**

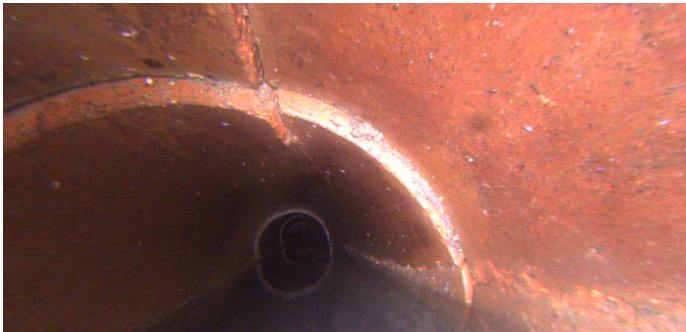
Code: **AMH**
Description: **Manhole**

Distance (ft): **9.7**
Structural Grade: **0**
O&M Grade: **0**
Clock Start/From:
Clock To:
1st Value:
2nd Value:
Value Percent:
Continuous Index:
Within 8" of Joint: **NO**
Remarks: **M-504-057**
