Profile/Photo Observation Report

Street:	FOXCROFT STREET	Flow Control:	Not Controlled
City:	Hobart, IN	Year Renewed:	
Location:	Light Highway	Tape/Media #:	
Purpose:	Routine Assessment	Dia/Height:	12"
Use:	Sanitary	Material:	VCP
Drain Area:	NA	Lining:	
Category:	NA		
Comment:	F_S_P_C at 8 ft grit/debris . Flow direction wrong		
Location Details:		Direction of Survey:	Downstream
US MH:	M-504-056	DS MH:	M-504-057
		Total Length Surveyed (ft):	9.7

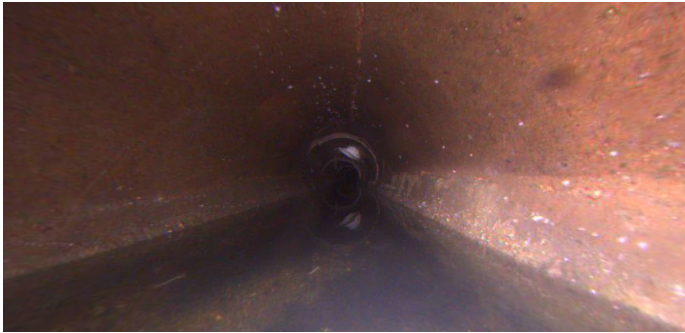
Code:	MWL
Description:	Water Level

Distance (ft):	.0
Structural Grade:	0
O&M Grade:	0
Clock Start/From:	
Clock To:	
1st Value:	
2nd Value:	
Value Percent:	20.000
Continuous Index:	
Within 8" of Joint:	NO
Remarks:

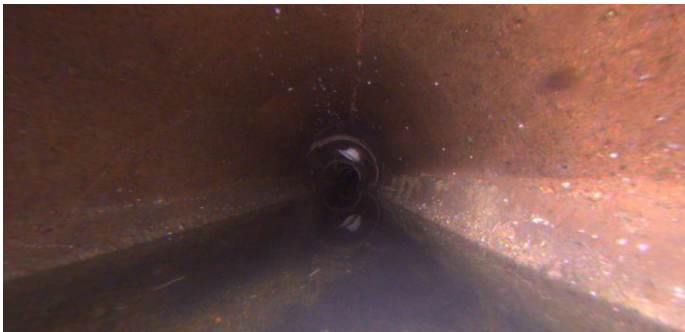
Code:	FL
Description:	Fracture Longitudinal

Distance (ft):	.0
Structural Grade:	3
O&M Grade:	0
Clock Start/From:	12
Clock To:	
1st Value:	
2nd Value:	
Value Percent:	
Continuous Index:	
Within 8" of Joint:	
Remarks:

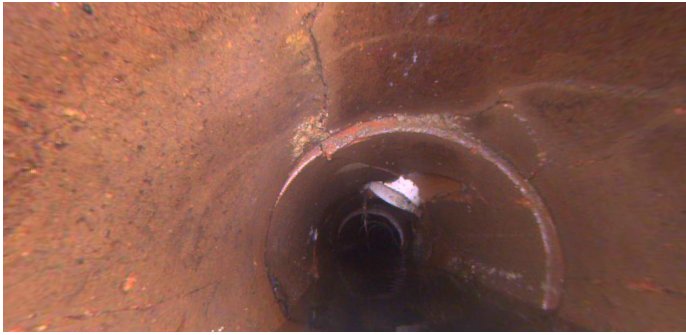
Code: **FM**
Description: **Fracture Multiple**

Distance (ft): **3.2**
Structural Grade: **4**
O&M Grade: **0**
Clock Start/From: **8**
Clock To: **4**
1st Value:
2nd Value:
Value Percent:
Continuous Index: **S01**
Within 8" of Joint: **YES**
Remarks:

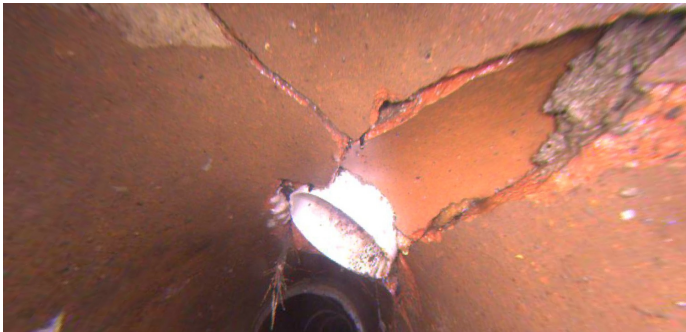
Code: **BSV**
Description: **Broken Soil Visible**

Distance (ft): **4.3**
Structural Grade: **5**
O&M Grade: **0**
Clock Start/From: **1**
Clock To: **2**
1st Value:
2nd Value:
Value Percent:
Continuous Index:
Within 8" of Joint:
Remarks:

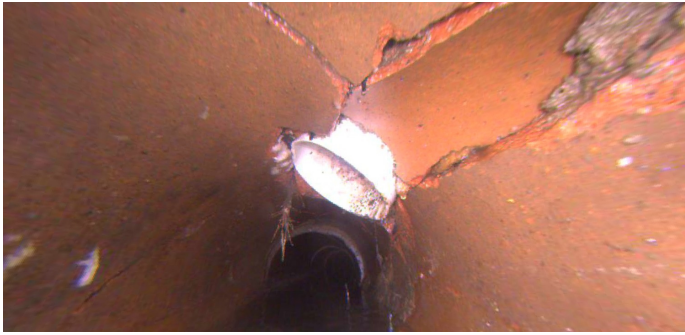
Code: **FM**
Description: **Fracture Multiple**

Distance (ft): **4.3**
Structural Grade: **4**
O&M Grade: **0**
Clock Start/From: **8**
Clock To: **4**
1st Value:
2nd Value:
Value Percent:
Continuous Index:
Within 8" of Joint:
Remarks:

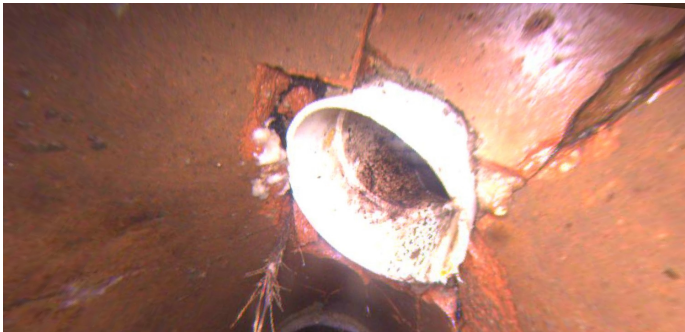
Code: **TBI**
Description: **Tap Break-in Intruding**

Distance (ft): **4.7**
Structural Grade: **0**
O&M Grade: **2**
Clock Start/From: **1**
Clock To:
1st Value: **4.000**
2nd Value: **1.000**
Value Percent:
Continuous Index:
Within 8" of Joint:
Remarks: **RFC**

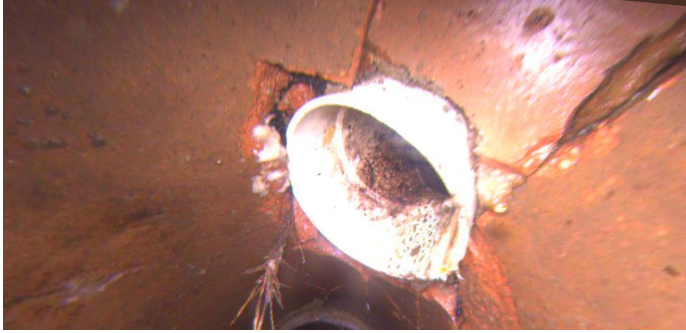
Code: **RFC**
Description: **Roots Fine Connection**

Distance (ft): **4.7**
Structural Grade: **0**
O&M Grade: **1**
Clock Start/From: **12**
Clock To:
1st Value:
2nd Value:
Value Percent:
Continuous Index:
Within 8" of Joint: **NO**
Remarks:

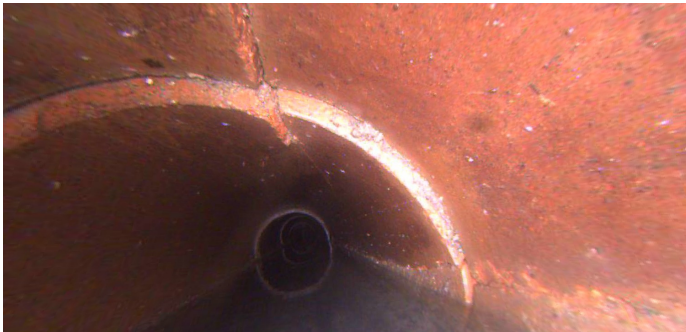
Code: **FM**
Description: **Fracture Multiple**

Distance (ft): **9.7**
Structural Grade: **4**
O&M Grade: **0**
Clock Start/From: **8**
Clock To: **4**
1st Value:
2nd Value:
Value Percent:
Continuous Index: **F01**
Within 8" of Joint: **YES**
Remarks:
