Profile/Photo Observation Report

Date:	09/12/2021	Weather:		Coding:	PACP 7.0
Pipe Length (ft):	330.0	Owner:	City of Hobart	Pre Clean:	Heavy Cleaning
P.O.#:	YES502259	Surveyor:	S. Bucklin	PSR:	P-504-057-056
Customer:	City of Hobart	Clean Date:	09/08/2021	Shape:	C

Street:	North Wilson Street	Flow Control:	Not Controlled
City:	Hobart, IN	Year Renewed:	
Location:	Alley	Tape/Media #:	
Purpose:	Routine Assessment	Dia/Height:	12"
Use:	Sanitary Sewage Pipe	Material:	VCP
Drain Area:		Lining:	None
Category:	NA		
Comment:			
Location Details:		Direction of Survey:	Downstream
US MH:	M-504-056	DS MH:	M-504-057
		Total Length Surveyed (ft):	91.5

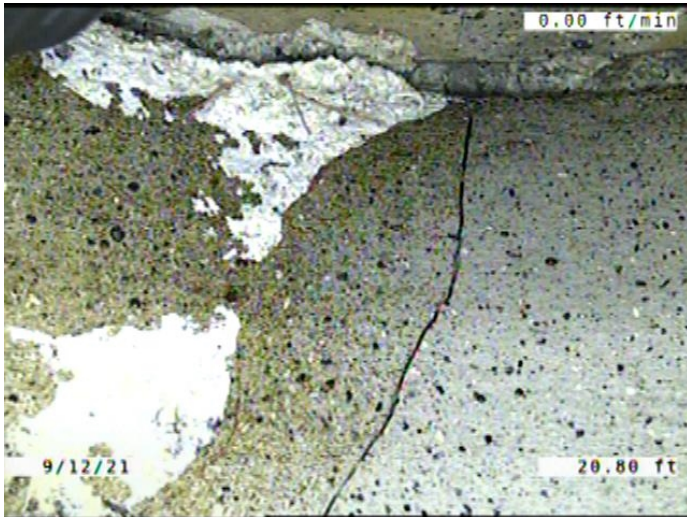
Code: **CS**
 Description: **Crack Spiral**

Distance (ft): **20.8**
 Structural Grade: **2**
 O&M Grade: **0**
 Clock Start/From: **9**
 Clock To: **11**
 1st Value:
 2nd Value:
 Value Percent:
 Continuous Index:
 Within 8" of Joint: **YES**
 Remarks:

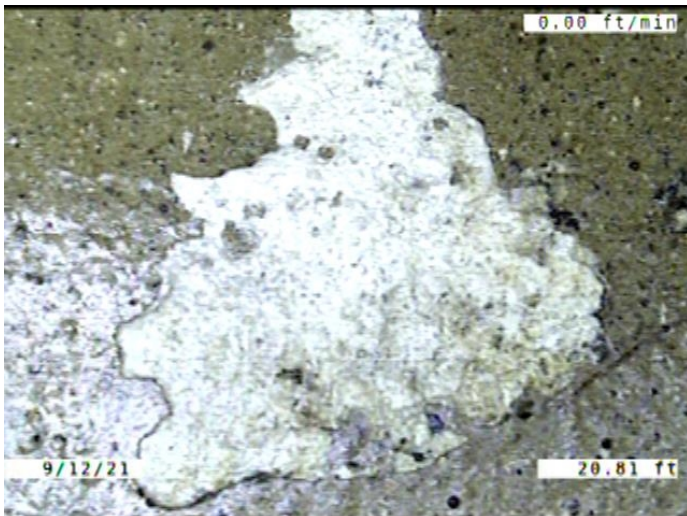
Code: **DAE**
 Description: **Deposits Attached Encrustation**

Distance (ft): **20.8**
 Structural Grade: **0**
 O&M Grade: **2**
 Clock Start/From: **9**
 Clock To: **10**
 1st Value:
 2nd Value:
 Value Percent: **5.000**
 Continuous Index:
 Within 8" of Joint: **YES**
 Remarks:

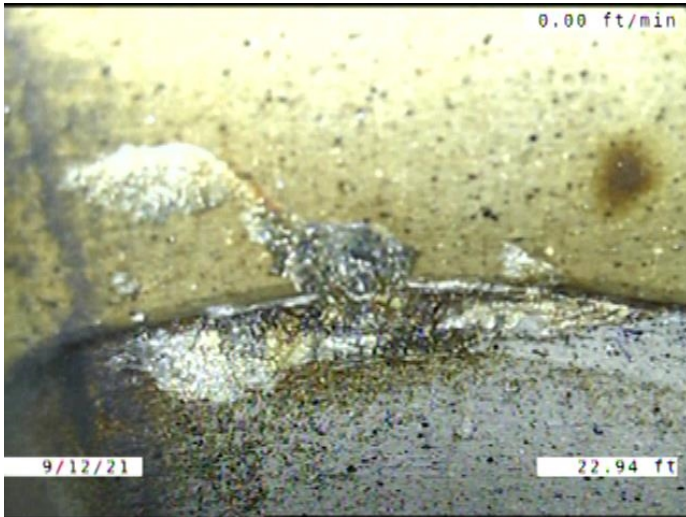
Code: **ISJ**
Description: **Infiltration Stain Joint**

Distance (ft): **22.9**
Structural Grade: **0**
O&M Grade: **1**
Clock Start/From: **7**
Clock To: **8**
1st Value:
2nd Value:
Value Percent:
Continuous Index:
Within 8" of Joint: **YES**
Remarks:

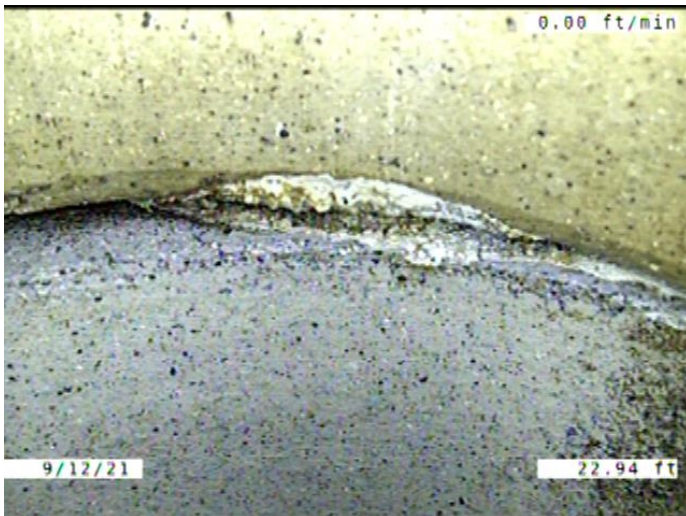
Code: **ISJ**
Description: **Infiltration Stain Joint**

Distance (ft): **22.9**
Structural Grade: **0**
O&M Grade: **1**
Clock Start/From: **2**
Clock To:
1st Value:
2nd Value:
Value Percent:
Continuous Index:
Within 8" of Joint: **YES**
Remarks:

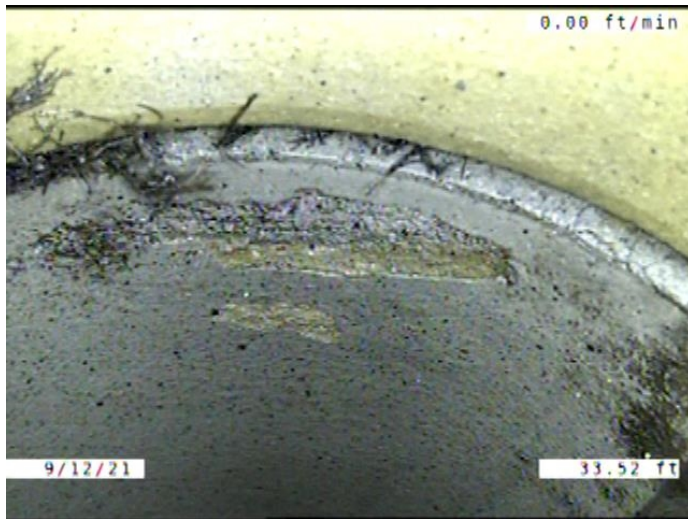
Code:	SSS
Description:	Surface Damage Surface Spalling
Distance (ft):	33.5
Structural Grade:	2
O&M Grade:	0
Clock Start/From:	8
Clock To:	2
1st Value:	
2nd Value:	
Value Percent:	
Continuous Index:	
Within 8" of Joint:	NO
Remarks:

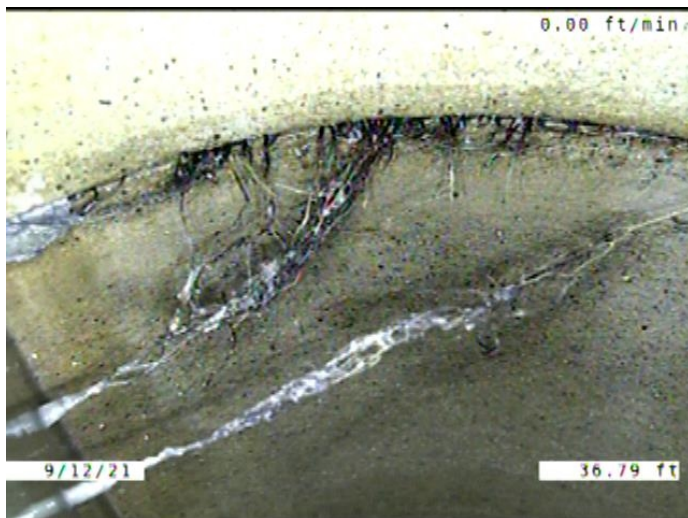
Code:	RFJ
Description:	Roots Fine Joint
Distance (ft):	36.8
Structural Grade:	0
O&M Grade:	1
Clock Start/From:	9
Clock To:	3
1st Value:	
2nd Value:	
Value Percent:	
Continuous Index:	
Within 8" of Joint:	YES
Remarks:

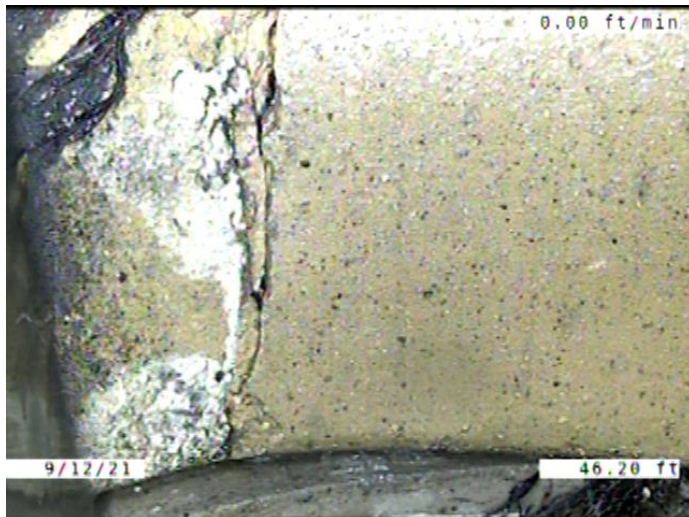
Code:	DAE
Description:	Deposits Attached Encrustation
Distance (ft):	46.2
Structural Grade:	0
O&M Grade:	2
Clock Start/From:	9
Clock To:	11
1st Value:	
2nd Value:	
Value Percent:	5.000
Continuous Index:	
Within 8" of Joint:	YES
Remarks:

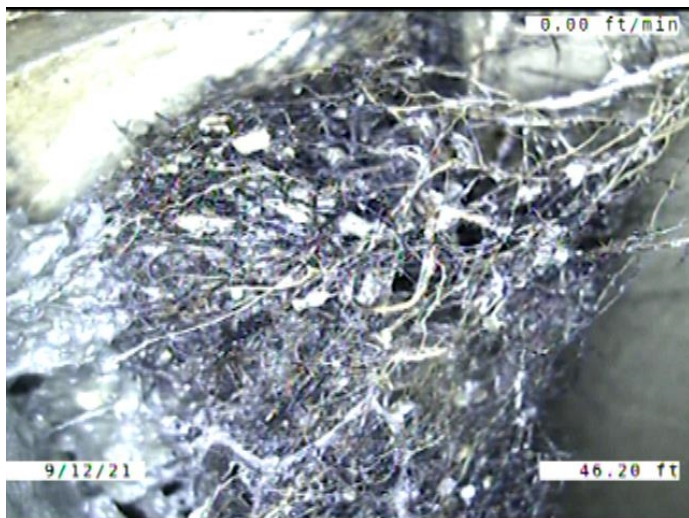
Code:	RMJ
Description:	Roots Medium Joint
Distance (ft):	46.2
Structural Grade:	0
O&M Grade:	3
Clock Start/From:	10
Clock To:	2
1st Value:	
2nd Value:	
Value Percent:	15.000
Continuous Index:	
Within 8" of Joint:	YES
Remarks:

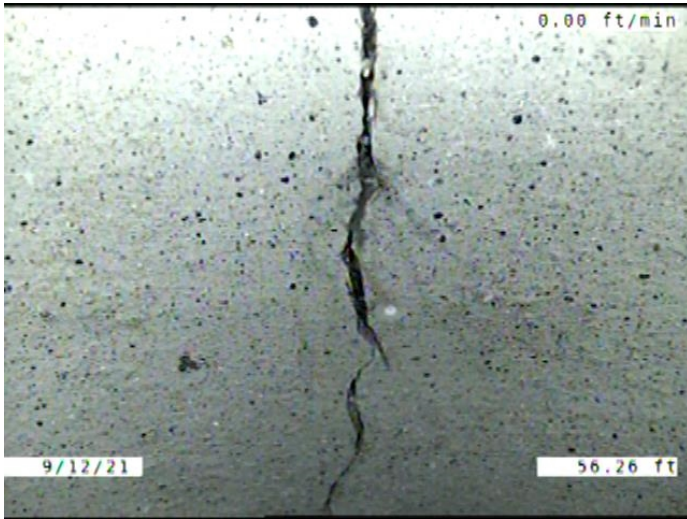
Code: **RFB**
 Description: **Roots Fine Barrel**

Distance (ft): **56.3**
 Structural Grade: **0**
 O&M Grade: **2**
 Clock Start/From: **1**
 Clock To:
 1st Value:
 2nd Value:
 Value Percent:
 Continuous Index:
 Within 8" of Joint: **NO**
 Remarks:

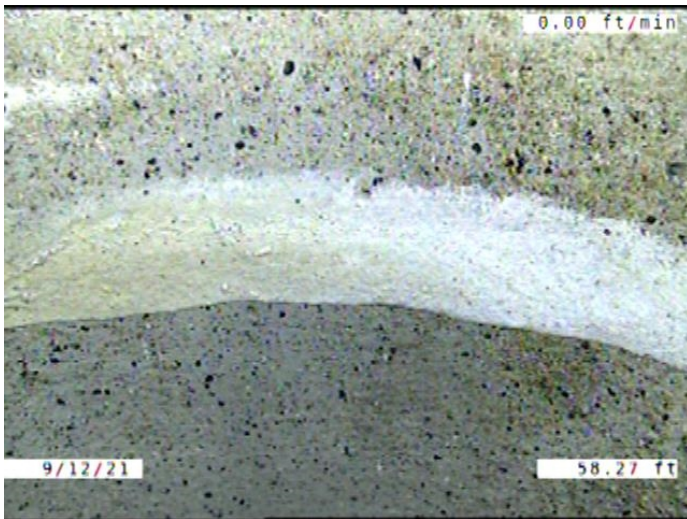
Code: **DAE**
 Description: **Deposits Attached Encrustation**

Distance (ft): **58.2**
 Structural Grade: **0**
 O&M Grade: **2**
 Clock Start/From: **12**
 Clock To: **3**
 1st Value:
 2nd Value:
 Value Percent: **5.000**
 Continuous Index: **S05**
 Within 8" of Joint: **YES**
 Remarks:

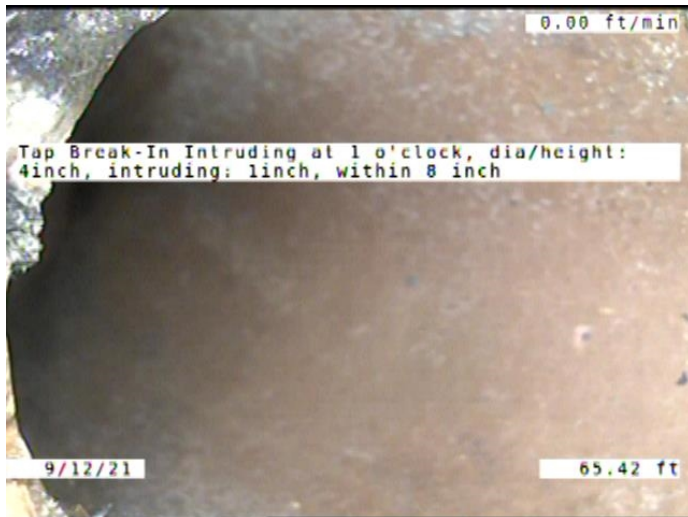
Code: **TBI**
 Description: **Tap Break-in Intruding**

Distance (ft): **65.4**
 Structural Grade: **0**
 O&M Grade: **2**
 Clock Start/From: **1**
 Clock To:
 1st Value: **4.000**
 2nd Value: **1.000**
 Value Percent:
 Continuous Index:
 Within 8" of Joint: **YES**
 Remarks:

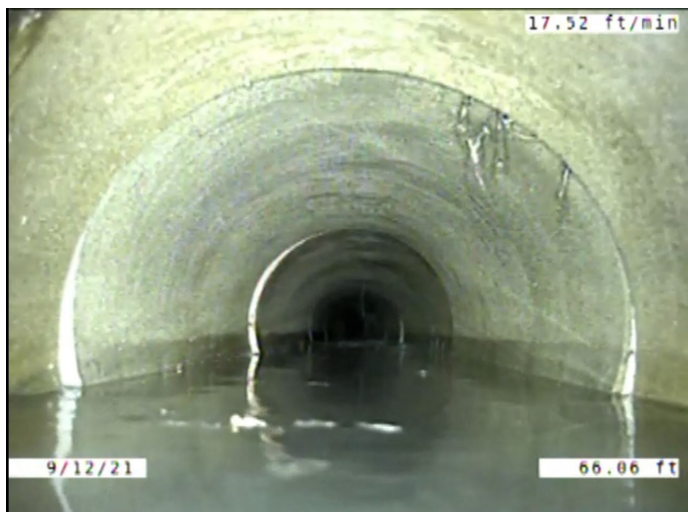
65.4	TBI	Tap Break-in Intruding	2604	M 2
66.0	FM(F02)	Fracture Multiple	2623	S 4
67.3	RFJ	Roots Fine Joint	2659	M 1
67.3	DAE(F04)	Deposits Attached Encrustation	2729	M 2

Code: **FM**
 Description: **Fracture Multiple**

Distance (ft): **66.0**
 Structural Grade: **4**
 O&M Grade: **0**
 Clock Start/From: **9**
 Clock To: **3**
 1st Value:
 2nd Value:
 Value Percent:
 Continuous Index: **F02**
 Within 8" of Joint: **NO**
 Remarks:

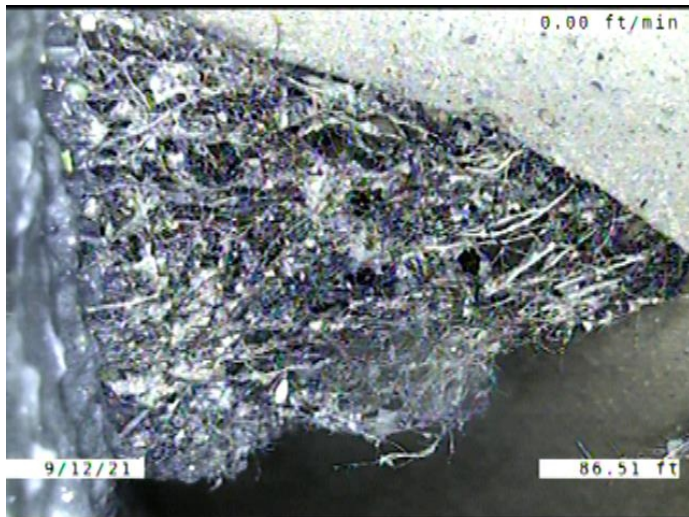
Code: **RMJ**
 Description: **Roots Medium Joint**

Distance (ft): **86.5**
 Structural Grade: **0**
 O&M Grade: **3**
 Clock Start/From: **9**
 Clock To: **3**
 1st Value:
 2nd Value:
 Value Percent: **15.000**
 Continuous Index:
 Within 8" of Joint: **YES**
 Remarks:

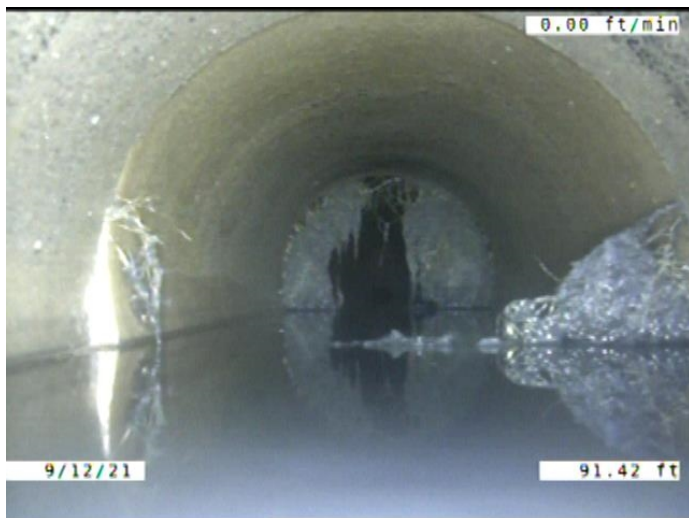
Code: **DSF**
 Description: **Deposits Settled Fine**

Distance (ft): **91.4**
 Structural Grade: **0**
 O&M Grade: **2**
 Clock Start/From: **5**
 Clock To: **7**
 1st Value:
 2nd Value:
 Value Percent: **5.000**
 Continuous Index: **F01**
 Within 8" of Joint: **YES**
 Remarks:
