# Profile/Photo Observation Report

Date:	<b>09/12/2021</b>	Weather:		Coding:	<b>PACP 7.0</b>
Pipe Length (ft):	<b>330.0</b>	Owner:	<b>City of Hobart</b>	Pre Clean:	<b>Heavy Cleaning</b>
P.O.#:	<b>YES502259</b>	Surveyor:	<b>S. Bucklin</b>	PSR:	<b>P-504-057-056</b>
Customer:	<b>City of Hobart</b>	Clean Date:	<b>09/08/2021</b>	Shape:	<b>C</b>

Street:	<b>North Wilson Street</b>	Flow Control:	<b>Not Controlled</b>
City:	<b>Hobart, IN</b>	Year Renewed:	
Location:	<b>Alley</b>	Tape/Media #:	
Purpose:	<b>Routine Assessment</b>	Dia/Height:	<b>12"</b>
Use:	<b>Sanitary Sewage Pipe</b>	Material:	<b>VCP</b>
Drain Area:		Lining:	<b>None</b>
Category:	<b>NA</b>		
Comment:			
Location Details:		Direction of Survey:	<b>Downstream</b>
US MH:	<b>M-504-056</b>	DS MH:	<b>M-504-057</b>
		Total Length Surveyed (ft):	<b>91.5</b>

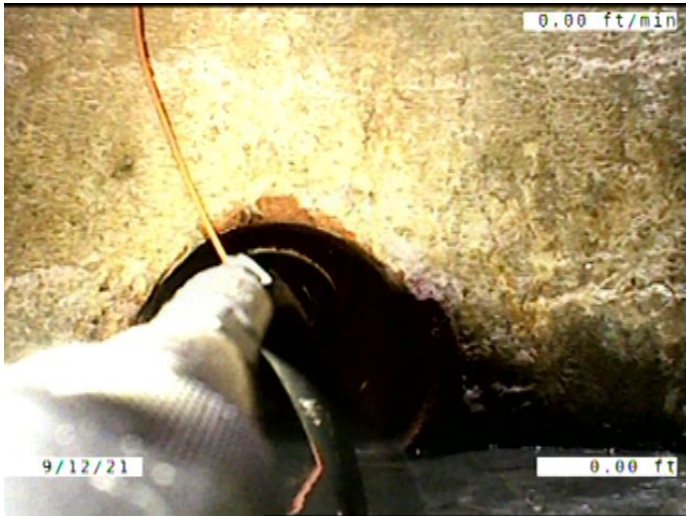
Code: **AMH**  
Description: **Manhole**

Distance (ft): **.0**  
Structural Grade: **0**  
O&M Grade: **0**  
Clock Start/From:  
Clock To:  
1st Value:  
2nd Value:  
Value Percent:  
Continuous Index:  
Within 8" of Joint: **NO**  
Remarks: **M-504-056**

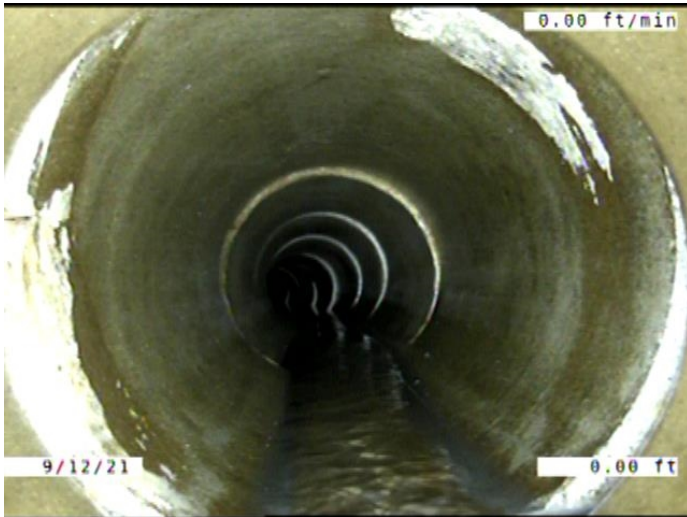
Code: **MWL**  
 Description: **Miscellaneous Water Level**

Distance (ft): **.0**  
 Structural Grade: **0**  
 O&M Grade: **0**  
 Clock Start/From:  
 Clock To:  
 1st Value:  
 2nd Value:  
 Value Percent: **5.000**  
 Continuous Index:  
 Within 8" of Joint: **NO**  
 Remarks:

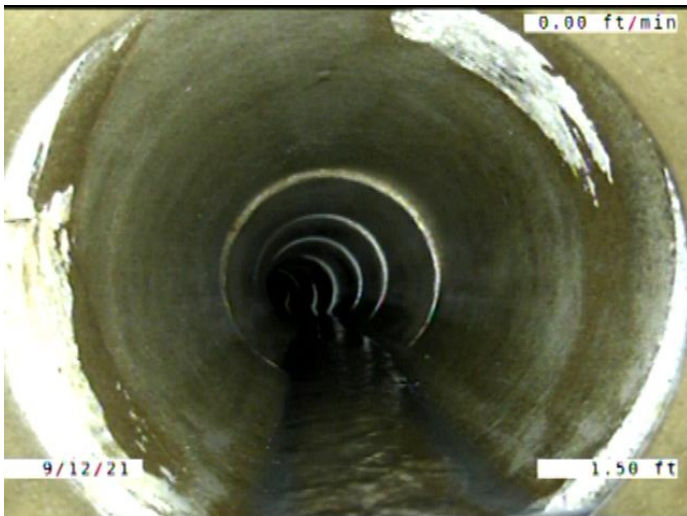
Code: **MGO**  
 Description: **Miscellaneous General Observation**

Distance (ft): **1.5**  
 Structural Grade: **0**  
 O&M Grade: **0**  
 Clock Start/From:  
 Clock To:  
 1st Value:  
 2nd Value:  
 Value Percent:  
 Continuous Index:  
 Within 8" of Joint: **NO**  
 Remarks: **DROP INTO THE MANHOLE. HAD TO START IN THE PIPE.**

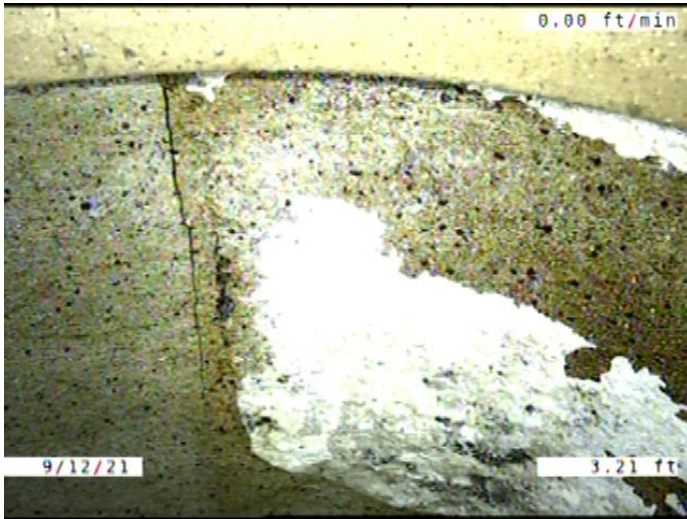
Code: **CM**  
 Description: **Crack Multiple**

Distance (ft): **3.2**  
 Structural Grade: **3**  
 O&M Grade: **0**  
 Clock Start/From: **7**  
 Clock To: **12**  
 1st Value:  
 2nd Value:  
 Value Percent:  
 Continuous Index:  
 Within 8" of Joint: **YES**  
 Remarks:

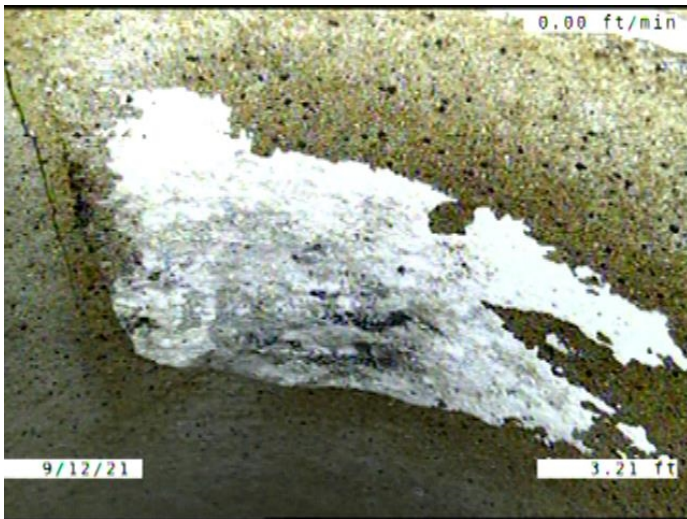
Code: **DAE**  
 Description: **Deposits Attached Encrustation**

Distance (ft): **3.2**  
 Structural Grade: **0**  
 O&M Grade: **2**  
 Clock Start/From: **1**  
 Clock To: **2**  
 1st Value:  
 2nd Value:  
 Value Percent: **5.000**  
 Continuous Index:  
 Within 8" of Joint: **YES**  
 Remarks:

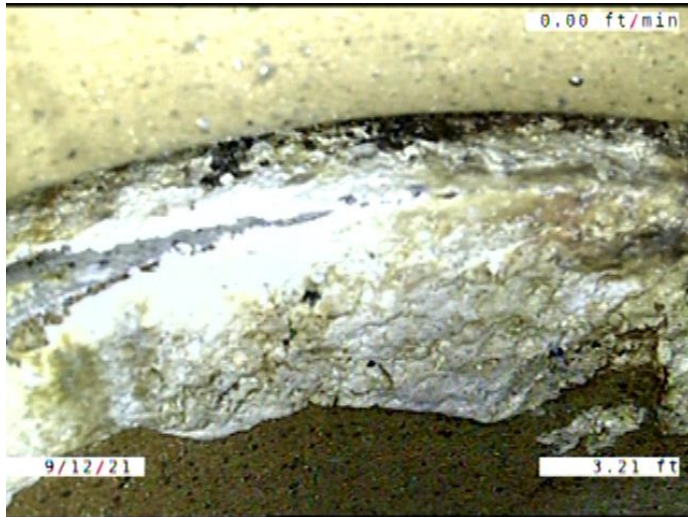
Code: **DAE**  
 Description: **Deposits Attached Encrustation**

Distance (ft): **3.2**  
 Structural Grade: **0**  
 O&M Grade: **2**  
 Clock Start/From: **8**  
 Clock To: **11**  
 1st Value:  
 2nd Value:  
 Value Percent: **5.000**  
 Continuous Index:  
 Within 8" of Joint: **YES**  
 Remarks:

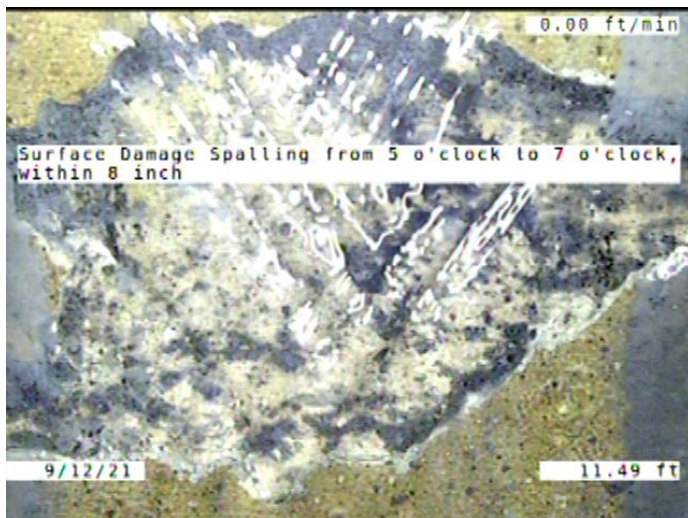
Code: **SSS**  
 Description: **Surface Damage Surface Spalling**

Distance (ft): **11.5**  
 Structural Grade: **2**  
 O&M Grade: **0**  
 Clock Start/From: **12**  
 Clock To: **12**  
 1st Value:  
 2nd Value:  
 Value Percent:  
 Continuous Index:  
 Within 8" of Joint: **YES**  
 Remarks:

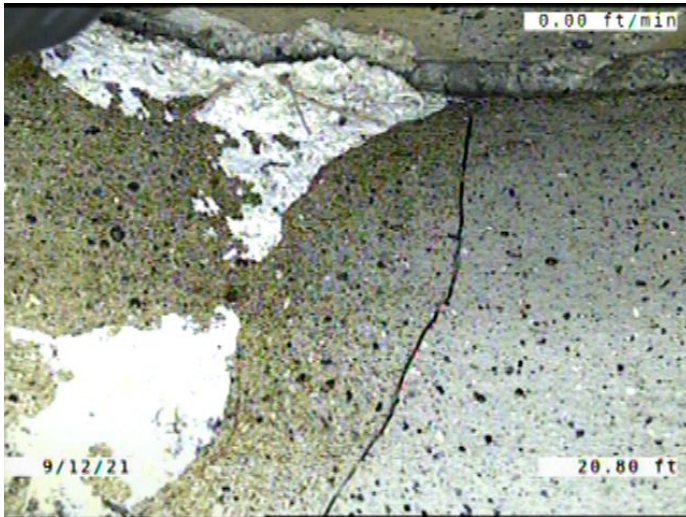
Code: **CS**  
 Description: **Crack Spiral**

Distance (ft): **20.8**  
 Structural Grade: **2**  
 O&M Grade: **0**  
 Clock Start/From: **9**  
 Clock To: **11**  
 1st Value:  
 2nd Value:  
 Value Percent:  
 Continuous Index:  
 Within 8" of Joint: **YES**  
 Remarks:

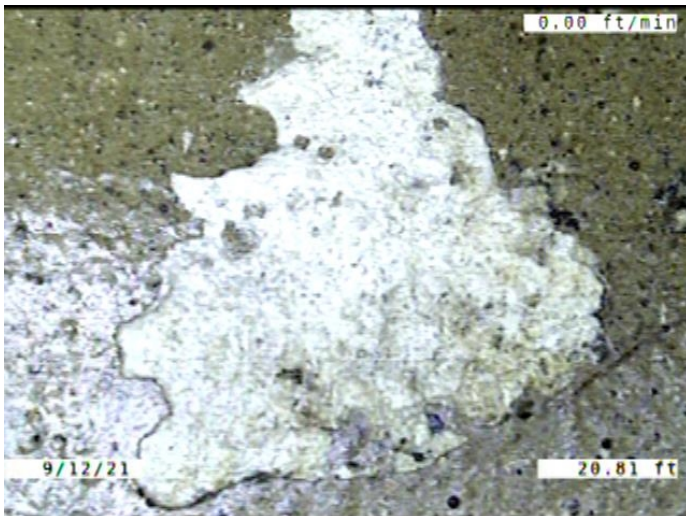
Code: **DAE**  
 Description: **Deposits Attached Encrustation**

Distance (ft): **20.8**  
 Structural Grade: **0**  
 O&M Grade: **2**  
 Clock Start/From: **9**  
 Clock To: **10**  
 1st Value:  
 2nd Value:  
 Value Percent: **5.000**  
 Continuous Index:  
 Within 8" of Joint: **YES**  
 Remarks:

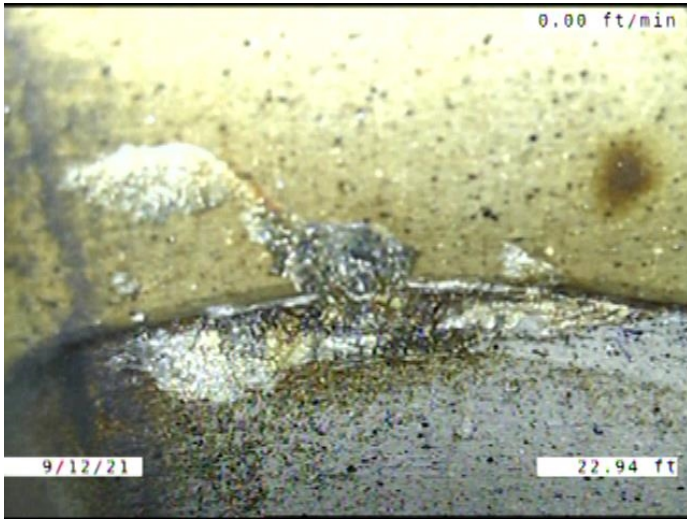
Code: **ISJ**  
Description: **Infiltration Stain Joint**

Distance (ft): **22.9**  
Structural Grade: **0**  
O&M Grade: **1**  
Clock Start/From: **7**  
Clock To: **8**  
1st Value:  
2nd Value:  
Value Percent:  
Continuous Index:  
Within 8" of Joint: **YES**  
Remarks:

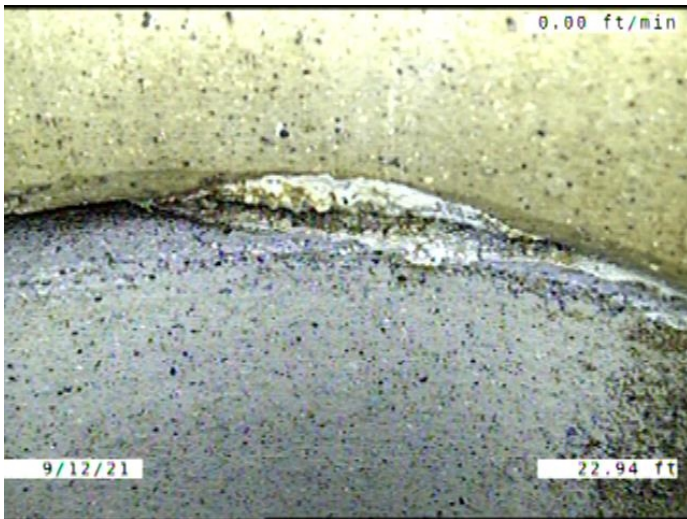
Code: **ISJ**  
Description: **Infiltration Stain Joint**

Distance (ft): **22.9**  
Structural Grade: **0**  
O&M Grade: **1**  
Clock Start/From: **2**  
Clock To:  
1st Value:  
2nd Value:  
Value Percent:  
Continuous Index:  
Within 8" of Joint: **YES**  
Remarks:

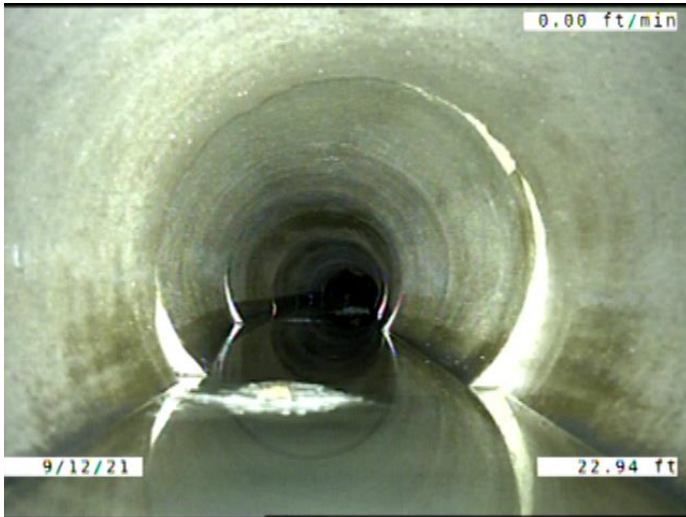
Code: **DSF**  
 Description: **Deposits Settled Fine**

Distance (ft): **22.9**  
 Structural Grade: **0**  
 O&M Grade: **2**  
 Clock Start/From: **5**  
 Clock To: **7**  
 1st Value:  
 2nd Value:  
 Value Percent: **5.000**  
 Continuous Index: **S01**  
 Within 8" of Joint: **YES**  
 Remarks:

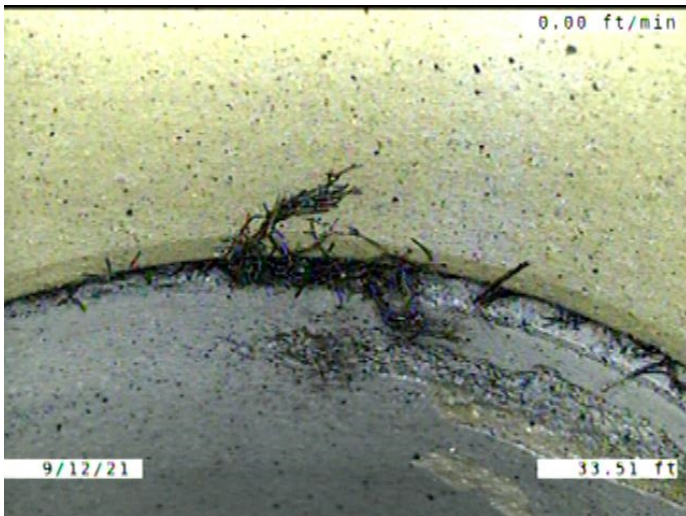
Code: **RFJ**  
 Description: **Roots Fine Joint**

Distance (ft): **33.5**  
 Structural Grade: **0**  
 O&M Grade: **1**  
 Clock Start/From: **11**  
 Clock To: **2**  
 1st Value:  
 2nd Value:  
 Value Percent:  
 Continuous Index:  
 Within 8" of Joint: **YES**  
 Remarks:

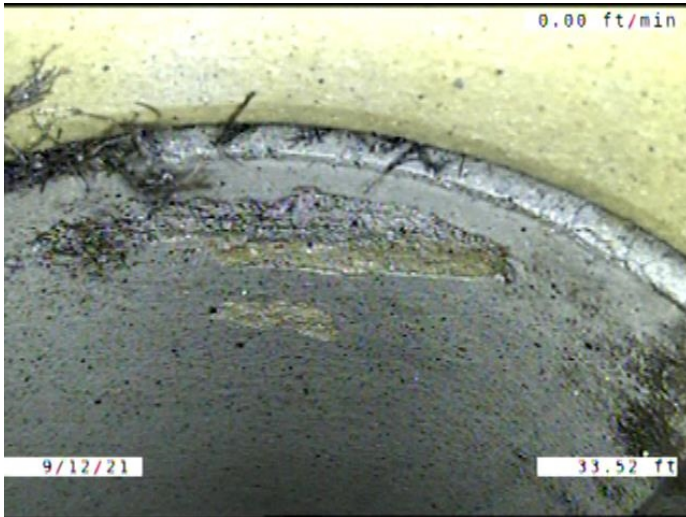
Code:	<b>SSS</b>
Description:	<b>Surface Damage Surface Spalling</b>
Distance (ft):	<b>33.5</b>
Structural Grade:	<b>2</b>
O&M Grade:	<b>0</b>
Clock Start/From:	<b>8</b>
Clock To:	<b>2</b>
1st Value:	
2nd Value:	
Value Percent:	
Continuous Index:	
Within 8" of Joint:	<b>NO</b>
Remarks:

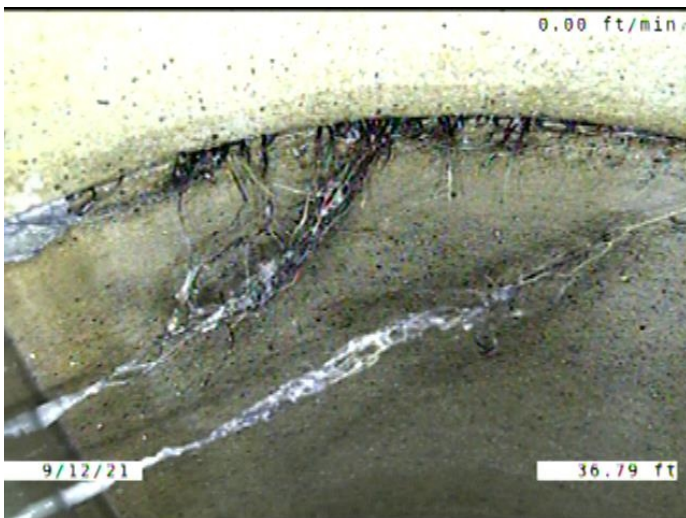
Code:	<b>RFJ</b>
Description:	<b>Roots Fine Joint</b>
Distance (ft):	<b>36.8</b>
Structural Grade:	<b>0</b>
O&M Grade:	<b>1</b>
Clock Start/From:	<b>9</b>
Clock To:	<b>3</b>
1st Value:	
2nd Value:	
Value Percent:	
Continuous Index:	
Within 8" of Joint:	<b>YES</b>
Remarks:

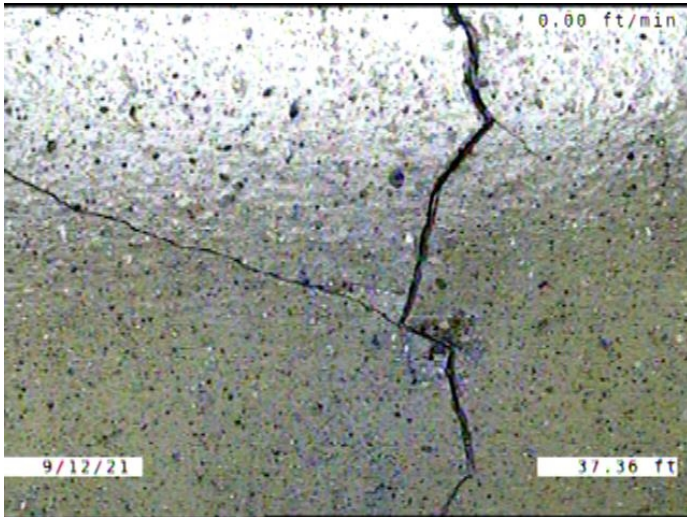
Code: **FM**  
 Description: **Fracture Multiple**

Distance (ft): **37.4**  
 Structural Grade: **4**  
 O&M Grade: **0**  
 Clock Start/From: **9**  
 Clock To: **3**  
 1st Value:  
 2nd Value:  
 Value Percent:  
 Continuous Index: **S02**  
 Within 8" of Joint: **YES**  
 Remarks:

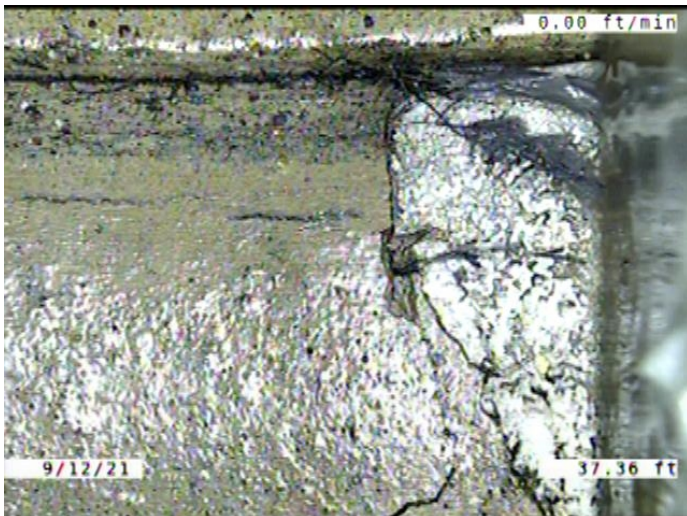
Code: **DAE**  
 Description: **Deposits Attached Encrustation**

Distance (ft): **37.4**  
 Structural Grade: **0**  
 O&M Grade: **2**  
 Clock Start/From: **3**  
 Clock To:  
 1st Value:  
 2nd Value:  
 Value Percent: **5.000**  
 Continuous Index:  
 Within 8" of Joint: **YES**  
 Remarks:

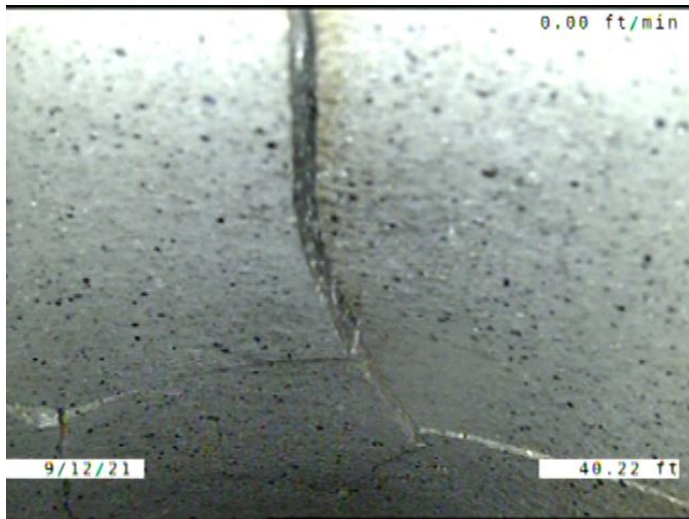
Code: **B**  
Description: **Broken**

Distance (ft): **40.2**  
Structural Grade: **4**  
O&M Grade: **0**  
Clock Start/From: **9**  
Clock To: **3**  
1st Value:  
2nd Value:  
Value Percent:  
Continuous Index: **S03**  
Within 8" of Joint: **YES**  
Remarks:

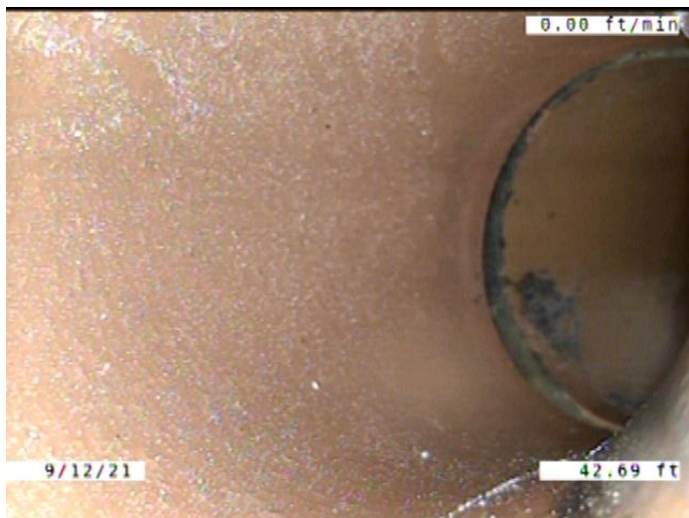
Code: **TBI**  
Description: **Tap Break-in Intruding**

Distance (ft): **42.7**  
Structural Grade: **0**  
O&M Grade: **2**  
Clock Start/From: **1**  
Clock To:  
1st Value: **4.000**  
2nd Value: **1.000**  
Value Percent:  
Continuous Index:  
Within 8" of Joint: **YES**  
Remarks:

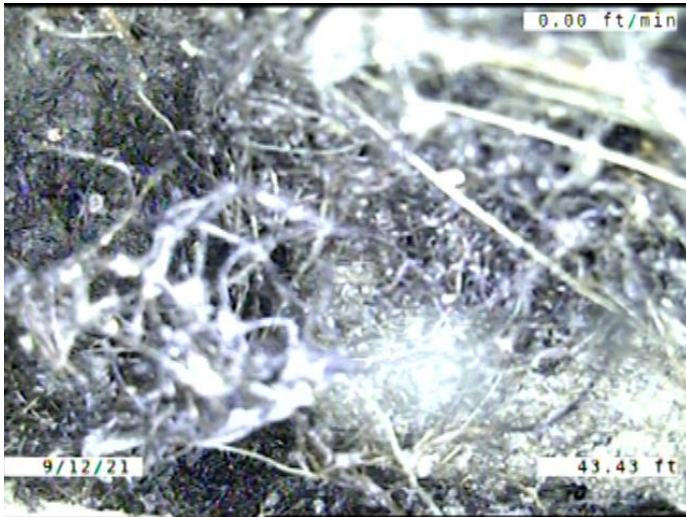
Code: **RML**  
 Description: **Roots Medium Lateral**

Distance (ft): **43.4**  
 Structural Grade: **0**  
 O&M Grade: **3**  
 Clock Start/From: **11**  
 Clock To: **2**  
 1st Value:  
 2nd Value:  
 Value Percent: **5.000**  
 Continuous Index:  
 Within 8" of Joint: **NO**  
 Remarks:

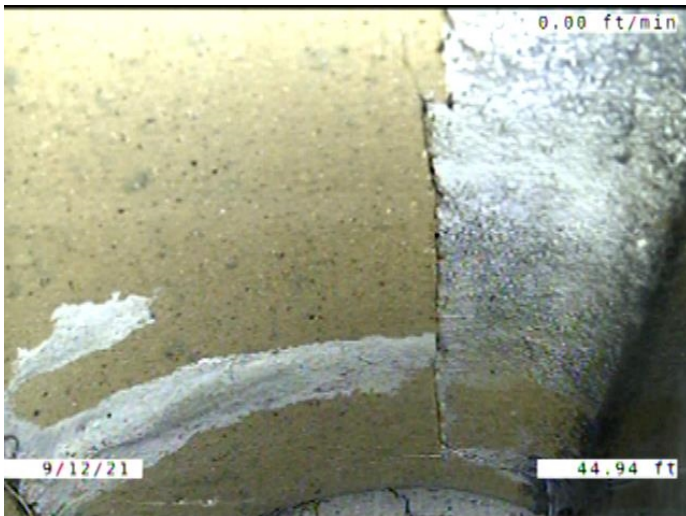
Code: **DAE**  
 Description: **Deposits Attached Encrustation**

Distance (ft): **44.9**  
 Structural Grade: **0**  
 O&M Grade: **2**  
 Clock Start/From: **1**  
 Clock To: **3**  
 1st Value:  
 2nd Value:  
 Value Percent: **5.000**  
 Continuous Index:  
 Within 8" of Joint: **YES**  
 Remarks:

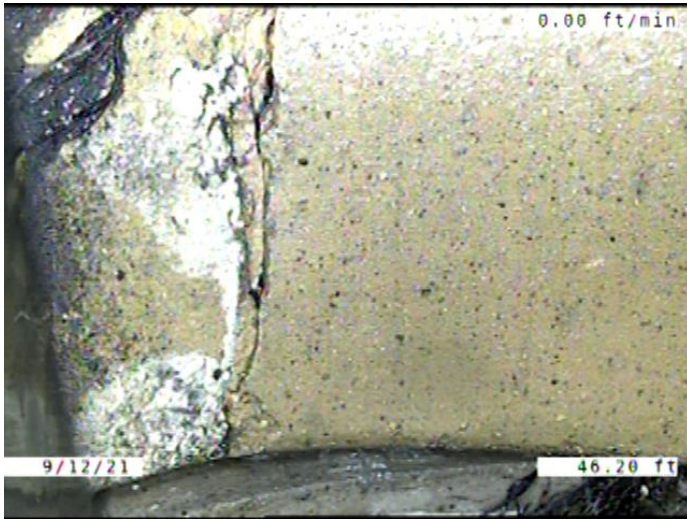
Code: **DAE**  
 Description: **Deposits Attached Encrustation**

Distance (ft): **46.2**  
 Structural Grade: **0**  
 O&M Grade: **2**  
 Clock Start/From: **9**  
 Clock To: **11**  
 1st Value:  
 2nd Value:  
 Value Percent: **5.000**  
 Continuous Index:  
 Within 8" of Joint: **YES**  
 Remarks:

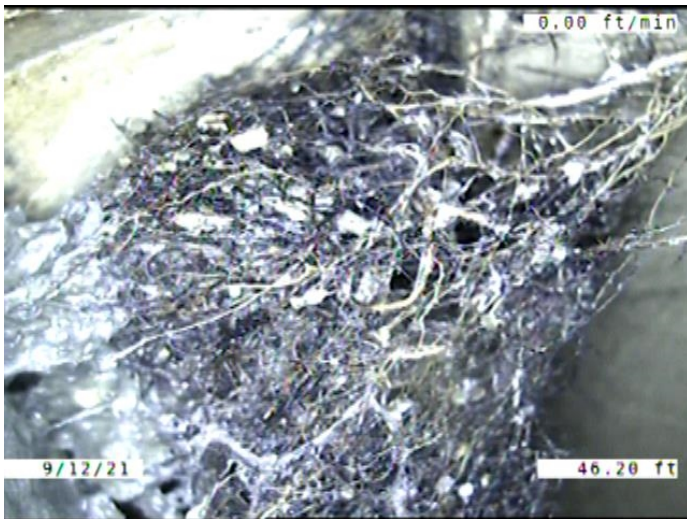
Code: **RMJ**  
 Description: **Roots Medium Joint**

Distance (ft): **46.2**  
 Structural Grade: **0**  
 O&M Grade: **3**  
 Clock Start/From: **10**  
 Clock To: **2**  
 1st Value:  
 2nd Value:  
 Value Percent: **15.000**  
 Continuous Index:  
 Within 8" of Joint: **YES**  
 Remarks:

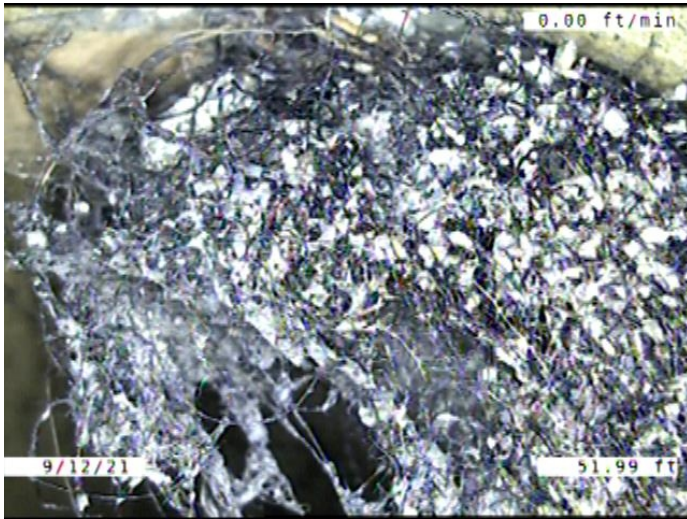
Code: **RMJ**  
 Description: **Roots Medium Joint**

Distance (ft): **52.0**  
 Structural Grade: **0**  
 O&M Grade: **3**  
 Clock Start/From: **10**  
 Clock To: **3**  
 1st Value:  
 2nd Value:  
 Value Percent: **15.000**  
 Continuous Index:  
 Within 8" of Joint: **YES**  
 Remarks:

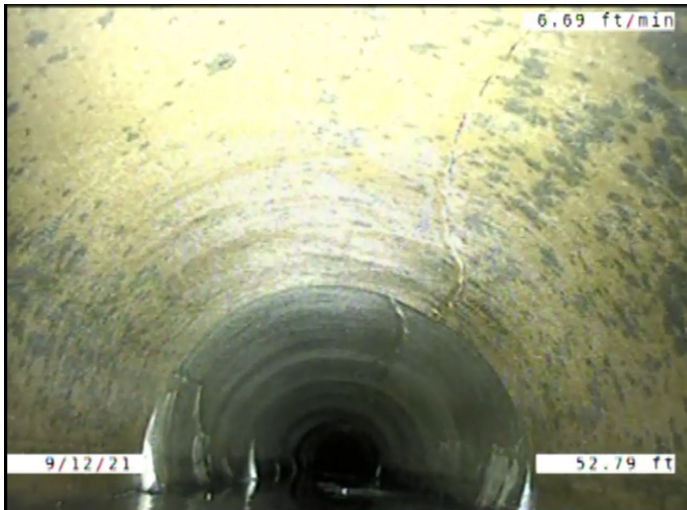
Code: **B**  
 Description: **Broken**

Distance (ft): **52.8**  
 Structural Grade: **4**  
 O&M Grade: **0**  
 Clock Start/From: **9**  
 Clock To: **3**  
 1st Value:  
 2nd Value:  
 Value Percent:  
 Continuous Index: **F03**  
 Within 8" of Joint: **YES**  
 Remarks:

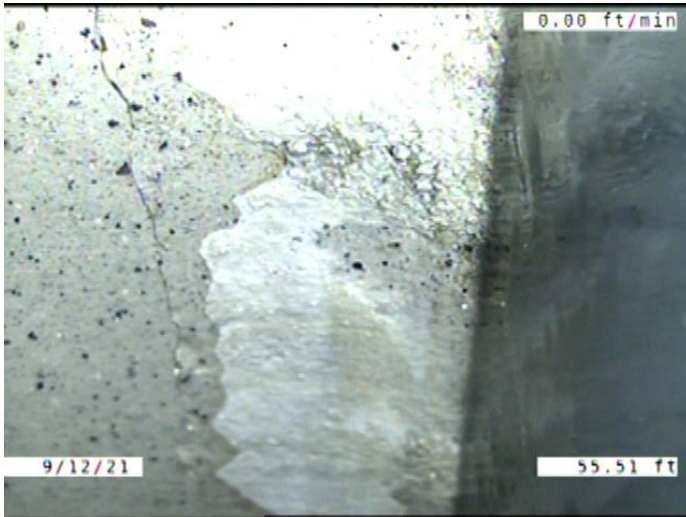
Code: **DAE**  
 Description: **Deposits Attached Encrustation**

Distance (ft): **55.5**  
 Structural Grade: **0**  
 O&M Grade: **2**  
 Clock Start/From: **3**  
 Clock To:  
 1st Value:  
 2nd Value:  
 Value Percent: **5.000**  
 Continuous Index:  
 Within 8" of Joint: **YES**  
 Remarks:

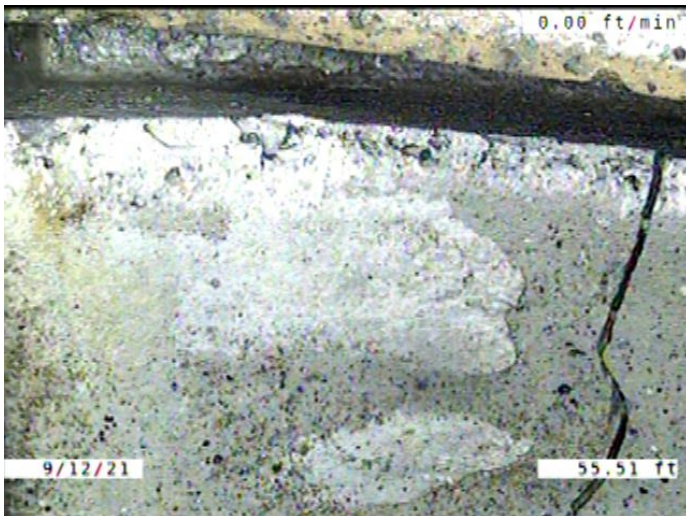
Code: **DAE**  
 Description: **Deposits Attached Encrustation**

Distance (ft): **55.5**  
 Structural Grade: **0**  
 O&M Grade: **2**  
 Clock Start/From: **9**  
 Clock To:  
 1st Value:  
 2nd Value:  
 Value Percent: **5.000**  
 Continuous Index: **S04**  
 Within 8" of Joint: **YES**  
 Remarks:

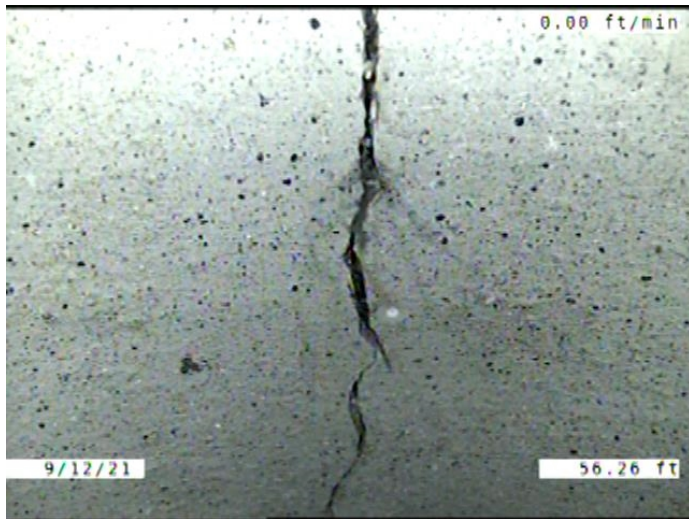
Code: **RFB**  
 Description: **Roots Fine Barrel**

Distance (ft): **56.3**  
 Structural Grade: **0**  
 O&M Grade: **2**  
 Clock Start/From: **1**  
 Clock To:  
 1st Value:  
 2nd Value:  
 Value Percent:  
 Continuous Index:  
 Within 8" of Joint: **NO**  
 Remarks:

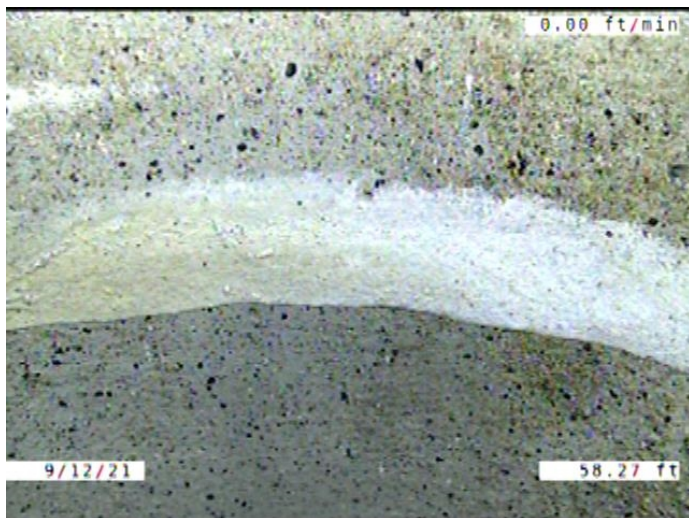
Code: **DAE**  
 Description: **Deposits Attached Encrustation**

Distance (ft): **58.2**  
 Structural Grade: **0**  
 O&M Grade: **2**  
 Clock Start/From: **12**  
 Clock To: **3**  
 1st Value:  
 2nd Value:  
 Value Percent: **5.000**  
 Continuous Index: **S05**  
 Within 8" of Joint: **YES**  
 Remarks:

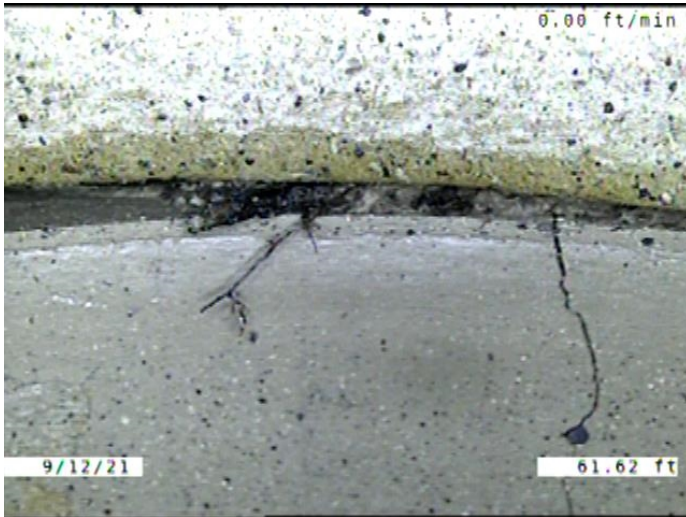
Code: **RFJ**  
 Description: **Roots Fine Joint**

Distance (ft): **61.6**  
 Structural Grade: **0**  
 O&M Grade: **1**  
 Clock Start/From: **10**  
 Clock To: **2**  
 1st Value:  
 2nd Value:  
 Value Percent:  
 Continuous Index:  
 Within 8" of Joint: **YES**  
 Remarks:

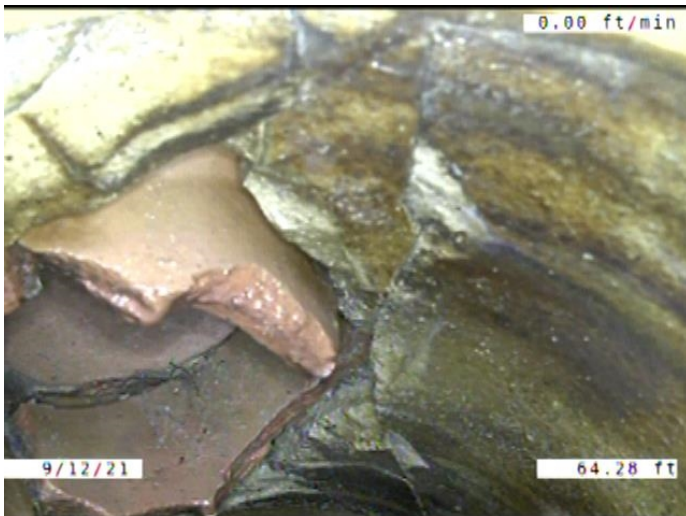
Code: **DAE**  
 Description: **Deposits Attached Encrustation**

Distance (ft): **64.3**  
 Structural Grade: **0**  
 O&M Grade: **2**  
 Clock Start/From: **9**  
 Clock To: **3**  
 1st Value:  
 2nd Value:  
 Value Percent: **5.000**  
 Continuous Index:  
 Within 8" of Joint: **YES**  
 Remarks:

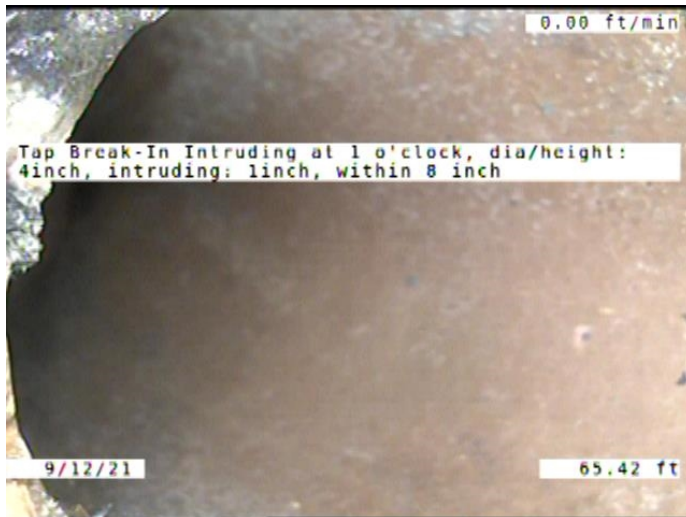
Code: **TBI**  
 Description: **Tap Break-in Intruding**

Distance (ft): **65.4**  
 Structural Grade: **0**  
 O&M Grade: **2**  
 Clock Start/From: **1**  
 Clock To:  
 1st Value: **4.000**  
 2nd Value: **1.000**  
 Value Percent:  
 Continuous Index:  
 Within 8" of Joint: **YES**  
 Remarks:

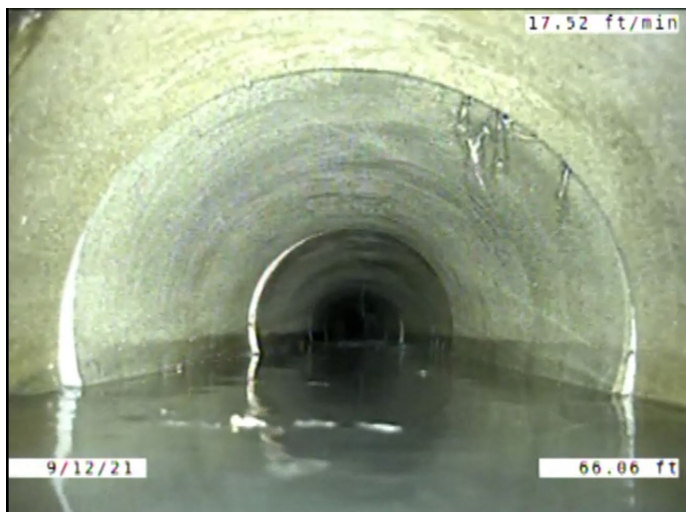
Code: **FM**  
 Description: **Fracture Multiple**

Distance (ft): **66.0**  
 Structural Grade: **4**  
 O&M Grade: **0**  
 Clock Start/From: **9**  
 Clock To: **3**  
 1st Value:  
 2nd Value:  
 Value Percent:  
 Continuous Index: **F02**  
 Within 8" of Joint: **NO**  
 Remarks:

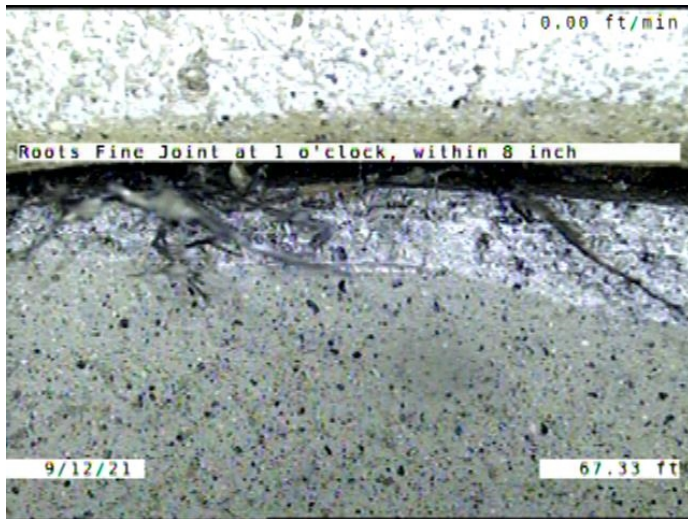
Code: **RFJ**  
 Description: **Roots Fine Joint**

Distance (ft): **67.3**  
 Structural Grade: **0**  
 O&M Grade: **1**  
 Clock Start/From: **1**  
 Clock To:  
 1st Value:  
 2nd Value:  
 Value Percent:  
 Continuous Index:  
 Within 8" of Joint: **YES**  
 Remarks:

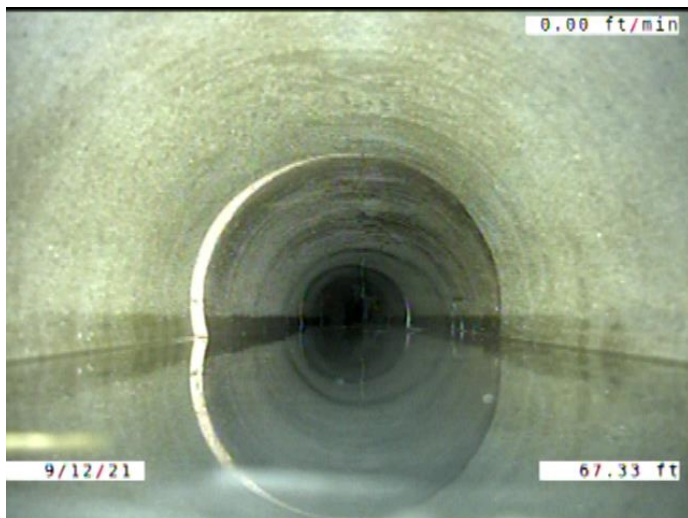
Code: **DAE**  
 Description: **Deposits Attached Encrustation**

Distance (ft): **67.3**  
 Structural Grade: **0**  
 O&M Grade: **2**  
 Clock Start/From: **9**  
 Clock To:  
 1st Value:  
 2nd Value:  
 Value Percent: **5.000**  
 Continuous Index: **F04**  
 Within 8" of Joint: **YES**  
 Remarks:

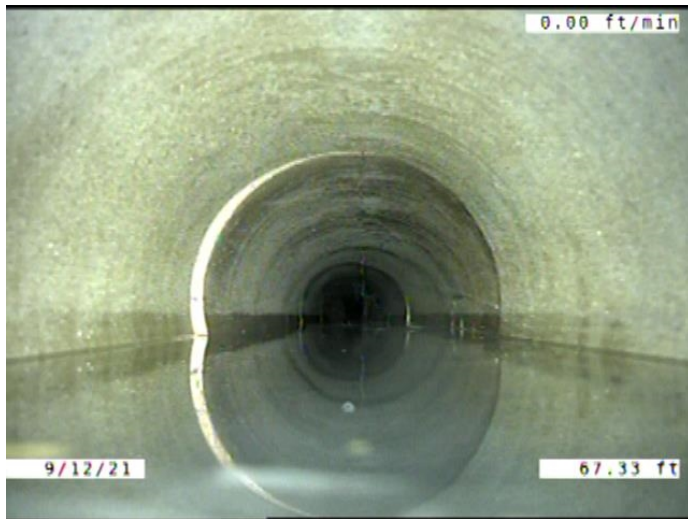
Code: **DAE**  
 Description: **Deposits Attached Encrustation**

Distance (ft): **67.3**  
 Structural Grade: **0**  
 O&M Grade: **2**  
 Clock Start/From: **12**  
 Clock To: **3**  
 1st Value:  
 2nd Value:  
 Value Percent: **5.000**  
 Continuous Index: **F05**  
 Within 8" of Joint: **YES**  
 Remarks:

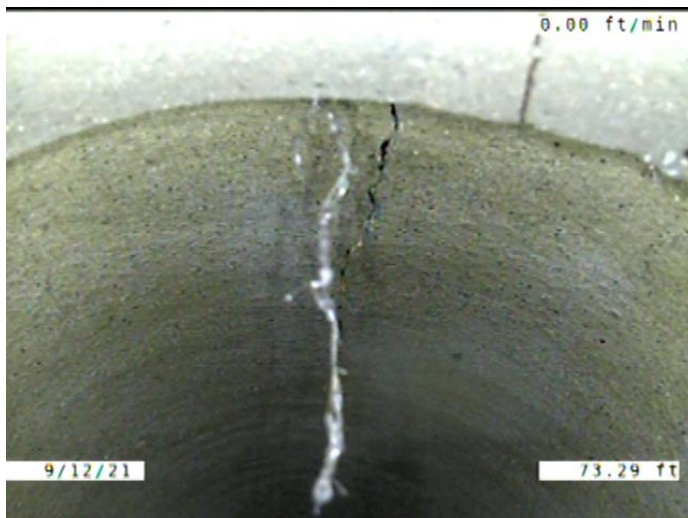
Code: **RFJ**  
 Description: **Roots Fine Joint**

Distance (ft): **73.3**  
 Structural Grade: **0**  
 O&M Grade: **1**  
 Clock Start/From: **12**  
 Clock To:  
 1st Value:  
 2nd Value:  
 Value Percent:  
 Continuous Index:  
 Within 8" of Joint: **YES**  
 Remarks:

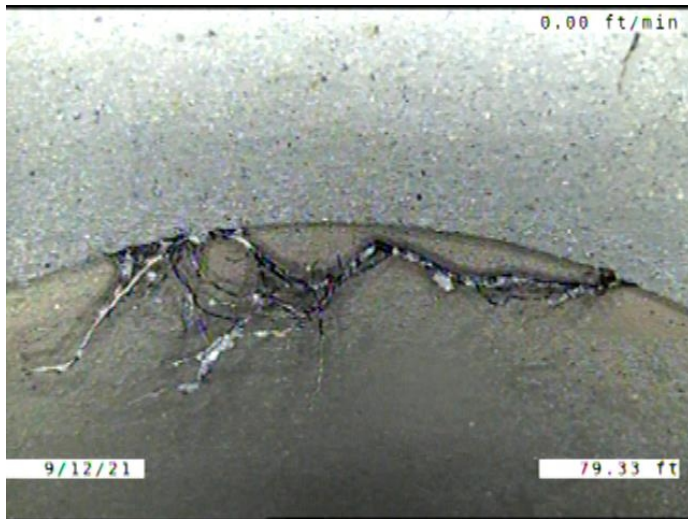
Code: **RFJ**  
 Description: **Roots Fine Joint**

Distance (ft): **79.3**  
 Structural Grade: **0**  
 O&M Grade: **1**  
 Clock Start/From: **10**  
 Clock To: **12**  
 1st Value:  
 2nd Value:  
 Value Percent:  
 Continuous Index:  
 Within 8" of Joint: **YES**  
 Remarks:

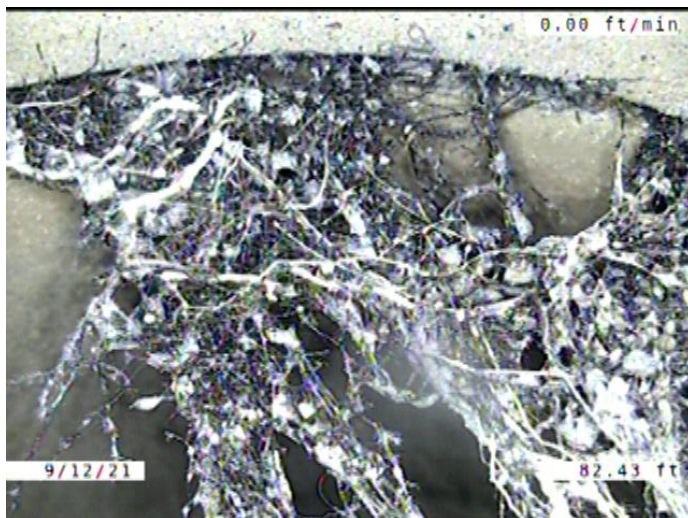
Code: **RMJ**  
 Description: **Roots Medium Joint**

Distance (ft): **82.4**  
 Structural Grade: **0**  
 O&M Grade: **3**  
 Clock Start/From: **11**  
 Clock To: **3**  
 1st Value:  
 2nd Value:  
 Value Percent: **5.000**  
 Continuous Index:  
 Within 8" of Joint: **YES**  
 Remarks:

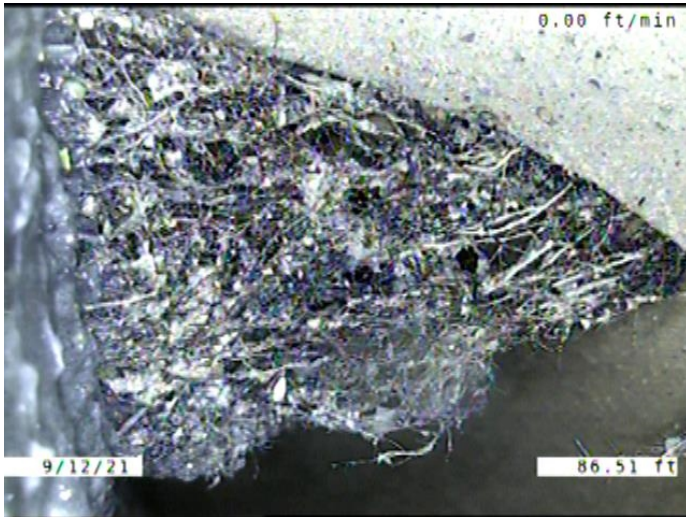
Code: **RMJ**  
 Description: **Roots Medium Joint**

Distance (ft): **86.5**  
 Structural Grade: **0**  
 O&M Grade: **3**  
 Clock Start/From: **9**  
 Clock To: **3**  
 1st Value:  
 2nd Value:  
 Value Percent: **15.000**  
 Continuous Index:  
 Within 8" of Joint: **YES**  
 Remarks:

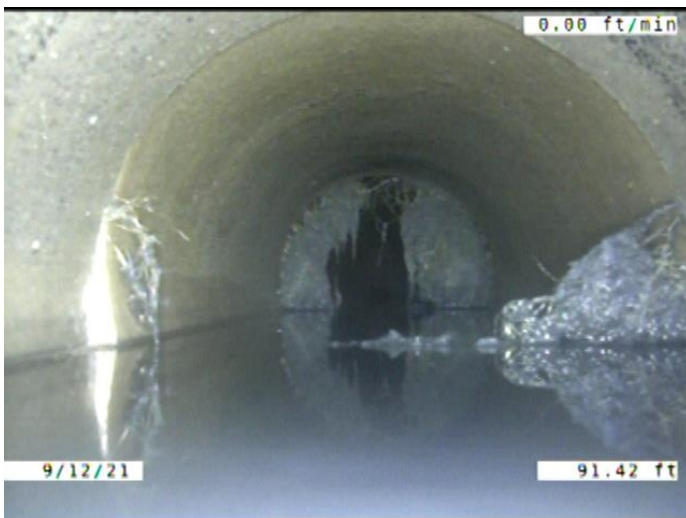
Code: **DSF**  
 Description: **Deposits Settled Fine**

Distance (ft): **91.4**  
 Structural Grade: **0**  
 O&M Grade: **2**  
 Clock Start/From: **5**  
 Clock To: **7**  
 1st Value:  
 2nd Value:  
 Value Percent: **5.000**  
 Continuous Index: **F01**  
 Within 8" of Joint: **YES**  
 Remarks:

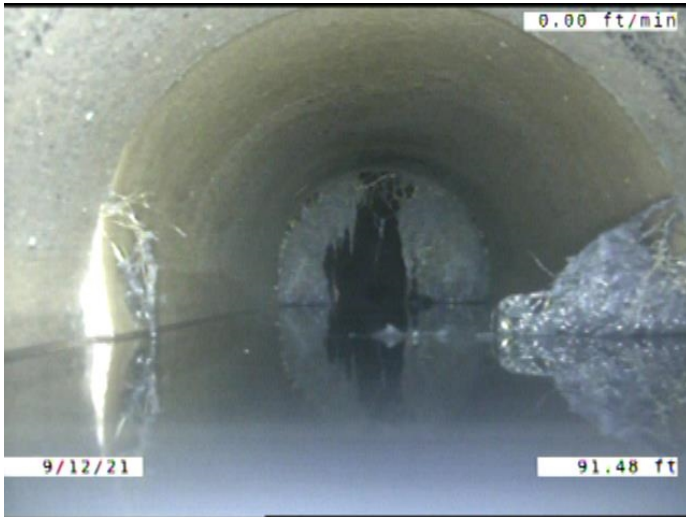
Code:	<b>MSA</b>
Description:	<b>Miscellaneous Survey Abandoned</b>
Distance (ft):	<b>91.5</b>
Structural Grade:	<b>0</b>
O&M Grade:	<b>0</b>
Clock Start/From:	
Clock To:	
1st Value:	
2nd Value:	
Value Percent:	
Continuous Index:	
Within 8" of Joint:	<b>NO</b>
Remarks:	<b>Camera cannot make it past roots.</b>
