Profile/Photo Observation Report

Street:	North Wilson Street	Flow Control:	Not Controlled
City:	Hobart, IN	Year Renewed:	
Location:	Alley	Tape/Media #:	
Purpose:	Routine Assessment	Dia/Height:	12"
Use:	Sanitary Sewage Pipe	Material:	VCP
Drain Area:		Lining:	None
Category:	NA		
Comment:			
Location Details:		Direction of Survey:	Upstream
US MH:	M-504-056	DS MH:	M-504-057
		Total Length Surveyed (ft):	103.5

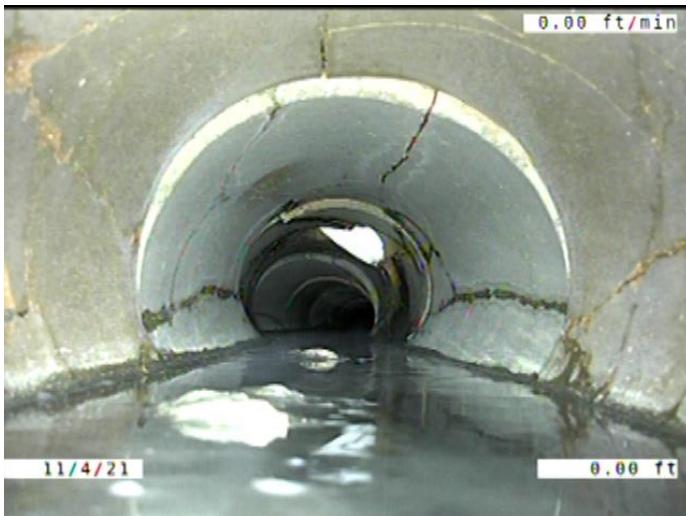
Code: **DSF**
 Description: **Deposits Settled Fine**

Distance (ft): **.0**
 Structural Grade: **0**
 O&M Grade: **2**
 Clock Start/From: **5**
 Clock To: **7**
 1st Value:
 2nd Value:
 Value Percent: **5.000**
 Continuous Index: **S01**
 Within 8" of Joint: **YES**
 Remarks: **ALSO RAGS**

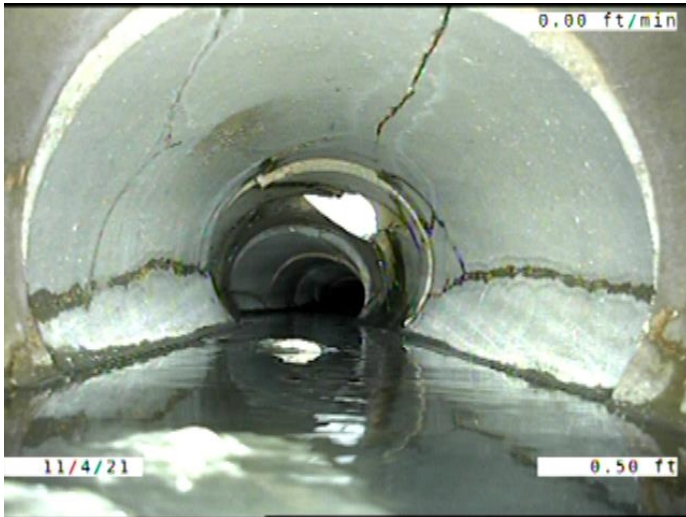
Code: **B**
 Description: **Broken**

Distance (ft): **.5**
 Structural Grade: **4**
 O&M Grade: **0**
 Clock Start/From: **8**
 Clock To: **4**
 1st Value:
 2nd Value:
 Value Percent:
 Continuous Index: **S02**
 Within 8" of Joint: **YES**
 Remarks:

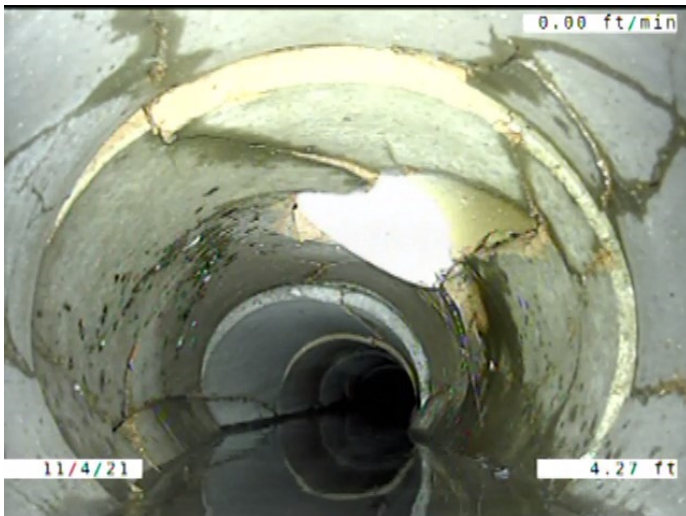
Code: **DR**
 Description: **Deformed Rigid**

Distance (ft): **3.4**
 Structural Grade: **4**
 O&M Grade: **0**
 Clock Start/From:
 Clock To:
 1st Value:
 2nd Value:
 Value Percent: **5.000**
 Continuous Index: **S03**
 Within 8" of Joint: **NO**
 Remarks:

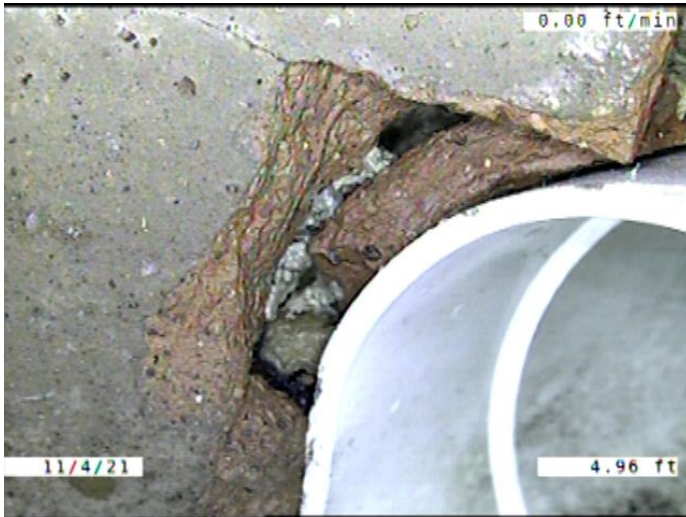
Code: **BSV**
 Description: **Broken Soil Visible**

Distance (ft): **4.8**
 Structural Grade: **5**
 O&M Grade: **0**
 Clock Start/From: **11**
 Clock To: **2**
 1st Value:
 2nd Value:
 Value Percent:
 Continuous Index:
 Within 8" of Joint: **YES**
 Remarks:

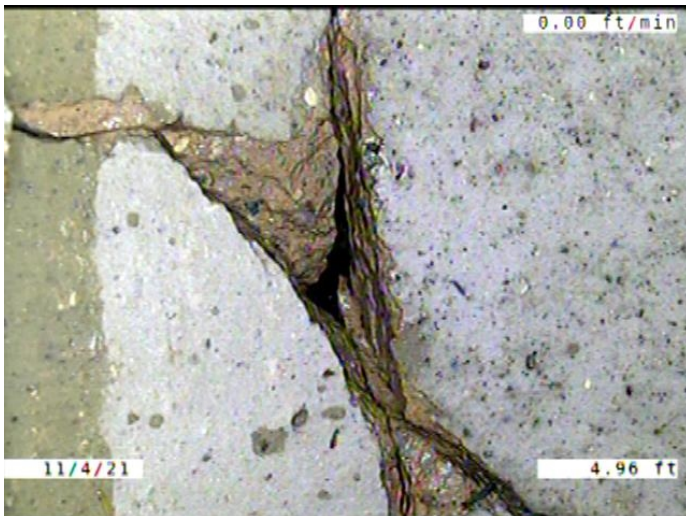
Code: **BVV**
 Description: **Broken Void Visible**

Distance (ft): **5.0**
 Structural Grade: **5**
 O&M Grade: **0**
 Clock Start/From: **9**
 Clock To:
 1st Value:
 2nd Value:
 Value Percent:
 Continuous Index:
 Within 8" of Joint: **YES**
 Remarks: **SOIL VISIBLE**

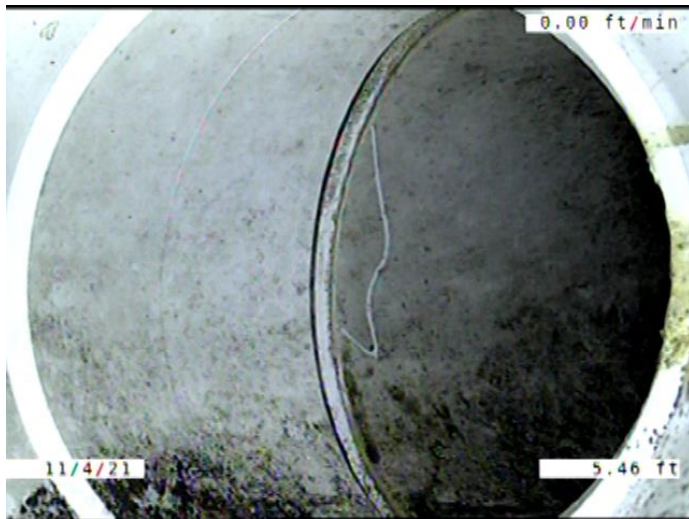
Code: **TBD**
 Description: **Tap Break-in/Hammer Defective**

Distance (ft): **5.5**
 Structural Grade: **0**
 O&M Grade: **3**
 Clock Start/From: **1**
 Clock To:
 1st Value: **4.000**
 2nd Value:
 Value Percent:
 Continuous Index:
 Within 8" of Joint: **YES**
 Remarks: **Defective**

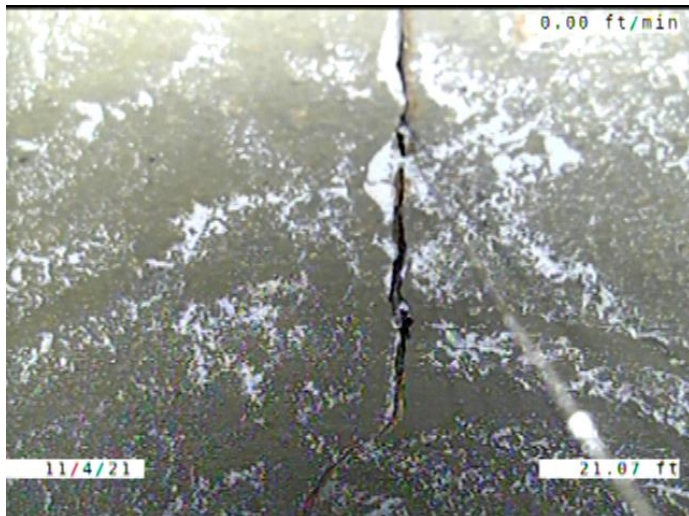
Code: **RFB**
 Description: **Roots Fine Barrel**

Distance (ft): **21.1**
 Structural Grade: **0**
 O&M Grade: **2**
 Clock Start/From: **12**
 Clock To:
 1st Value:
 2nd Value:
 Value Percent:
 Continuous Index:
 Within 8" of Joint: **NO**
 Remarks:

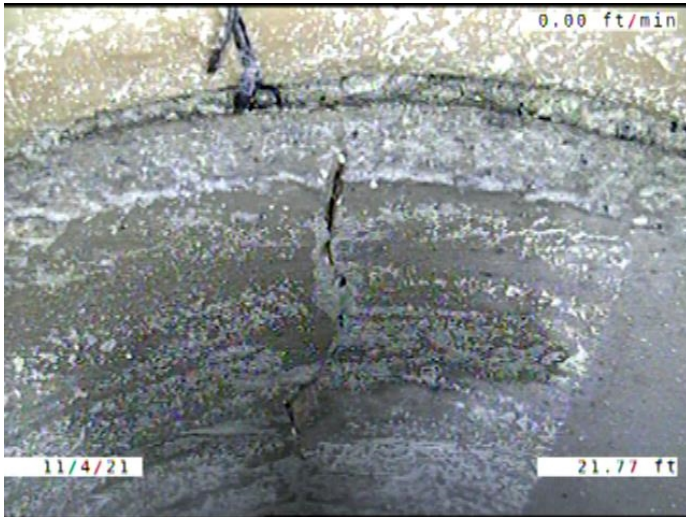
Code: **JOMD**
 Description: **Joint Offset Medium Defective**

Distance (ft): **21.8**
 Structural Grade: **3**
 O&M Grade: **0**
 Clock Start/From:
 Clock To:
 1st Value:
 2nd Value:
 Value Percent:
 Continuous Index:
 Within 8" of Joint: **NO**
 Remarks:

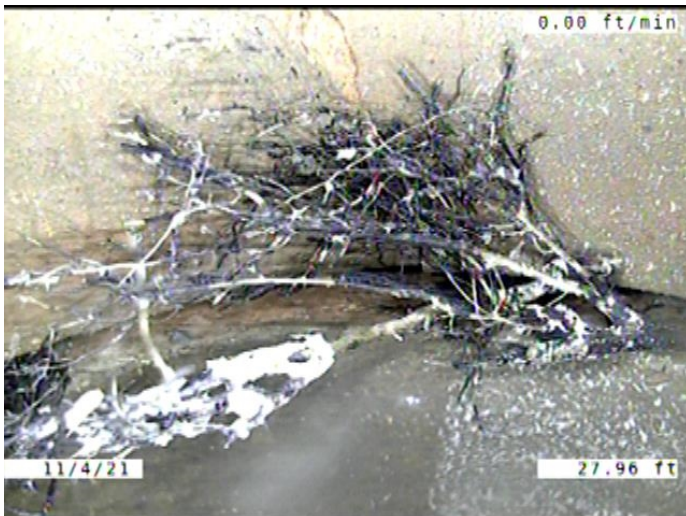
Code: **RFJ**
 Description: **Roots Fine Joint**

Distance (ft): **28.0**
 Structural Grade: **0**
 O&M Grade: **1**
 Clock Start/From: **9**
 Clock To: **11**
 1st Value:
 2nd Value:
 Value Percent:
 Continuous Index:
 Within 8" of Joint: **YES**
 Remarks:

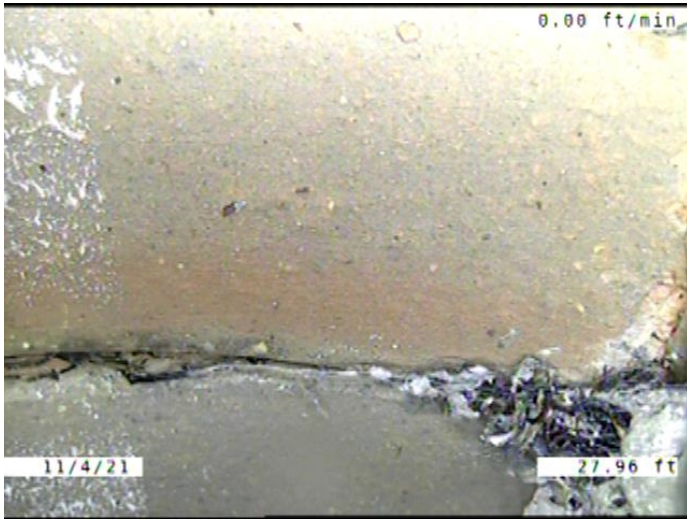
Code: **RFJ**
Description: **Roots Fine Joint**

Distance (ft): **28.0**
Structural Grade: **0**
O&M Grade: **1**
Clock Start/From: **1**
Clock To: **3**
1st Value:
2nd Value:
Value Percent:
Continuous Index:
Within 8" of Joint: **YES**
Remarks:

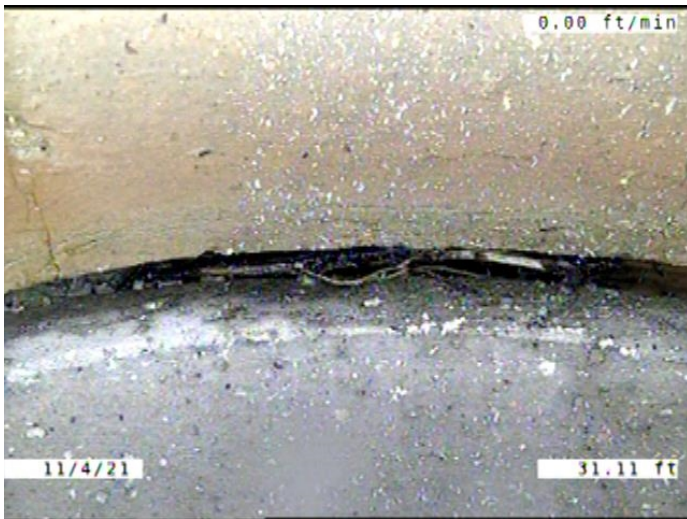
Code: **RFJ**
Description: **Roots Fine Joint**

Distance (ft): **31.1**
Structural Grade: **0**
O&M Grade: **1**
Clock Start/From: **9**
Clock To: **10**
1st Value:
2nd Value:
Value Percent:
Continuous Index:
Within 8" of Joint: **YES**
Remarks:

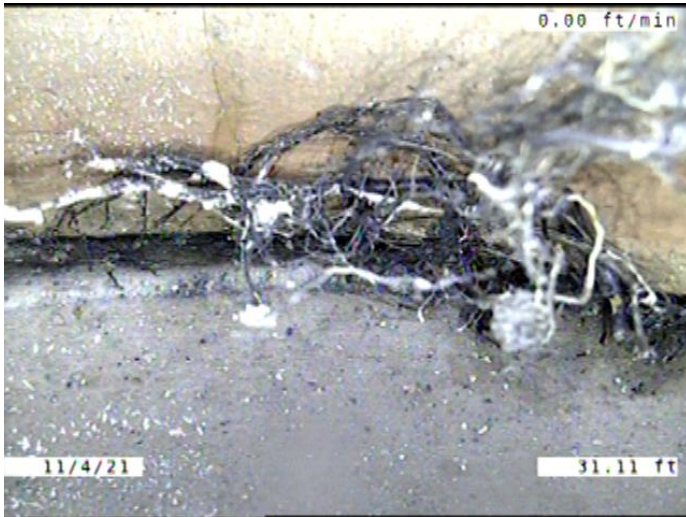
Code: **RFJ**
 Description: **Roots Fine Joint**

Distance (ft): **31.1**
 Structural Grade: **0**
 O&M Grade: **1**
 Clock Start/From: **2**
 Clock To: **3**
 1st Value:
 2nd Value:
 Value Percent:
 Continuous Index:
 Within 8" of Joint: **YES**
 Remarks:

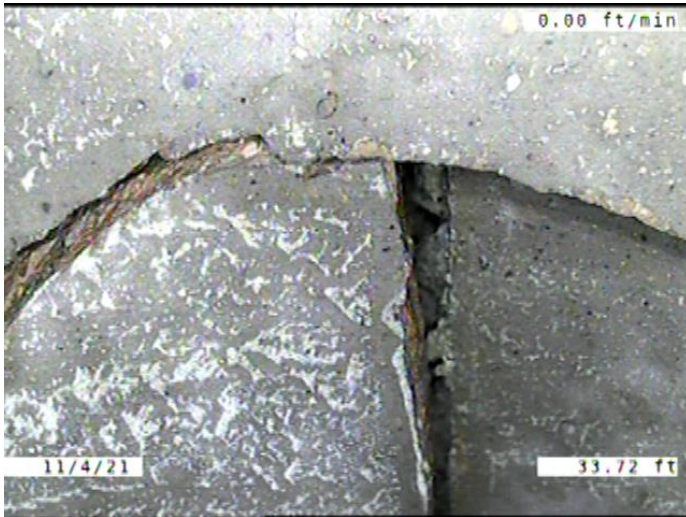
Code: **BSV**
 Description: **Broken Soil Visible**

Distance (ft): **33.7**
 Structural Grade: **5**
 O&M Grade: **0**
 Clock Start/From: **1**
 Clock To: **6**
 1st Value:
 2nd Value:
 Value Percent:
 Continuous Index:
 Within 8" of Joint: **YES**
 Remarks:

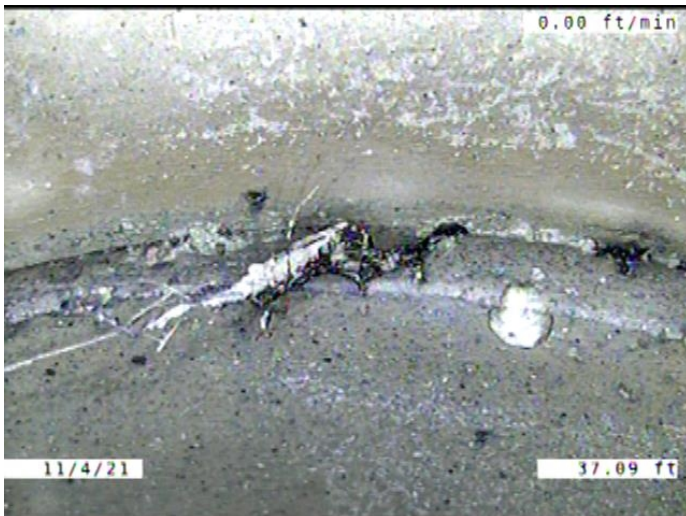
Code: **RFJ**
 Description: **Roots Fine Joint**

Distance (ft): **37.1**
 Structural Grade: **0**
 O&M Grade: **1**
 Clock Start/From: **10**
 Clock To: **1**
 1st Value:
 2nd Value:
 Value Percent:
 Continuous Index:
 Within 8" of Joint: **YES**
 Remarks:

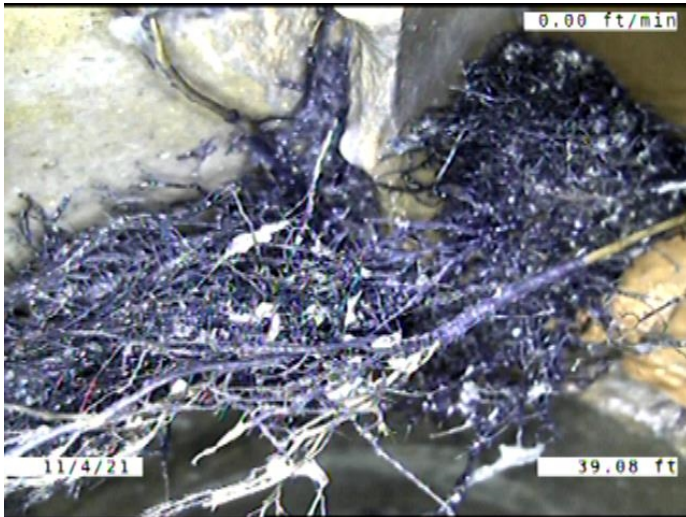
Code: **RMC**
 Description: **Roots Medium Connection**

Distance (ft): **39.1**
 Structural Grade: **0**
 O&M Grade: **3**
 Clock Start/From: **10**
 Clock To: **12**
 1st Value:
 2nd Value:
 Value Percent: **5.000**
 Continuous Index:
 Within 8" of Joint: **NO**
 Remarks:

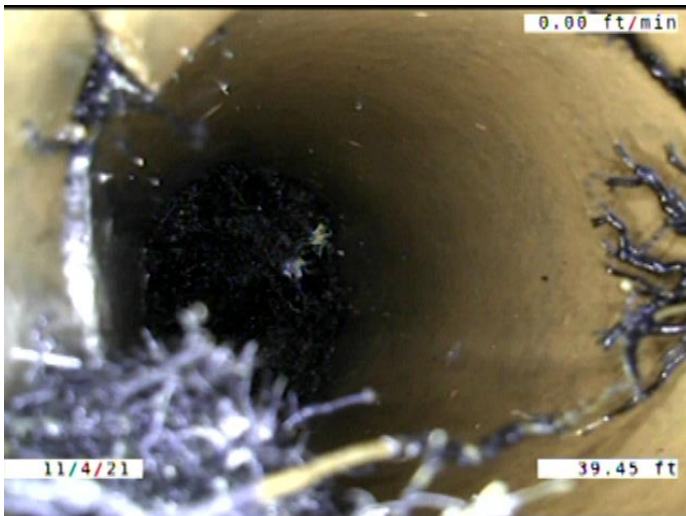
Code: **TBI**
 Description: **Tap Break-in Intruding**

Distance (ft): **39.4**
 Structural Grade: **0**
 O&M Grade: **2**
 Clock Start/From: **11**
 Clock To:
 1st Value: **4.000**
 2nd Value: **1.000**
 Value Percent:
 Continuous Index:
 Within 8" of Joint: **YES**
 Remarks: **CONSTANTLY RUNNING WATER.
 ROOTS GROWING FROM THE CONN**

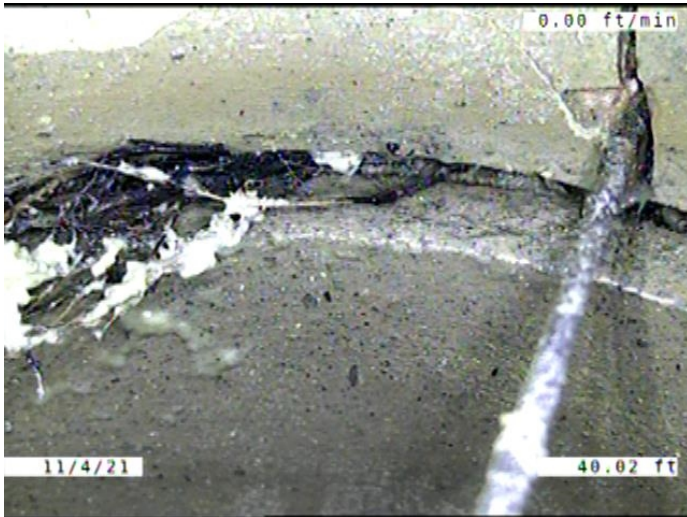
Code: **RFB**
 Description: **Roots Fine Barrel**

Distance (ft): **40.0**
 Structural Grade: **0**
 O&M Grade: **2**
 Clock Start/From: **10**
 Clock To: **2**
 1st Value:
 2nd Value:
 Value Percent:
 Continuous Index:
 Within 8" of Joint: **NO**
 Remarks:

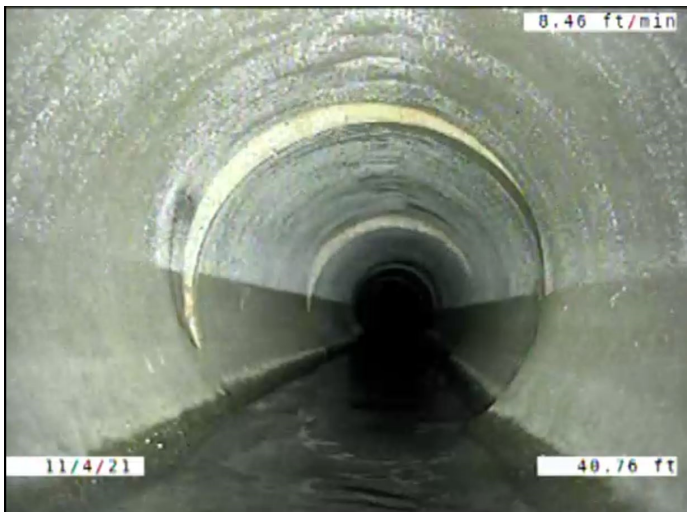
Code: **B**
 Description: **Broken**

Distance (ft): **40.8**
 Structural Grade: **4**
 O&M Grade: **0**
 Clock Start/From: **8**
 Clock To: **4**
 1st Value:
 2nd Value:
 Value Percent:
 Continuous Index: **F02**
 Within 8" of Joint: **YES**
 Remarks:

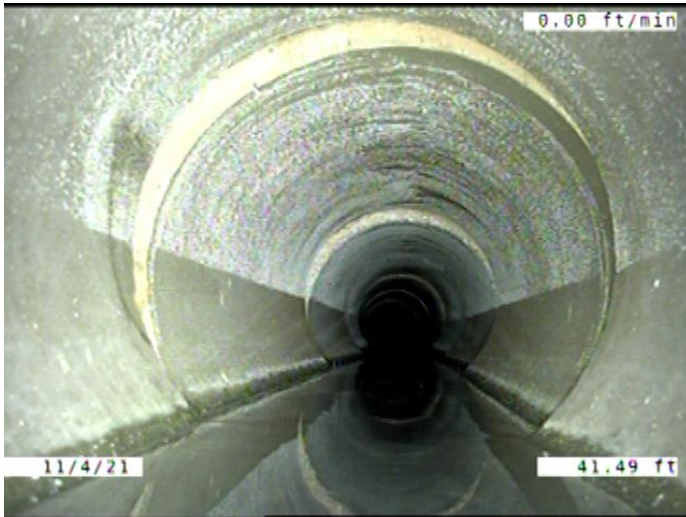
Code: **DR**
 Description: **Deformed Rigid**

Distance (ft): **41.5**
 Structural Grade: **4**
 O&M Grade: **0**
 Clock Start/From:
 Clock To:
 1st Value:
 2nd Value:
 Value Percent: **5.000**
 Continuous Index: **F03**
 Within 8" of Joint: **NO**
 Remarks:

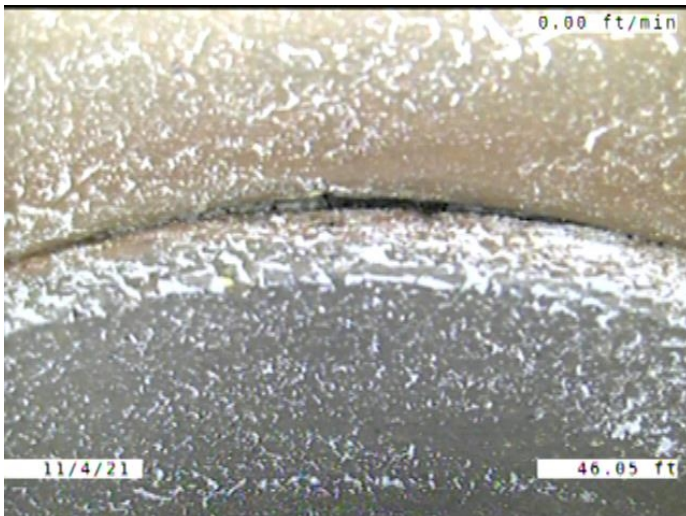
Code: **JOM**
 Description: **Joint Offset Medium**

Distance (ft): **46.0**
 Structural Grade: **3**
 O&M Grade: **0**
 Clock Start/From:
 Clock To:
 1st Value:
 2nd Value:
 Value Percent:
 Continuous Index:
 Within 8" of Joint: **NO**
 Remarks:

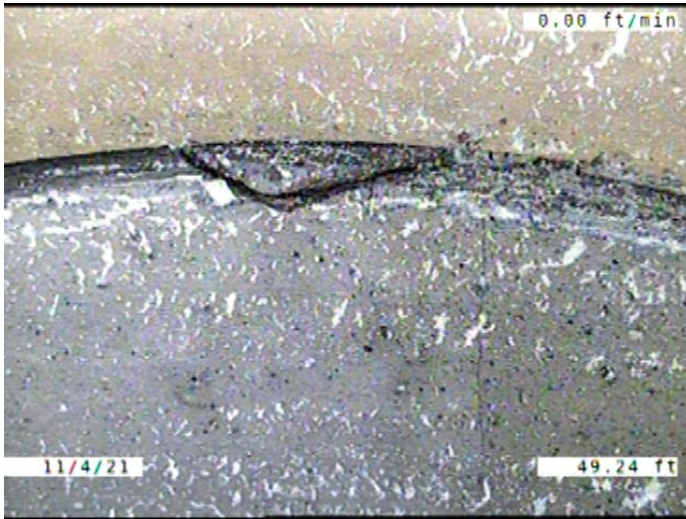
Code: **B**
 Description: **Broken**

Distance (ft): **49.2**
 Structural Grade: **4**
 O&M Grade: **0**
 Clock Start/From: **11**
 Clock To:
 1st Value:
 2nd Value:
 Value Percent:
 Continuous Index:
 Within 8" of Joint: **YES**
 Remarks:

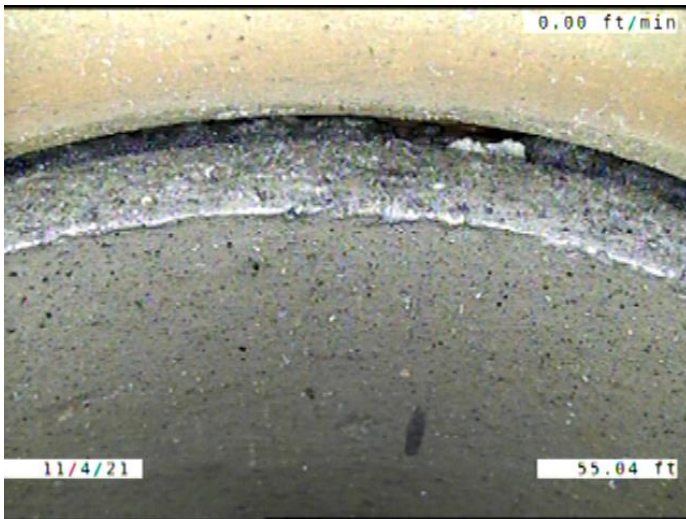
Code: **JOM**
 Description: **Joint Offset Medium**

Distance (ft): **55.0**
 Structural Grade: **3**
 O&M Grade: **0**
 Clock Start/From:
 Clock To:
 1st Value:
 2nd Value:
 Value Percent:
 Continuous Index:
 Within 8" of Joint: **NO**
 Remarks:

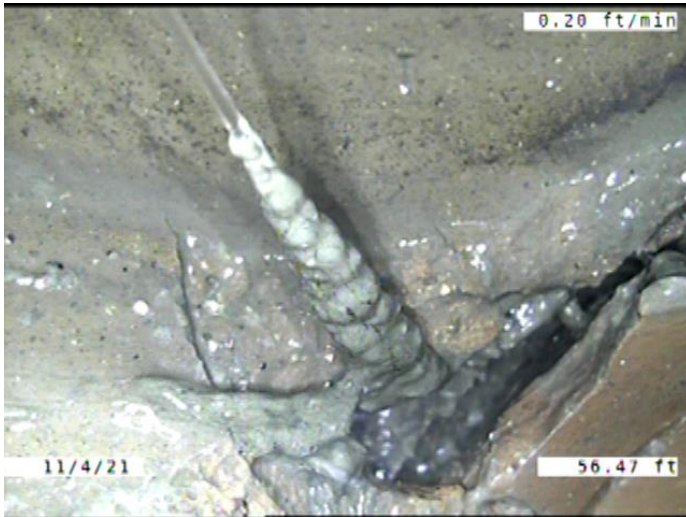
Code: **IRC**
 Description: **Infiltration Runner Connection**

Distance (ft): **56.5**
 Structural Grade: **0**
 O&M Grade: **4**
 Clock Start/From: **1**
 Clock To:
 1st Value:
 2nd Value:
 Value Percent:
 Continuous Index:
 Within 8" of Joint: **YES**
 Remarks:

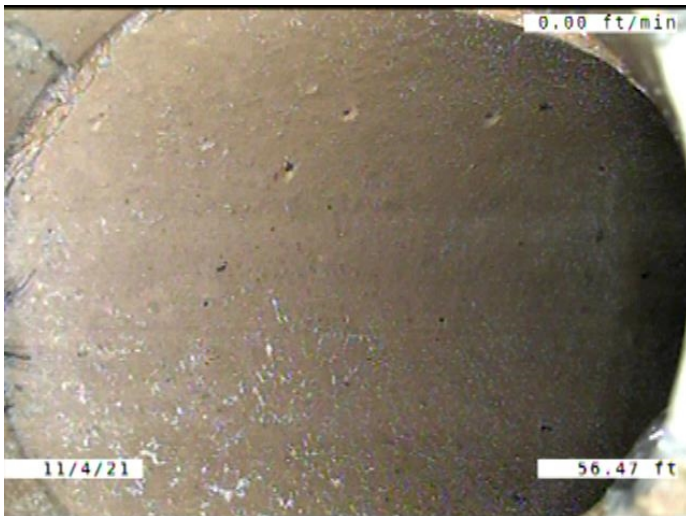
Code: **TBI**
 Description: **Tap Break-in Intruding**

Distance (ft): **56.5**
 Structural Grade: **0**
 O&M Grade: **2**
 Clock Start/From: **2**
 Clock To:
 1st Value: **4.000**
 2nd Value: **1.000**
 Value Percent:
 Continuous Index:
 Within 8" of Joint: **YES**
 Remarks: **CONSTANTLY RUNNING WATER**

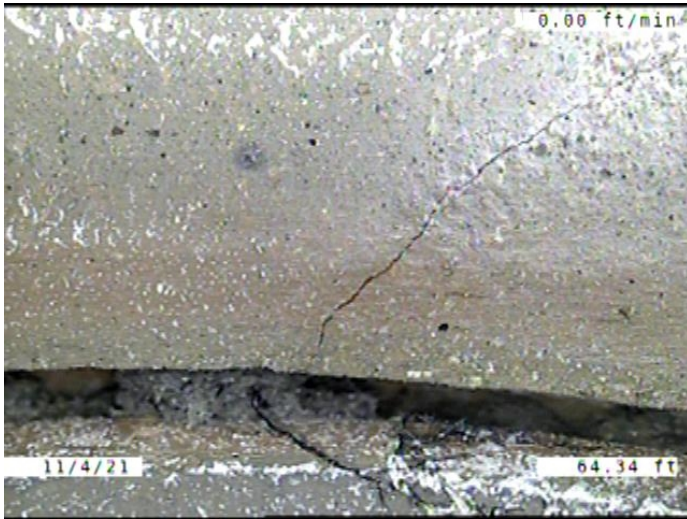
Code: **CM**
Description: **Crack Multiple**

Distance (ft): **64.3**
Structural Grade: **3**
O&M Grade: **0**
Clock Start/From: **2**
Clock To: **4**
1st Value:
2nd Value:
Value Percent:
Continuous Index:
Within 8" of Joint: **YES**
Remarks:

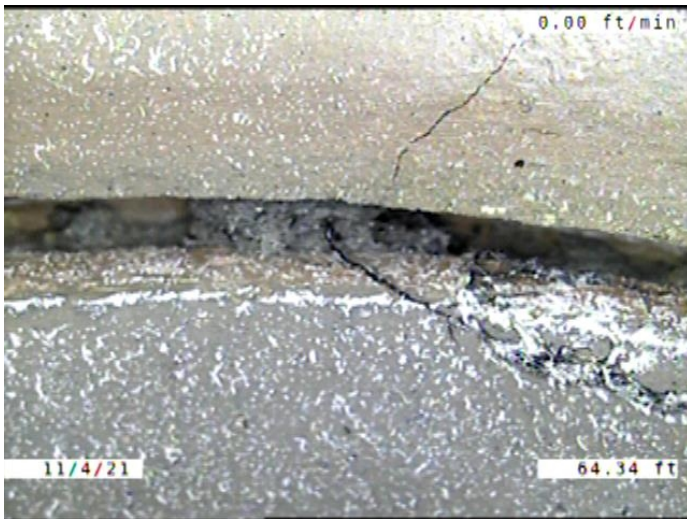
Code: **RFJ**
Description: **Roots Fine Joint**

Distance (ft): **64.3**
Structural Grade: **0**
O&M Grade: **1**
Clock Start/From: **2**
Clock To:
1st Value:
2nd Value:
Value Percent:
Continuous Index:
Within 8" of Joint: **YES**
Remarks:

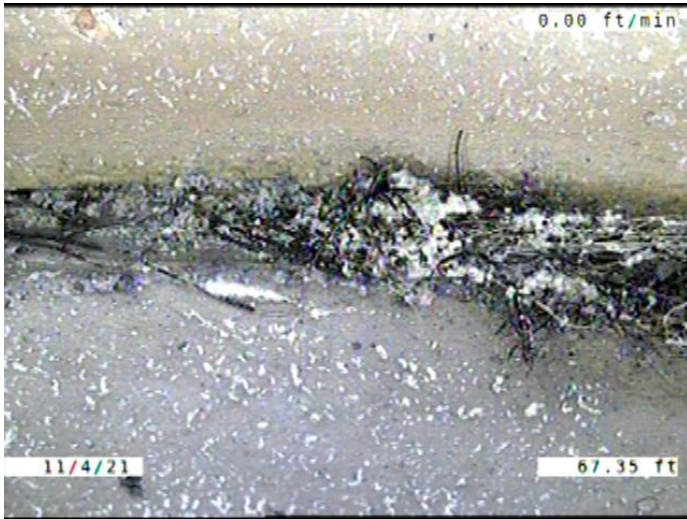
Code: **RFJ**
Description: **Roots Fine Joint**

Distance (ft): **67.3**
Structural Grade: **0**
O&M Grade: **1**
Clock Start/From: **2**
Clock To: **4**
1st Value:
2nd Value:
Value Percent:
Continuous Index:
Within 8" of Joint: **YES**
Remarks:

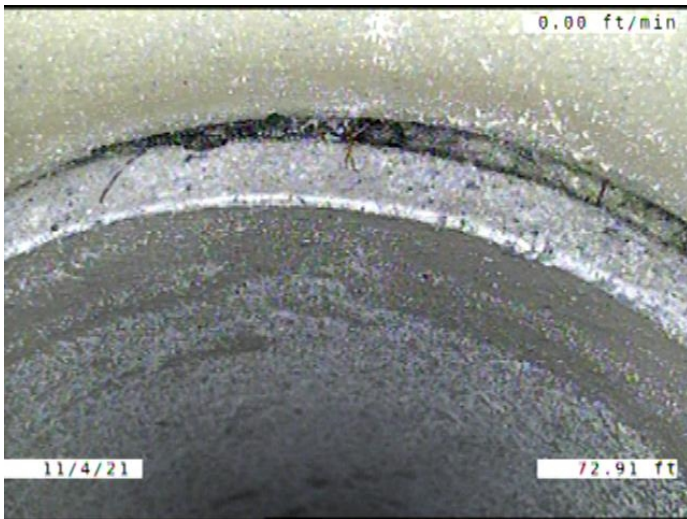
Code: **JOM**
Description: **Joint Offset Medium**

Distance (ft): **72.9**
Structural Grade: **3**
O&M Grade: **0**
Clock Start/From:
Clock To:
1st Value:
2nd Value:
Value Percent:
Continuous Index:
Within 8" of Joint: **NO**
Remarks:

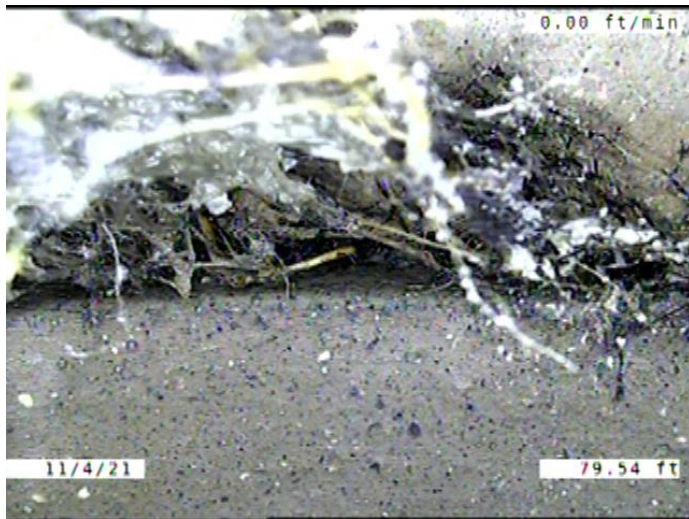
Code: **RMJ**
 Description: **Roots Medium Joint**

Distance (ft): **79.5**
 Structural Grade: **0**
 O&M Grade: **3**
 Clock Start/From: **9**
 Clock To: **2**
 1st Value:
 2nd Value:
 Value Percent: **10.000**
 Continuous Index:
 Within 8" of Joint: **YES**
 Remarks:

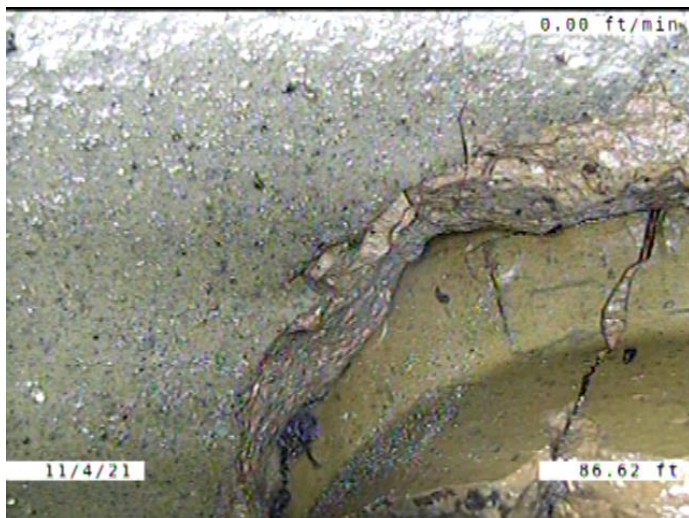
Code: **CM**
 Description: **Crack Multiple**

Distance (ft): **86.6**
 Structural Grade: **3**
 O&M Grade: **0**
 Clock Start/From: **11**
 Clock To: **1**
 1st Value:
 2nd Value:
 Value Percent:
 Continuous Index:
 Within 8" of Joint: **YES**
 Remarks:

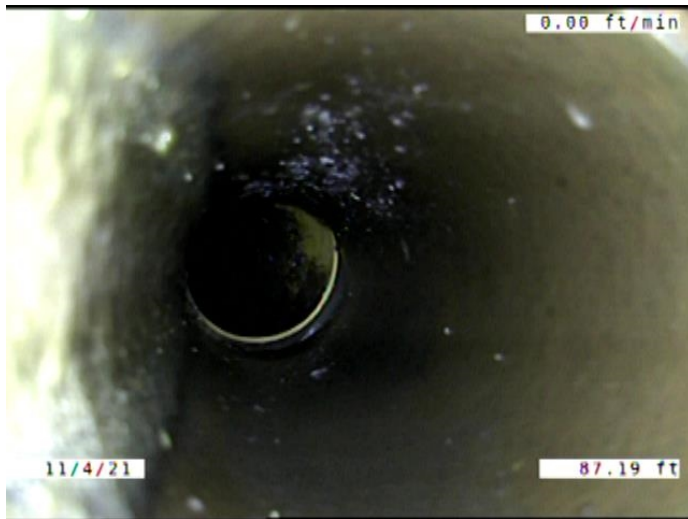
Code: **TBI**
 Description: **Tap Break-in Intruding**

Distance (ft): **87.2**
 Structural Grade: **0**
 O&M Grade: **2**
 Clock Start/From: **12**
 Clock To:
 1st Value: **4.000**
 2nd Value: **2.000**
 Value Percent:
 Continuous Index:
 Within 8" of Joint: **YES**
 Remarks: **CONSTANTLY RUNNING WATER.**

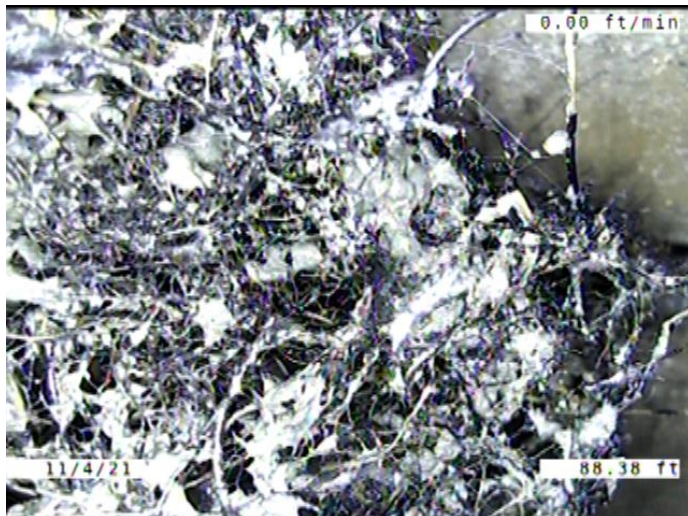
Code: **RMJ**
 Description: **Roots Medium Joint**

Distance (ft): **88.4**
 Structural Grade: **0**
 O&M Grade: **3**
 Clock Start/From: **8**
 Clock To: **4**
 1st Value:
 2nd Value:
 Value Percent: **15.000**
 Continuous Index:
 Within 8" of Joint: **YES**
 Remarks:

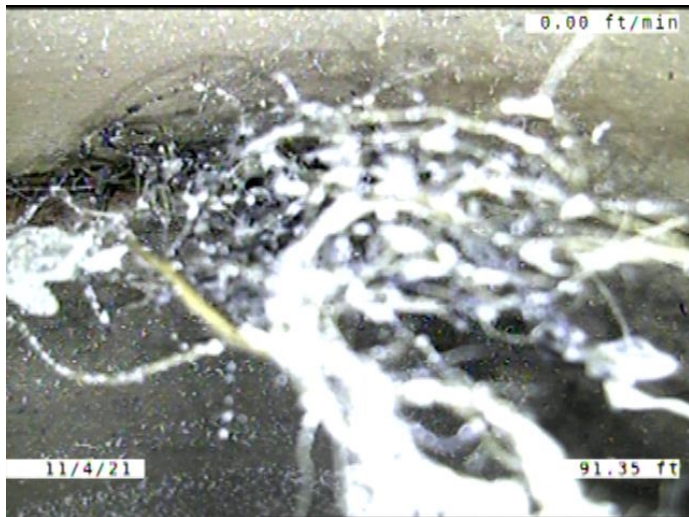
Code: **RMJ**
 Description: **Roots Medium Joint**

Distance (ft): **91.3**
 Structural Grade: **0**
 O&M Grade: **3**
 Clock Start/From: **11**
 Clock To: **2**
 1st Value:
 2nd Value:
 Value Percent: **5.000**
 Continuous Index:
 Within 8" of Joint: **YES**
 Remarks:

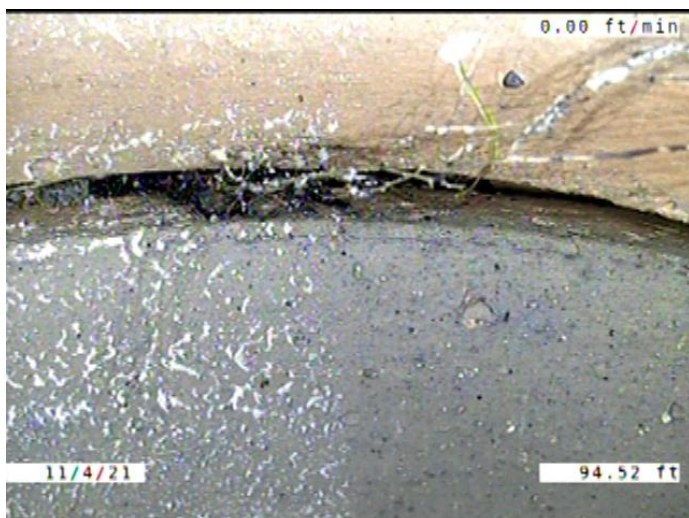
Code: **RFJ**
 Description: **Roots Fine Joint**

Distance (ft): **94.5**
 Structural Grade: **0**
 O&M Grade: **1**
 Clock Start/From: **9**
 Clock To: **3**
 1st Value:
 2nd Value:
 Value Percent:
 Continuous Index:
 Within 8" of Joint: **YES**
 Remarks:

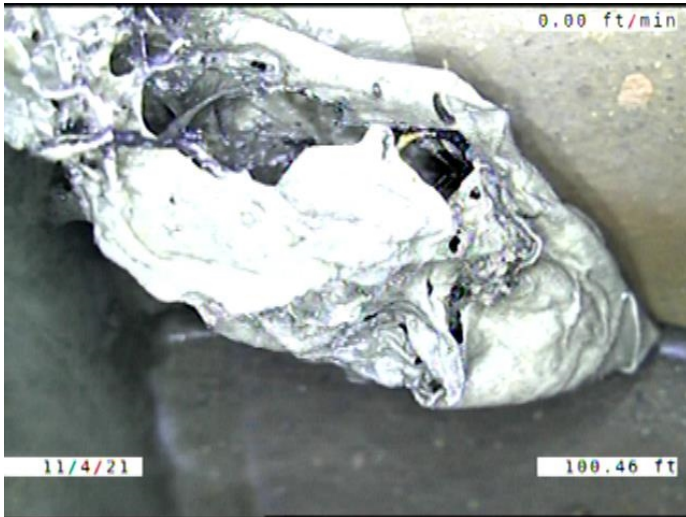
Code: **RMJ**
 Description: **Roots Medium Joint**

Distance (ft): **100.5**
 Structural Grade: **0**
 O&M Grade: **3**
 Clock Start/From: **9**
 Clock To: **3**
 1st Value:
 2nd Value:
 Value Percent: **5.000**
 Continuous Index:
 Within 8" of Joint: **YES**
 Remarks:

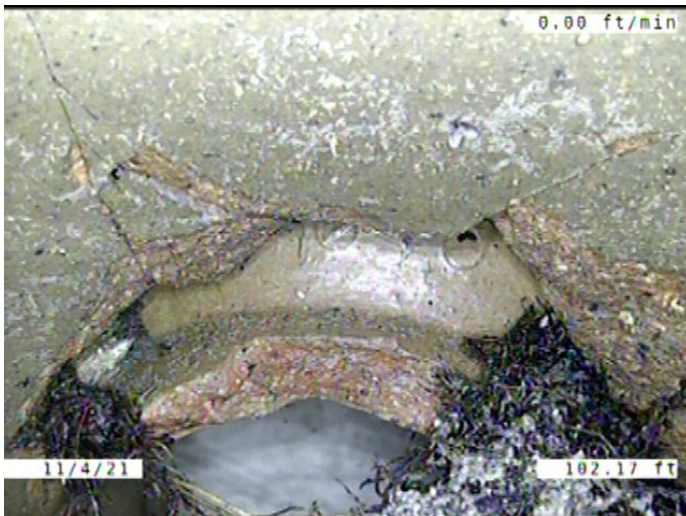
Code: **FM**
 Description: **Fracture Multiple**

Distance (ft): **102.2**
 Structural Grade: **4**
 O&M Grade: **0**
 Clock Start/From: **10**
 Clock To: **4**
 1st Value:
 2nd Value:
 Value Percent:
 Continuous Index:
 Within 8" of Joint: **YES**
 Remarks:

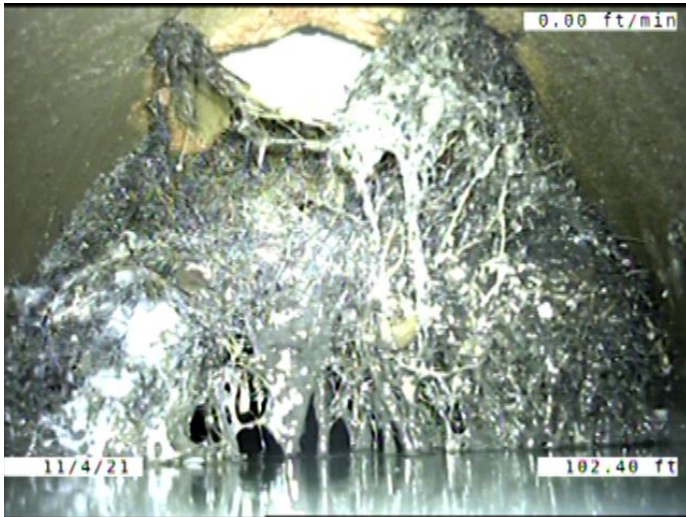
Code: **RBC**
 Description: **Roots Ball Connection**

Distance (ft): **102.4**
 Structural Grade: **0**
 O&M Grade: **4**
 Clock Start/From: **10**
 Clock To: **2**
 1st Value:
 2nd Value:
 Value Percent: **95.000**
 Continuous Index:
 Within 8" of Joint: **NO**
 Remarks:

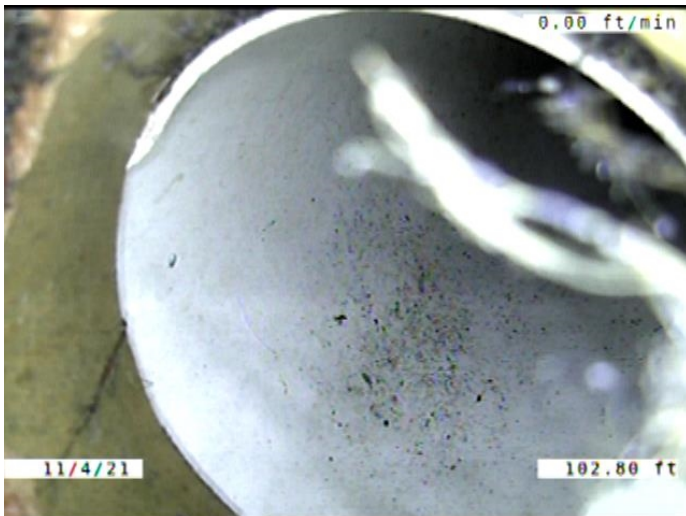
Code: **TBI**
 Description: **Tap Break-in Intruding**

Distance (ft): **102.8**
 Structural Grade: **0**
 O&M Grade: **2**
 Clock Start/From: **12**
 Clock To:
 1st Value: **4.000**
 2nd Value: **1.000**
 Value Percent:
 Continuous Index:
 Within 8" of Joint: **YES**
 Remarks:

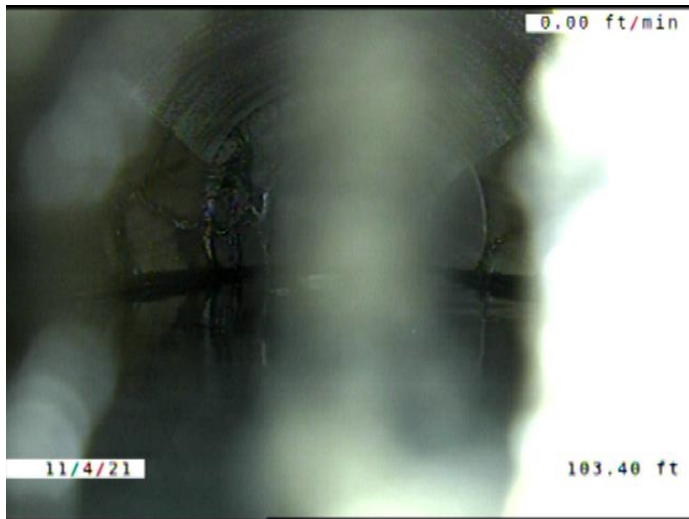
Code: **DSF**
 Description: **Deposits Settled Fine**

Distance (ft): **103.4**
 Structural Grade: **0**
 O&M Grade: **2**
 Clock Start/From: **5**
 Clock To: **7**
 1st Value:
 2nd Value:
 Value Percent: **5.000**
 Continuous Index: **F01**
 Within 8" of Joint: **YES**
 Remarks: **ALSO RAGS**

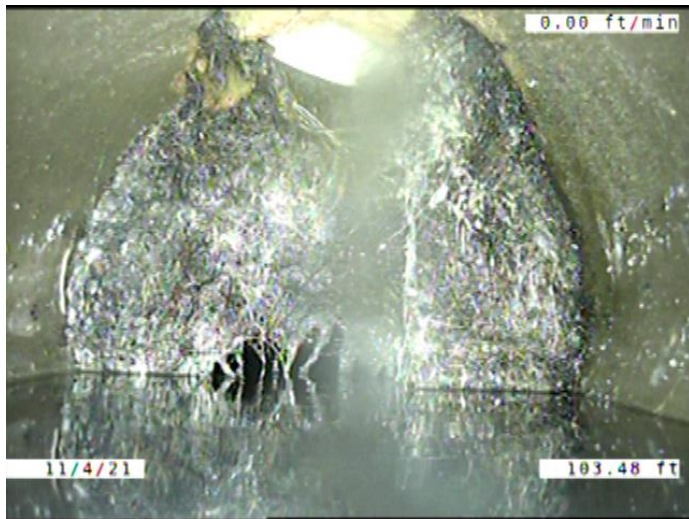
Code: **MSA**
 Description: **Miscellaneous Survey Abandoned**

Distance (ft): **103.5**
 Structural Grade: **0**
 O&M Grade: **0**
 Clock Start/From:
 Clock To:
 1st Value:
 2nd Value:
 Value Percent:
 Continuous Index:
 Within 8" of Joint: **NO**
 Remarks: **CAMERA CANT MAKE IT PAST ROOTS**
