Profile/Photo Observation Report

Date:	11/05/2021	Weather:		Coding:	PACP 7.0
Pipe Length (ft):	330.0	Owner:	City of Hobart	Pre Clean:	Heavy Cleaning
P.O.#:	YES502259	Surveyor:	S. Bucklin	PSR:	P-504-057-056
Customer:	City of Hobart	Clean Date:	11/04/2021	Shape:	C

Street:	North Wilson Street	Flow Control:	Not Controlled
City:	Hobart, IN	Year Renewed:	
Location:	Alley	Tape/Media #:	
Purpose:	Routine Assessment	Dia/Height:	12"
Use:	Sanitary Sewage Pipe	Material:	VCP
Drain Area:		Lining:	None
Category:	NA		
Comment:			
Location Details:		Direction of Survey:	Downstream
US MH:	M-504-057	DS MH:	M-504-056
		Total Length Surveyed (ft):	233.0

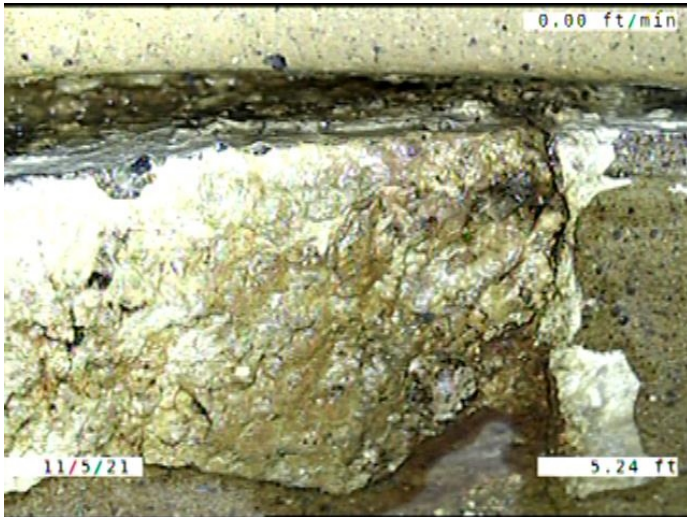
Code: **DAE**
 Description: **Deposits Attached Encrustation**

Distance (ft): **5.2**
 Structural Grade: **0**
 O&M Grade: **2**
 Clock Start/From: **8**
 Clock To: **12**
 1st Value:
 2nd Value:
 Value Percent: **5.000**
 Continuous Index:
 Within 8" of Joint: **YES**
 Remarks:

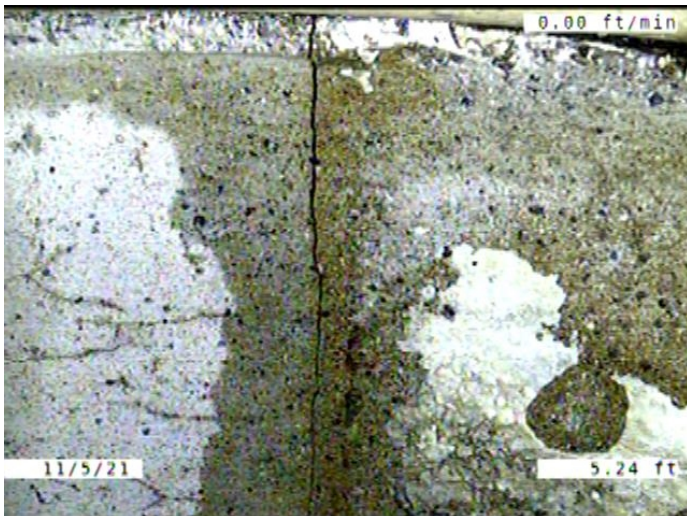
Code: **CL**
 Description: **Crack Longitudinal**

Distance (ft): **5.2**
 Structural Grade: **2**
 O&M Grade: **0**
 Clock Start/From: **1**
 Clock To:
 1st Value:
 2nd Value:
 Value Percent:
 Continuous Index:
 Within 8" of Joint: **YES**
 Remarks:

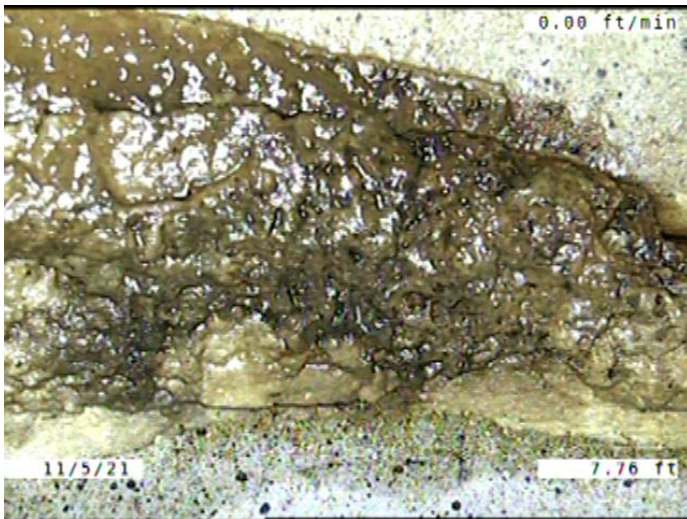
Code: **DAE**
 Description: **Deposits Attached Encrustation**

Distance (ft): **7.8**
 Structural Grade: **0**
 O&M Grade: **2**
 Clock Start/From: **8**
 Clock To: **5**
 1st Value:
 2nd Value:
 Value Percent: **5.000**
 Continuous Index:
 Within 8" of Joint: **YES**
 Remarks:

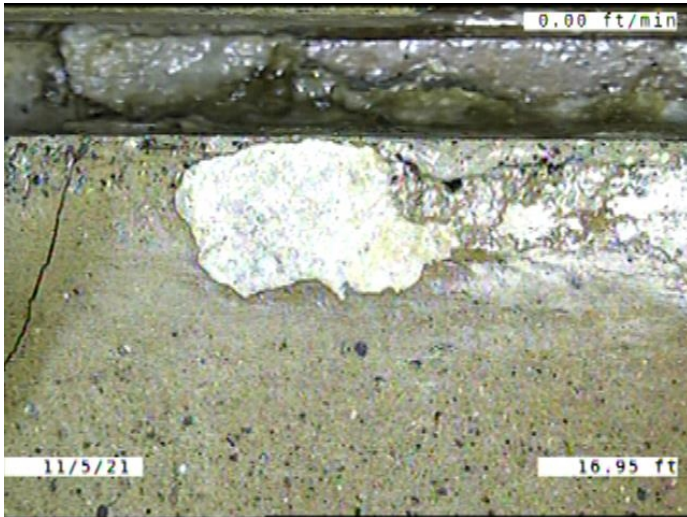
Code: **DAE**
 Description: **Deposits Attached Encrustation**

Distance (ft): **16.9**
 Structural Grade: **0**
 O&M Grade: **2**
 Clock Start/From: **3**
 Clock To:
 1st Value:
 2nd Value:
 Value Percent: **5.000**
 Continuous Index:
 Within 8" of Joint: **YES**
 Remarks:

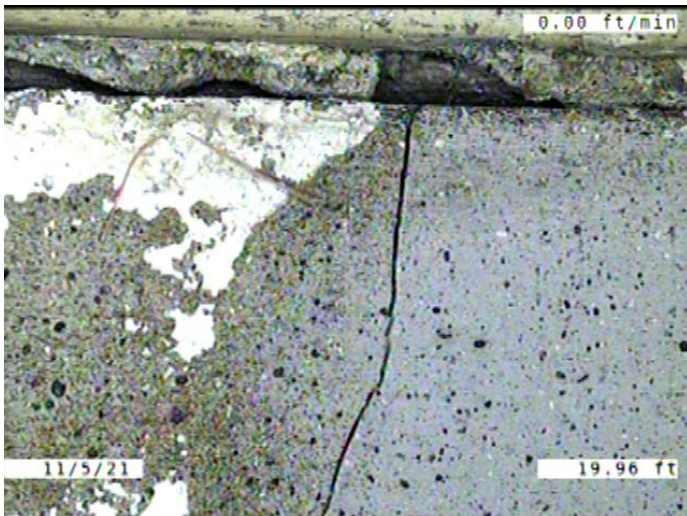
Code: **FS**
 Description: **Fracture Spiral**

Distance (ft): **20.0**
 Structural Grade: **3**
 O&M Grade: **0**
 Clock Start/From: **8**
 Clock To: **11**
 1st Value:
 2nd Value:
 Value Percent:
 Continuous Index:
 Within 8" of Joint: **YES**
 Remarks:

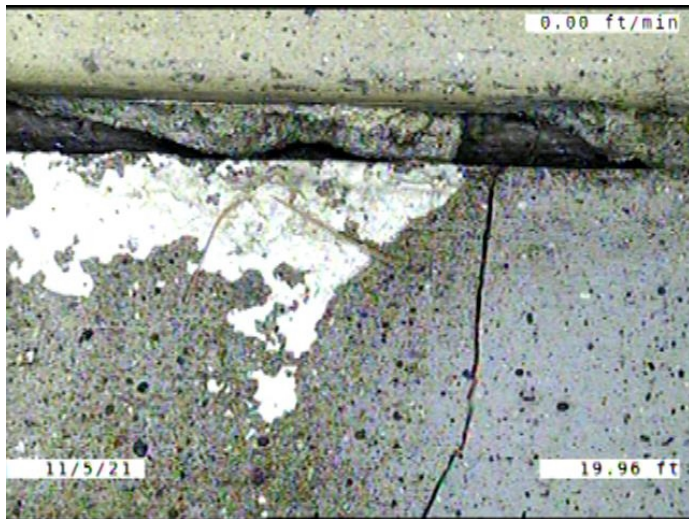
Code: **DAE**
 Description: **Deposits Attached Encrustation**

Distance (ft): **20.0**
 Structural Grade: **0**
 O&M Grade: **2**
 Clock Start/From: **9**
 Clock To: **11**
 1st Value:
 2nd Value:
 Value Percent: **5.000**
 Continuous Index:
 Within 8" of Joint: **YES**
 Remarks:

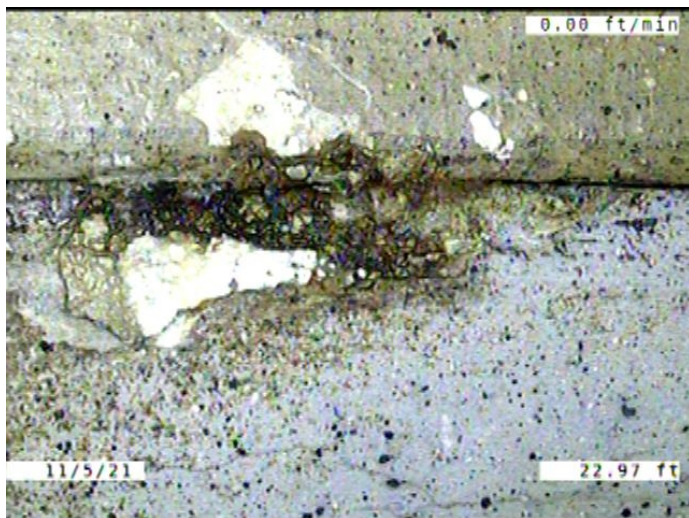
Code: **DAE**
 Description: **Deposits Attached Encrustation**

Distance (ft): **23.0**
 Structural Grade: **0**
 O&M Grade: **2**
 Clock Start/From: **8**
 Clock To: **9**
 1st Value:
 2nd Value:
 Value Percent: **5.000**
 Continuous Index:
 Within 8" of Joint: **YES**
 Remarks:

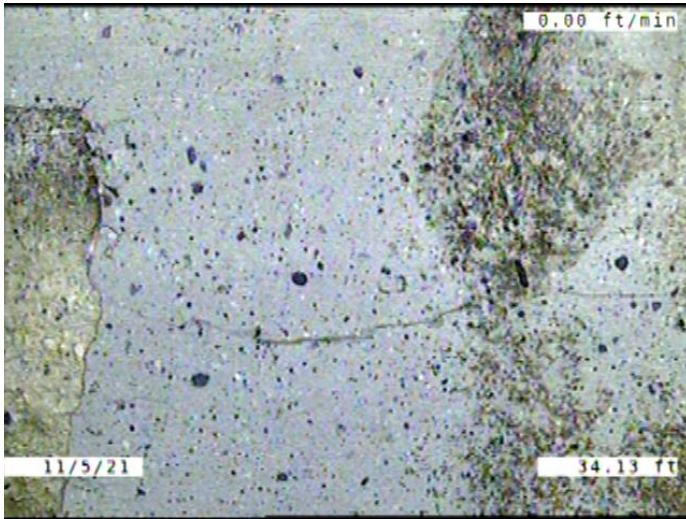
Code: **CM**
Description: **Crack Multiple**

Distance (ft): **34.1**
Structural Grade: **3**
O&M Grade: **0**
Clock Start/From: **3**
Clock To: **5**
1st Value:
2nd Value:
Value Percent:
Continuous Index:
Within 8" of Joint: **YES**
Remarks:

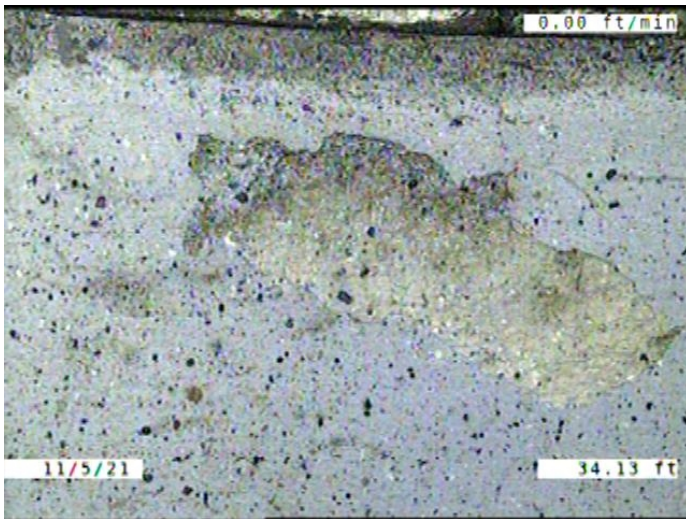
Code: **SSS**
Description: **Surface Damage Surface Spalling**

Distance (ft): **34.1**
Structural Grade: **2**
O&M Grade: **0**
Clock Start/From: **11**
Clock To:
1st Value:
2nd Value:
Value Percent:
Continuous Index:
Within 8" of Joint: **YES**
Remarks:

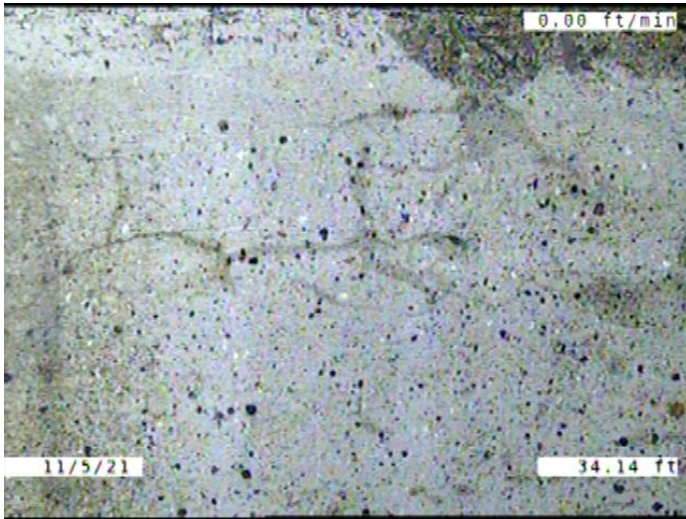
Code: **CM**
Description: **Crack Multiple**

Distance (ft): **34.1**
Structural Grade: **3**
O&M Grade: **0**
Clock Start/From: **9**
Clock To: **10**
1st Value:
2nd Value:
Value Percent:
Continuous Index:
Within 8" of Joint: **YES**
Remarks:

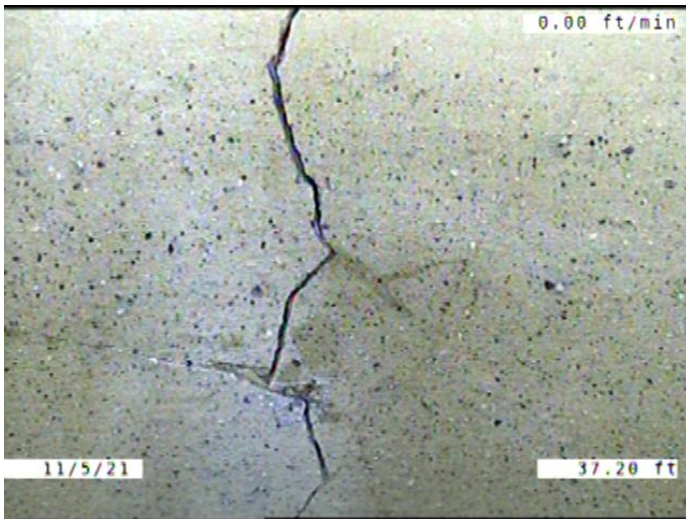
Code: **FM**
Description: **Fracture Multiple**

Distance (ft): **37.2**
Structural Grade: **4**
O&M Grade: **0**
Clock Start/From: **8**
Clock To: **4**
1st Value:
2nd Value:
Value Percent:
Continuous Index: **S01**
Within 8" of Joint: **YES**
Remarks:

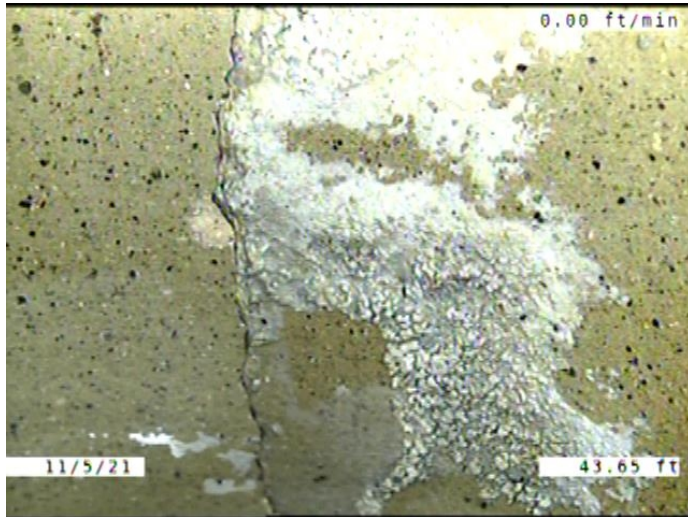
Code: **DAE**
 Description: **Deposits Attached Encrustation**

Distance (ft): **43.6**
 Structural Grade: **0**
 O&M Grade: **2**
 Clock Start/From: **8**
 Clock To: **4**
 1st Value:
 2nd Value:
 Value Percent: **5.000**
 Continuous Index:
 Within 8" of Joint: **YES**
 Remarks:

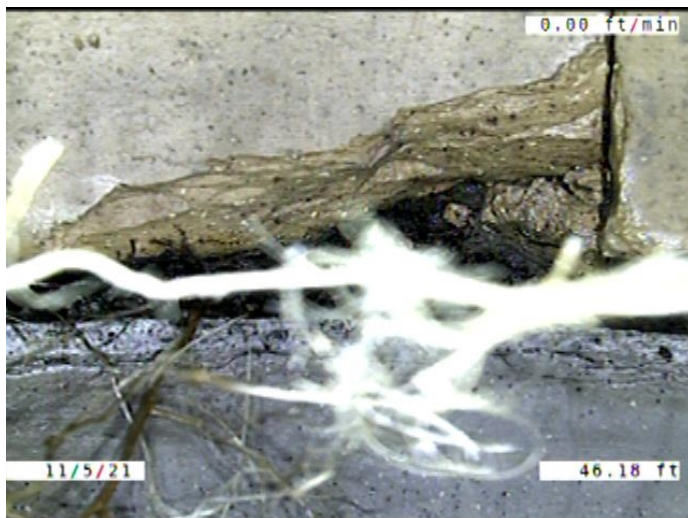
Code: **RFJ**
 Description: **Roots Fine Joint**

Distance (ft): **46.2**
 Structural Grade: **0**
 O&M Grade: **1**
 Clock Start/From: **9**
 Clock To: **11**
 1st Value:
 2nd Value:
 Value Percent:
 Continuous Index:
 Within 8" of Joint: **YES**
 Remarks:

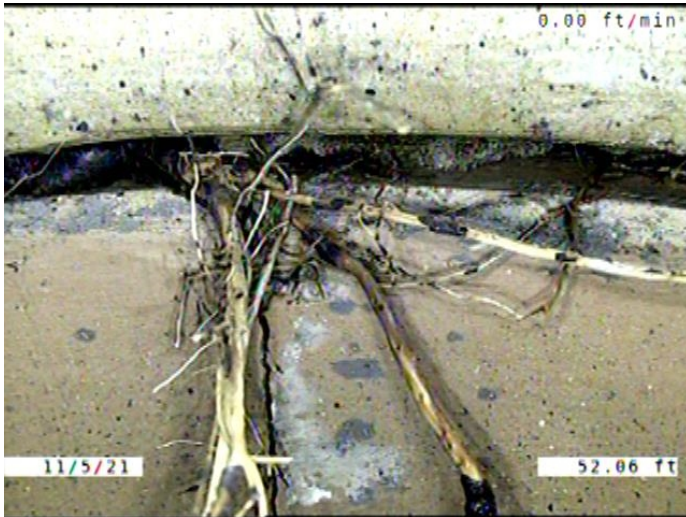
Code: **RFJ**
 Description: **Roots Fine Joint**

Distance (ft): **52.1**
 Structural Grade: **0**
 O&M Grade: **1**
 Clock Start/From: **10**
 Clock To: **2**
 1st Value:
 2nd Value:
 Value Percent:
 Continuous Index:
 Within 8" of Joint: **YES**
 Remarks:

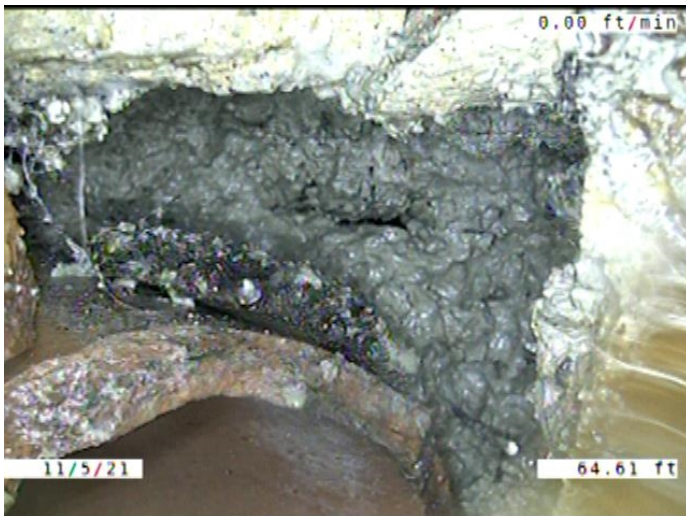
Code: **HSV**
 Description: **Hole Soil Visible**

Distance (ft): **64.6**
 Structural Grade: **5**
 O&M Grade: **0**
 Clock Start/From: **12**
 Clock To: **1**
 1st Value:
 2nd Value:
 Value Percent:
 Continuous Index:
 Within 8" of Joint: **YES**
 Remarks: **SOIL VISIBLE**

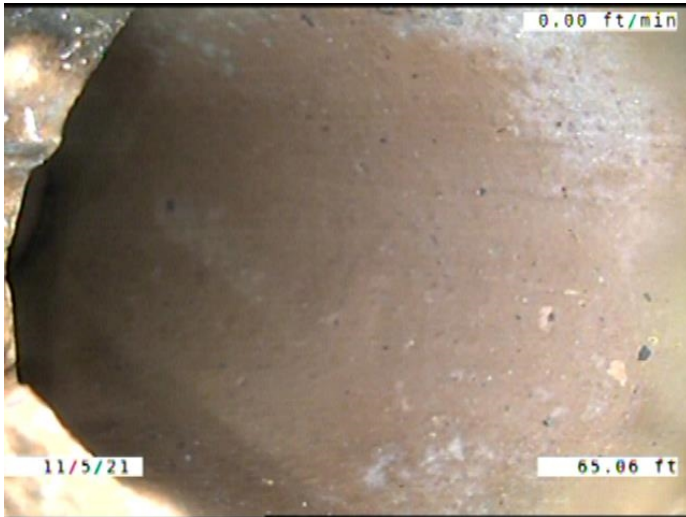
Code: **TBI**
 Description: **Tap Break-in Intruding**

Distance (ft): **65.1**
 Structural Grade: **0**
 O&M Grade: **2**
 Clock Start/From: **12**
 Clock To:
 1st Value: **4.000**
 2nd Value: **1.000**
 Value Percent:
 Continuous Index:
 Within 8" of Joint: **YES**
 Remarks:

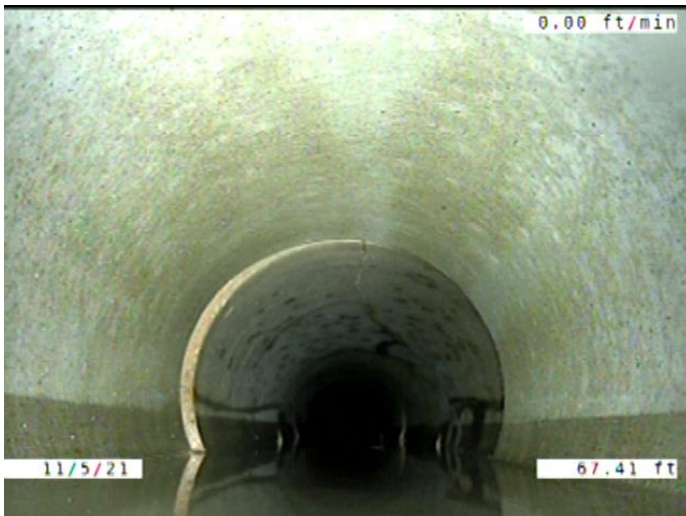
Code: **DR**
 Description: **Deformed Rigid**

Distance (ft): **67.4**
 Structural Grade: **4**
 O&M Grade: **0**
 Clock Start/From:
 Clock To:
 1st Value:
 2nd Value:
 Value Percent: **5.000**
 Continuous Index: **F02**
 Within 8" of Joint: **NO**
 Remarks:

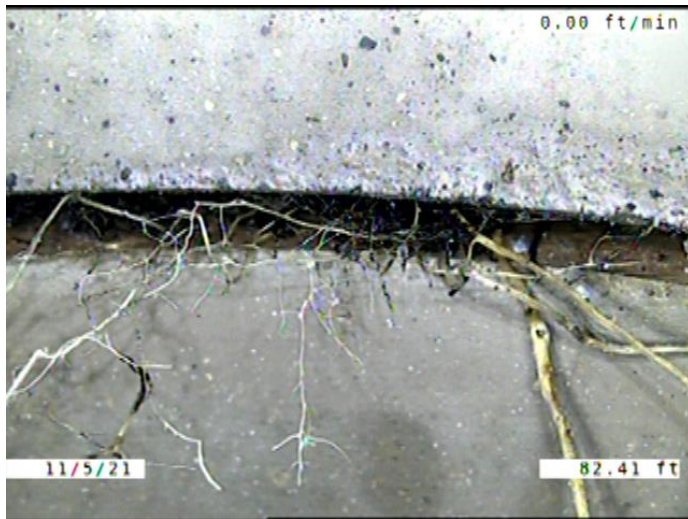
Code: **RFJ**
 Description: **Roots Fine Joint**

Distance (ft): **82.4**
 Structural Grade: **0**
 O&M Grade: **1**
 Clock Start/From: **11**
 Clock To: **3**
 1st Value:
 2nd Value:
 Value Percent:
 Continuous Index:
 Within 8" of Joint: **YES**
 Remarks:

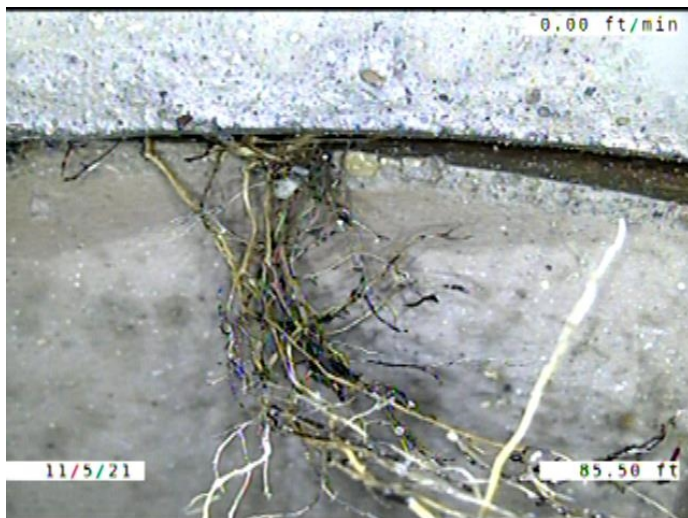
Code: **RFJ**
 Description: **Roots Fine Joint**

Distance (ft): **85.5**
 Structural Grade: **0**
 O&M Grade: **1**
 Clock Start/From: **10**
 Clock To: **2**
 1st Value:
 2nd Value:
 Value Percent:
 Continuous Index:
 Within 8" of Joint: **YES**
 Remarks:

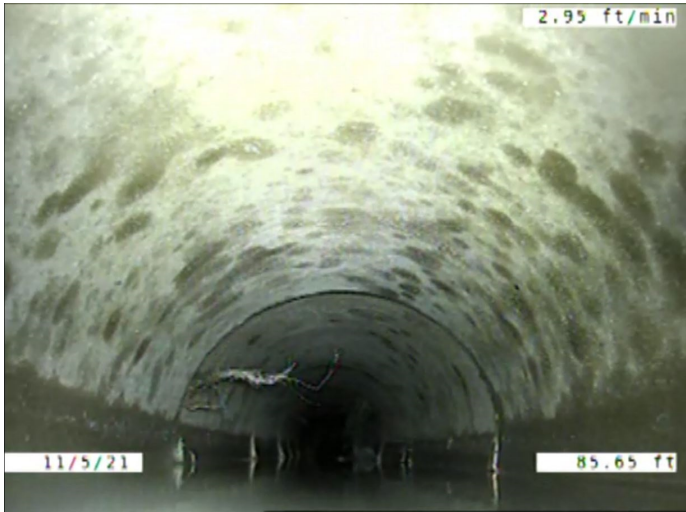
Code: **FM**
Description: **Fracture Multiple**

Distance (ft): **85.7**
Structural Grade: **4**
O&M Grade: **0**
Clock Start/From: **8**
Clock To: **4**
1st Value:
2nd Value:
Value Percent:
Continuous Index: **F01**
Within 8" of Joint: **YES**
Remarks:

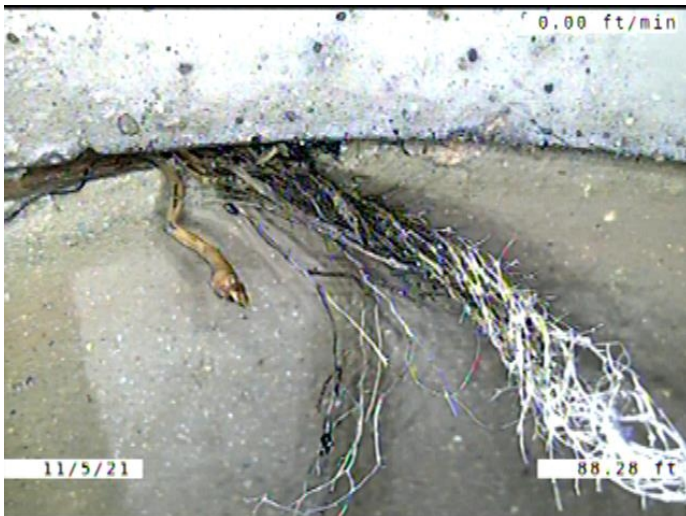
Code: **RFJ**
Description: **Roots Fine Joint**

Distance (ft): **88.3**
Structural Grade: **0**
O&M Grade: **1**
Clock Start/From: **10**
Clock To: **11**
1st Value:
2nd Value:
Value Percent:
Continuous Index:
Within 8" of Joint: **YES**
Remarks:

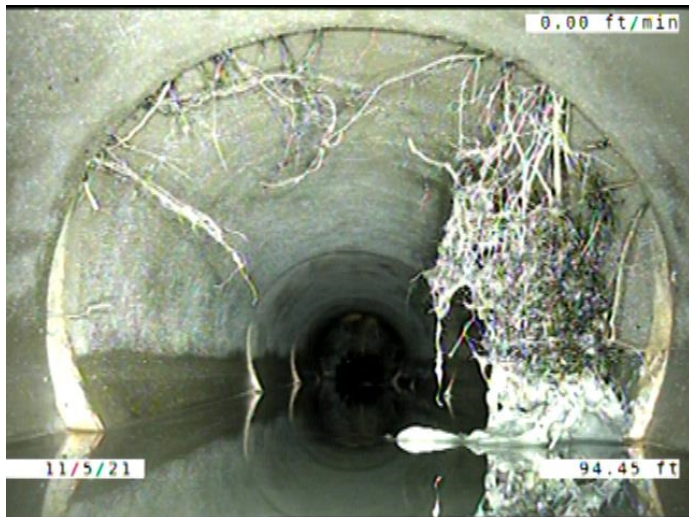
Code: **RMJ**
 Description: **Roots Medium Joint**

Distance (ft): **94.4**
 Structural Grade: **0**
 O&M Grade: **3**
 Clock Start/From: **9**
 Clock To: **4**
 1st Value:
 2nd Value:
 Value Percent: **10.000**
 Continuous Index:
 Within 8" of Joint: **YES**
 Remarks:

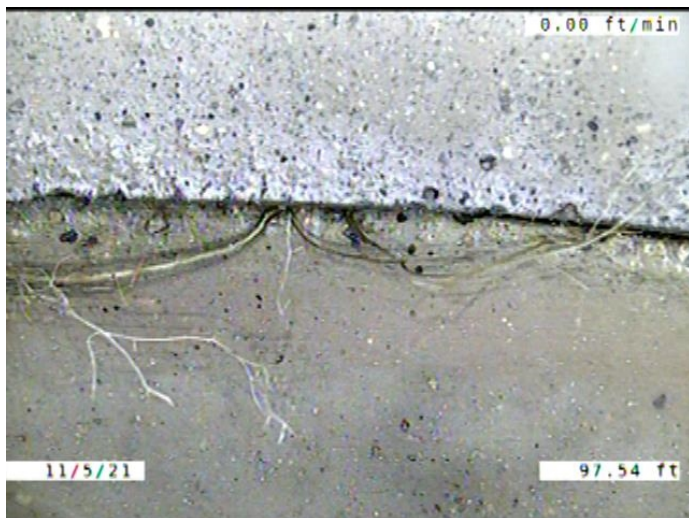
Code: **RFJ**
 Description: **Roots Fine Joint**

Distance (ft): **97.5**
 Structural Grade: **0**
 O&M Grade: **1**
 Clock Start/From: **11**
 Clock To: **3**
 1st Value:
 2nd Value:
 Value Percent:
 Continuous Index:
 Within 8" of Joint: **YES**
 Remarks:

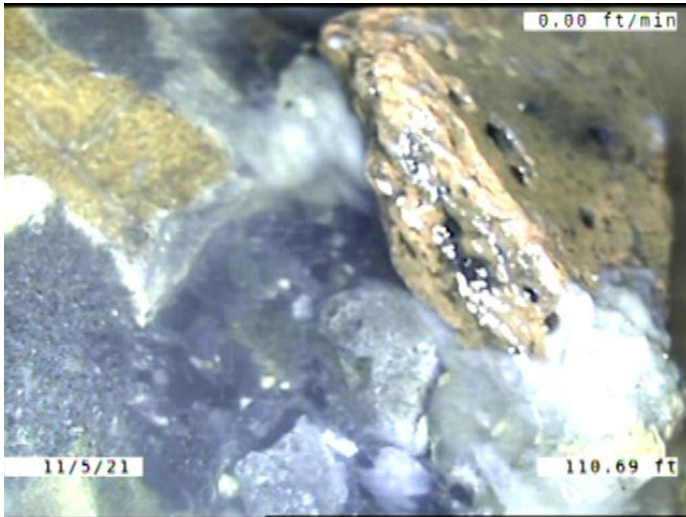
Code:	OBM
Description:	Obstruction Pipe Material in Invert
Distance (ft):	110.7
Structural Grade:	0
O&M Grade:	2
Clock Start/From:	5
Clock To:	6
1st Value:	
2nd Value:	
Value Percent:	5.000
Continuous Index:	
Within 8" of Joint:	YES
Remarks:

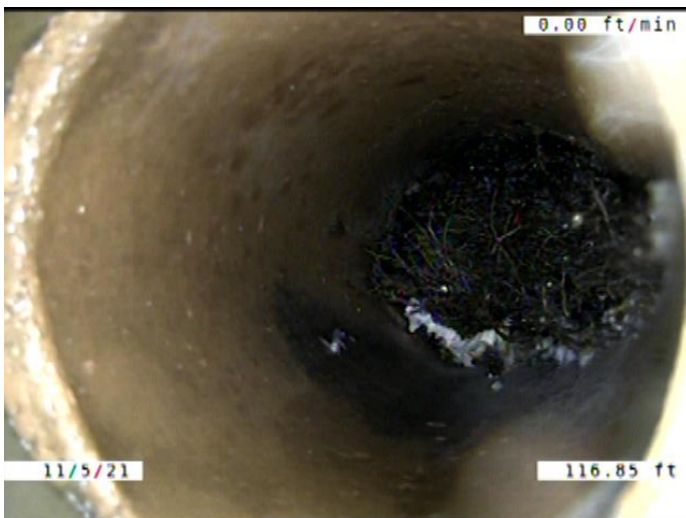
Code:	TBI
Description:	Tap Break-in Intruding
Distance (ft):	116.8
Structural Grade:	0
O&M Grade:	2
Clock Start/From:	1
Clock To:	
1st Value:	4.000
2nd Value:	1.000
Value Percent:	
Continuous Index:	
Within 8" of Joint:	YES
Remarks:	CONSTANTLY RUNNING WATER. LOOKS TO BE 100% PLUGGED WITH

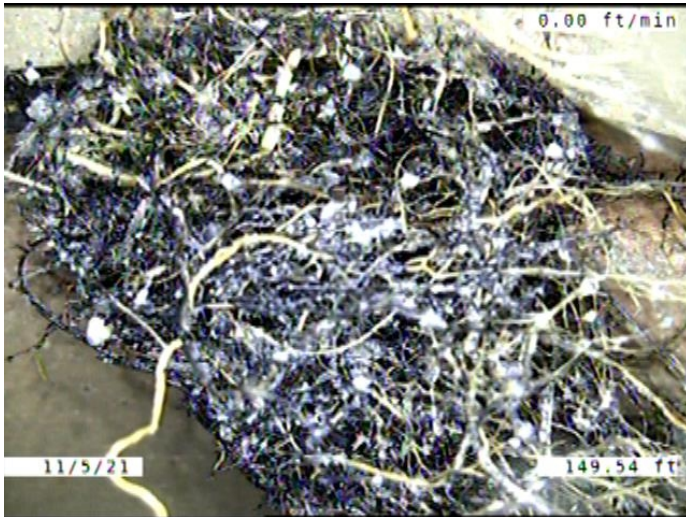
Code: **RMJ**
 Description: **Roots Medium Joint**

Distance (ft): **149.5**
 Structural Grade: **0**
 O&M Grade: **3**
 Clock Start/From: **8**
 Clock To: **4**
 1st Value:
 2nd Value:
 Value Percent: **5.000**
 Continuous Index:
 Within 8" of Joint: **YES**
 Remarks:

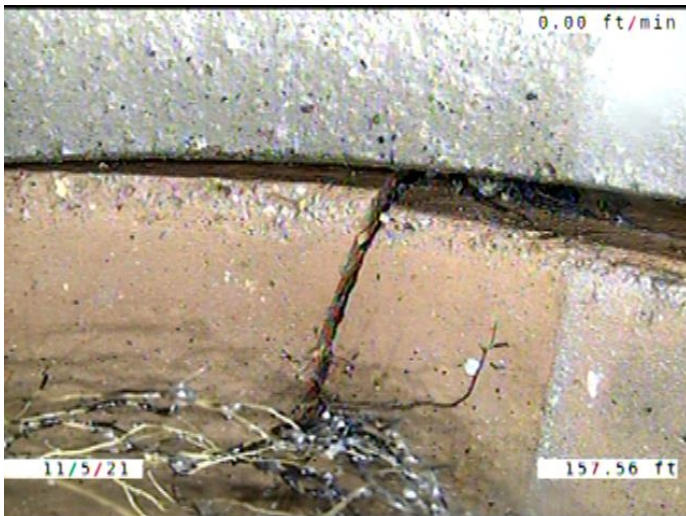
Code: **B**
 Description: **Broken**

Distance (ft): **157.6**
 Structural Grade: **4**
 O&M Grade: **0**
 Clock Start/From: **8**
 Clock To: **3**
 1st Value:
 2nd Value:
 Value Percent:
 Continuous Index:
 Within 8" of Joint: **YES**
 Remarks:

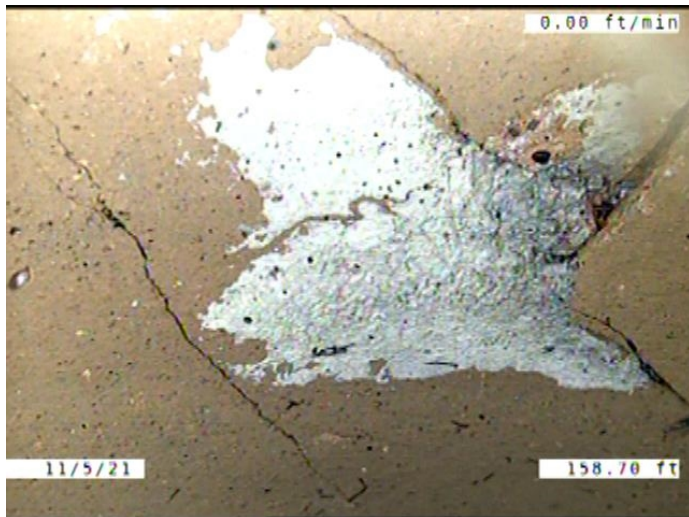
Code: **DAE**
 Description: **Deposits Attached Encrustation**

Distance (ft): **158.7**
 Structural Grade: **0**
 O&M Grade: **2**
 Clock Start/From: **9**
 Clock To: **11**
 1st Value:
 2nd Value:
 Value Percent: **5.000**
 Continuous Index:
 Within 8" of Joint: **NO**
 Remarks:

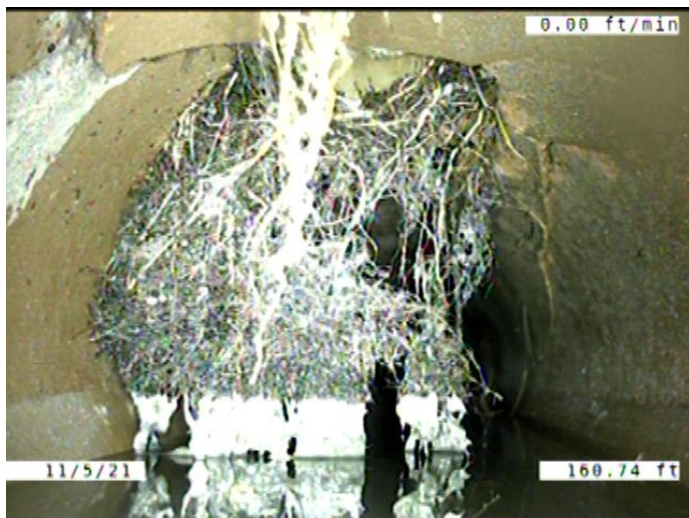
Code: **RMC**
 Description: **Roots Medium Connection**

Distance (ft): **160.7**
 Structural Grade: **0**
 O&M Grade: **3**
 Clock Start/From: **10**
 Clock To: **1**
 1st Value:
 2nd Value:
 Value Percent: **50.000**
 Continuous Index:
 Within 8" of Joint: **NO**
 Remarks:

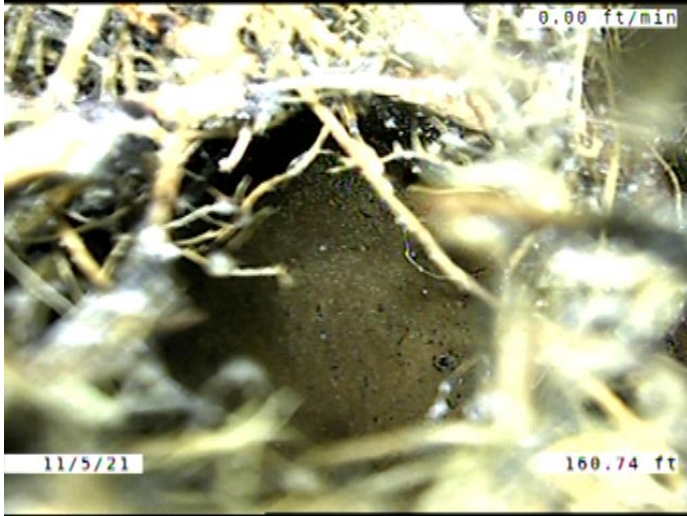
Code: **TBI**
Description: **Tap Break-in Intruding**

Distance (ft): **160.7**
Structural Grade: **0**
O&M Grade: **2**
Clock Start/From: **12**
Clock To:
1st Value: **4.000**
2nd Value: **1.000**
Value Percent:
Continuous Index:
Within 8" of Joint: **YES**
Remarks:

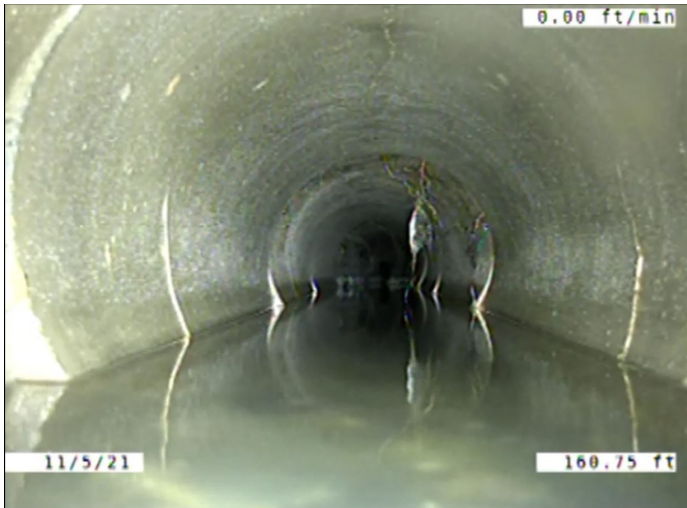
Code: **CM**
Description: **Crack Multiple**

Distance (ft): **160.8**
Structural Grade: **3**
O&M Grade: **0**
Clock Start/From: **8**
Clock To: **4**
1st Value:
2nd Value:
Value Percent:
Continuous Index:
Within 8" of Joint: **NO**
Remarks:

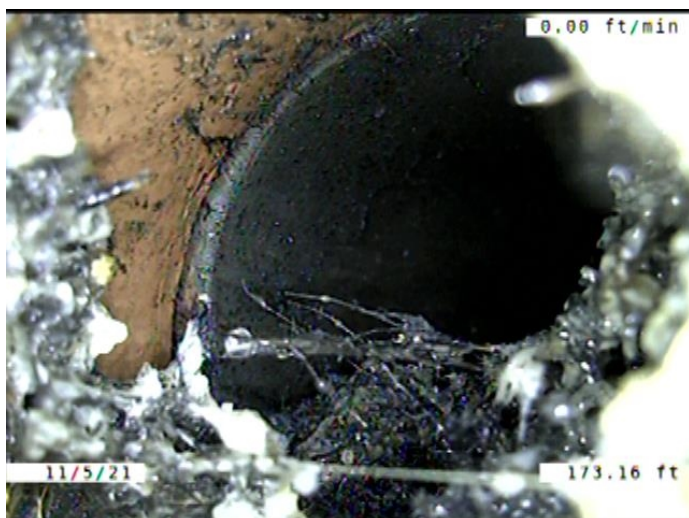
Code: **TBD**
 Description: **Tap Break-in/Hammer Defective**

Distance (ft): **173.2**
 Structural Grade: **0**
 O&M Grade: **3**
 Clock Start/From: **12**
 Clock To:
 1st Value: **4.000**
 2nd Value:
 Value Percent:
 Continuous Index:
 Within 8" of Joint: **YES**
 Remarks: **ROOTS GROWING OUT OF THE TAP AND INTO THE MAIN. ROOTS ALSO**

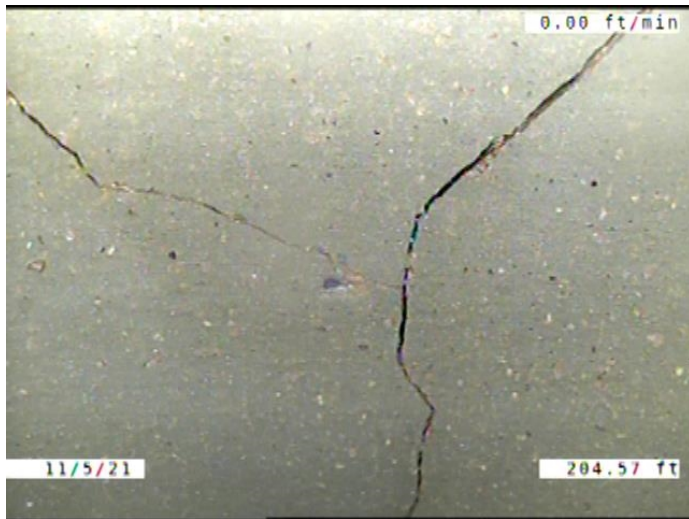
Code: **FM**
 Description: **Fracture Multiple**

Distance (ft): **204.6**
 Structural Grade: **4**
 O&M Grade: **0**
 Clock Start/From: **11**
 Clock To: **1**
 1st Value:
 2nd Value:
 Value Percent:
 Continuous Index:
 Within 8" of Joint: **YES**
 Remarks:

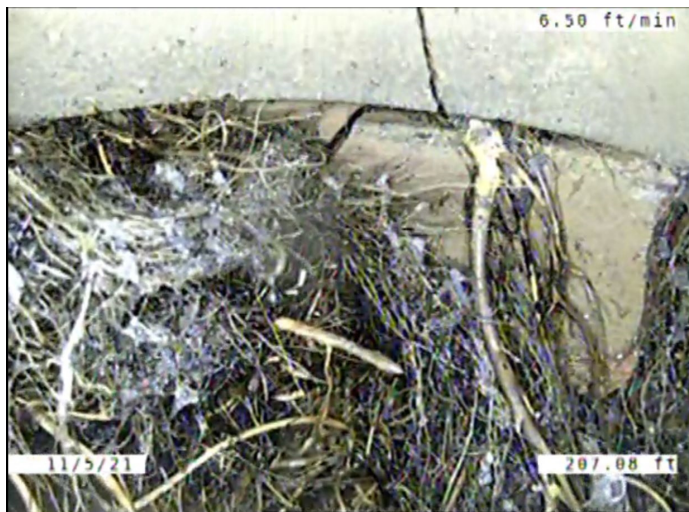
Code: **B**
 Description: **Broken**

Distance (ft): **207.1**
 Structural Grade: **4**
 O&M Grade: **0**
 Clock Start/From: **12**
 Clock To: **1**
 1st Value:
 2nd Value:
 Value Percent:
 Continuous Index:
 Within 8" of Joint: **YES**
 Remarks:

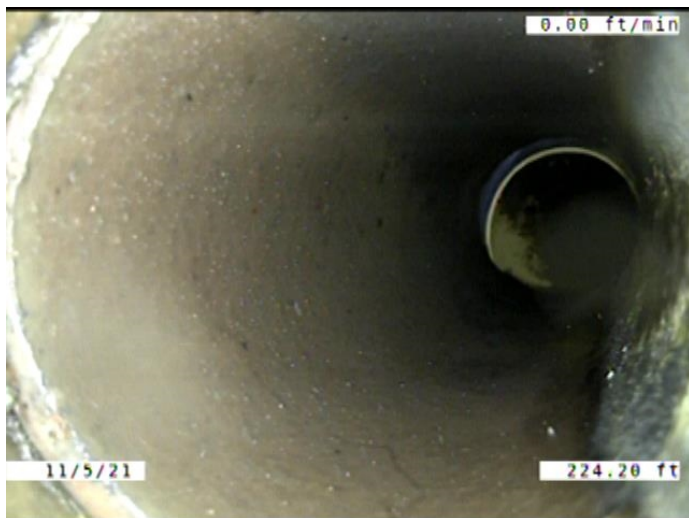
Code: **TBI**
 Description: **Tap Break-in Intruding**

Distance (ft): **224.2**
 Structural Grade: **0**
 O&M Grade: **2**
 Clock Start/From: **12**
 Clock To:
 1st Value: **4.000**
 2nd Value: **2.000**
 Value Percent:
 Continuous Index:
 Within 8" of Joint: **YES**
 Remarks: **CONSTANTLY RUNNING WATER**
