Profile/Photo Observation Report

Date:	11/05/2021	Weather:		Coding:	PACP 7.0
Pipe Length (ft):	330.0	Owner:	City of Hobart	Pre Clean:	Heavy Cleaning
P.O.#:	YES502259	Surveyor:	S. Bucklin	PSR:	P-504-057-056
Customer:	City of Hobart	Clean Date:	11/04/2021	Shape:	C

Street:	North Wilson Street	Flow Control:	Not Controlled
City:	Hobart, IN	Year Renewed:	
Location:	Alley	Tape/Media #:	
Purpose:	Routine Assessment	Dia/Height:	12"
Use:	Sanitary Sewage Pipe	Material:	VCP
Drain Area:		Lining:	None
Category:	NA		
Comment:			
Location Details:		Direction of Survey:	Downstream
US MH:	M-504-057	DS MH:	M-504-056
		Total Length Surveyed (ft):	233.0

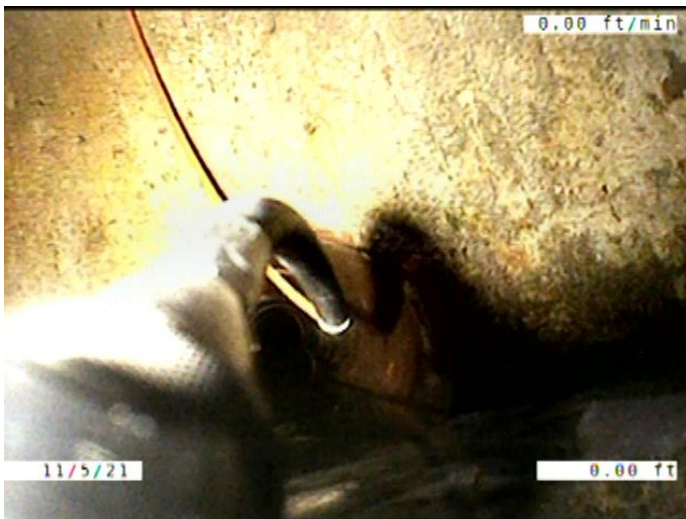
Code: **AMH**
Description: **Manhole**

Distance (ft): **.0**
Structural Grade: **0**
O&M Grade: **0**
Clock Start/From:
Clock To:
1st Value:
2nd Value:
Value Percent:
Continuous Index:
Within 8" of Joint: **NO**
Remarks: **M-504-057**

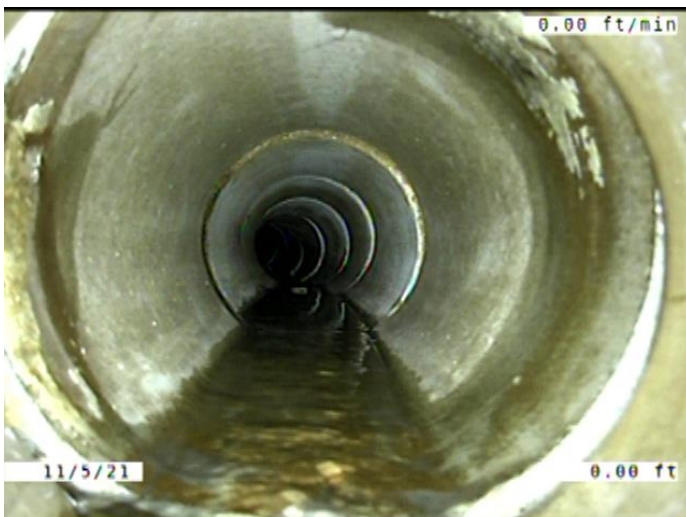
Code: **MWL**
Description: **Miscellaneous Water Level**

Distance (ft): **.0**
Structural Grade: **0**
O&M Grade: **0**
Clock Start/From:
Clock To:
1st Value:
2nd Value:
Value Percent: **5.000**
Continuous Index:
Within 8" of Joint: **NO**
Remarks:

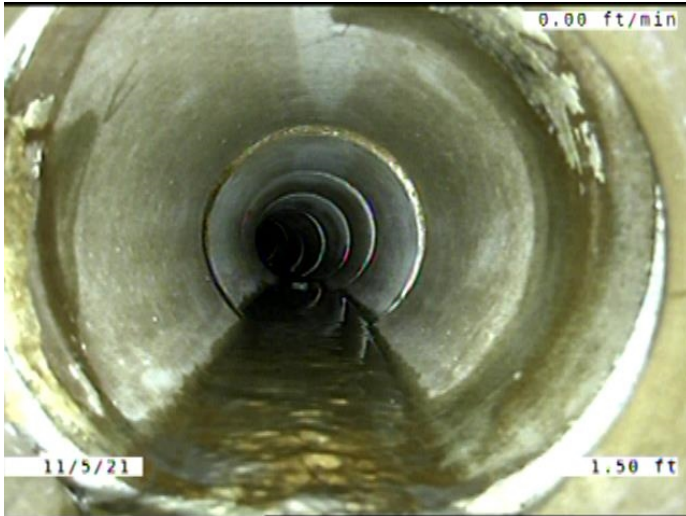
Code:	MGO
Description:	Miscellaneous General Observation
Distance (ft):	1.5
Structural Grade:	0
O&M Grade:	0
Clock Start/From:	
Clock To:	
1st Value:	
2nd Value:	
Value Percent:	
Continuous Index:	
Within 8" of Joint:	NO
Remarks:	DROP INTO THE MANHOLE. HAD TO START IN THE PIPE.

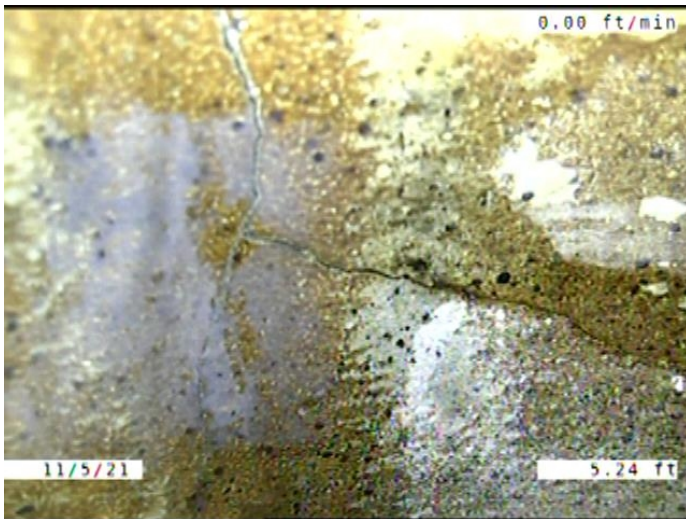
Code:	CM
Description:	Crack Multiple
Distance (ft):	5.2
Structural Grade:	3
O&M Grade:	0
Clock Start/From:	7
Clock To:	12
1st Value:	
2nd Value:	
Value Percent:	
Continuous Index:	
Within 8" of Joint:	YES
Remarks:

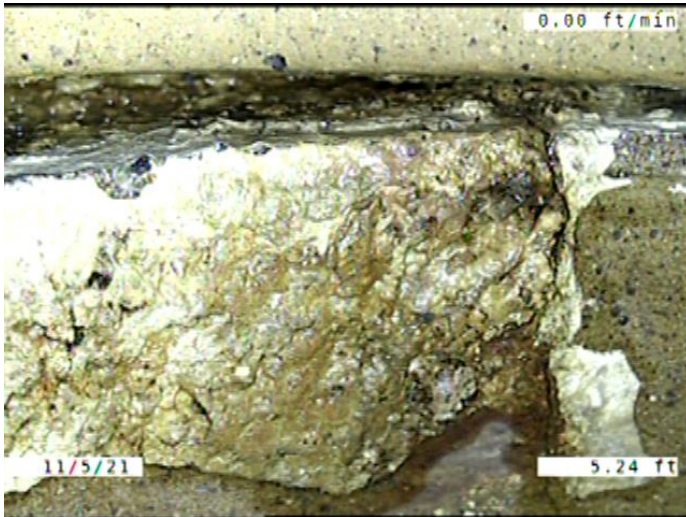
Code: **DAE**
 Description: **Deposits Attached Encrustation**

Distance (ft): **5.2**
 Structural Grade: **0**
 O&M Grade: **2**
 Clock Start/From: **8**
 Clock To: **12**
 1st Value:
 2nd Value:
 Value Percent: **5.000**
 Continuous Index:
 Within 8" of Joint: **YES**
 Remarks:

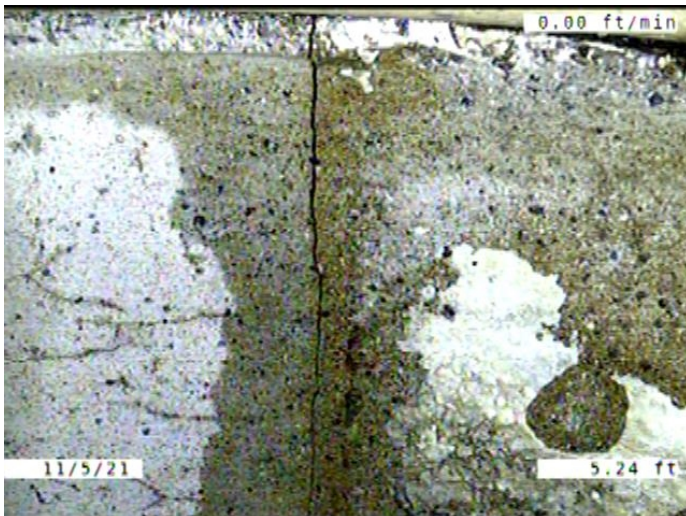
Code: **CL**
 Description: **Crack Longitudinal**

Distance (ft): **5.2**
 Structural Grade: **2**
 O&M Grade: **0**
 Clock Start/From: **1**
 Clock To:
 1st Value:
 2nd Value:
 Value Percent:
 Continuous Index:
 Within 8" of Joint: **YES**
 Remarks:

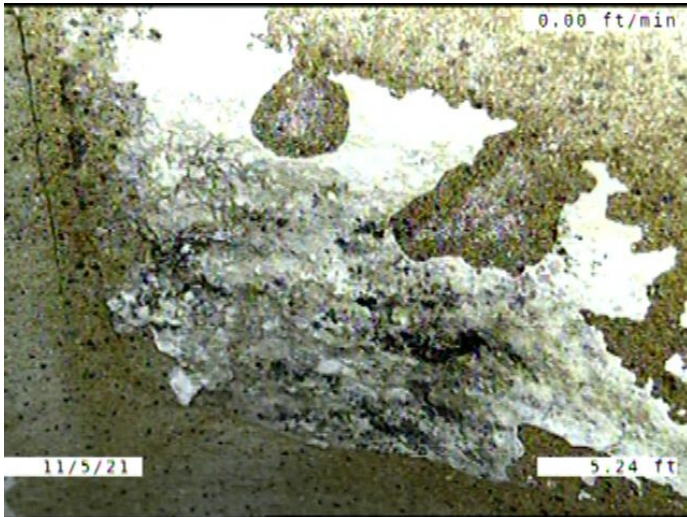
Code: **DAE**
 Description: **Deposits Attached Encrustation**

Distance (ft): **5.2**
 Structural Grade: **0**
 O&M Grade: **2**
 Clock Start/From: **1**
 Clock To: **3**
 1st Value:
 2nd Value:
 Value Percent: **5.000**
 Continuous Index:
 Within 8" of Joint: **YES**
 Remarks:

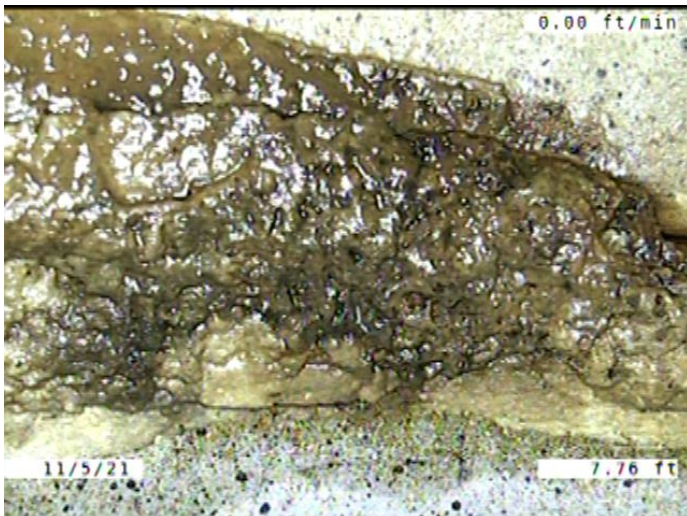
Code: **DAE**
 Description: **Deposits Attached Encrustation**

Distance (ft): **7.8**
 Structural Grade: **0**
 O&M Grade: **2**
 Clock Start/From: **8**
 Clock To: **5**
 1st Value:
 2nd Value:
 Value Percent: **5.000**
 Continuous Index:
 Within 8" of Joint: **YES**
 Remarks:

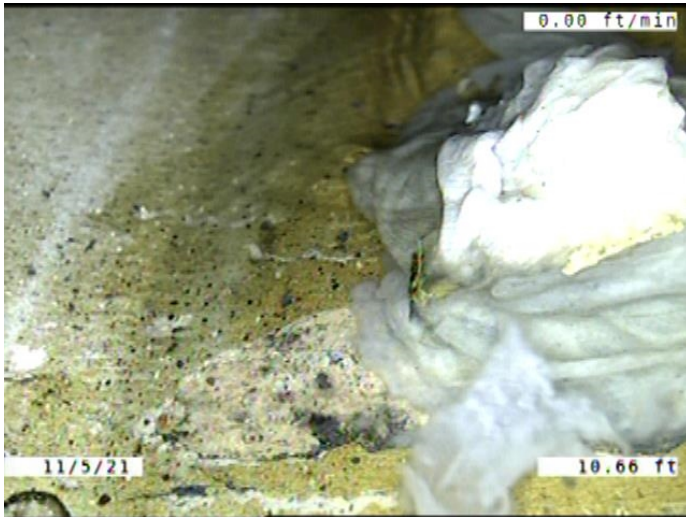
Code: **SSS**
Description: **Surface Damage Surface Spalling**

Distance (ft): **10.7**
Structural Grade: **2**
O&M Grade: **0**
Clock Start/From: **5**
Clock To: **7**
1st Value:
2nd Value:
Value Percent:
Continuous Index:
Within 8" of Joint: **YES**
Remarks:

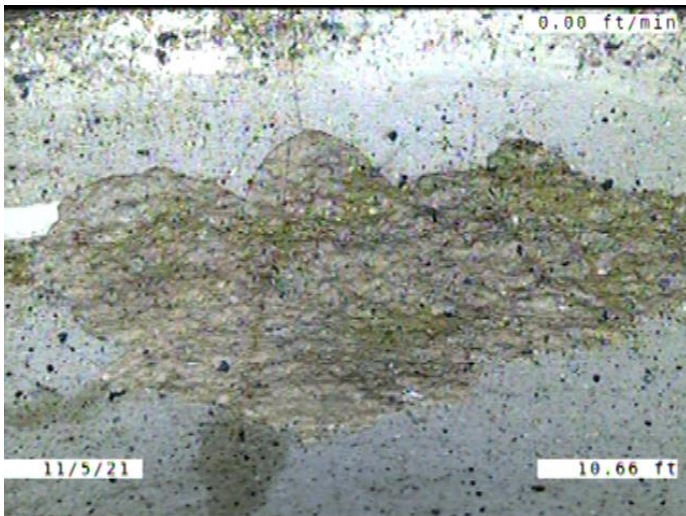
Code: **SSS**
Description: **Surface Damage Surface Spalling**

Distance (ft): **10.7**
Structural Grade: **2**
O&M Grade: **0**
Clock Start/From: **10**
Clock To: **11**
1st Value:
2nd Value:
Value Percent:
Continuous Index:
Within 8" of Joint: **YES**
Remarks:

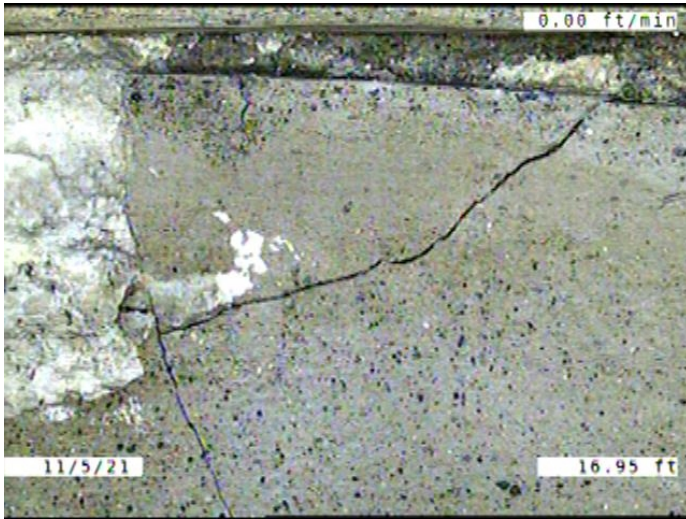
Code: **CM**
 Description: **Crack Multiple**

Distance (ft): **16.9**
 Structural Grade: **3**
 O&M Grade: **0**
 Clock Start/From: **11**
 Clock To: **3**
 1st Value:
 2nd Value:
 Value Percent:
 Continuous Index:
 Within 8" of Joint: **YES**
 Remarks:

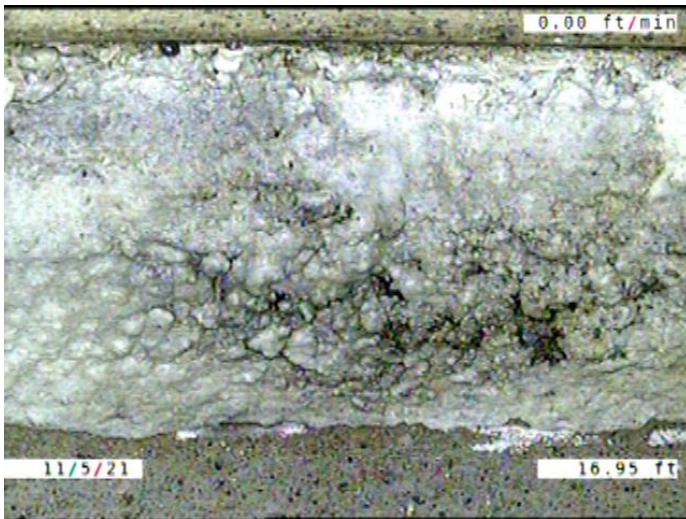
Code: **DAE**
 Description: **Deposits Attached Encrustation**

Distance (ft): **16.9**
 Structural Grade: **0**
 O&M Grade: **2**
 Clock Start/From: **8**
 Clock To: **11**
 1st Value:
 2nd Value:
 Value Percent: **5.000**
 Continuous Index:
 Within 8" of Joint: **YES**
 Remarks:

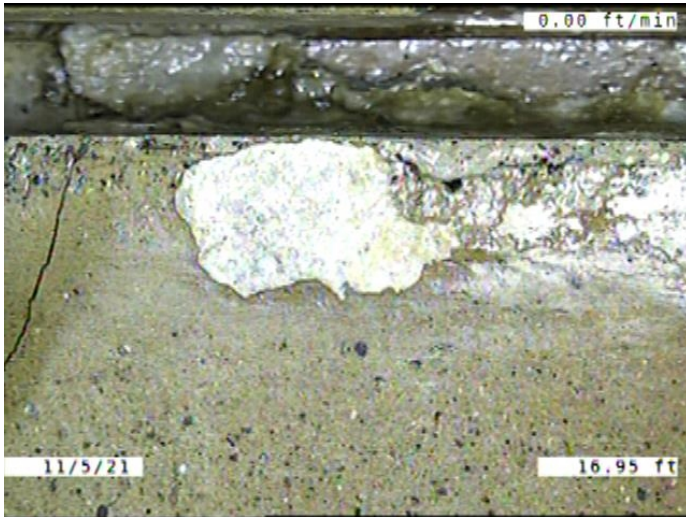
Code: **DAE**
 Description: **Deposits Attached Encrustation**

Distance (ft): **16.9**
 Structural Grade: **0**
 O&M Grade: **2**
 Clock Start/From: **3**
 Clock To:
 1st Value:
 2nd Value:
 Value Percent: **5.000**
 Continuous Index:
 Within 8" of Joint: **YES**
 Remarks:

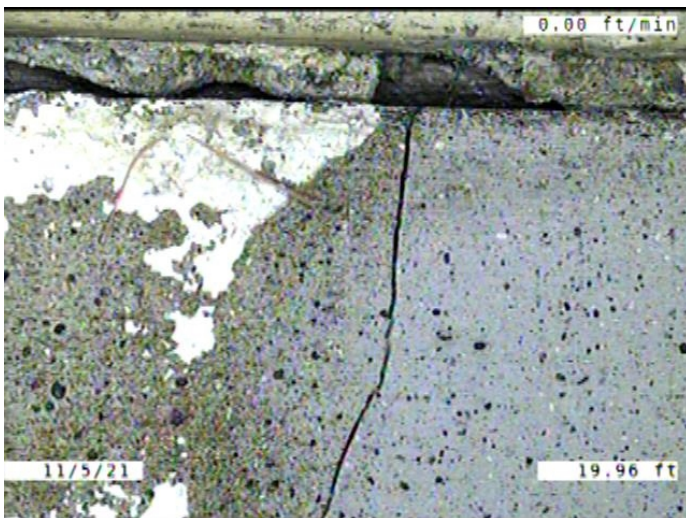
Code: **FS**
 Description: **Fracture Spiral**

Distance (ft): **20.0**
 Structural Grade: **3**
 O&M Grade: **0**
 Clock Start/From: **8**
 Clock To: **11**
 1st Value:
 2nd Value:
 Value Percent:
 Continuous Index:
 Within 8" of Joint: **YES**
 Remarks:

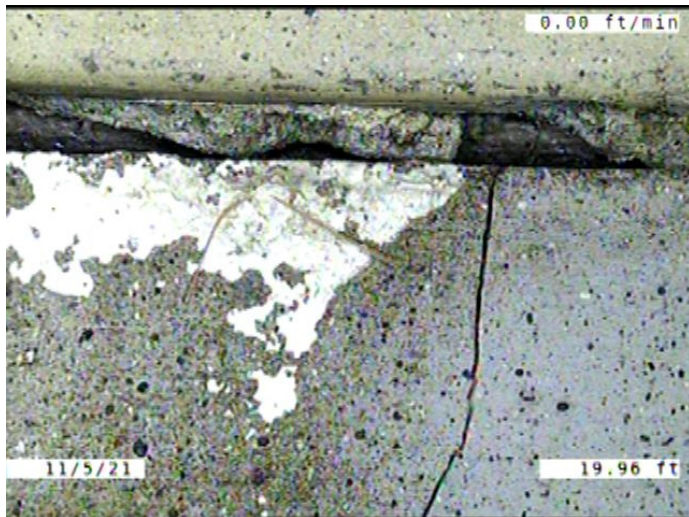
Code: **DAE**
 Description: **Deposits Attached Encrustation**

Distance (ft): **20.0**
 Structural Grade: **0**
 O&M Grade: **2**
 Clock Start/From: **9**
 Clock To: **11**
 1st Value:
 2nd Value:
 Value Percent: **5.000**
 Continuous Index:
 Within 8" of Joint: **YES**
 Remarks:

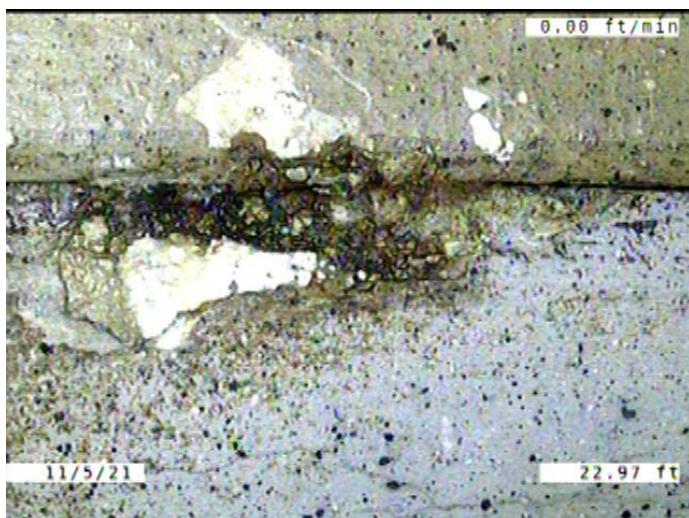
Code: **DAE**
 Description: **Deposits Attached Encrustation**

Distance (ft): **23.0**
 Structural Grade: **0**
 O&M Grade: **2**
 Clock Start/From: **8**
 Clock To: **9**
 1st Value:
 2nd Value:
 Value Percent: **5.000**
 Continuous Index:
 Within 8" of Joint: **YES**
 Remarks:

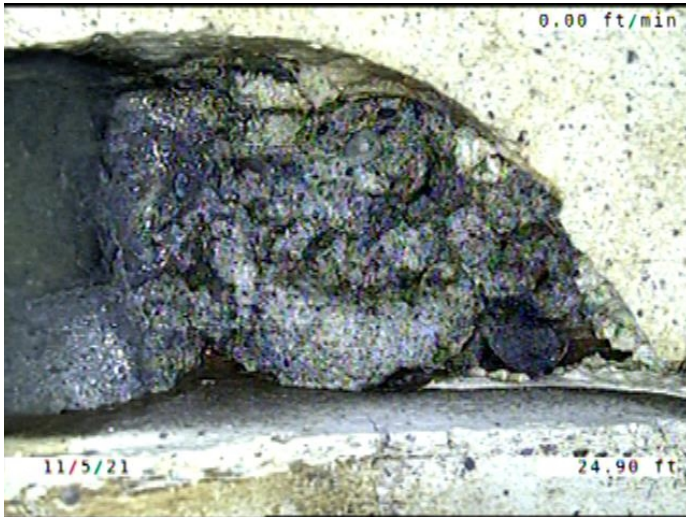
Code: **HSV**
Description: **Hole Soil Visible**

Distance (ft): **24.9**
Structural Grade: **5**
O&M Grade: **0**
Clock Start/From: **5**
Clock To: **9**
1st Value:
2nd Value:
Value Percent:
Continuous Index:
Within 8" of Joint: **YES**
Remarks: **INSIDE OF THE JOINT**

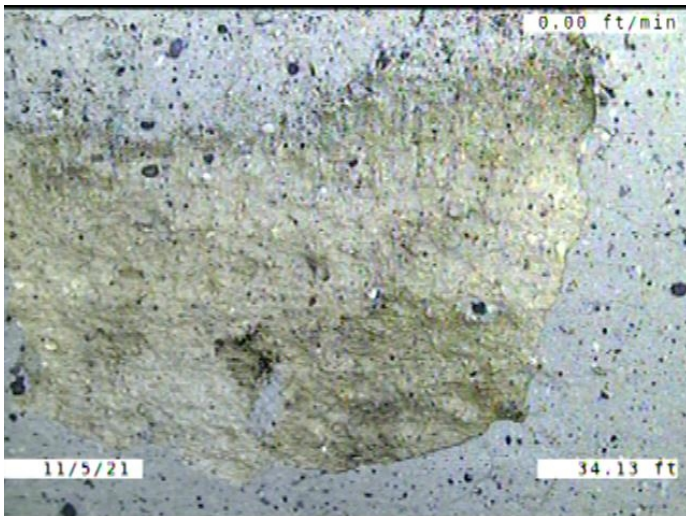
Code: **SSS**
Description: **Surface Damage Surface Spalling**

Distance (ft): **34.1**
Structural Grade: **2**
O&M Grade: **0**
Clock Start/From: **2**
Clock To: **3**
1st Value:
2nd Value:
Value Percent:
Continuous Index:
Within 8" of Joint: **YES**
Remarks:

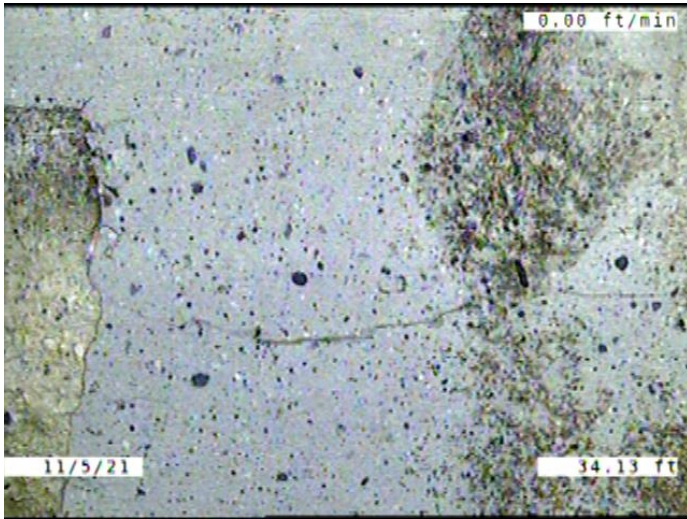
Code: **CM**
Description: **Crack Multiple**

Distance (ft): **34.1**
Structural Grade: **3**
O&M Grade: **0**
Clock Start/From: **3**
Clock To: **5**
1st Value:
2nd Value:
Value Percent:
Continuous Index:
Within 8" of Joint: **YES**
Remarks:

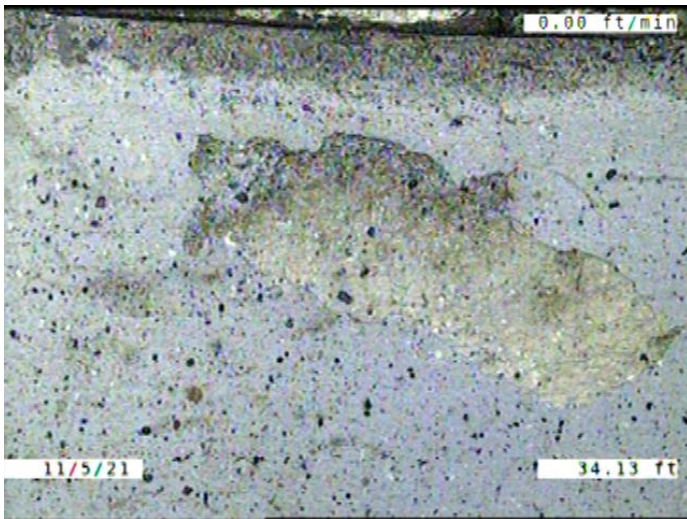
Code: **SSS**
Description: **Surface Damage Surface Spalling**

Distance (ft): **34.1**
Structural Grade: **2**
O&M Grade: **0**
Clock Start/From: **11**
Clock To:
1st Value:
2nd Value:
Value Percent:
Continuous Index:
Within 8" of Joint: **YES**
Remarks:

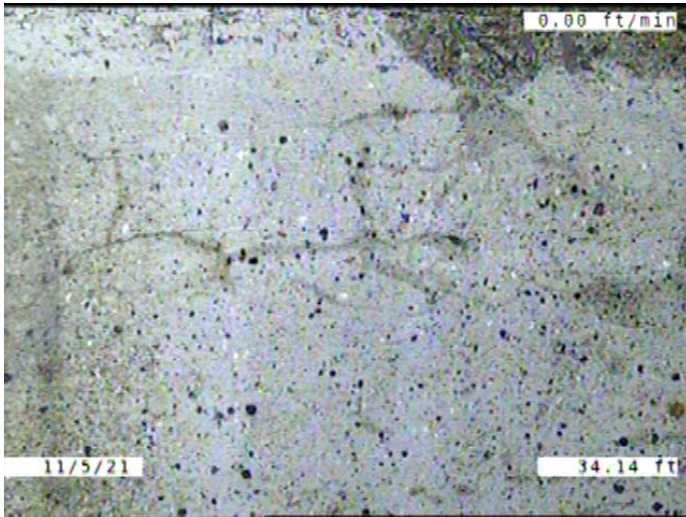
Code: **CM**
Description: **Crack Multiple**

Distance (ft): **34.1**
Structural Grade: **3**
O&M Grade: **0**
Clock Start/From: **9**
Clock To: **10**
1st Value:
2nd Value:
Value Percent:
Continuous Index:
Within 8" of Joint: **YES**
Remarks:

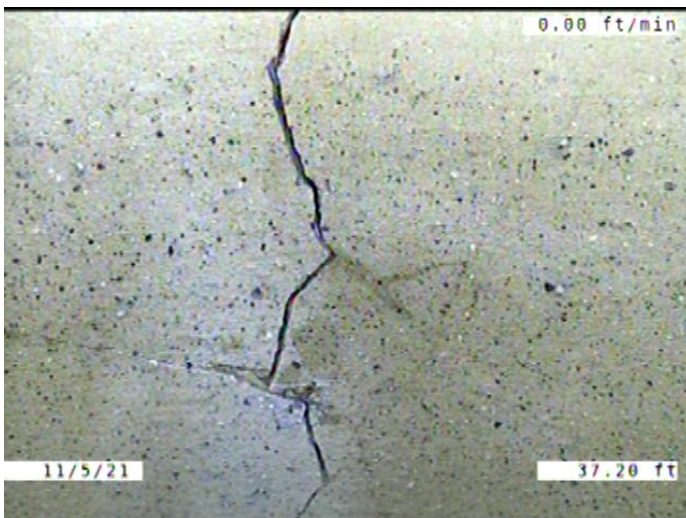
Code: **FM**
Description: **Fracture Multiple**

Distance (ft): **37.2**
Structural Grade: **4**
O&M Grade: **0**
Clock Start/From: **8**
Clock To: **4**
1st Value:
2nd Value:
Value Percent:
Continuous Index: **S01**
Within 8" of Joint: **YES**
Remarks:

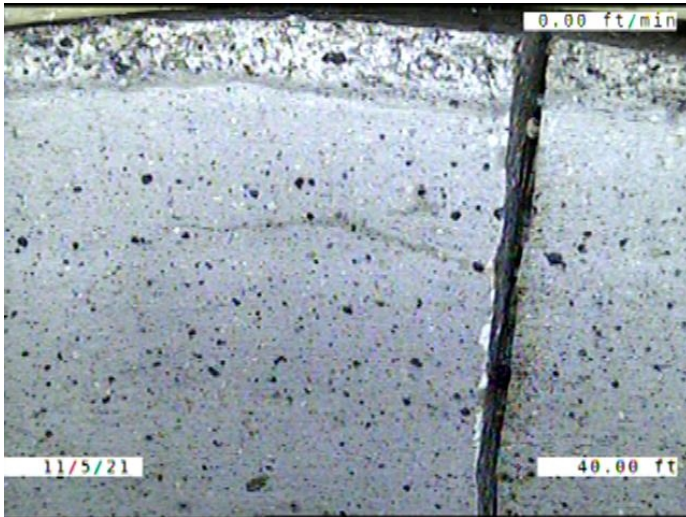
Code: **DR**
Description: **Deformed Rigid**

Distance (ft): **40.0**
Structural Grade: **4**
O&M Grade: **0**
Clock Start/From:
Clock To:
1st Value:
2nd Value:
Value Percent: **5.000**
Continuous Index: **S02**
Within 8" of Joint: **NO**
Remarks:

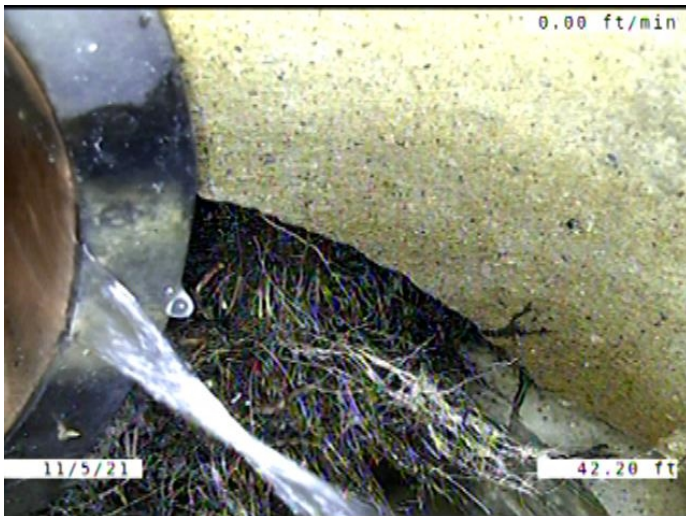
Code: **RFB**
Description: **Roots Fine Barrel**

Distance (ft): **42.2**
Structural Grade: **0**
O&M Grade: **2**
Clock Start/From: **11**
Clock To: **3**
1st Value:
2nd Value:
Value Percent:
Continuous Index:
Within 8" of Joint: **NO**
Remarks:

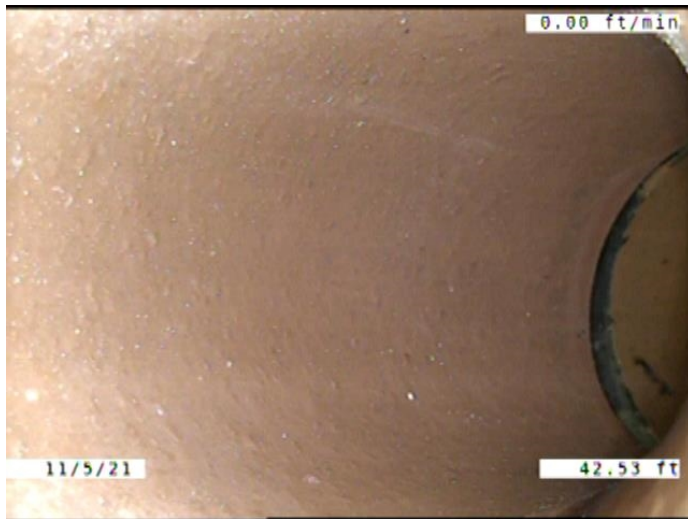
Code: **TBI**
 Description: **Tap Break-in Intruding**

Distance (ft): **42.5**
 Structural Grade: **0**
 O&M Grade: **2**
 Clock Start/From: **1**
 Clock To:
 1st Value: **4.000**
 2nd Value: **1.000**
 Value Percent:
 Continuous Index:
 Within 8" of Joint: **YES**
 Remarks:

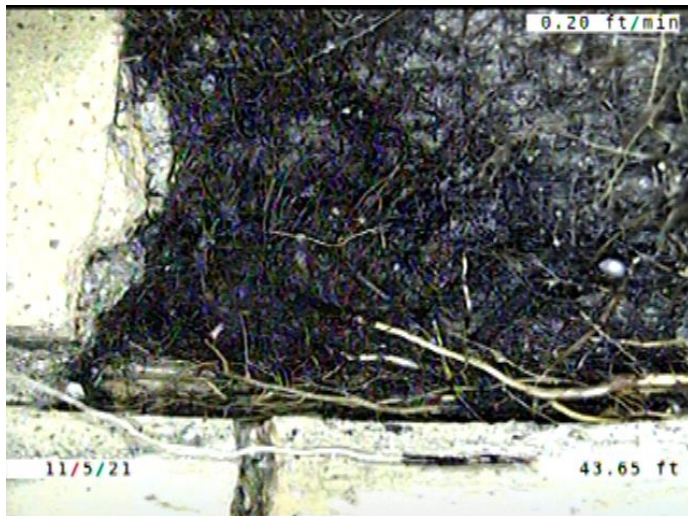
Code: **HSV**
 Description: **Hole Soil Visible**

Distance (ft): **43.6**
 Structural Grade: **5**
 O&M Grade: **0**
 Clock Start/From: **12**
 Clock To: **3**
 1st Value:
 2nd Value:
 Value Percent:
 Continuous Index:
 Within 8" of Joint: **YES**
 Remarks:

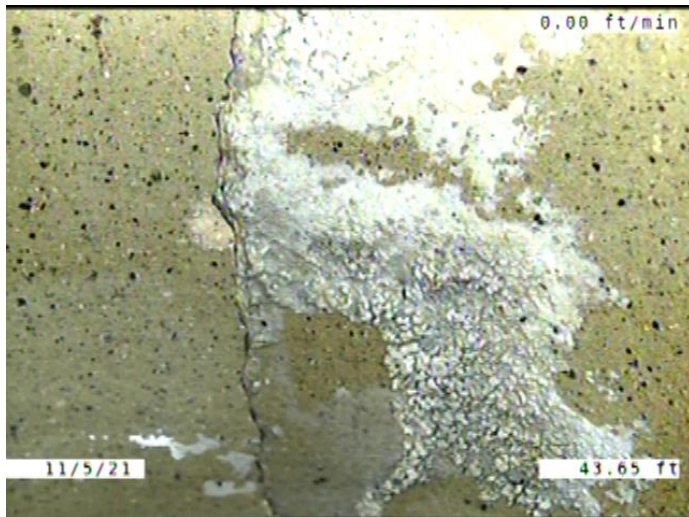
Code: **DAE**
 Description: **Deposits Attached Encrustation**

Distance (ft): **43.6**
 Structural Grade: **0**
 O&M Grade: **2**
 Clock Start/From: **8**
 Clock To: **4**
 1st Value:
 2nd Value:
 Value Percent: **5.000**
 Continuous Index:
 Within 8" of Joint: **YES**
 Remarks:

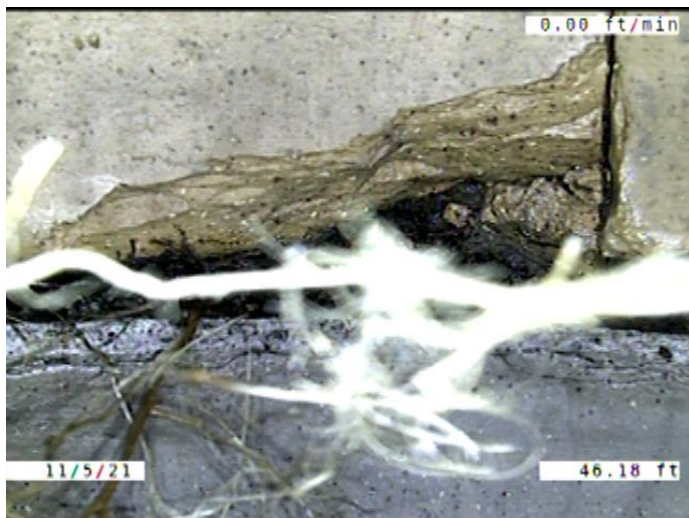
Code: **RFJ**
 Description: **Roots Fine Joint**

Distance (ft): **46.2**
 Structural Grade: **0**
 O&M Grade: **1**
 Clock Start/From: **9**
 Clock To: **11**
 1st Value:
 2nd Value:
 Value Percent:
 Continuous Index:
 Within 8" of Joint: **YES**
 Remarks:

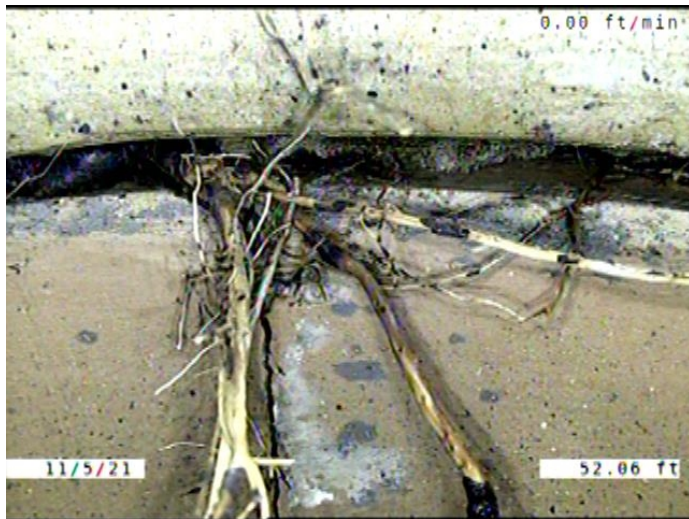
Code: **RFJ**
 Description: **Roots Fine Joint**

Distance (ft): **52.1**
 Structural Grade: **0**
 O&M Grade: **1**
 Clock Start/From: **10**
 Clock To: **2**
 1st Value:
 2nd Value:
 Value Percent:
 Continuous Index:
 Within 8" of Joint: **YES**
 Remarks:

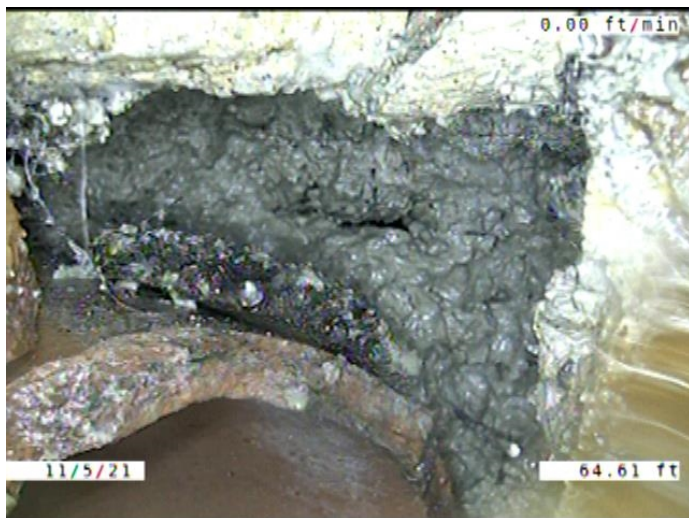
Code: **HSV**
 Description: **Hole Soil Visible**

Distance (ft): **64.6**
 Structural Grade: **5**
 O&M Grade: **0**
 Clock Start/From: **12**
 Clock To: **1**
 1st Value:
 2nd Value:
 Value Percent:
 Continuous Index:
 Within 8" of Joint: **YES**
 Remarks: **SOIL VISIBLE**

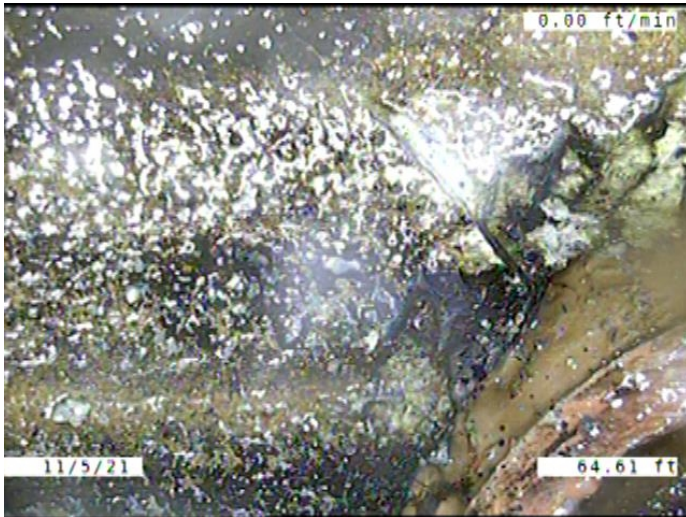
Code: **ISC**
 Description: **Infiltration Stain Connection**

Distance (ft): **64.6**
 Structural Grade: **0**
 O&M Grade: **1**
 Clock Start/From: **8**
 Clock To: **11**
 1st Value:
 2nd Value:
 Value Percent:
 Continuous Index:
 Within 8" of Joint: **YES**
 Remarks:

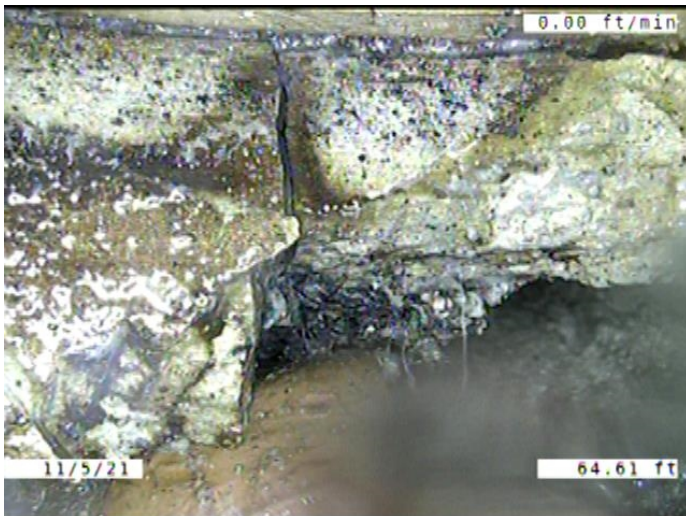
Code: **IRB**
 Description: **Infiltration Runner Barrel**

Distance (ft): **64.6**
 Structural Grade: **0**
 O&M Grade: **4**
 Clock Start/From: **12**
 Clock To:
 1st Value:
 2nd Value:
 Value Percent:
 Continuous Index:
 Within 8" of Joint: **YES**
 Remarks:

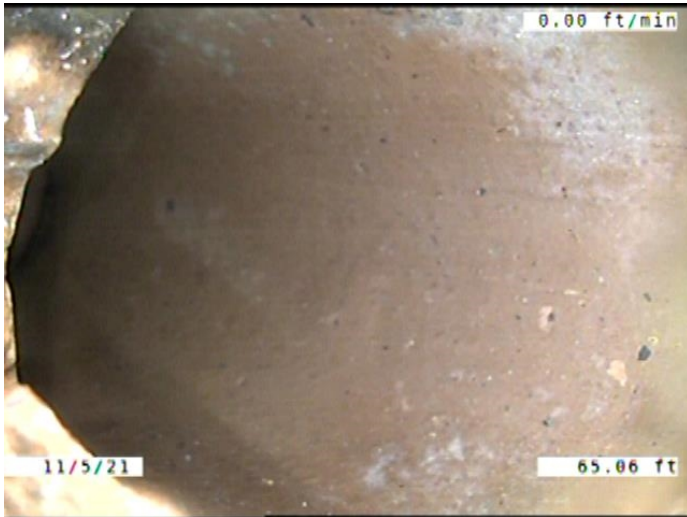
Code: **TBI**
Description: **Tap Break-in Intruding**

Distance (ft): **65.1**
Structural Grade: **0**
O&M Grade: **2**
Clock Start/From: **12**
Clock To:
1st Value: **4.000**
2nd Value: **1.000**
Value Percent:
Continuous Index:
Within 8" of Joint: **YES**
Remarks:

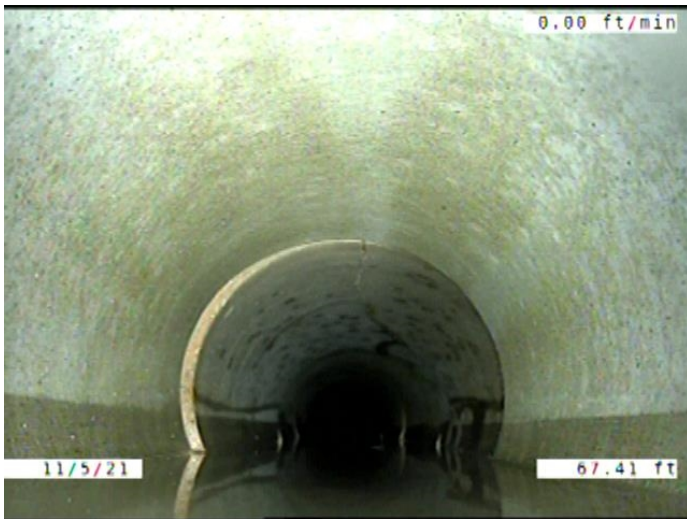
Code: **DR**
Description: **Deformed Rigid**

Distance (ft): **67.4**
Structural Grade: **4**
O&M Grade: **0**
Clock Start/From:
Clock To:
1st Value:
2nd Value:
Value Percent: **5.000**
Continuous Index: **F02**
Within 8" of Joint: **NO**
Remarks:

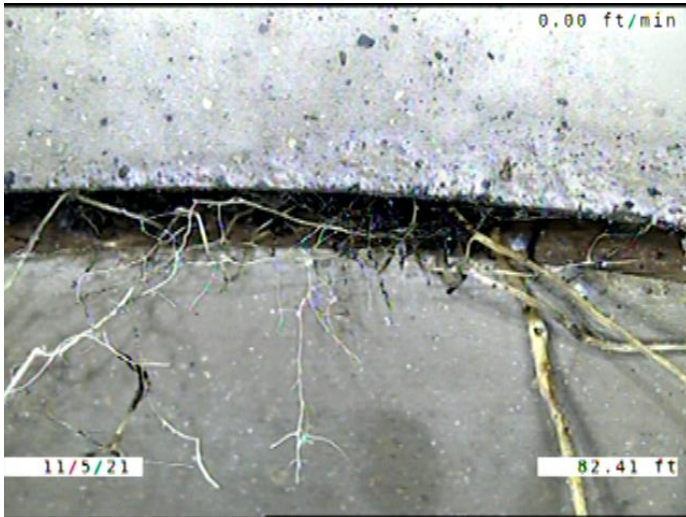
Code: **RFJ**
Description: **Roots Fine Joint**

Distance (ft): **82.4**
Structural Grade: **0**
O&M Grade: **1**
Clock Start/From: **11**
Clock To: **3**
1st Value:
2nd Value:
Value Percent:
Continuous Index:
Within 8" of Joint: **YES**
Remarks:

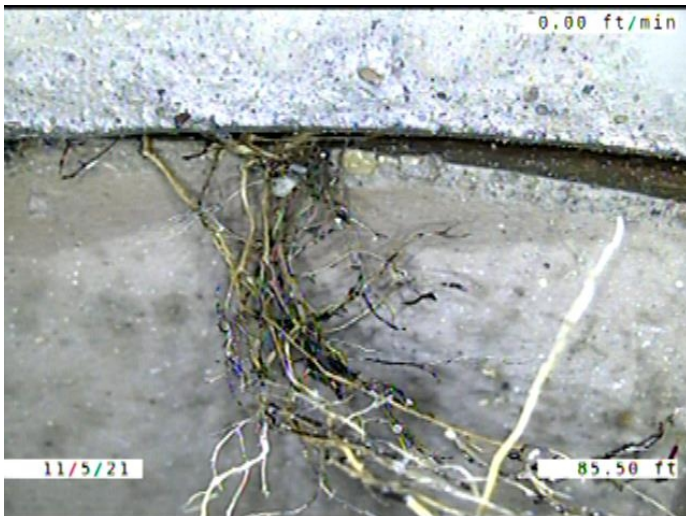
Code: **RFJ**
Description: **Roots Fine Joint**

Distance (ft): **85.5**
Structural Grade: **0**
O&M Grade: **1**
Clock Start/From: **10**
Clock To: **2**
1st Value:
2nd Value:
Value Percent:
Continuous Index:
Within 8" of Joint: **YES**
Remarks:

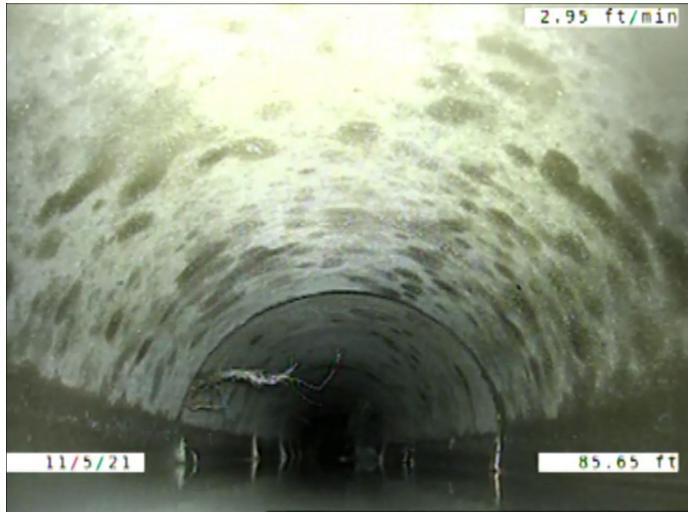
Code: **FM**
 Description: **Fracture Multiple**

Distance (ft): **85.7**
 Structural Grade: **4**
 O&M Grade: **0**
 Clock Start/From: **8**
 Clock To: **4**
 1st Value:
 2nd Value:
 Value Percent:
 Continuous Index: **F01**
 Within 8" of Joint: **YES**
 Remarks:

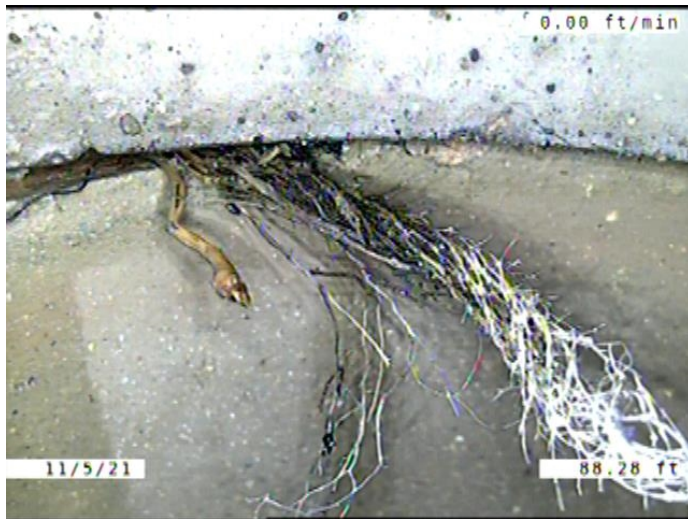
Code: **RFJ**
 Description: **Roots Fine Joint**

Distance (ft): **88.3**
 Structural Grade: **0**
 O&M Grade: **1**
 Clock Start/From: **10**
 Clock To: **11**
 1st Value:
 2nd Value:
 Value Percent:
 Continuous Index:
 Within 8" of Joint: **YES**
 Remarks:

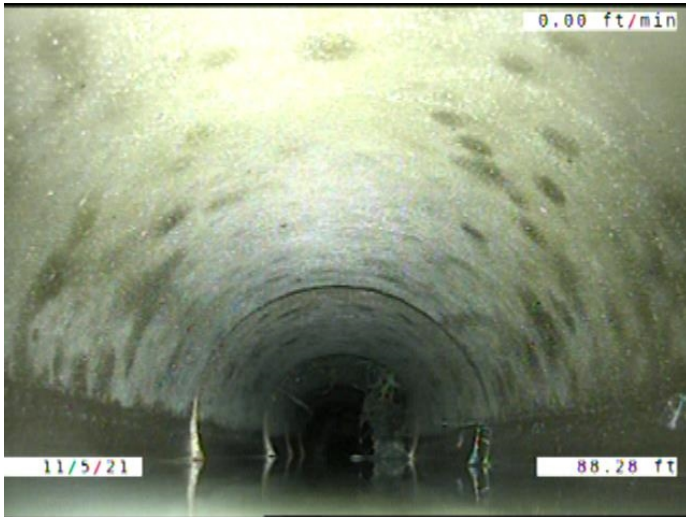
Code: **MWL**
 Description: **Miscellaneous Water Level**

Distance (ft): **88.3**
 Structural Grade: **0**
 O&M Grade: **0**
 Clock Start/From:
 Clock To:
 1st Value:
 2nd Value:
 Value Percent: **15.000**
 Continuous Index:
 Within 8" of Joint: **NO**
 Remarks:

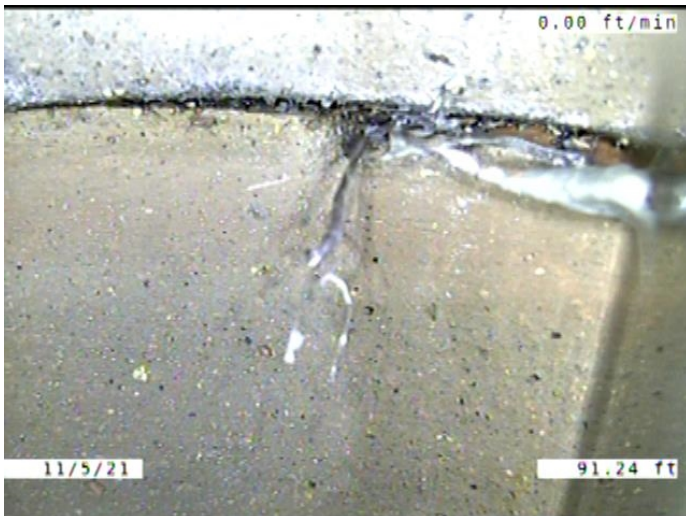
Code: **RFJ**
 Description: **Roots Fine Joint**

Distance (ft): **91.2**
 Structural Grade: **0**
 O&M Grade: **1**
 Clock Start/From: **3**
 Clock To:
 1st Value:
 2nd Value:
 Value Percent:
 Continuous Index:
 Within 8" of Joint: **YES**
 Remarks:

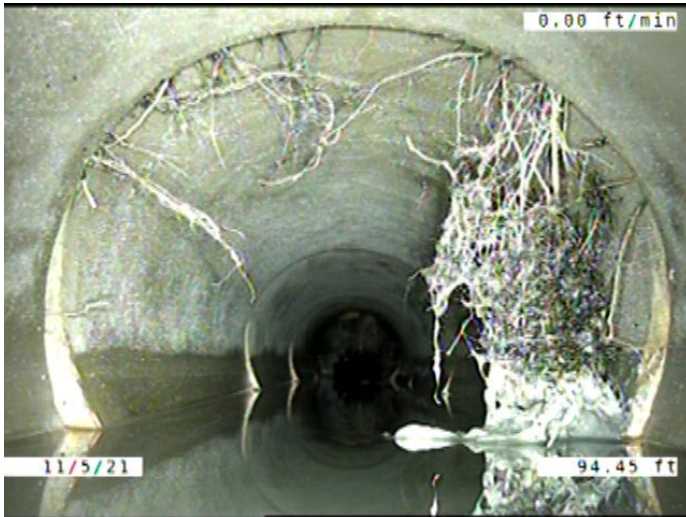
Code: **RMJ**
 Description: **Roots Medium Joint**

Distance (ft): **94.4**
 Structural Grade: **0**
 O&M Grade: **3**
 Clock Start/From: **9**
 Clock To: **4**
 1st Value:
 2nd Value:
 Value Percent: **10.000**
 Continuous Index:
 Within 8" of Joint: **YES**
 Remarks:

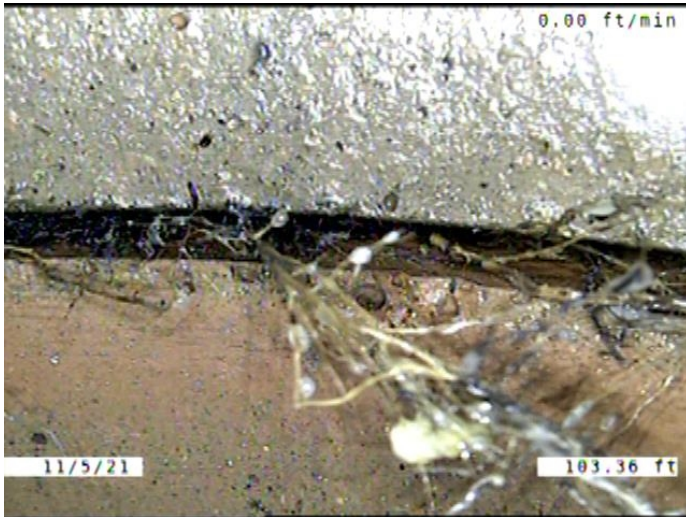
Code: **RFJ**
 Description: **Roots Fine Joint**

Distance (ft): **103.4**
 Structural Grade: **0**
 O&M Grade: **1**
 Clock Start/From: **1**
 Clock To: **3**
 1st Value:
 2nd Value:
 Value Percent:
 Continuous Index:
 Within 8" of Joint: **YES**
 Remarks:

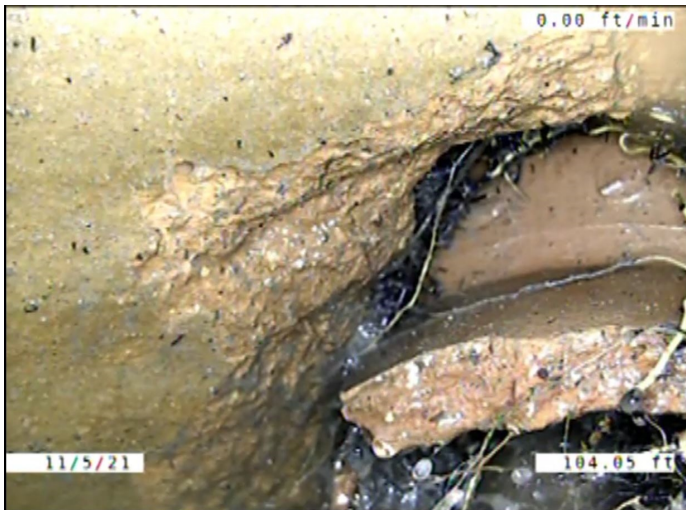
Code: **SSS**
 Description: **Surface Damage Surface Spalling**

Distance (ft): **104.1**
 Structural Grade: **2**
 O&M Grade: **0**
 Clock Start/From: **10**
 Clock To: **12**
 1st Value:
 2nd Value:
 Value Percent:
 Continuous Index:
 Within 8" of Joint: **NO**
 Remarks:

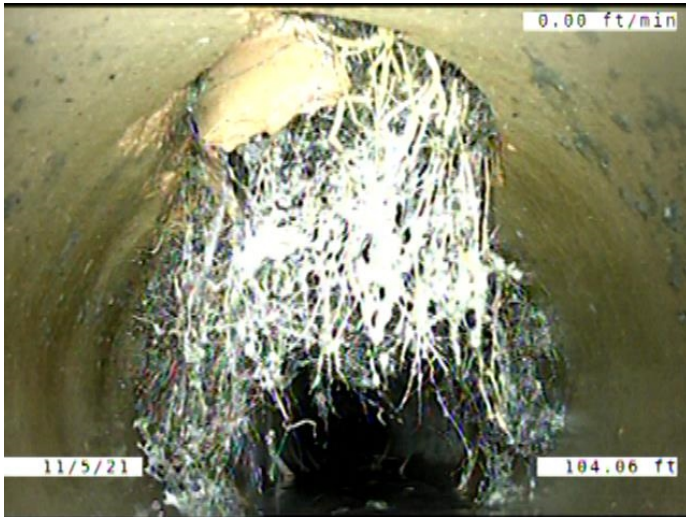
Code: **RMC**
Description: **Roots Medium Connection**

Distance (ft): **104.1**
Structural Grade: **0**
O&M Grade: **3**
Clock Start/From: **8**
Clock To: **4**
1st Value:
2nd Value:
Value Percent: **50.000**
Continuous Index:
Within 8" of Joint: **NO**
Remarks:

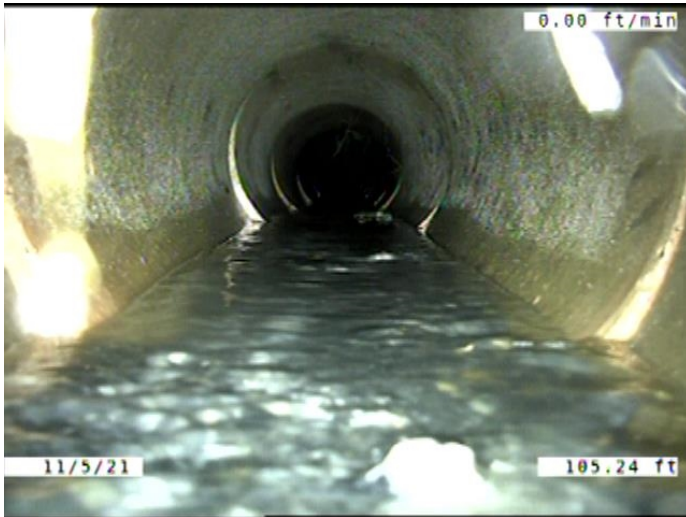
Code: **DSF**
 Description: **Deposits Settled Fine**

Distance (ft): **105.2**
 Structural Grade: **0**
 O&M Grade: **2**
 Clock Start/From: **5**
 Clock To: **7**
 1st Value:
 2nd Value:
 Value Percent: **5.000**
 Continuous Index: **S03**
 Within 8" of Joint: **YES**
 Remarks:

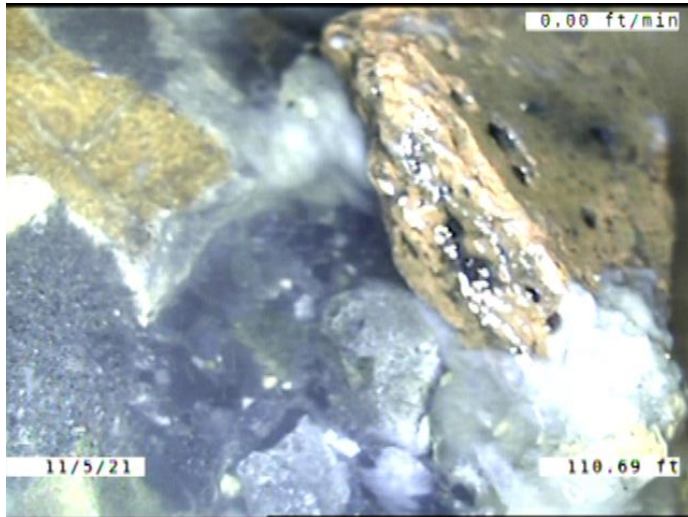
Code:	OBM
Description:	Obstruction Pipe Material in Invert
Distance (ft):	110.7
Structural Grade:	0
O&M Grade:	2
Clock Start/From:	5
Clock To:	6
1st Value:	
2nd Value:	
Value Percent:	5.000
Continuous Index:	
Within 8" of Joint:	YES
Remarks:

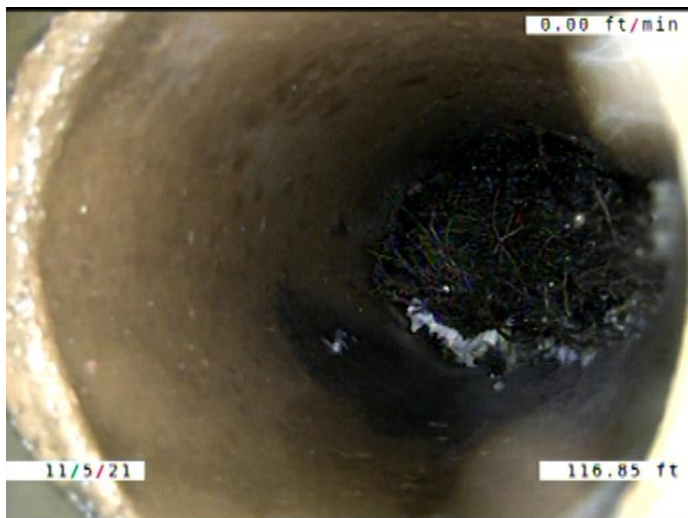
Code:	TBI
Description:	Tap Break-in Intruding
Distance (ft):	116.8
Structural Grade:	0
O&M Grade:	2
Clock Start/From:	1
Clock To:	
1st Value:	4.000
2nd Value:	1.000
Value Percent:	
Continuous Index:	
Within 8" of Joint:	YES
Remarks:	CONSTANTLY RUNNING WATER. LOOKS TO BE 100% PLUGGED WITH

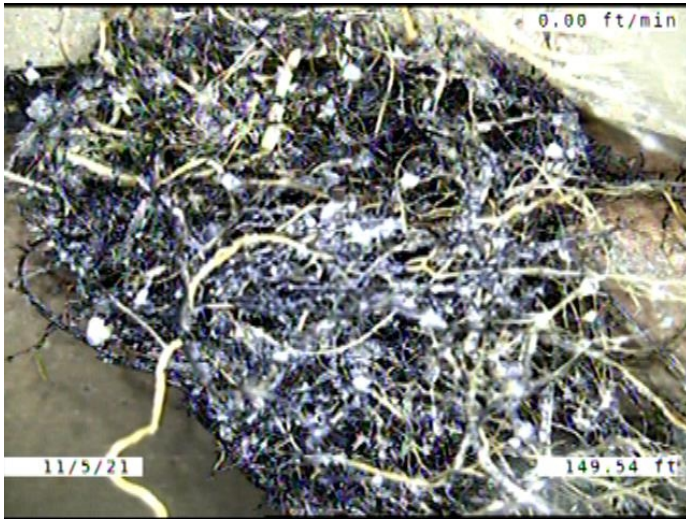
Code: **RMJ**
 Description: **Roots Medium Joint**

Distance (ft): **149.5**
 Structural Grade: **0**
 O&M Grade: **3**
 Clock Start/From: **8**
 Clock To: **4**
 1st Value:
 2nd Value:
 Value Percent: **5.000**
 Continuous Index:
 Within 8" of Joint: **YES**
 Remarks:

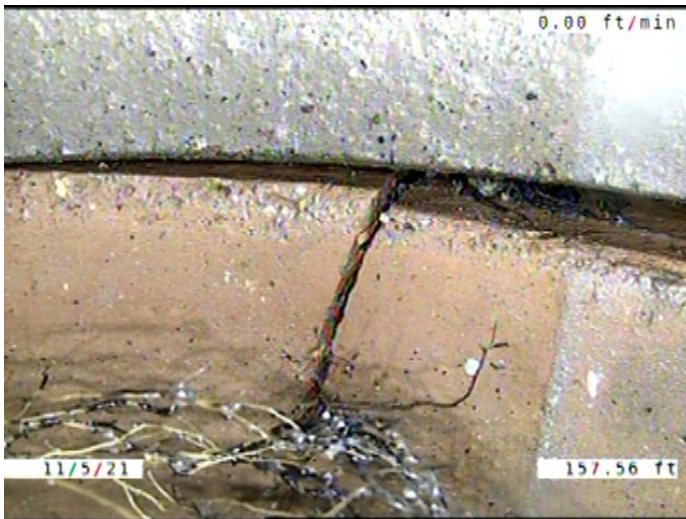
Code: **B**
 Description: **Broken**

Distance (ft): **157.6**
 Structural Grade: **4**
 O&M Grade: **0**
 Clock Start/From: **8**
 Clock To: **3**
 1st Value:
 2nd Value:
 Value Percent:
 Continuous Index:
 Within 8" of Joint: **YES**
 Remarks:

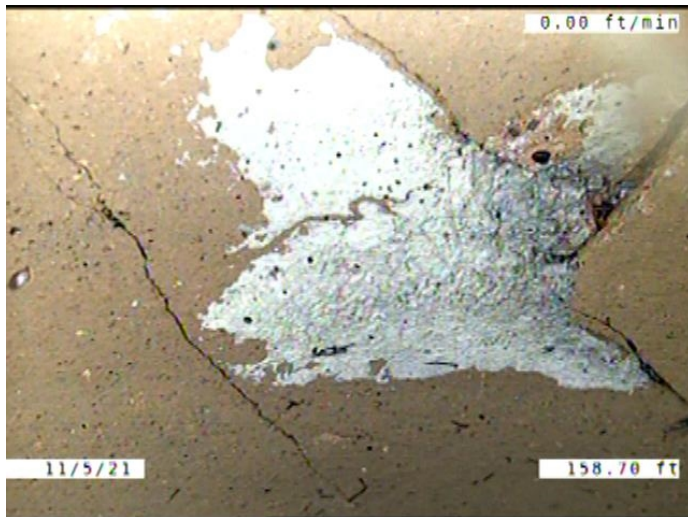
Code: **DAE**
 Description: **Deposits Attached Encrustation**

Distance (ft): **158.7**
 Structural Grade: **0**
 O&M Grade: **2**
 Clock Start/From: **9**
 Clock To: **11**
 1st Value:
 2nd Value:
 Value Percent: **5.000**
 Continuous Index:
 Within 8" of Joint: **NO**
 Remarks:

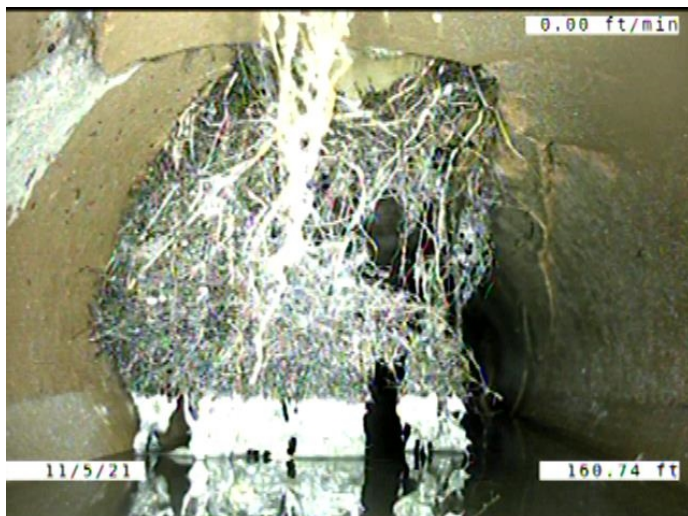
Code: **RMC**
 Description: **Roots Medium Connection**

Distance (ft): **160.7**
 Structural Grade: **0**
 O&M Grade: **3**
 Clock Start/From: **10**
 Clock To: **1**
 1st Value:
 2nd Value:
 Value Percent: **50.000**
 Continuous Index:
 Within 8" of Joint: **NO**
 Remarks:

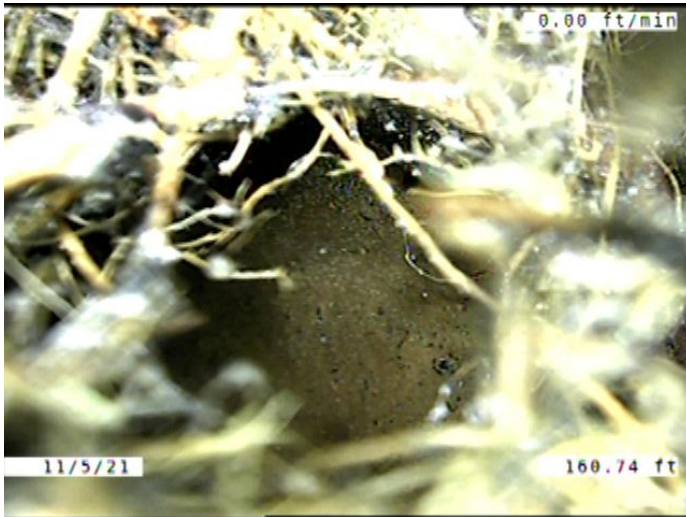
Code: **TBI**
 Description: **Tap Break-in Intruding**

Distance (ft): **160.7**
 Structural Grade: **0**
 O&M Grade: **2**
 Clock Start/From: **12**
 Clock To:
 1st Value: **4.000**
 2nd Value: **1.000**
 Value Percent:
 Continuous Index:
 Within 8" of Joint: **YES**
 Remarks:

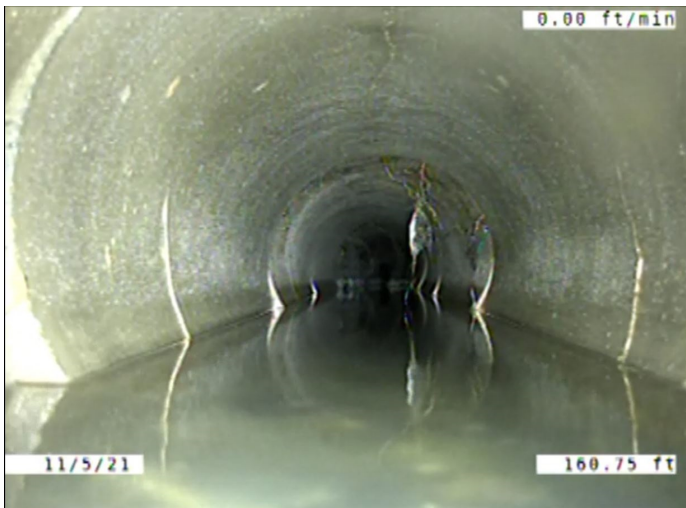
Code: **CM**
 Description: **Crack Multiple**

Distance (ft): **160.8**
 Structural Grade: **3**
 O&M Grade: **0**
 Clock Start/From: **8**
 Clock To: **4**
 1st Value:
 2nd Value:
 Value Percent:
 Continuous Index:
 Within 8" of Joint: **NO**
 Remarks:
