Profile/Photo Observation Report

Date:	11/05/2021	Weather:		Coding:	PACP 7.0
Pipe Length (ft):	330.0	Owner:	City of Hobart	Pre Clean:	Heavy Cleaning
P.O.#:	YES502259	Surveyor:	S. Bucklin	PSR:	P-504-057-056
Customer:	City of Hobart	Clean Date:	11/04/2021	Shape:	C

Street:	North Wilson Street	Flow Control:	Not Controlled
City:	Hobart, IN	Year Renewed:	
Location:	Alley	Tape/Media #:	
Purpose:	Routine Assessment	Dia/Height:	12"
Use:	Sanitary Sewage Pipe	Material:	VCP
Drain Area:		Lining:	None
Category:	NA		
Comment:			
Location Details:		Direction of Survey:	Downstream
US MH:	M-504-057	DS MH:	M-504-056
		Total Length Surveyed (ft):	233.0

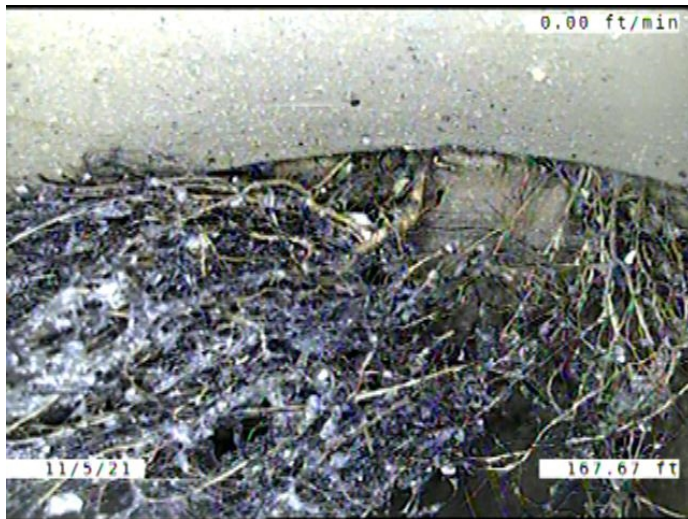
Code: **RMJ**
 Description: **Roots Medium Joint**

Distance (ft): **167.7**
 Structural Grade: **0**
 O&M Grade: **3**
 Clock Start/From: **9**
 Clock To: **2**
 1st Value:
 2nd Value:
 Value Percent: **5.000**
 Continuous Index:
 Within 8" of Joint: **YES**
 Remarks:

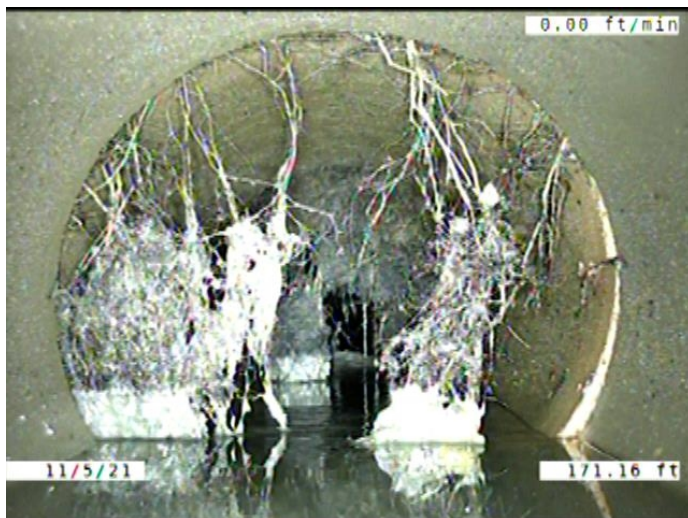
Code: **RMJ**
 Description: **Roots Medium Joint**

Distance (ft): **171.2**
 Structural Grade: **0**
 O&M Grade: **3**
 Clock Start/From: **8**
 Clock To: **2**
 1st Value:
 2nd Value:
 Value Percent: **15.000**
 Continuous Index:
 Within 8" of Joint: **YES**
 Remarks:

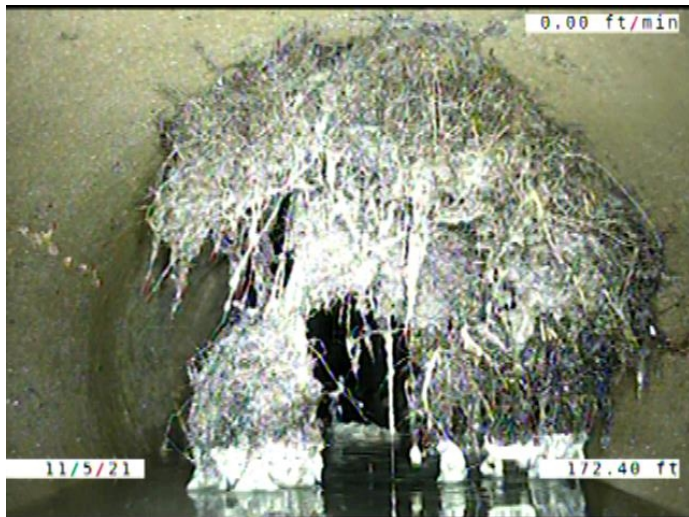
Code: **RMC**
 Description: **Roots Medium Connection**

Distance (ft): **172.4**
 Structural Grade: **0**
 O&M Grade: **3**
 Clock Start/From: **10**
 Clock To: **4**
 1st Value:
 2nd Value:
 Value Percent: **50.000**
 Continuous Index:
 Within 8" of Joint: **NO**
 Remarks:

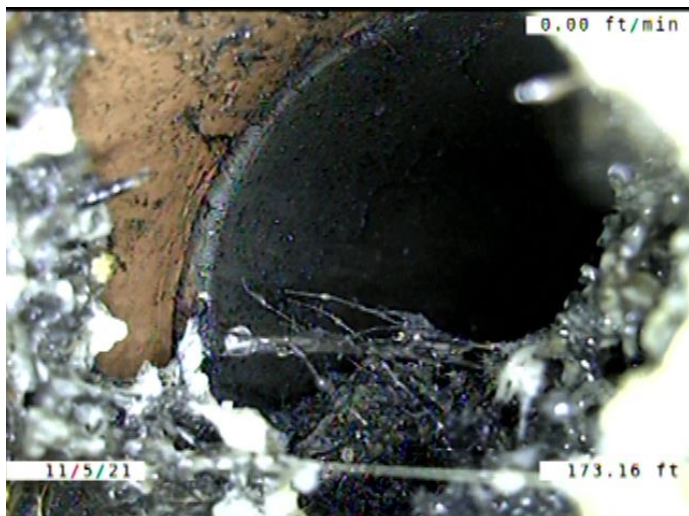
Code: **TBD**
 Description: **Tap Break-in/Hammer Defective**

Distance (ft): **173.2**
 Structural Grade: **0**
 O&M Grade: **3**
 Clock Start/From: **12**
 Clock To:
 1st Value: **4.000**
 2nd Value:
 Value Percent:
 Continuous Index:
 Within 8" of Joint: **YES**
 Remarks: **ROOTS GROWING OUT OF THE TAP AND INTO THE MAIN. ROOTS ALSO**

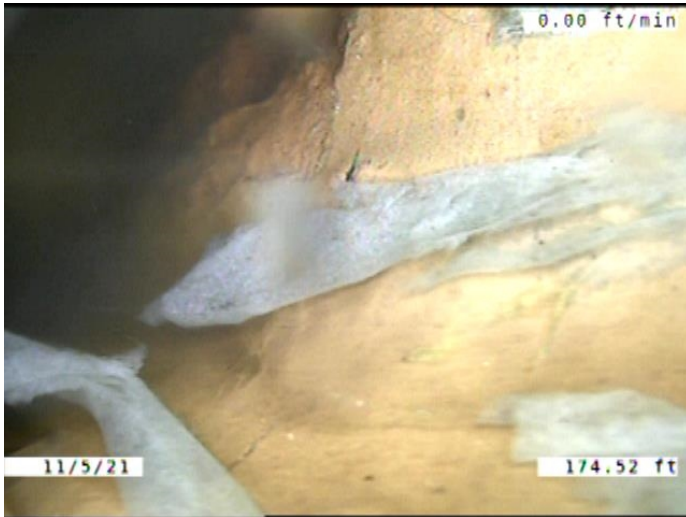
Code: **OBM**
 Description: **Obstruction Pipe Material in Invert**

Distance (ft): **174.5**
 Structural Grade: **0**
 O&M Grade: **2**
 Clock Start/From: **4**
 Clock To: **8**
 1st Value:
 2nd Value:
 Value Percent: **10.000**
 Continuous Index:
 Within 8" of Joint: **YES**
 Remarks:

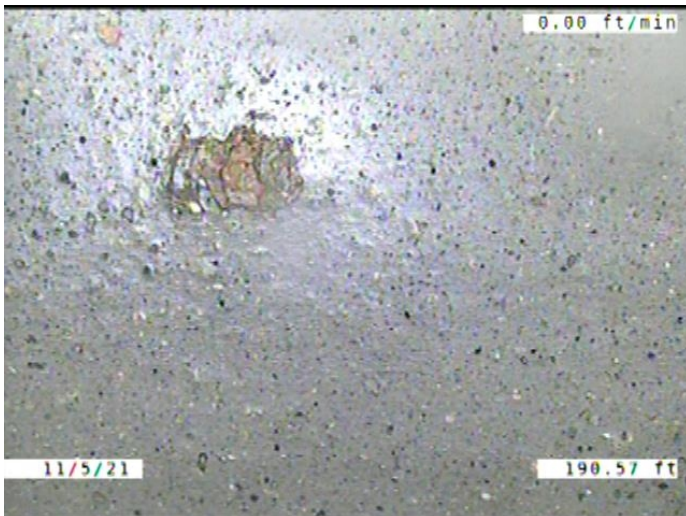
Code: **SSS**
 Description: **Surface Damage Surface Spalling**

Distance (ft): **190.6**
 Structural Grade: **2**
 O&M Grade: **0**
 Clock Start/From: **1**
 Clock To:
 1st Value:
 2nd Value:
 Value Percent:
 Continuous Index:
 Within 8" of Joint: **NO**
 Remarks:

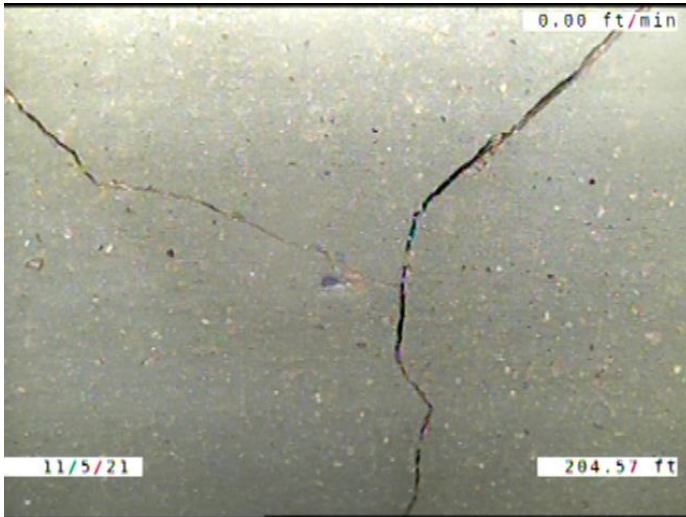
Code: **FM**
 Description: **Fracture Multiple**

Distance (ft): **204.6**
 Structural Grade: **4**
 O&M Grade: **0**
 Clock Start/From: **11**
 Clock To: **1**
 1st Value:
 2nd Value:
 Value Percent:
 Continuous Index:
 Within 8" of Joint: **YES**
 Remarks:

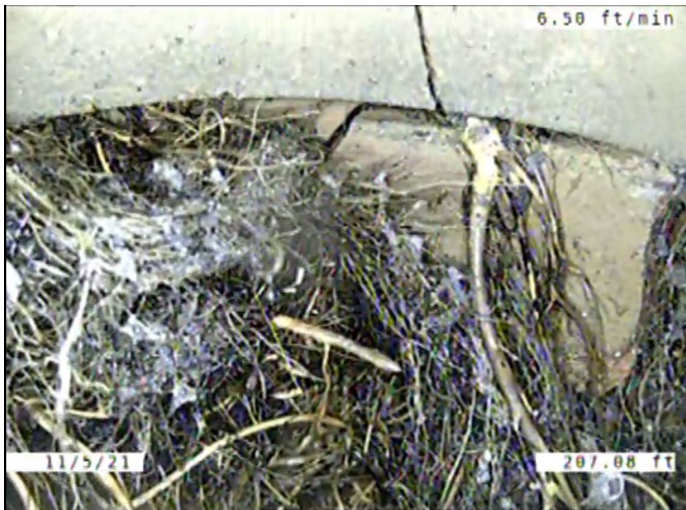
Code: **B**
 Description: **Broken**

Distance (ft): **207.1**
 Structural Grade: **4**
 O&M Grade: **0**
 Clock Start/From: **12**
 Clock To: **1**
 1st Value:
 2nd Value:
 Value Percent:
 Continuous Index:
 Within 8" of Joint: **YES**
 Remarks:

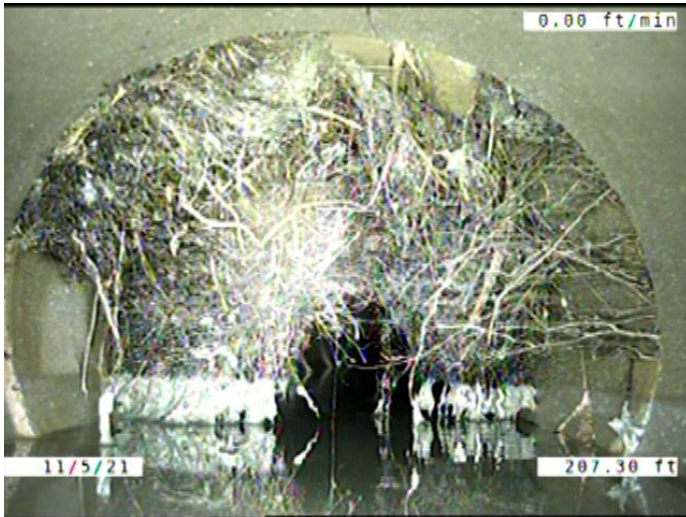
Code: **RBB**
 Description: **Roots Ball Barrel**

Distance (ft): **207.3**
 Structural Grade: **0**
 O&M Grade: **5**
 Clock Start/From: **9**
 Clock To: **4**
 1st Value:
 2nd Value:
 Value Percent: **75.000**
 Continuous Index:
 Within 8" of Joint: **NO**
 Remarks:

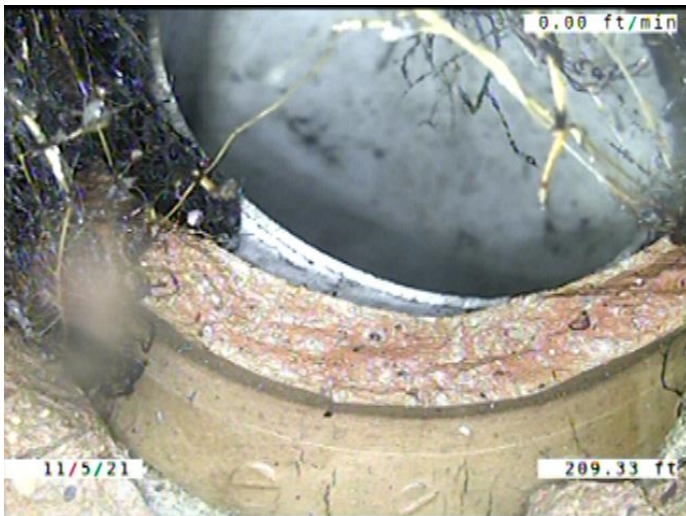
Code: **TBD**
 Description: **Tap Break-in/Hammer Defective**

Distance (ft): **209.3**
 Structural Grade: **0**
 O&M Grade: **3**
 Clock Start/From: **11**
 Clock To:
 1st Value: **4.000**
 2nd Value:
 Value Percent:
 Continuous Index:
 Within 8" of Joint: **YES**
 Remarks: **ROOTS GROWING AROUND IT AND INTO THE MAIN**

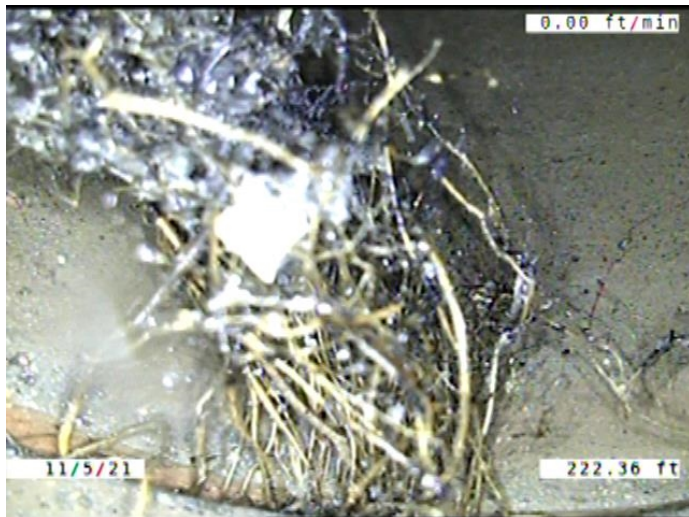
Code: **RMJ**
 Description: **Roots Medium Joint**

Distance (ft): **222.4**
 Structural Grade: **0**
 O&M Grade: **3**
 Clock Start/From: **9**
 Clock To: **3**
 1st Value:
 2nd Value:
 Value Percent: **5.000**
 Continuous Index:
 Within 8" of Joint: **YES**
 Remarks:

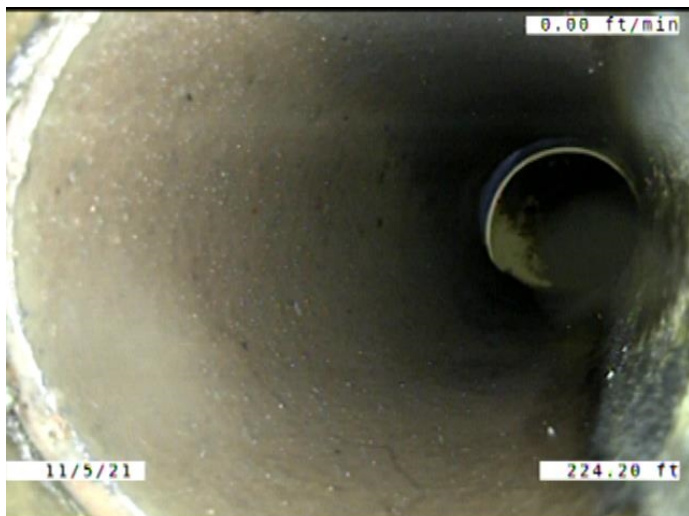
Code: **TBI**
 Description: **Tap Break-in Intruding**

Distance (ft): **224.2**
 Structural Grade: **0**
 O&M Grade: **2**
 Clock Start/From: **12**
 Clock To:
 1st Value: **4.000**
 2nd Value: **2.000**
 Value Percent:
 Continuous Index:
 Within 8" of Joint: **YES**
 Remarks: **CONSTANTLY RUNNING WATER**

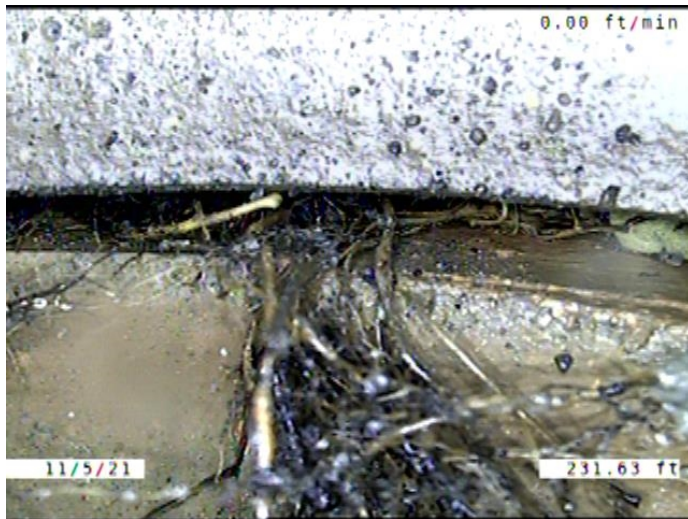
Code: **RMJ**
 Description: **Roots Medium Joint**

Distance (ft): **231.6**
 Structural Grade: **0**
 O&M Grade: **3**
 Clock Start/From: **2**
 Clock To: **4**
 1st Value:
 2nd Value:
 Value Percent: **5.000**
 Continuous Index:
 Within 8" of Joint: **YES**
 Remarks:

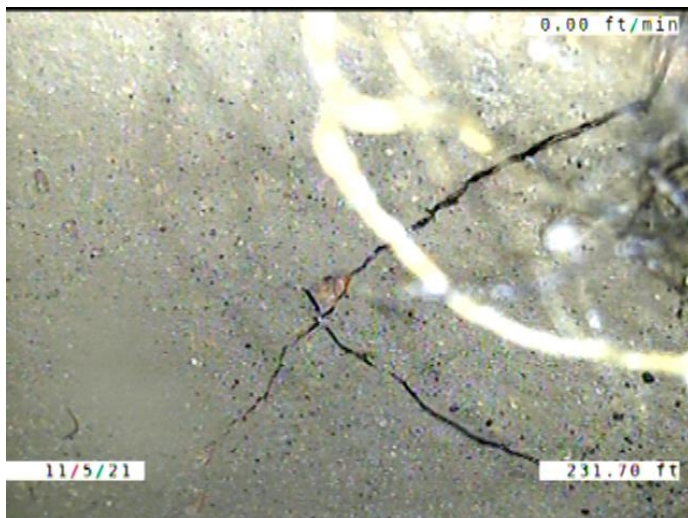
Code: **FS**
 Description: **Fracture Spiral**

Distance (ft): **231.7**
 Structural Grade: **3**
 O&M Grade: **0**
 Clock Start/From: **2**
 Clock To: **3**
 1st Value:
 2nd Value:
 Value Percent:
 Continuous Index:
 Within 8" of Joint: **YES**
 Remarks:

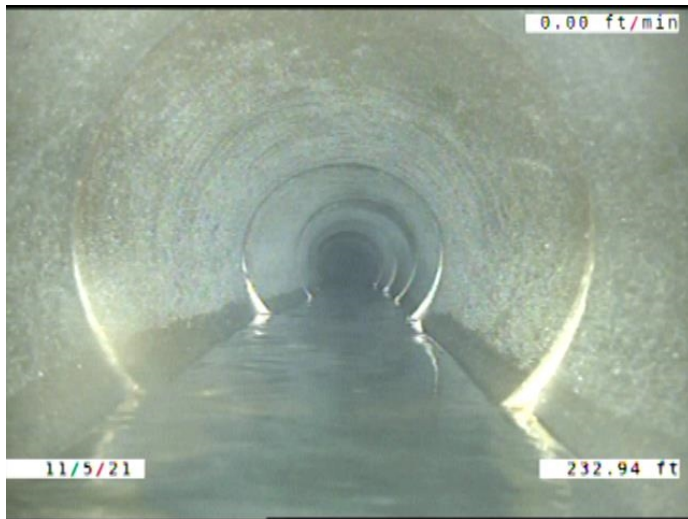
Code: **RFJ**
Description: **Roots Fine Joint**

Distance (ft): **232.9**
Structural Grade: **0**
O&M Grade: **1**
Clock Start/From: **9**
Clock To: **3**
1st Value:
2nd Value:
Value Percent:
Continuous Index: **F04**
Within 8" of Joint: **YES**
Remarks:

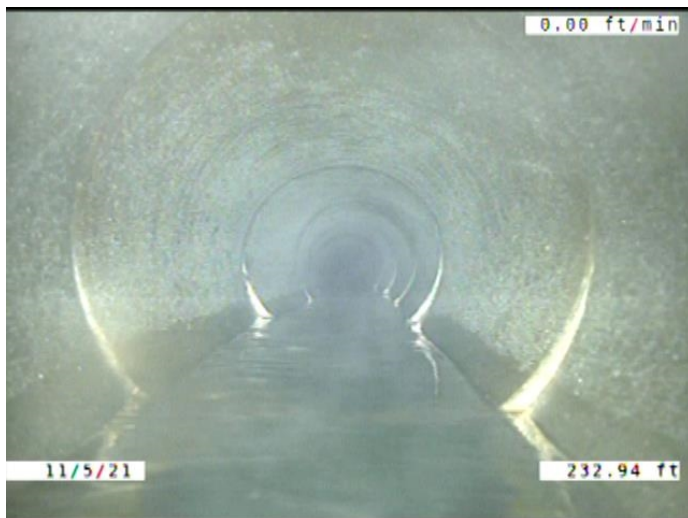
Code: **DSF**
Description: **Deposits Settled Fine**

Distance (ft): **232.9**
Structural Grade: **0**
O&M Grade: **2**
Clock Start/From: **5**
Clock To: **7**
1st Value:
2nd Value:
Value Percent: **5.000**
Continuous Index: **F03**
Within 8" of Joint: **YES**
Remarks:

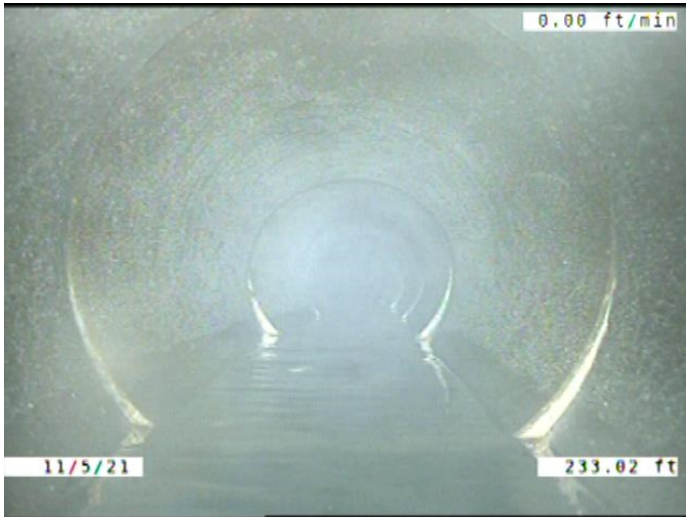
Code:	MSA
Description:	Miscellaneous Survey Abandoned
Distance (ft):	233.0
Structural Grade:	0
O&M Grade:	0
Clock Start/From:	
Clock To:	
1st Value:	
2nd Value:	
Value Percent:	
Continuous Index:	
Within 8" of Joint:	NO
Remarks:	MADE IT TO THE POINT OF OVERLAP. REVERSAL COMPLETE.
