Profile/Photo Observation Report

Date:	04/22/2018	Weather:		Coding:	PACP 6.0
Pipe Length (ft):	313.0	Owner:	NA	Pre Clean:	No Pre-Cleaning
P.O.#:		Surveyor:	Mark Ruby	PSR:	P-504-058-057
Customer:		Clean Date:	01/01/1900	Shape:	C

Street:	W HOME AVE	Flow Control:	Not Controlled
City:	Hobart, IN	Year Renewed:	
Location:	Light Highway	Tape/Media #:	
Purpose:	Routine Assessment	Dia/Height:	10"
Use:	Sanitary	Material:	VCP
Drain Area:	NA	Lining:	
Category:	NA		
Comment:	P_C at 108 ft part of broken pipe . Flow direction wrong		
Location Details:		Direction of Survey:	Downstream
US MH:	M-504-057	DS MH:	M-504-058
		Total Length Surveyed (ft):	110.0

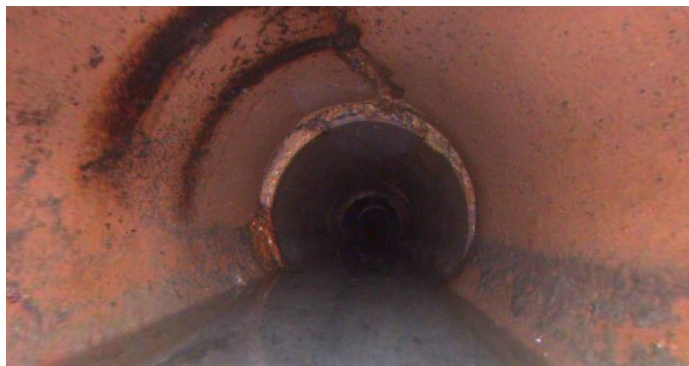
Code: **AMH**
 Description: **Manhole**

Distance (ft): **.0**
 Structural Grade: **0**
 O&M Grade: **0**
 Clock Start/From:
 Clock To:
 1st Value:
 2nd Value:
 Value Percent:
 Continuous Index:
 Within 8" of Joint: **NO**
 Remarks: **M-504-057**

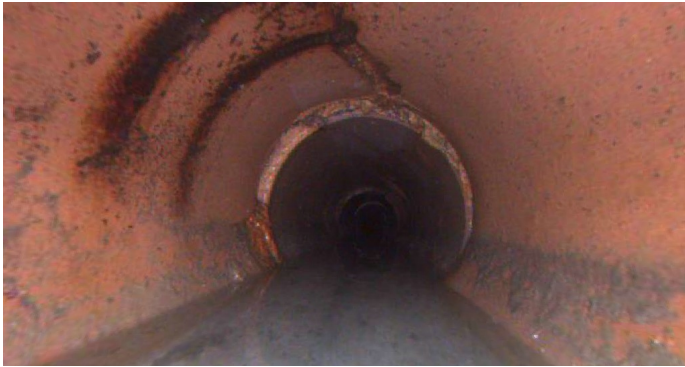
Code:	MWL
Description:	Water Level

Distance (ft):	.0
Structural Grade:	0
O&M Grade:	0
Clock Start/From:	
Clock To:	
1st Value:	
2nd Value:	
Value Percent:	10.000
Continuous Index:	
Within 8" of Joint:	NO
Remarks:

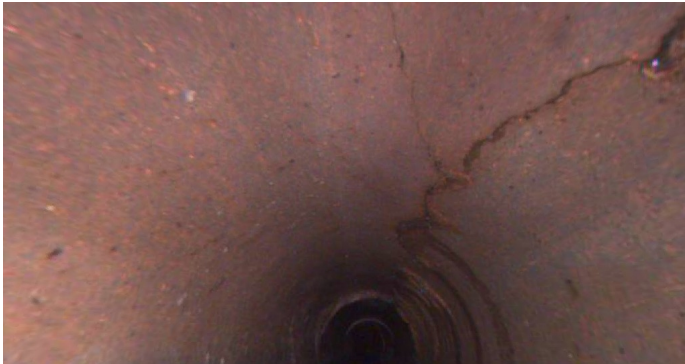
Code:	CM
Description:	Crack Multiple

Distance (ft):	2.5
Structural Grade:	3
O&M Grade:	0
Clock Start/From:	1
Clock To:	5
1st Value:	
2nd Value:	
Value Percent:	
Continuous Index:	
Within 8" of Joint:	
Remarks:

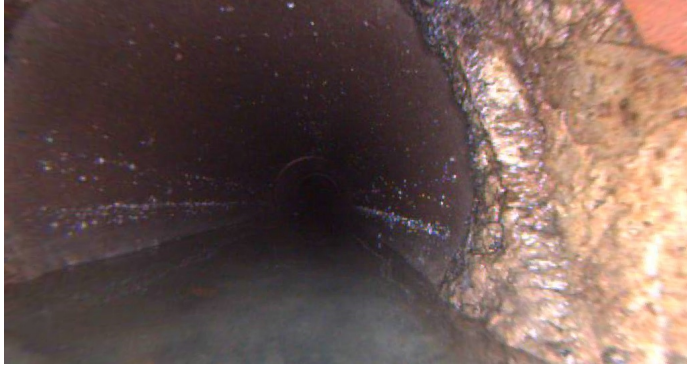
Code:	DAZ
Description:	Deposits Attached Other
Distance (ft):	19.9
Structural Grade:	0
O&M Grade:	2
Clock Start/From:	7
Clock To:	5
1st Value:	
2nd Value:	
Value Percent:	5.000
Continuous Index:	
Within 8" of Joint:	NO
Remarks:

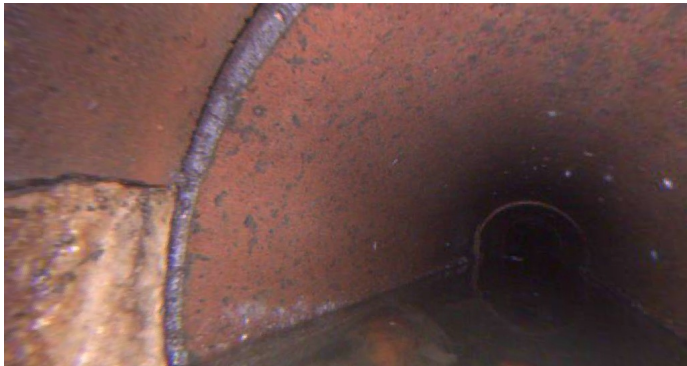
Code:	CL
Description:	Crack Longitudinal
Distance (ft):	41.0
Structural Grade:	2
O&M Grade:	0
Clock Start/From:	8
Clock To:	
1st Value:	
2nd Value:	
Value Percent:	
Continuous Index:	
Within 8" of Joint:	YES
Remarks:

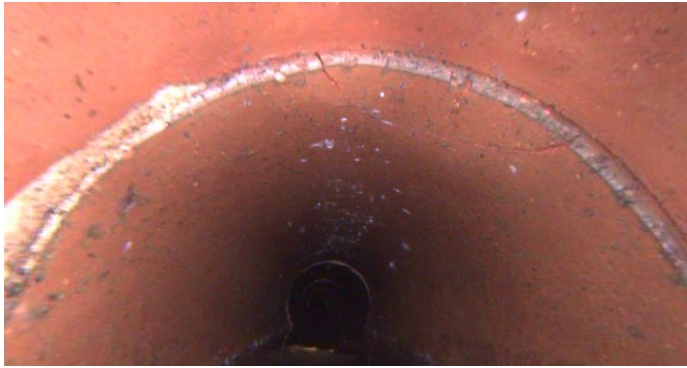
Code: **CS**
Description: **Crack Spiral**

Distance (ft): **46.9**
Structural Grade: **2**
O&M Grade: **0**
Clock Start/From: **11**
Clock To: **2**
1st Value:
2nd Value:
Value Percent:
Continuous Index:
Within 8" of Joint: **YES**
Remarks:

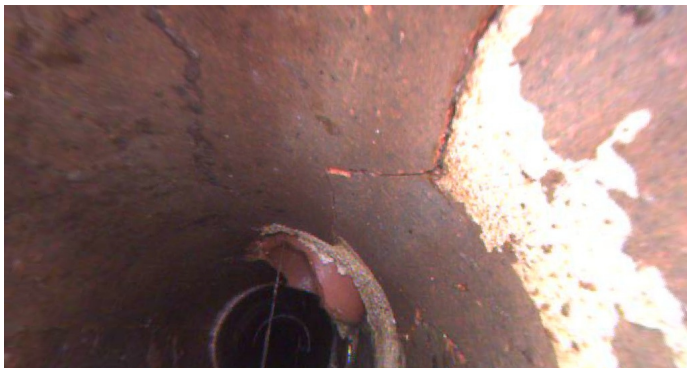
Code: **CM**
Description: **Crack Multiple**

Distance (ft): **59.7**
Structural Grade: **3**
O&M Grade: **0**
Clock Start/From: **7**
Clock To: **5**
1st Value:
2nd Value:
Value Percent:
Continuous Index: **S01**
Within 8" of Joint:
Remarks:

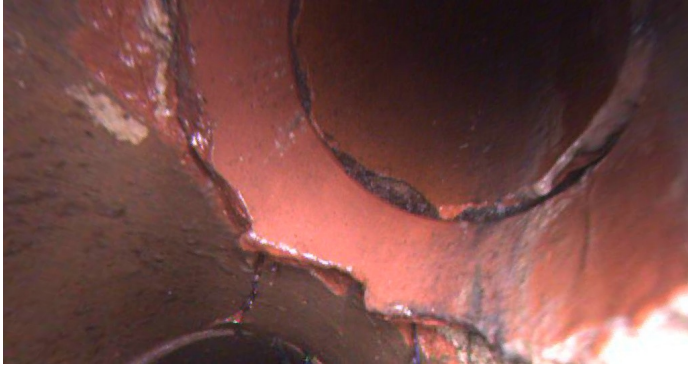
Code: **TB**
Description: **Tap Break-in**

Distance (ft): **61.0**
Structural Grade: **0**
O&M Grade: **0**
Clock Start/From: **2**
Clock To:
1st Value: **4.000**
2nd Value:
Value Percent:
Continuous Index:
Within 8" of Joint:
Remarks:

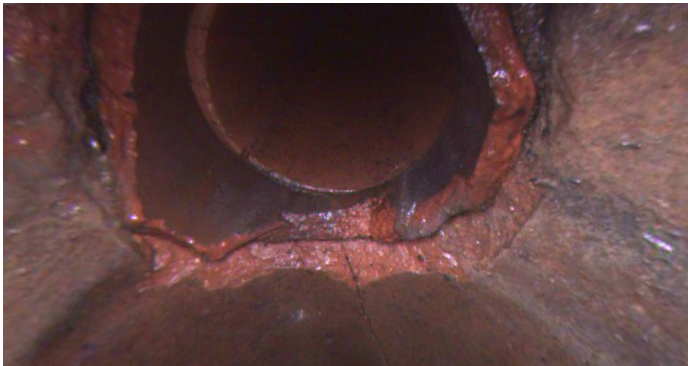
Code: **TB**
Description: **Tap Break-in**

Distance (ft): **66.0**
Structural Grade: **0**
O&M Grade: **0**
Clock Start/From: **12**
Clock To:
1st Value: **4.000**
2nd Value:
Value Percent:
Continuous Index:
Within 8" of Joint:
Remarks:

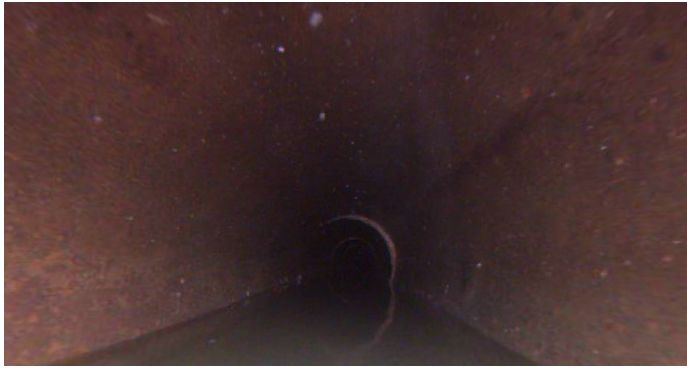
Code: **CM**
Description: **Crack Multiple**

Distance (ft): **71.4**
Structural Grade: **3**
O&M Grade: **0**
Clock Start/From: **7**
Clock To: **5**
1st Value:
2nd Value:
Value Percent:
Continuous Index: **F01**
Within 8" of Joint:
Remarks:

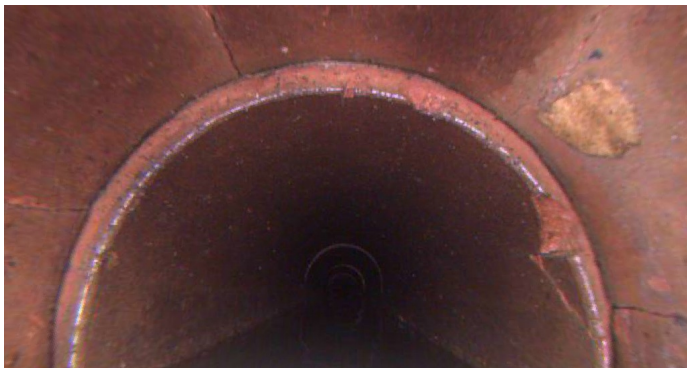
Code: **CM**
Description: **Crack Multiple**

Distance (ft): **79.9**
Structural Grade: **3**
O&M Grade: **0**
Clock Start/From: **7**
Clock To: **5**
1st Value:
2nd Value:
Value Percent:
Continuous Index:
Within 8" of Joint: **YES**
Remarks:

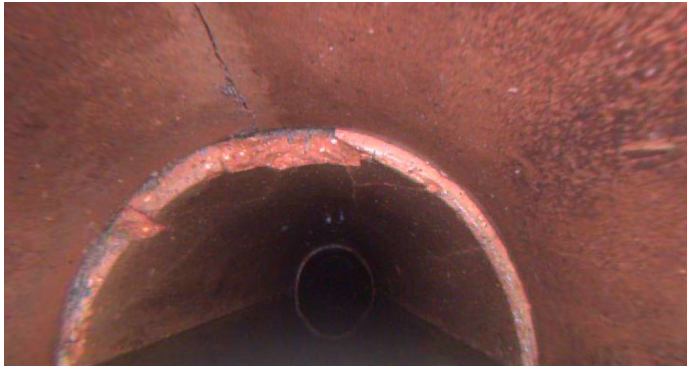
Code: **CM**
Description: **Crack Multiple**

Distance (ft): **88.8**
Structural Grade: **3**
O&M Grade: **0**
Clock Start/From: **7**
Clock To: **5**
1st Value:
2nd Value:
Value Percent:
Continuous Index:
Within 8" of Joint: **YES**
Remarks:

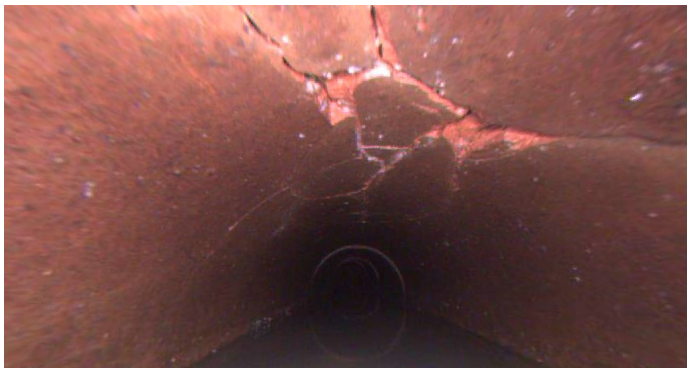
Code: **FM**
Description: **Fracture Multiple**

Distance (ft): **92.6**
Structural Grade: **4**
O&M Grade: **0**
Clock Start/From: **7**
Clock To: **5**
1st Value:
2nd Value:
Value Percent:
Continuous Index:
Within 8" of Joint:
Remarks:

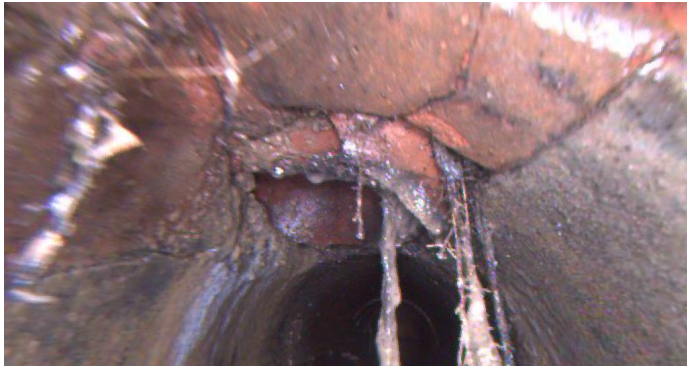
Code: **FM**
Description: **Fracture Multiple**

Distance (ft): **104.4**
Structural Grade: **4**
O&M Grade: **0**
Clock Start/From: **7**
Clock To: **2**
1st Value:
2nd Value:
Value Percent:
Continuous Index:
Within 8" of Joint:
Remarks:

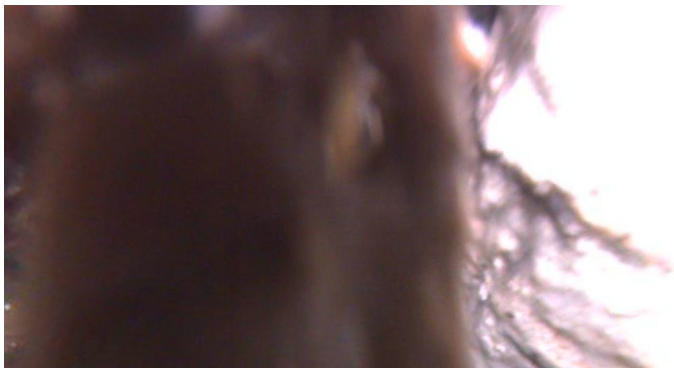
Code: **TBD**
Description: **Tap Break-in Defective**

Distance (ft): **105.1**
Structural Grade: **0**
O&M Grade: **3**
Clock Start/From: **12**
Clock To:
1st Value: **4.000**
2nd Value:
Value Percent:
Continuous Index:
Within 8" of Joint:
Remarks: **debris**

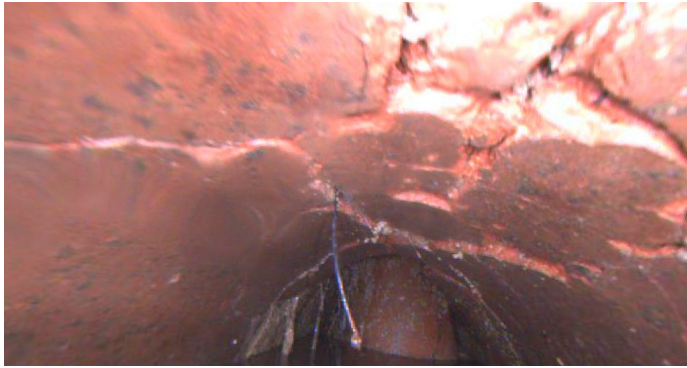
Code: **FM**
Description: **Fracture Multiple**

Distance (ft): **108.0**
Structural Grade: **4**
O&M Grade: **0**
Clock Start/From: **7**
Clock To: **5**
1st Value:
2nd Value:
Value Percent:
Continuous Index:
Within 8" of Joint:
Remarks:

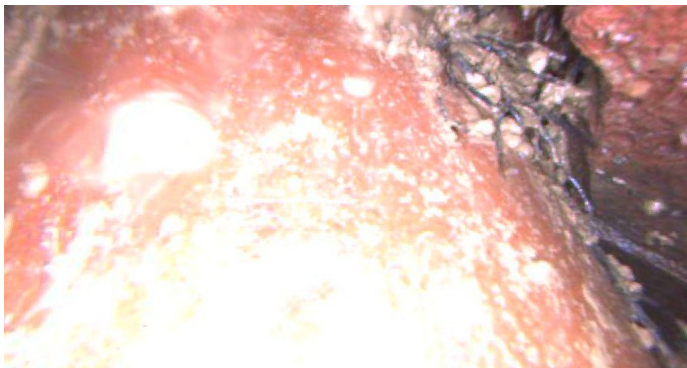
Code: **TBI**
Description: **Tap Break-in Intruding**

Distance (ft): **110.0**
Structural Grade: **0**
O&M Grade: **2**
Clock Start/From: **12**
Clock To:
1st Value: **4.000**
2nd Value: **4.000**
Value Percent:
Continuous Index:
Within 8" of Joint:
Remarks:

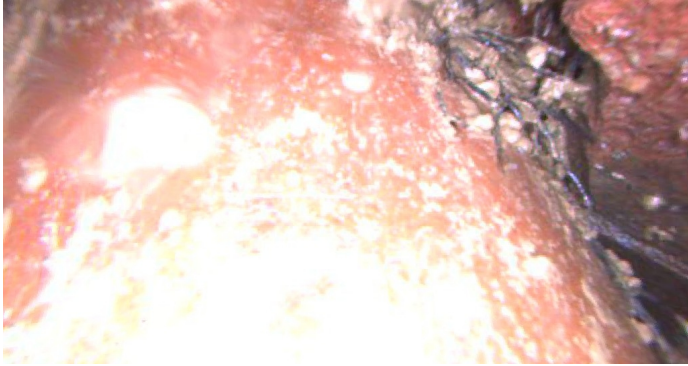
Code:	MSA
Description:	Abandoned Survey
Distance (ft):	110.0
Structural Grade:	0
O&M Grade:	0
Clock Start/From:	
Clock To:	
1st Value:	
2nd Value:	
Value Percent:	
Continuous Index:	
Within 8" of Joint:	NO
Remarks:	TBI
