Profile/Photo Observation Report

Date:	04/22/2018	Weather:		Coding:	PACP 6.0
Pipe Length (ft):	313.0	Owner:	NA	Pre Clean:	No Pre-Cleaning
P.O.#:		Surveyor:	Mark Ruby	PSR:	P-504-058-057
Customer:		Clean Date:	01/01/1900	Shape:	C

Street:	FOXCROFT STREET	Flow Control:	Not Controlled
City:	Hobart, IN	Year Renewed:	
Location:	Light Highway	Tape/Media #:	
Purpose:	Routine Assessment	Dia/Height:	10"
Use:	Sanitary	Material:	VCP
Drain Area:	NA	Lining:	
Category:	NA		
Comment:	P_C at 108 ft part of broken pipe . Flow direction wrong		
Location Details:		Direction of Survey:	Downstream
US MH:	M-504-057	DS MH:	M-504-058
		Total Length Surveyed (ft):	110.0

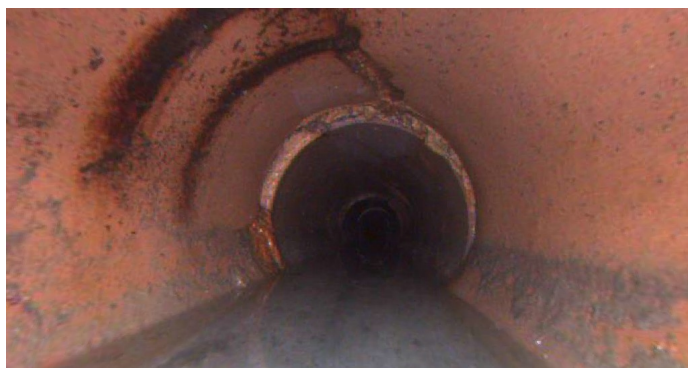
Code: **AMH**
 Description: **Manhole**

Distance (ft): **.0**
 Structural Grade: **0**
 O&M Grade: **0**
 Clock Start/From:
 Clock To:
 1st Value:
 2nd Value:
 Value Percent:
 Continuous Index:
 Within 8" of Joint: **NO**
 Remarks: **M-504-057**

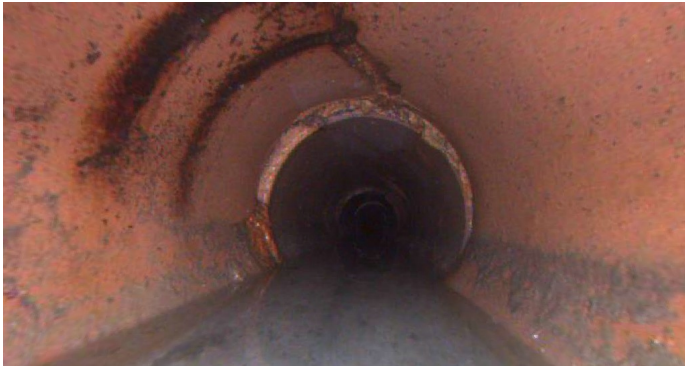
Code:	MWL
Description:	Water Level

Distance (ft):	.0
Structural Grade:	0
O&M Grade:	0
Clock Start/From:	
Clock To:	
1st Value:	
2nd Value:	
Value Percent:	10.000
Continuous Index:	
Within 8" of Joint:	NO
Remarks:

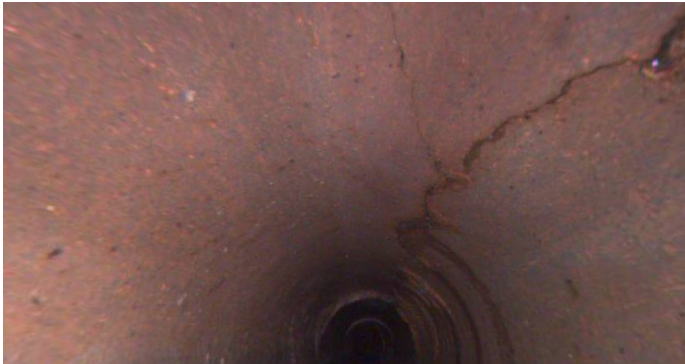
Code:	CM
Description:	Crack Multiple

Distance (ft):	2.5
Structural Grade:	3
O&M Grade:	0
Clock Start/From:	1
Clock To:	5
1st Value:	
2nd Value:	
Value Percent:	
Continuous Index:	
Within 8" of Joint:	
Remarks:

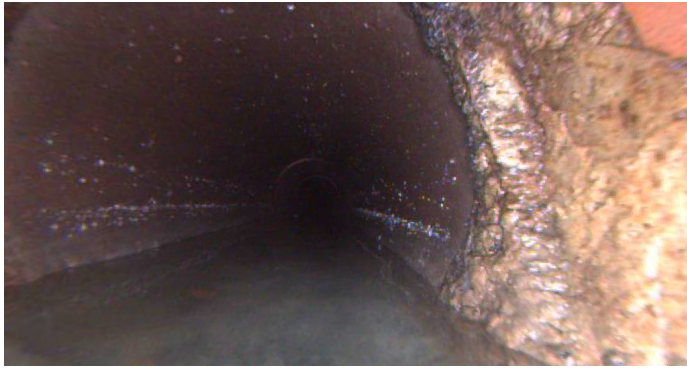
Code:	DAZ
Description:	Deposits Attached Other
Distance (ft):	19.9
Structural Grade:	0
O&M Grade:	2
Clock Start/From:	7
Clock To:	5
1st Value:	
2nd Value:	
Value Percent:	5.000
Continuous Index:	
Within 8" of Joint:	NO
Remarks:

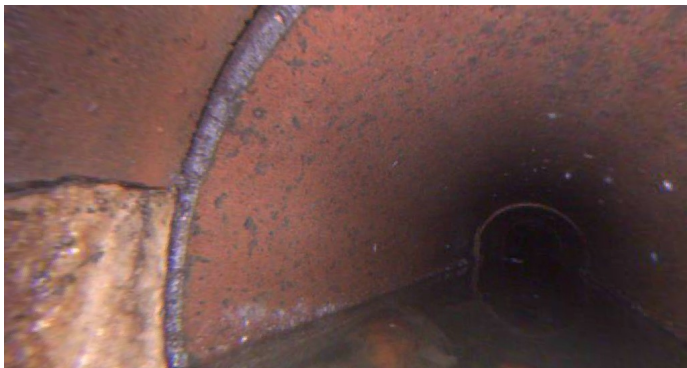
Code:	CL
Description:	Crack Longitudinal
Distance (ft):	41.0
Structural Grade:	2
O&M Grade:	0
Clock Start/From:	8
Clock To:	
1st Value:	
2nd Value:	
Value Percent:	
Continuous Index:	
Within 8" of Joint:	YES
Remarks:

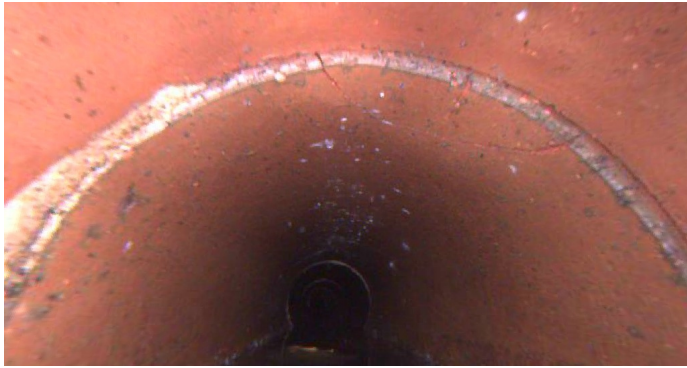
Code: **CS**
Description: **Crack Spiral**

Distance (ft): **46.9**
Structural Grade: **2**
O&M Grade: **0**
Clock Start/From: **11**
Clock To: **2**
1st Value:
2nd Value:
Value Percent:
Continuous Index:
Within 8" of Joint: **YES**
Remarks:

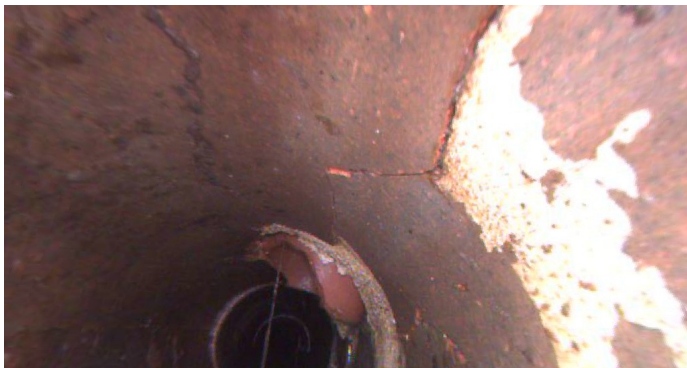
Code: **CM**
Description: **Crack Multiple**

Distance (ft): **59.7**
Structural Grade: **3**
O&M Grade: **0**
Clock Start/From: **7**
Clock To: **5**
1st Value:
2nd Value:
Value Percent:
Continuous Index: **S01**
Within 8" of Joint:
Remarks:

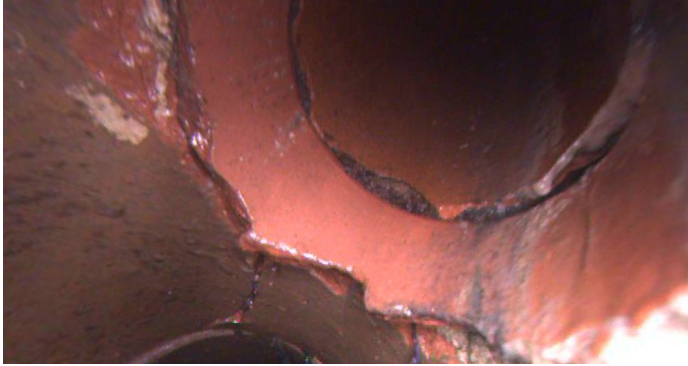
Code: **TB**
Description: **Tap Break-in**

Distance (ft): **61.0**
Structural Grade: **0**
O&M Grade: **0**
Clock Start/From: **2**
Clock To:
1st Value: **4.000**
2nd Value:
Value Percent:
Continuous Index:
Within 8" of Joint:
Remarks:

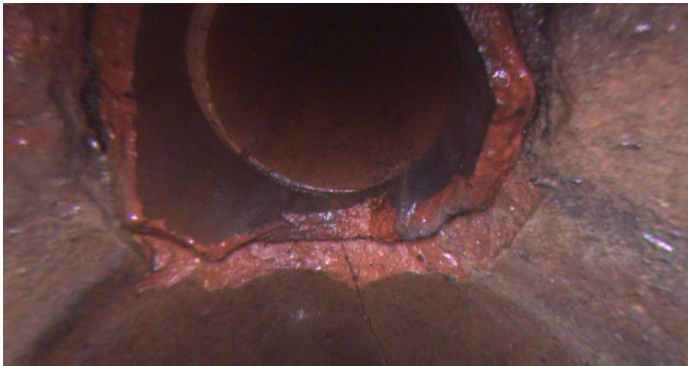
Code: **TB**
Description: **Tap Break-in**

Distance (ft): **66.0**
Structural Grade: **0**
O&M Grade: **0**
Clock Start/From: **12**
Clock To:
1st Value: **4.000**
2nd Value:
Value Percent:
Continuous Index:
Within 8" of Joint:
Remarks:

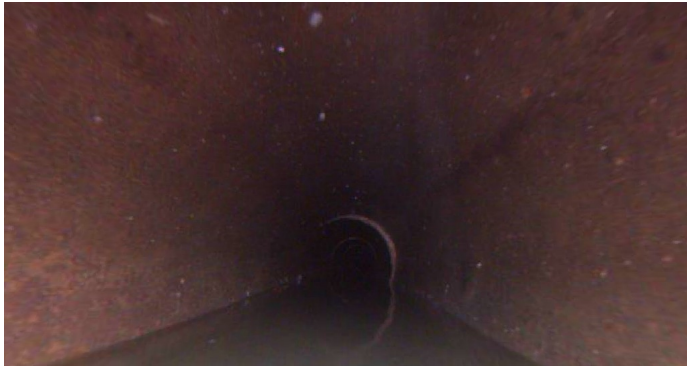
Code: **CM**
Description: **Crack Multiple**

Distance (ft): **71.4**
Structural Grade: **3**
O&M Grade: **0**
Clock Start/From: **7**
Clock To: **5**
1st Value:
2nd Value:
Value Percent:
Continuous Index: **F01**
Within 8" of Joint:
Remarks:

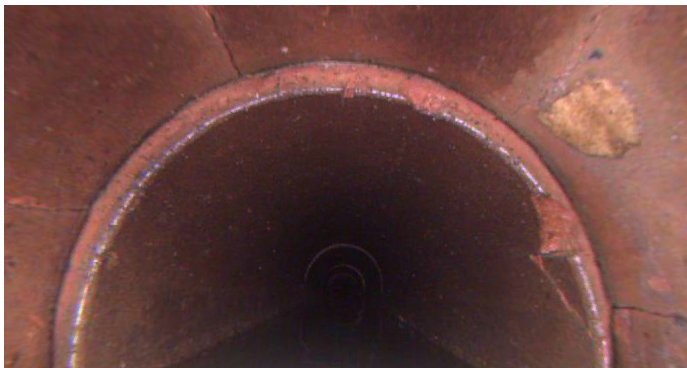
Code: **CM**
Description: **Crack Multiple**

Distance (ft): **79.9**
Structural Grade: **3**
O&M Grade: **0**
Clock Start/From: **7**
Clock To: **5**
1st Value:
2nd Value:
Value Percent:
Continuous Index:
Within 8" of Joint: **YES**
Remarks:

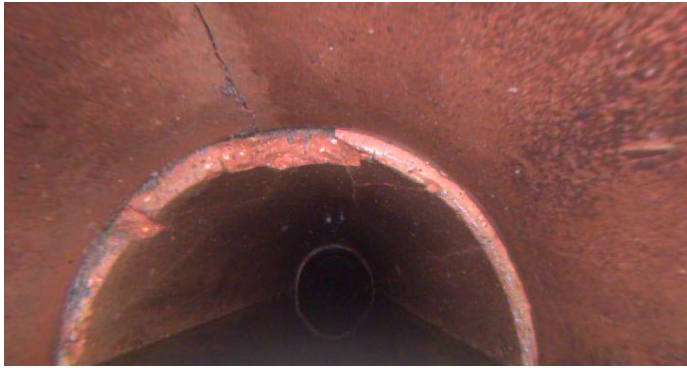
Code: **CM**
Description: **Crack Multiple**

Distance (ft): **88.8**
Structural Grade: **3**
O&M Grade: **0**
Clock Start/From: **7**
Clock To: **5**
1st Value:
2nd Value:
Value Percent:
Continuous Index:
Within 8" of Joint: **YES**
Remarks:

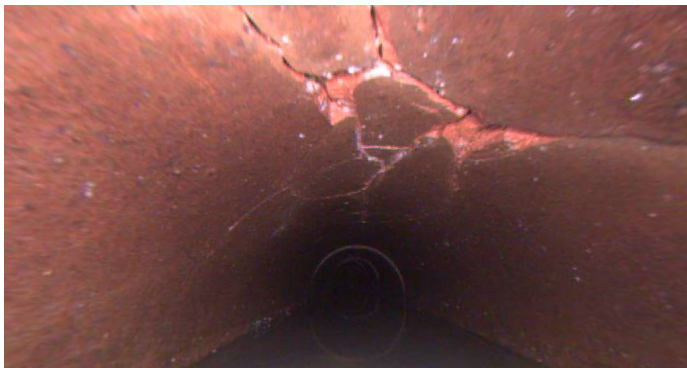
Code: **FM**
Description: **Fracture Multiple**

Distance (ft): **92.6**
Structural Grade: **4**
O&M Grade: **0**
Clock Start/From: **7**
Clock To: **5**
1st Value:
2nd Value:
Value Percent:
Continuous Index:
Within 8" of Joint:
Remarks:

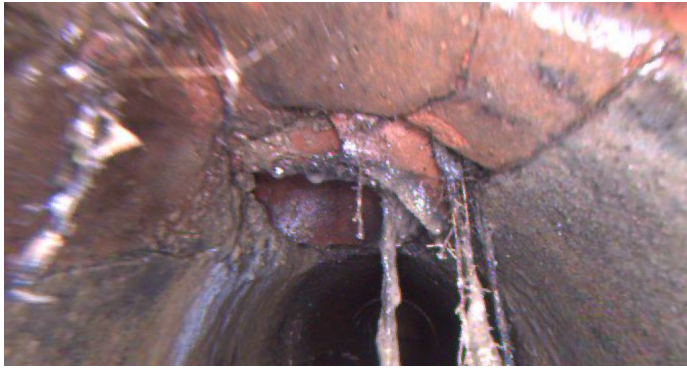
Code: **FM**
Description: **Fracture Multiple**

Distance (ft): **104.4**
Structural Grade: **4**
O&M Grade: **0**
Clock Start/From: **7**
Clock To: **2**
1st Value:
2nd Value:
Value Percent:
Continuous Index:
Within 8" of Joint:
Remarks:

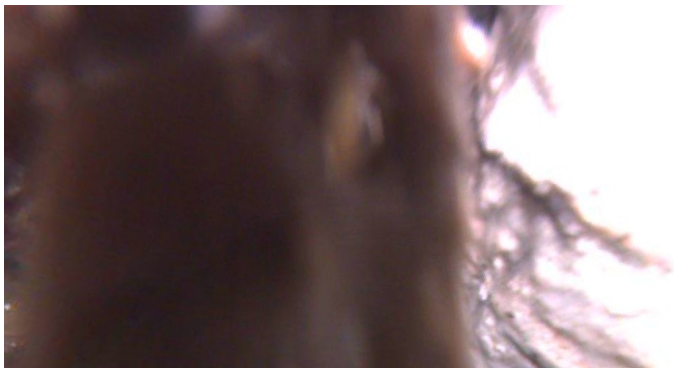
Code: **TBD**
Description: **Tap Break-in Defective**

Distance (ft): **105.1**
Structural Grade: **0**
O&M Grade: **3**
Clock Start/From: **12**
Clock To:
1st Value: **4.000**
2nd Value:
Value Percent:
Continuous Index:
Within 8" of Joint:
Remarks: **debris**

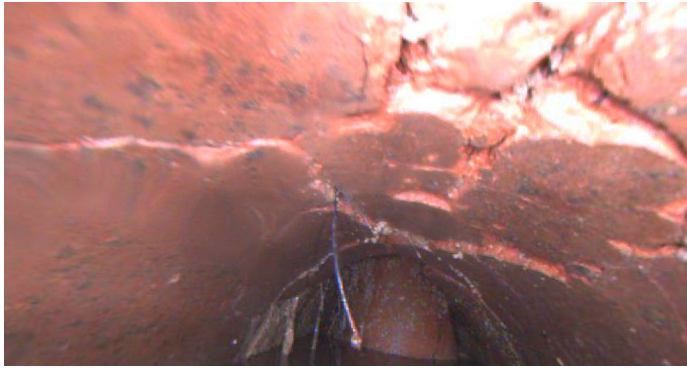
Code: **FM**
Description: **Fracture Multiple**

Distance (ft): **108.0**
Structural Grade: **4**
O&M Grade: **0**
Clock Start/From: **7**
Clock To: **5**
1st Value:
2nd Value:
Value Percent:
Continuous Index:
Within 8" of Joint:
Remarks:

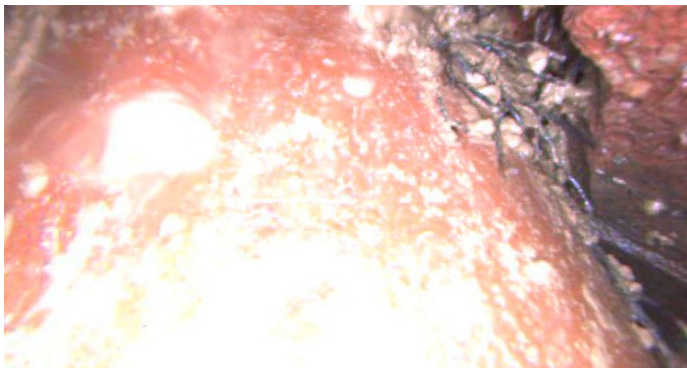
Code: **TBI**
Description: **Tap Break-in Intruding**

Distance (ft): **110.0**
Structural Grade: **0**
O&M Grade: **2**
Clock Start/From: **12**
Clock To:
1st Value: **4.000**
2nd Value: **4.000**
Value Percent:
Continuous Index:
Within 8" of Joint:
Remarks:

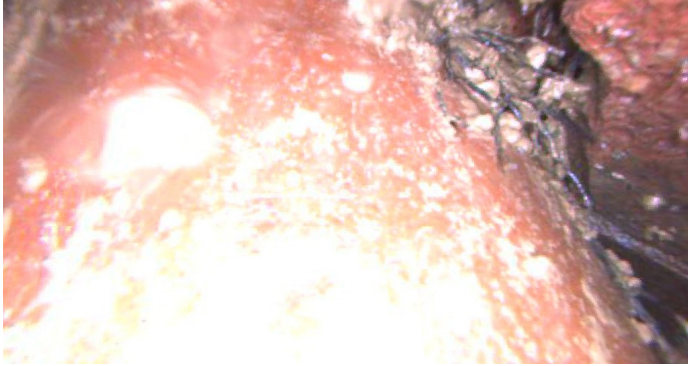
Code:	MSA
Description:	Abandoned Survey
Distance (ft):	110.0
Structural Grade:	0
O&M Grade:	0
Clock Start/From:	
Clock To:	
1st Value:	
2nd Value:	
Value Percent:	
Continuous Index:	
Within 8" of Joint:	NO
Remarks:	TBI
