Profile/Photo Observation Report

Date:	09/13/2021	Weather:		Coding:	PACP 7.0
Pipe Length (ft):	311.0	Owner:	City of Hobart	Pre Clean:	Light Cleaning
P.O.#:	YES502259	Surveyor:	S. Bucklin	PSR:	P-504-059-058
Customer:	City of Hobart	Clean Date:	09/07/2021	Shape:	C

Street:	North Wilson Street	Flow Control:	Not Controlled
City:	Hobart, IN	Year Renewed:	
Location:		Tape/Media #:	
Purpose:	Routine Assessment	Dia/Height:	10"
Use:	Sanitary Sewage Pipe	Material:	VCP
Drain Area:		Lining:	None
Category:	NA		
Comment:			
Location Details:		Direction of Survey:	Downstream
US MH:	M-504-058	DS MH:	M-504-059
		Total Length Surveyed (ft):	311.0

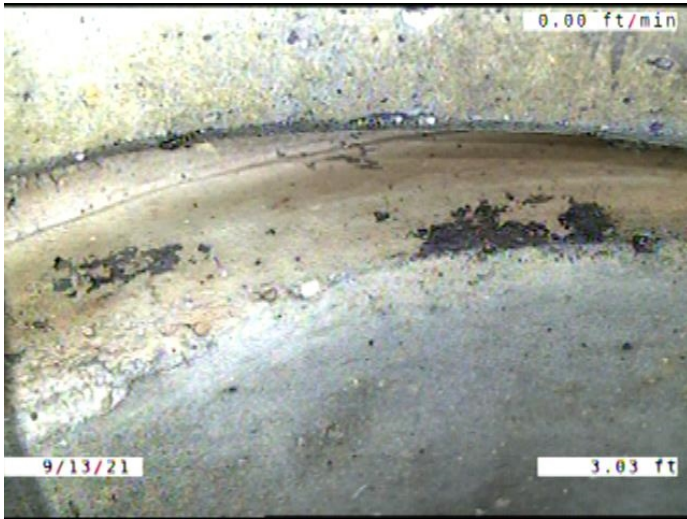
Code: **JAM**
Description: **Joint Angular Medium**

Distance (ft): **3.0**
Structural Grade: **3**
O&M Grade: **0**
Clock Start/From:
Clock To:
1st Value:
2nd Value:
Value Percent:
Continuous Index:
Within 8" of Joint: **NO**
Remarks:

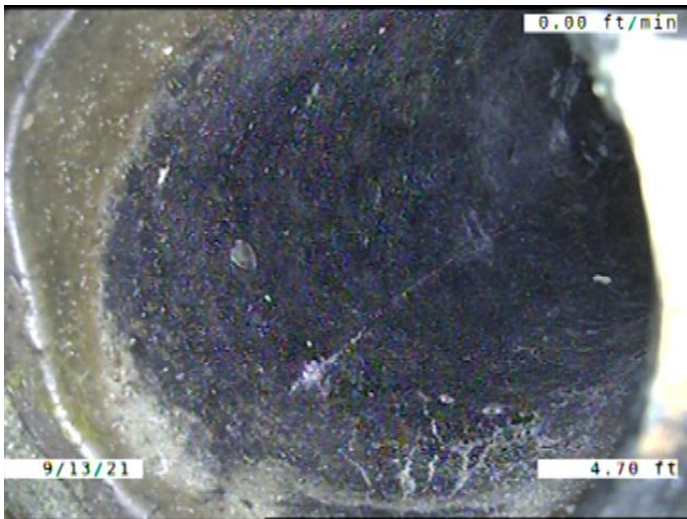
Code: **TBI**
Description: **Tap Break-in Intruding**

Distance (ft): **4.7**
Structural Grade: **0**
O&M Grade: **2**
Clock Start/From: **1**
Clock To:
1st Value: **4.000**
2nd Value: **1.000**
Value Percent:
Continuous Index:
Within 8" of Joint: **YES**
Remarks:

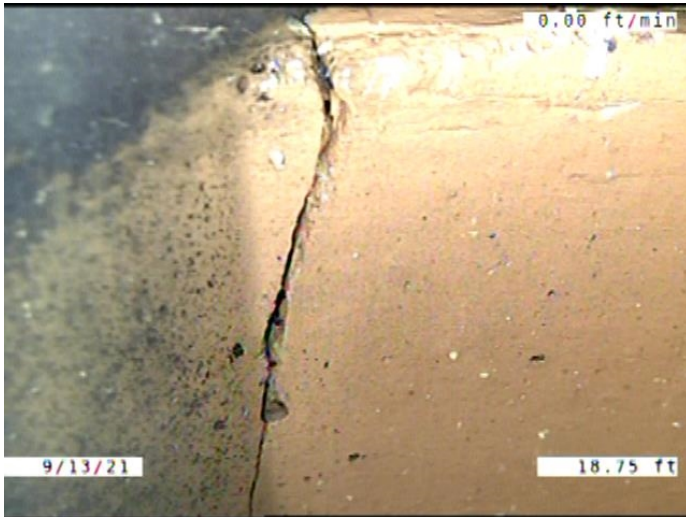
Code: **FL**
Description: **Fracture Longitudinal**

Distance (ft): **18.8**
Structural Grade: **3**
O&M Grade: **0**
Clock Start/From: **8**
Clock To:
1st Value:
2nd Value:
Value Percent:
Continuous Index:
Within 8" of Joint: **YES**
Remarks:

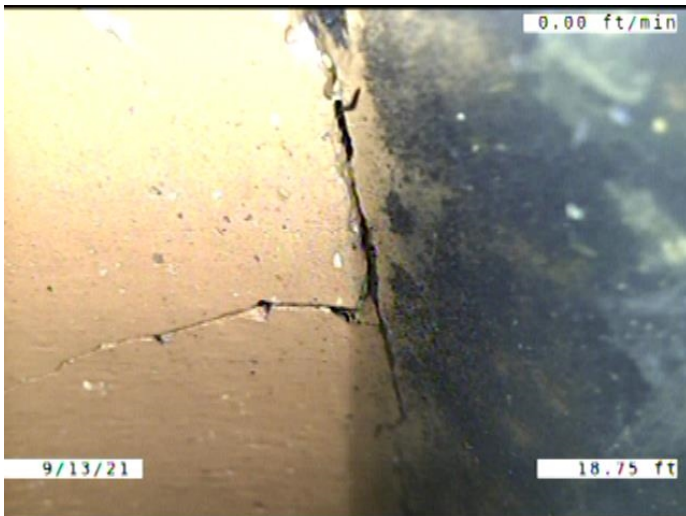
Code: **FM**
Description: **Fracture Multiple**

Distance (ft): **18.8**
Structural Grade: **4**
O&M Grade: **0**
Clock Start/From: **1**
Clock To: **4**
1st Value:
2nd Value:
Value Percent:
Continuous Index:
Within 8" of Joint: **YES**
Remarks:

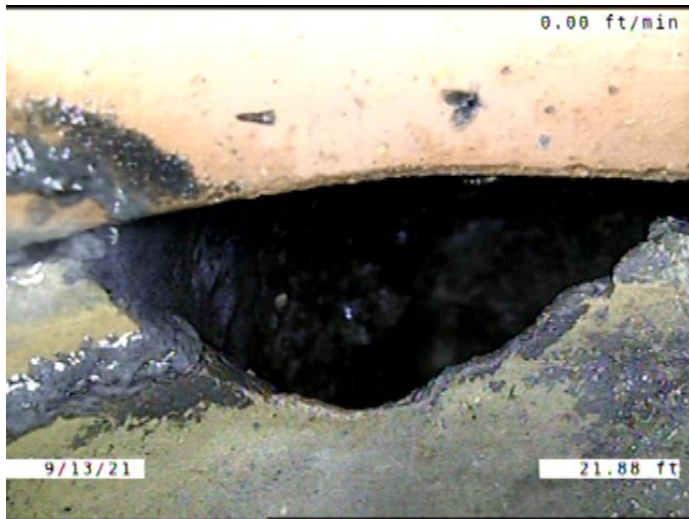
Code: **HSV**
Description: **Hole Soil Visible**

Distance (ft): **21.9**
Structural Grade: **5**
O&M Grade: **0**
Clock Start/From: **8**
Clock To: **9**
1st Value:
2nd Value:
Value Percent:
Continuous Index:
Within 8" of Joint: **YES**
Remarks:

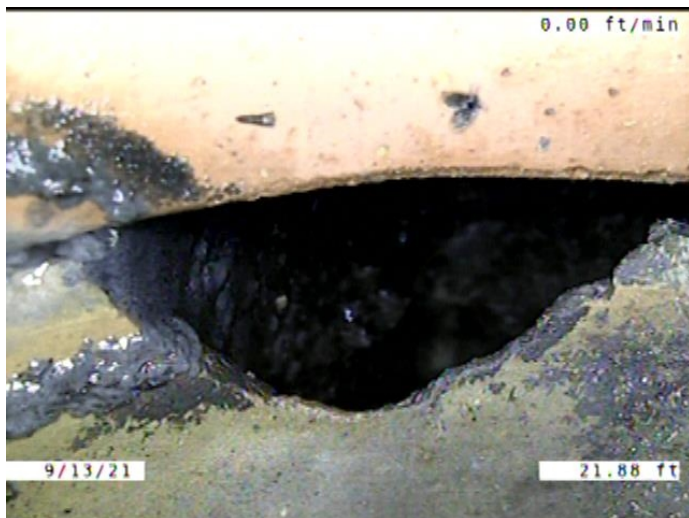
Code: **IRB**
Description: **Infiltration Runner Barrel**

Distance (ft): **21.9**
Structural Grade: **0**
O&M Grade: **4**
Clock Start/From: **8**
Clock To: **9**
1st Value:
2nd Value:
Value Percent:
Continuous Index:
Within 8" of Joint: **YES**
Remarks:

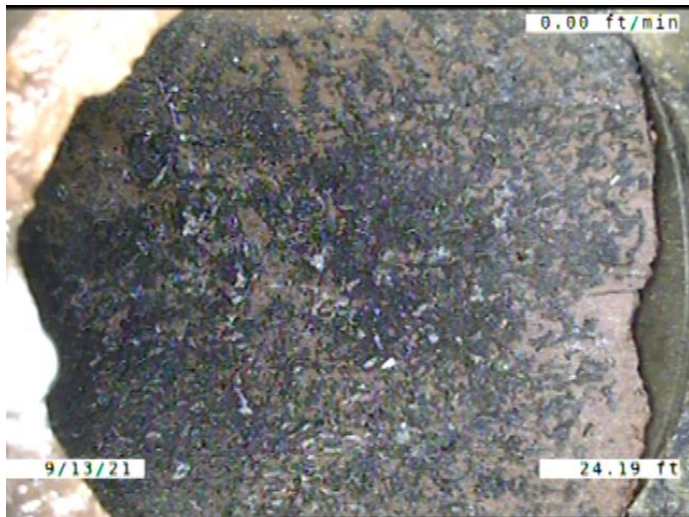
Code: **TBD**
 Description: **Tap Break-in/Hammer Defective**

Distance (ft): **24.2**
 Structural Grade: **0**
 O&M Grade: **3**
 Clock Start/From: **11**
 Clock To:
 1st Value: **4.000**
 2nd Value:
 Value Percent:
 Continuous Index:
 Within 8" of Joint: **NO**
 Remarks: **Defective**

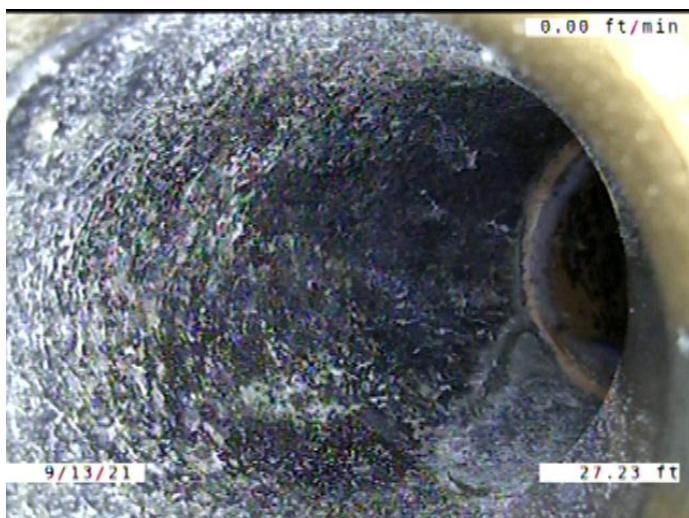
Code: **TBI**
 Description: **Tap Break-in Intruding**

Distance (ft): **27.2**
 Structural Grade: **0**
 O&M Grade: **2**
 Clock Start/From: **1**
 Clock To:
 1st Value: **4.000**
 2nd Value: **1.000**
 Value Percent:
 Continuous Index:
 Within 8" of Joint: **NO**
 Remarks:

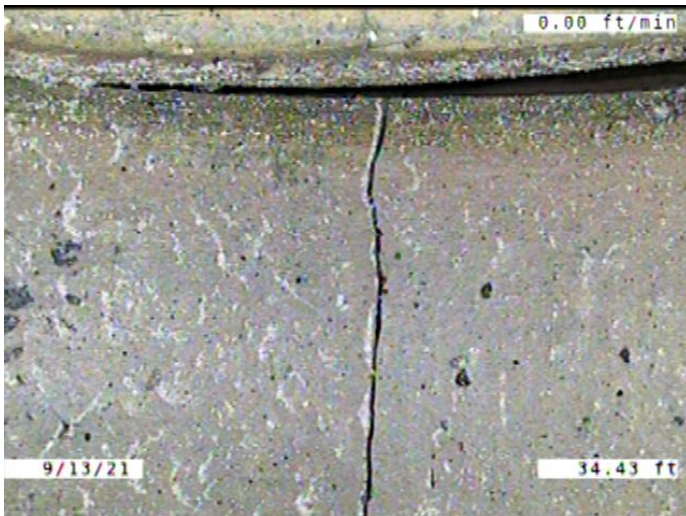
Code: **CL**
Description: **Crack Longitudinal**

Distance (ft): **34.4**
Structural Grade: **2**
O&M Grade: **0**
Clock Start/From: **1**
Clock To:
1st Value:
2nd Value:
Value Percent:
Continuous Index:
Within 8" of Joint: **YES**
Remarks:

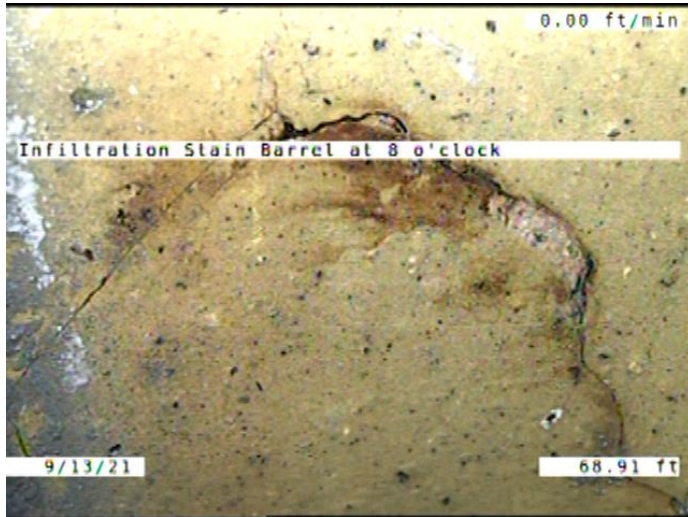
Code: **ISB**
 Description: **Infiltration Stain Barrel**

Distance (ft): **68.9**
 Structural Grade: **0**
 O&M Grade: **1**
 Clock Start/From: **8**
 Clock To:
 1st Value:
 2nd Value:
 Value Percent:
 Continuous Index:
 Within 8" of Joint: **NO**
 Remarks:

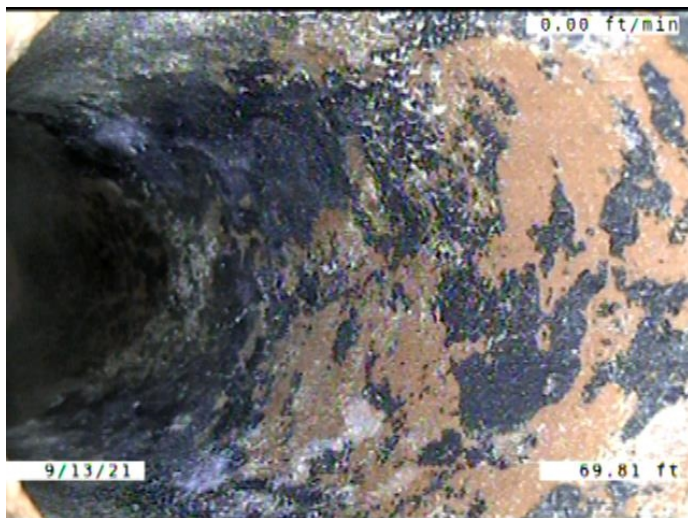
Code: **TBI**
 Description: **Tap Break-in Intruding**

Distance (ft): **69.8**
 Structural Grade: **0**
 O&M Grade: **2**
 Clock Start/From: **10**
 Clock To:
 1st Value: **4.000**
 2nd Value: **2.000**
 Value Percent:
 Continuous Index:
 Within 8" of Joint: **NO**
 Remarks:

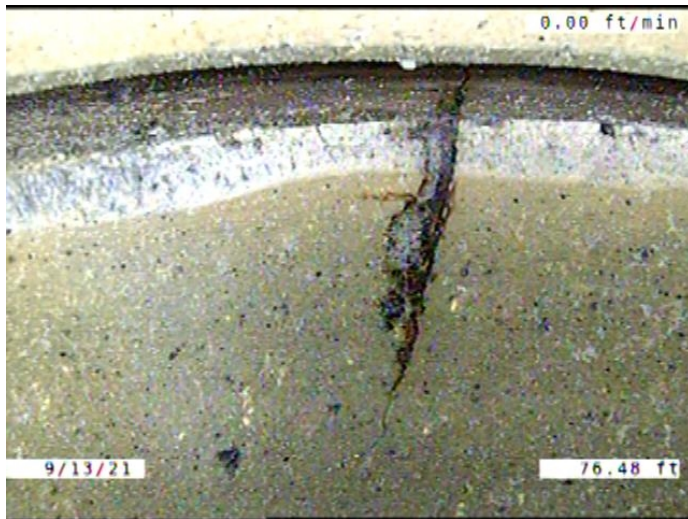
Code: **CL**
 Description: **Crack Longitudinal**

Distance (ft): **76.5**
 Structural Grade: **2**
 O&M Grade: **0**
 Clock Start/From: **11**
 Clock To:
 1st Value:
 2nd Value:
 Value Percent:
 Continuous Index:
 Within 8" of Joint: **YES**
 Remarks:

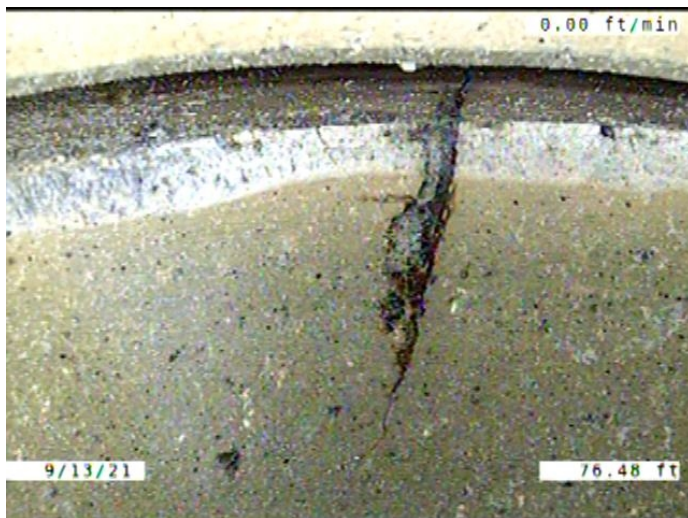
Code: **ISB**
 Description: **Infiltration Stain Barrel**

Distance (ft): **76.5**
 Structural Grade: **0**
 O&M Grade: **1**
 Clock Start/From: **11**
 Clock To:
 1st Value:
 2nd Value:
 Value Percent:
 Continuous Index:
 Within 8" of Joint: **YES**
 Remarks:

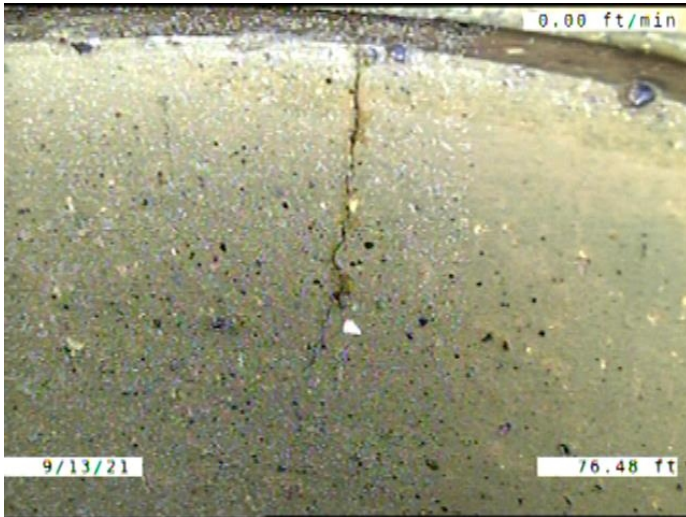
Code: **CL**
 Description: **Crack Longitudinal**

Distance (ft): **76.5**
 Structural Grade: **2**
 O&M Grade: **0**
 Clock Start/From: **2**
 Clock To:
 1st Value:
 2nd Value:
 Value Percent:
 Continuous Index:
 Within 8" of Joint: **YES**
 Remarks:

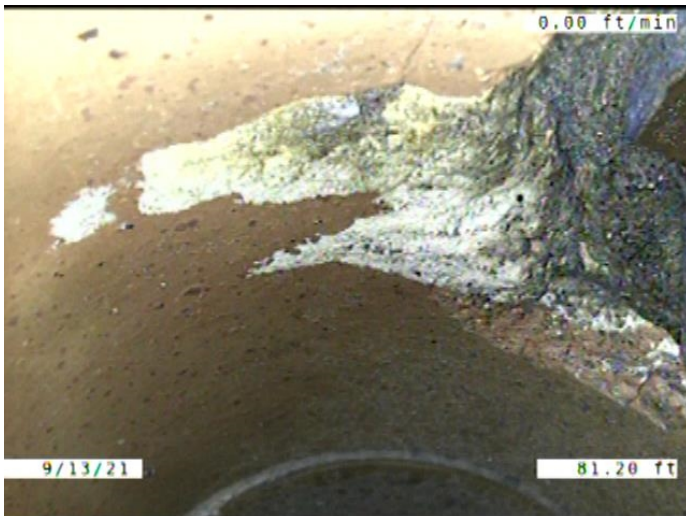
Code: **DAE**
 Description: **Deposits Attached Encrustation**

Distance (ft): **81.2**
 Structural Grade: **0**
 O&M Grade: **2**
 Clock Start/From: **10**
 Clock To: **2**
 1st Value:
 2nd Value:
 Value Percent: **5.000**
 Continuous Index:
 Within 8" of Joint: **NO**
 Remarks:

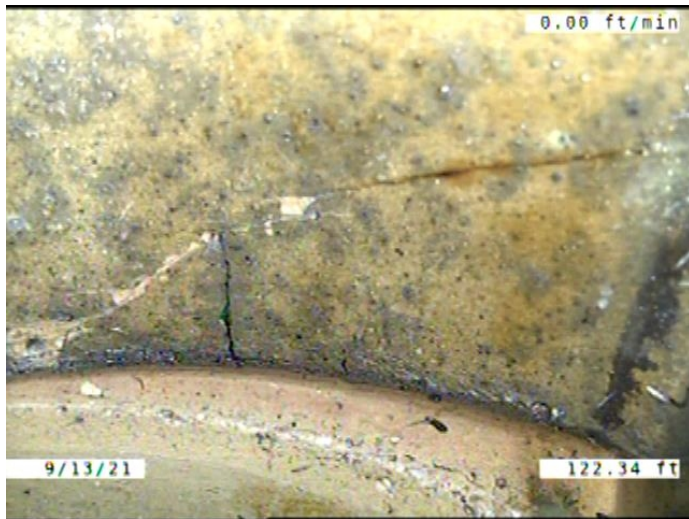
Code: **FM**
 Description: **Fracture Multiple**

Distance (ft): **122.3**
 Structural Grade: **4**
 O&M Grade: **0**
 Clock Start/From: **9**
 Clock To: **4**
 1st Value:
 2nd Value:
 Value Percent:
 Continuous Index:
 Within 8" of Joint: **YES**
 Remarks:

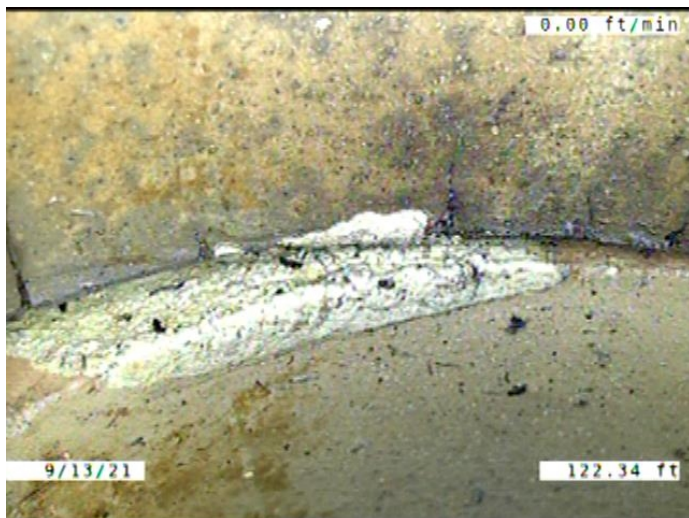
Code: **DAE**
 Description: **Deposits Attached Encrustation**

Distance (ft): **122.3**
 Structural Grade: **0**
 O&M Grade: **2**
 Clock Start/From: **10**
 Clock To:
 1st Value:
 2nd Value:
 Value Percent: **5.000**
 Continuous Index:
 Within 8" of Joint: **YES**
 Remarks:

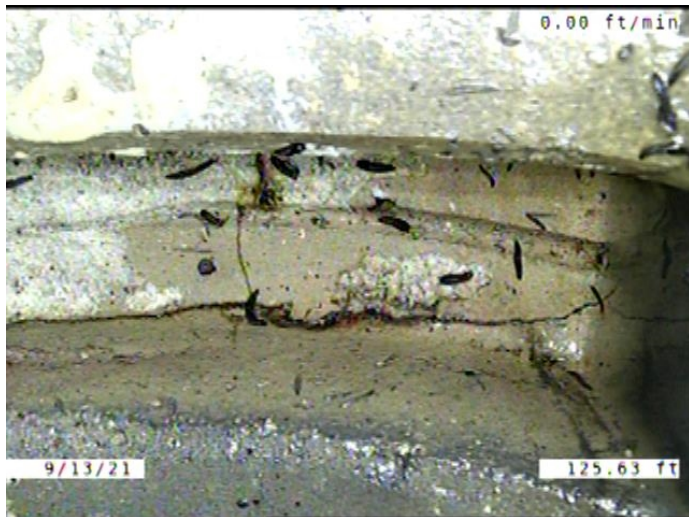
Code: **CM**
 Description: **Crack Multiple**

Distance (ft): **125.6**
 Structural Grade: **3**
 O&M Grade: **0**
 Clock Start/From: **1**
 Clock To: **3**
 1st Value:
 2nd Value:
 Value Percent:
 Continuous Index:
 Within 8" of Joint: **YES**
 Remarks:

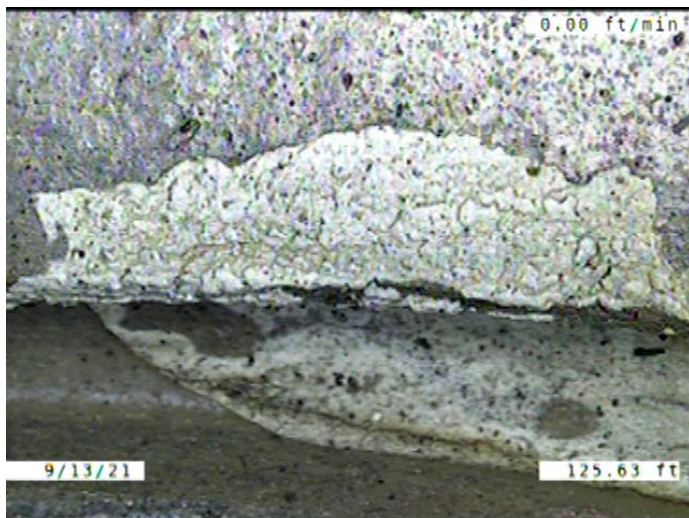
Code: **DAE**
 Description: **Deposits Attached Encrustation**

Distance (ft): **125.6**
 Structural Grade: **0**
 O&M Grade: **2**
 Clock Start/From: **1**
 Clock To: **3**
 1st Value:
 2nd Value:
 Value Percent: **5.000**
 Continuous Index:
 Within 8" of Joint: **YES**
 Remarks:

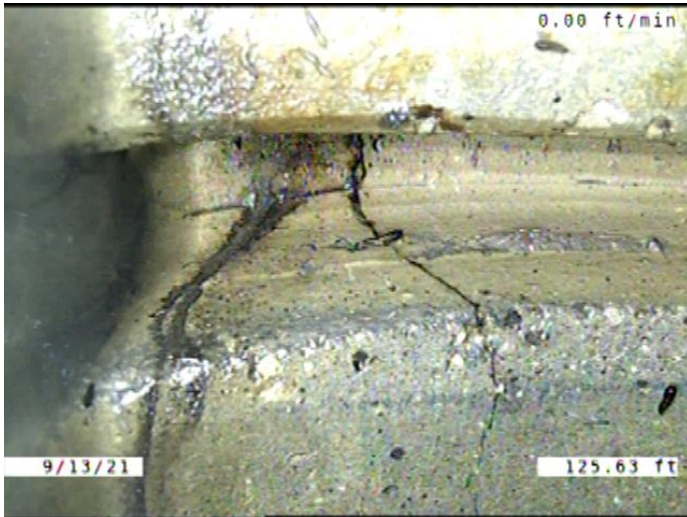
Code: **CM**
 Description: **Crack Multiple**

Distance (ft): **125.6**
 Structural Grade: **3**
 O&M Grade: **0**
 Clock Start/From: **8**
 Clock To: **9**
 1st Value:
 2nd Value:
 Value Percent:
 Continuous Index:
 Within 8" of Joint: **YES**
 Remarks:

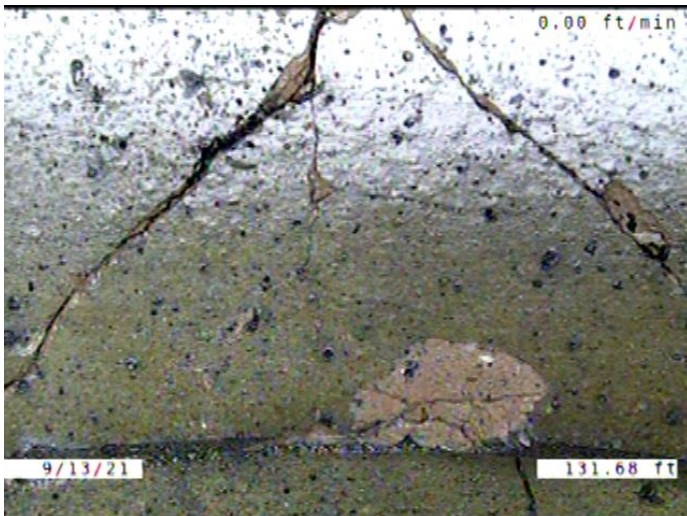
Code: **FM**
 Description: **Fracture Multiple**

Distance (ft): **131.7**
 Structural Grade: **4**
 O&M Grade: **0**
 Clock Start/From: **11**
 Clock To: **2**
 1st Value:
 2nd Value:
 Value Percent:
 Continuous Index:
 Within 8" of Joint: **YES**
 Remarks:

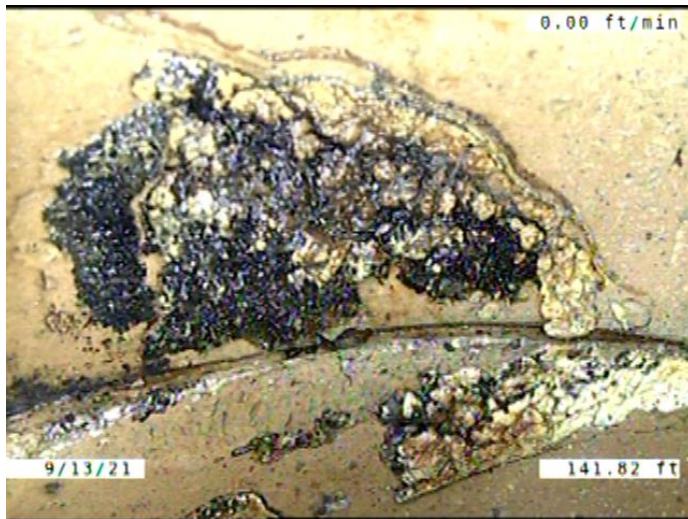
Code: **DAE**
 Description: **Deposits Attached Encrustation**

Distance (ft): **141.8**
 Structural Grade: **0**
 O&M Grade: **2**
 Clock Start/From: **8**
 Clock To: **10**
 1st Value:
 2nd Value:
 Value Percent: **5.000**
 Continuous Index:
 Within 8" of Joint: **YES**
 Remarks:

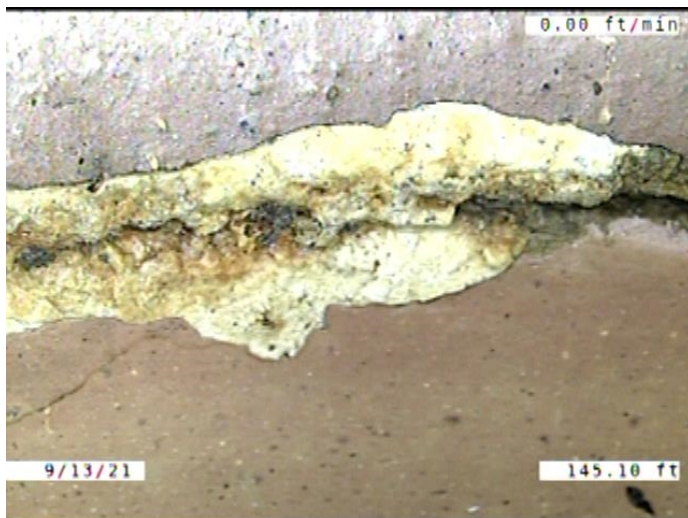
Code: **DAE**
 Description: **Deposits Attached Encrustation**

Distance (ft): **145.1**
 Structural Grade: **0**
 O&M Grade: **2**
 Clock Start/From: **8**
 Clock To: **3**
 1st Value:
 2nd Value:
 Value Percent: **5.000**
 Continuous Index:
 Within 8" of Joint: **YES**
 Remarks:

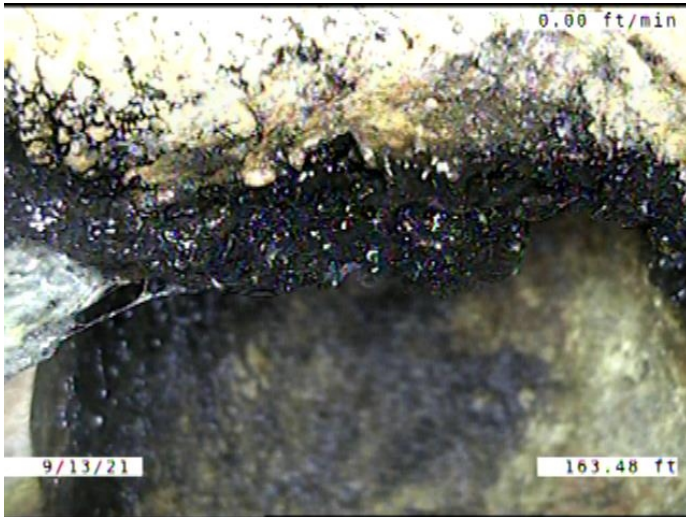
Code: **IWC**
Description: **Infiltration Weeper Connection**

Distance (ft): **163.5**
Structural Grade: **0**
O&M Grade: **2**
Clock Start/From: **10**
Clock To:
1st Value:
2nd Value:
Value Percent:
Continuous Index:
Within 8" of Joint: **YES**
Remarks:

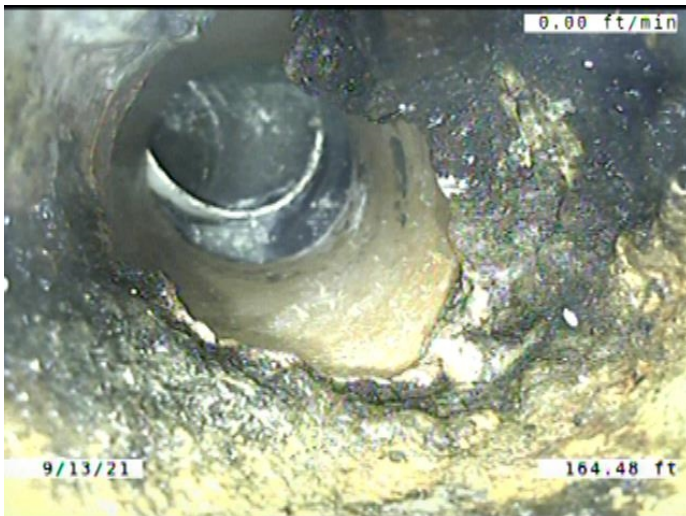
Code: **TFD**
Description: **Tap Factory Defective**

Distance (ft): **164.5**
Structural Grade: **0**
O&M Grade: **3**
Clock Start/From: **11**
Clock To:
1st Value: **4.000**
2nd Value:
Value Percent:
Continuous Index:
Within 8" of Joint: **YES**
Remarks: **ENCRUSTATION IN THE TAP**

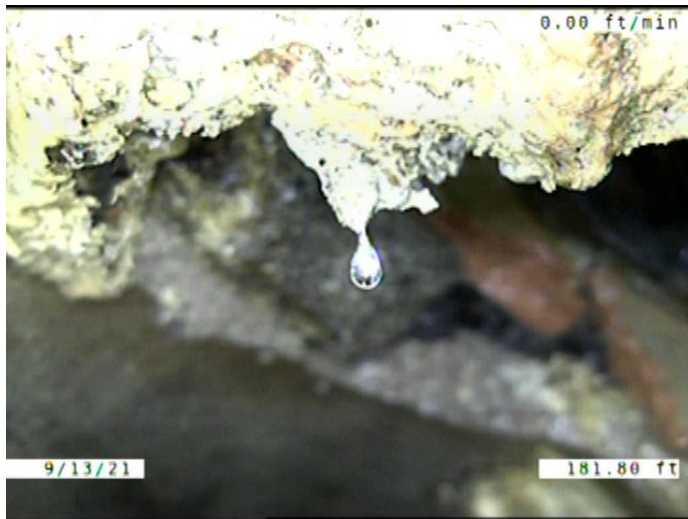
Code: **IWC**
Description: **Infiltration Weeper Connection**

Distance (ft): **181.8**
Structural Grade: **0**
O&M Grade: **2**
Clock Start/From: **12**
Clock To:
1st Value:
2nd Value:
Value Percent:
Continuous Index:
Within 8" of Joint: **YES**
Remarks:

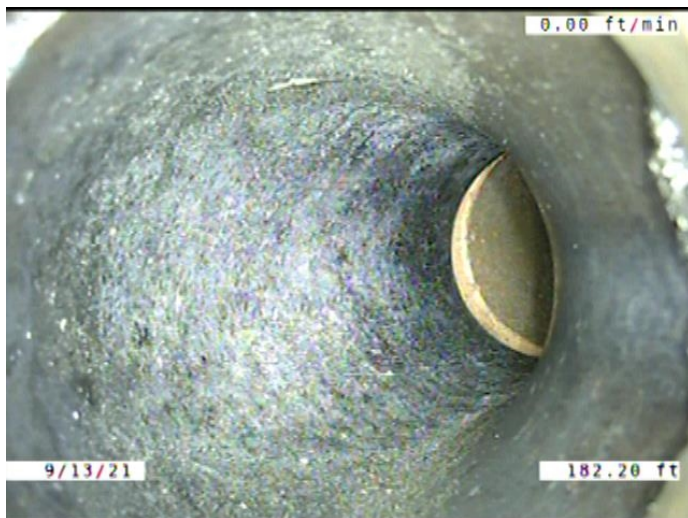
Code: **TBD**
Description: **Tap Break-in/Hammer Defective**

Distance (ft): **182.2**
Structural Grade: **0**
O&M Grade: **3**
Clock Start/From: **1**
Clock To:
1st Value: **4.000**
2nd Value:
Value Percent:
Continuous Index:
Within 8" of Joint: **NO**
Remarks: **Defective**

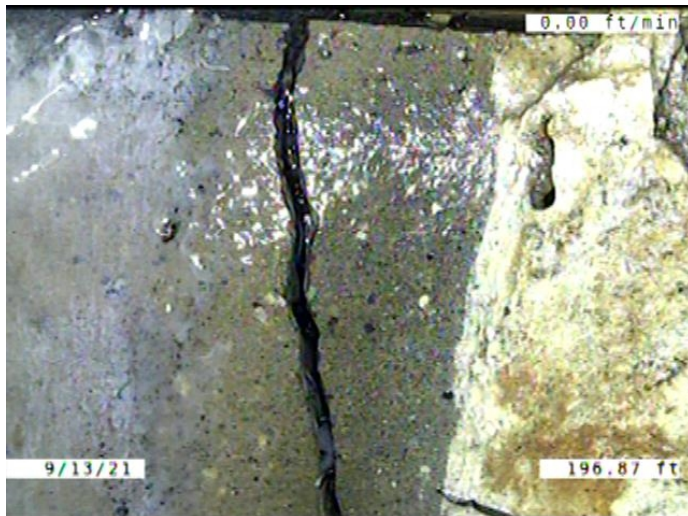
Code: **FM**
 Description: **Fracture Multiple**

Distance (ft): **196.6**
 Structural Grade: **4**
 O&M Grade: **0**
 Clock Start/From: **7**
 Clock To: **1**
 1st Value:
 2nd Value:
 Value Percent:
 Continuous Index: **S06**
 Within 8" of Joint: **NO**
 Remarks:

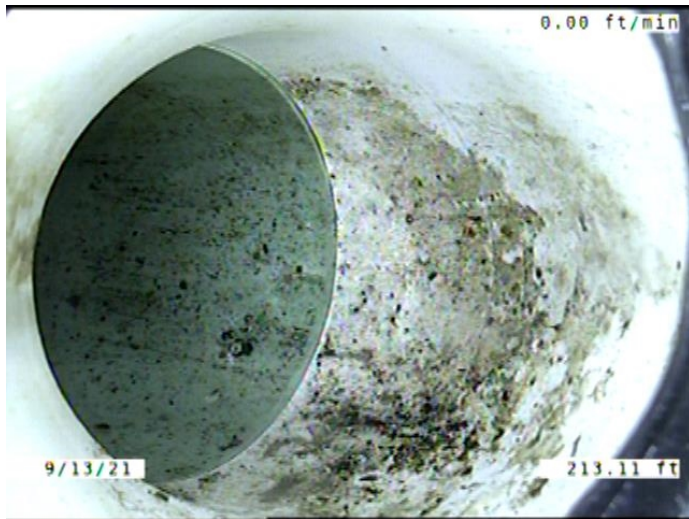
Code: **TBD**
 Description: **Tap Break-in/Hammer Defective**

Distance (ft): **213.1**
 Structural Grade: **0**
 O&M Grade: **3**
 Clock Start/From: **12**
 Clock To:
 1st Value: **4.000**
 2nd Value:
 Value Percent:
 Continuous Index:
 Within 8" of Joint: **YES**
 Remarks: **Defective**

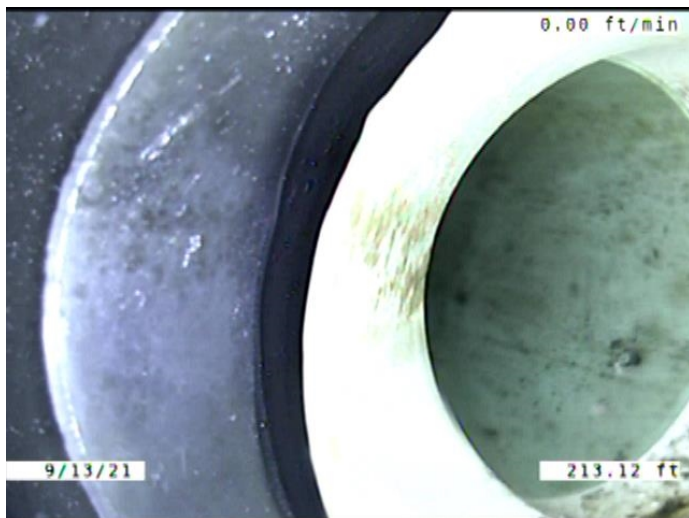
Code: **IRC**
 Description: **Infiltration Runner Connection**

Distance (ft): **213.1**
 Structural Grade: **0**
 O&M Grade: **4**
 Clock Start/From: **11**
 Clock To:
 1st Value:
 2nd Value:
 Value Percent:
 Continuous Index:
 Within 8" of Joint: **YES**
 Remarks:

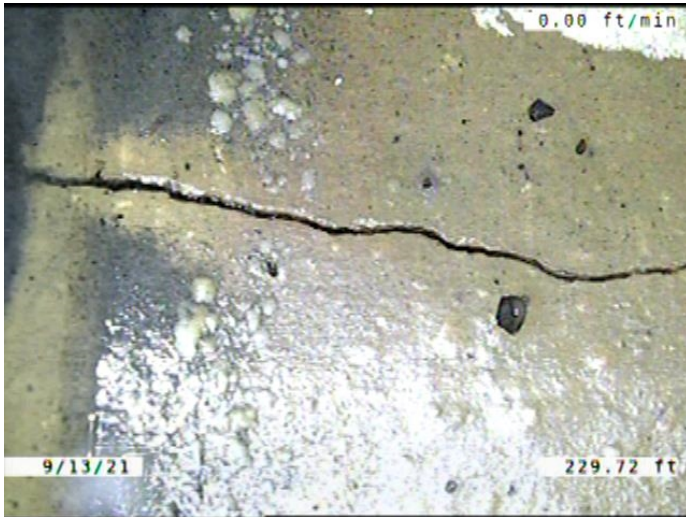
Code: **FM**
 Description: **Fracture Multiple**

Distance (ft): **229.7**
 Structural Grade: **4**
 O&M Grade: **0**
 Clock Start/From: **7**
 Clock To: **5**
 1st Value:
 2nd Value:
 Value Percent:
 Continuous Index:
 Within 8" of Joint: **YES**
 Remarks:

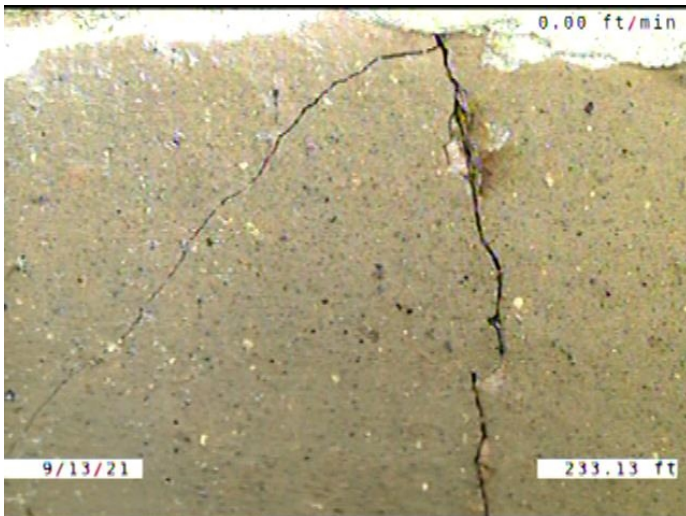
Code: **FM**
 Description: **Fracture Multiple**

Distance (ft): **233.1**
 Structural Grade: **4**
 O&M Grade: **0**
 Clock Start/From: **12**
 Clock To: **3**
 1st Value:
 2nd Value:
 Value Percent:
 Continuous Index:
 Within 8" of Joint: **YES**
 Remarks:

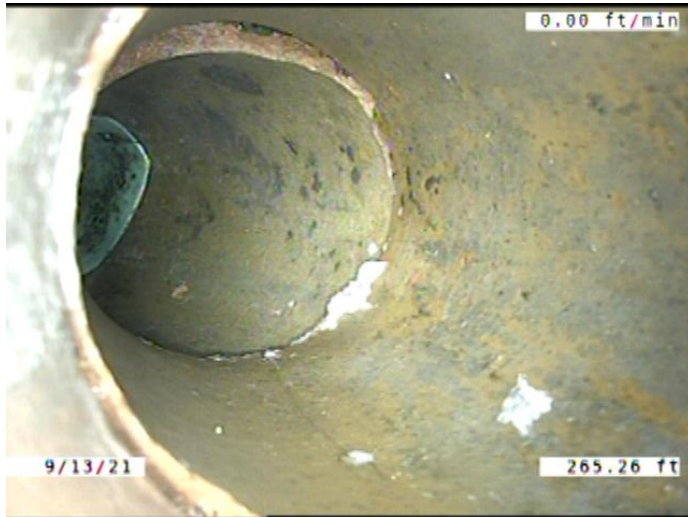
Code: **TBI**
 Description: **Tap Break-in Intruding**

Distance (ft): **265.3**
 Structural Grade: **0**
 O&M Grade: **2**
 Clock Start/From: **11**
 Clock To:
 1st Value: **4.000**
 2nd Value: **1.000**
 Value Percent:
 Continuous Index:
 Within 8" of Joint: **YES**
 Remarks:

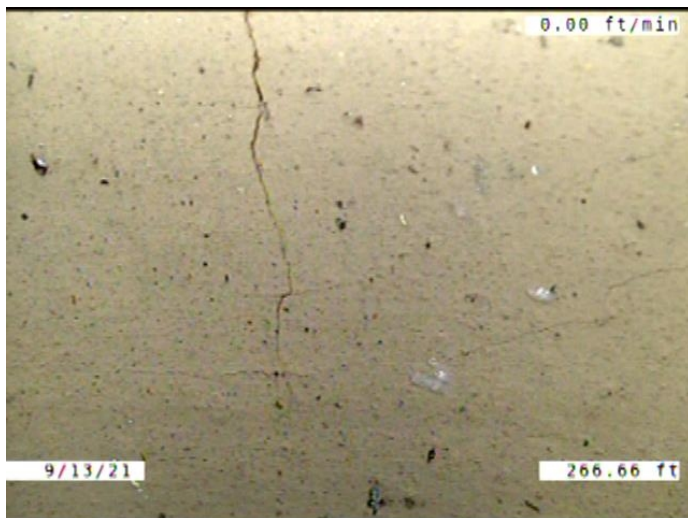
Code: **CM**
 Description: **Crack Multiple**

Distance (ft): **266.7**
 Structural Grade: **3**
 O&M Grade: **0**
 Clock Start/From: **1**
 Clock To: **4**
 1st Value:
 2nd Value:
 Value Percent:
 Continuous Index:
 Within 8" of Joint: **YES**
 Remarks:
