# Profile/Photo Observation Report

Date:	09/13/2021	Weather:		Coding:	PACP 7.0
Pipe Length (ft):	311.0	Owner:	City of Hobart	Pre Clean:	Light Cleaning
P.O.#:	YES502259	Surveyor:	S. Bucklin	PSR:	P-504-059-058
Customer:	City of Hobart	Clean Date:	09/07/2021	Shape:	C

Street:	North Wilson Street	Flow Control:	Not Controlled
City:	Hobart, IN	Year Renewed:	
Location:		Tape/Media #:	
Purpose:	Routine Assessment	Dia/Height:	10"
Use:	Sanitary Sewage Pipe	Material:	VCP
Drain Area:		Lining:	None
Category:	NA		
Comment:			
Location Details:		Direction of Survey:	Downstream
US MH:	M-504-058	DS MH:	M-504-059
		Total Length Surveyed (ft):	311.0

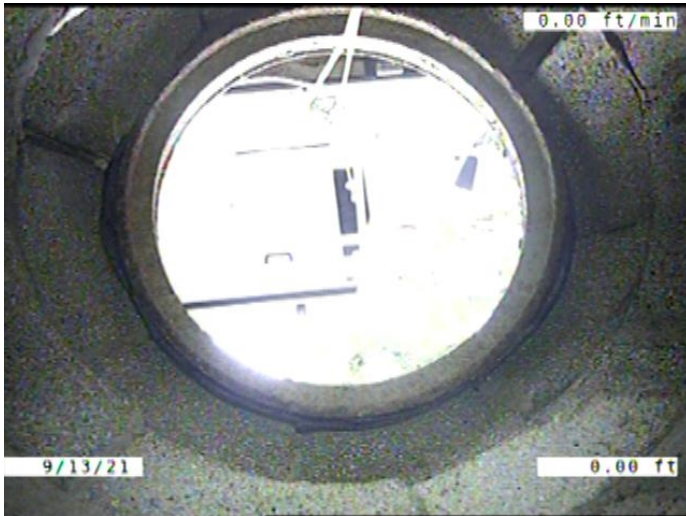
Code: **AMH**  
Description: **Manhole**

Distance (ft): **.0**  
Structural Grade: **0**  
O&M Grade: **0**  
Clock Start/From:  
Clock To:  
1st Value:  
2nd Value:  
Value Percent:  
Continuous Index:  
Within 8" of Joint: **NO**  
Remarks: **M-504-058**

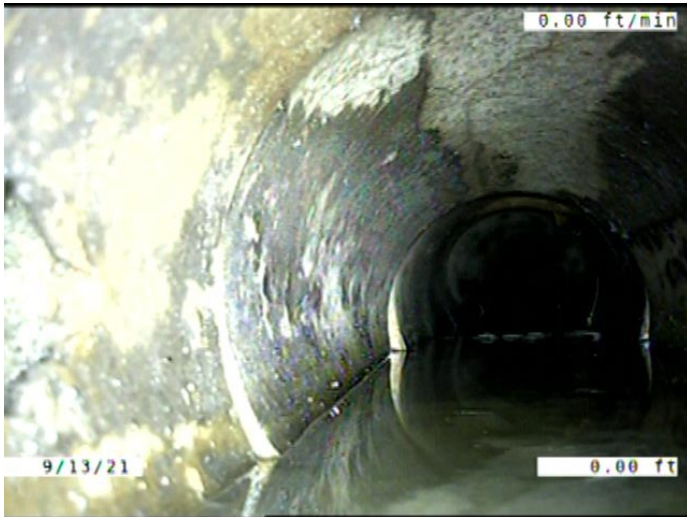
Code: **MWL**  
 Description: **Miscellaneous Water Level**

Distance (ft): **.0**  
 Structural Grade: **0**  
 O&M Grade: **0**  
 Clock Start/From:  
 Clock To:  
 1st Value:  
 2nd Value:  
 Value Percent: **10.000**  
 Continuous Index:  
 Within 8" of Joint: **NO**  
 Remarks:

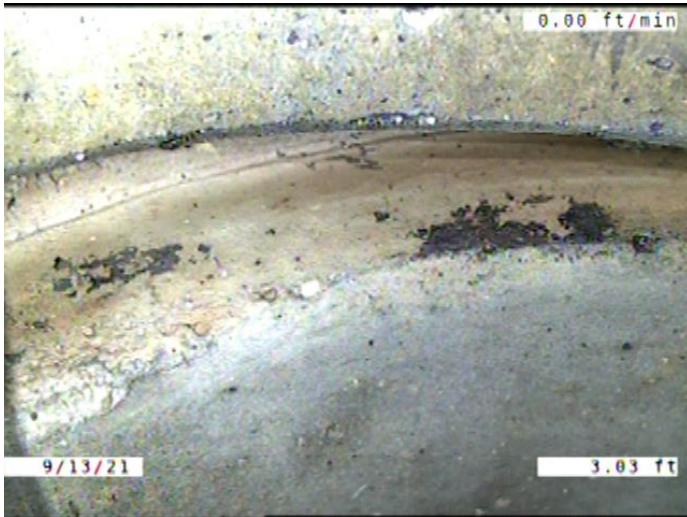
Code: **JAM**  
 Description: **Joint Angular Medium**

Distance (ft): **3.0**  
 Structural Grade: **3**  
 O&M Grade: **0**  
 Clock Start/From:  
 Clock To:  
 1st Value:  
 2nd Value:  
 Value Percent:  
 Continuous Index:  
 Within 8" of Joint: **NO**  
 Remarks:

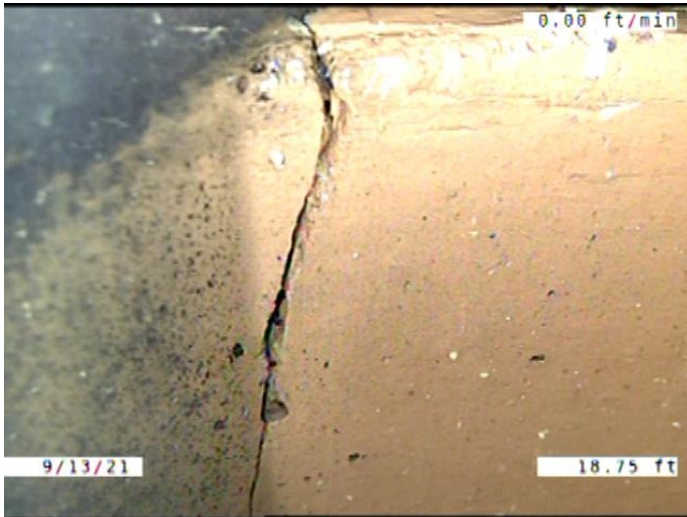
Code: **FL**  
 Description: **Fracture Longitudinal**

Distance (ft): **18.8**  
 Structural Grade: **3**  
 O&M Grade: **0**  
 Clock Start/From: **8**  
 Clock To:  
 1st Value:  
 2nd Value:  
 Value Percent:  
 Continuous Index:  
 Within 8" of Joint: **YES**  
 Remarks:

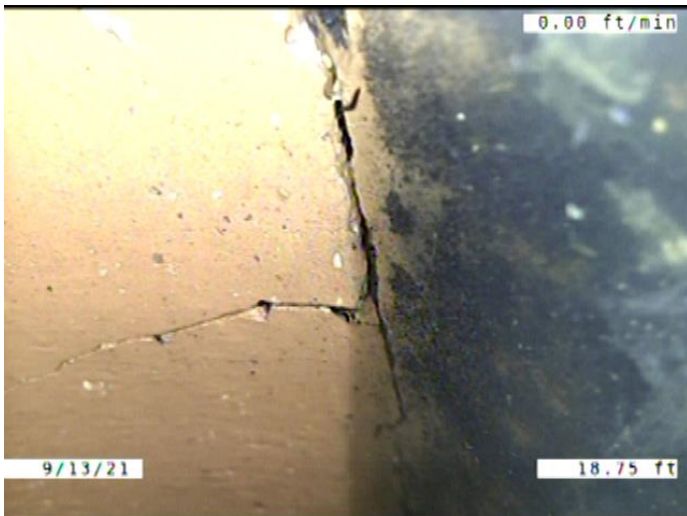
Code: **FM**  
 Description: **Fracture Multiple**

Distance (ft): **18.8**  
 Structural Grade: **4**  
 O&M Grade: **0**  
 Clock Start/From: **1**  
 Clock To: **4**  
 1st Value:  
 2nd Value:  
 Value Percent:  
 Continuous Index:  
 Within 8" of Joint: **YES**  
 Remarks:

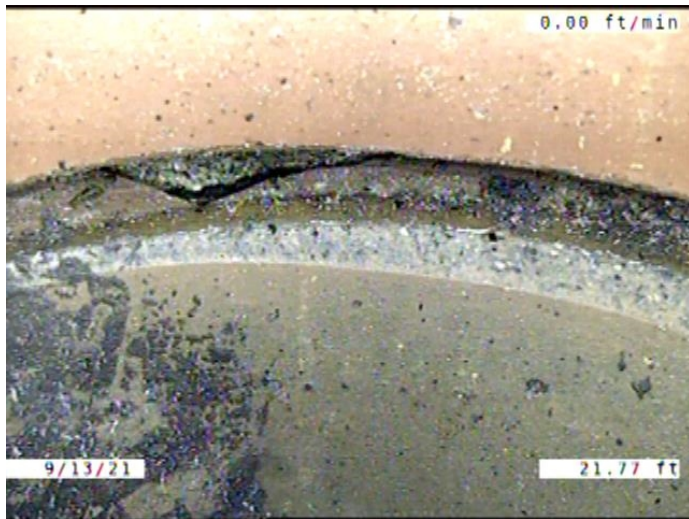
Code: **B**  
 Description: **Broken**

Distance (ft): **21.8**  
 Structural Grade: **4**  
 O&M Grade: **0**  
 Clock Start/From: **12**  
 Clock To:  
 1st Value:  
 2nd Value:  
 Value Percent:  
 Continuous Index:  
 Within 8" of Joint: **YES**  
 Remarks:

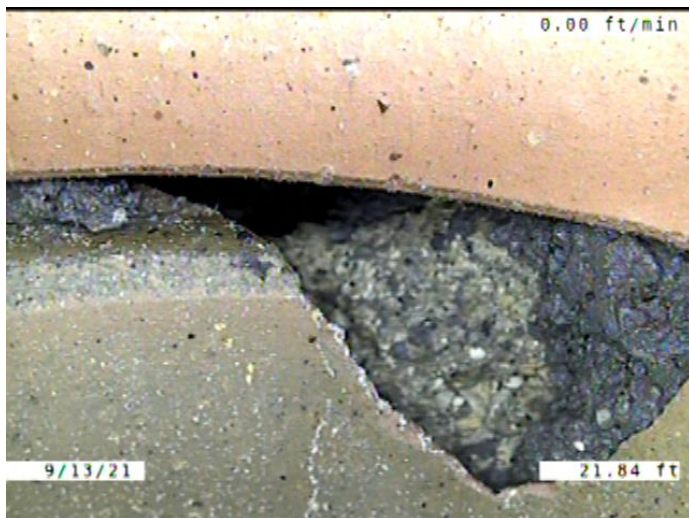
Code: **HSV**  
 Description: **Hole Soil Visible**

Distance (ft): **21.8**  
 Structural Grade: **5**  
 O&M Grade: **0**  
 Clock Start/From: **2**  
 Clock To: **3**  
 1st Value:  
 2nd Value:  
 Value Percent:  
 Continuous Index:  
 Within 8" of Joint: **YES**  
 Remarks:

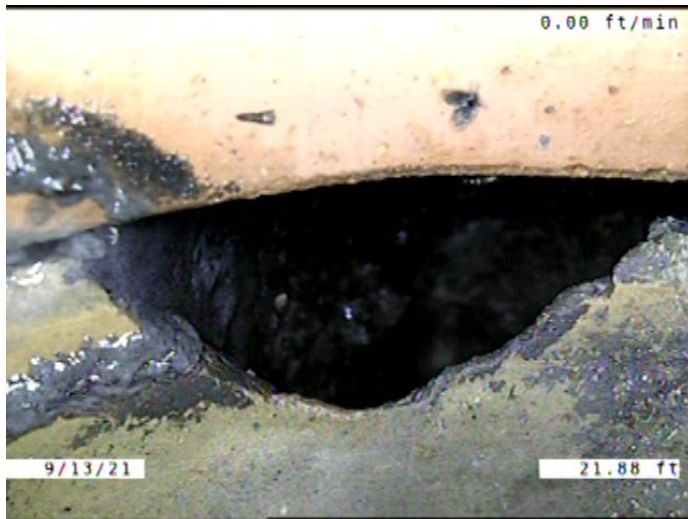
Code: **HSV**  
 Description: **Hole Soil Visible**

Distance (ft): **21.9**  
 Structural Grade: **5**  
 O&M Grade: **0**  
 Clock Start/From: **8**  
 Clock To: **9**  
 1st Value:  
 2nd Value:  
 Value Percent:  
 Continuous Index:  
 Within 8" of Joint: **YES**  
 Remarks:

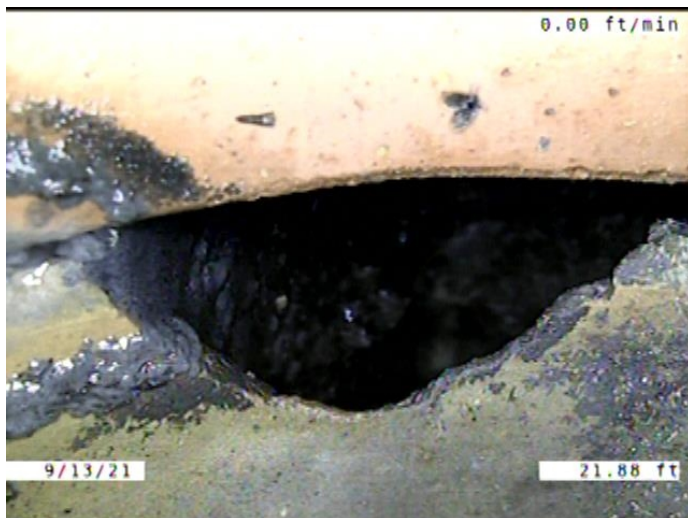
Code: **IRB**  
 Description: **Infiltration Runner Barrel**

Distance (ft): **21.9**  
 Structural Grade: **0**  
 O&M Grade: **4**  
 Clock Start/From: **8**  
 Clock To: **9**  
 1st Value:  
 2nd Value:  
 Value Percent:  
 Continuous Index:  
 Within 8" of Joint: **YES**  
 Remarks:

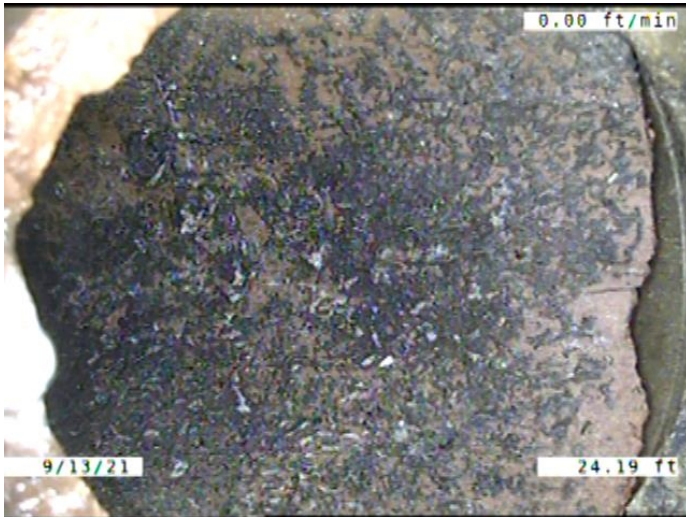
Code: **TBD**  
 Description: **Tap Break-in/Hammer Defective**

Distance (ft): **24.2**  
 Structural Grade: **0**  
 O&M Grade: **3**  
 Clock Start/From: **11**  
 Clock To:  
 1st Value: **4.000**  
 2nd Value:  
 Value Percent:  
 Continuous Index:  
 Within 8" of Joint: **NO**  
 Remarks: **Defective**

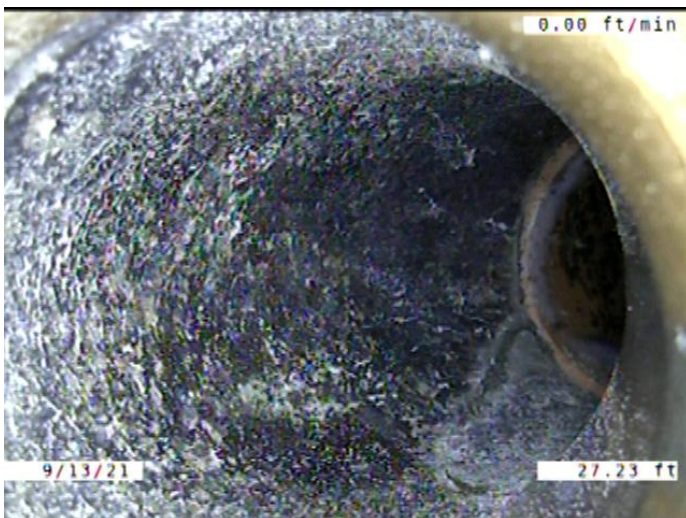
Code: **TBI**  
 Description: **Tap Break-in Intruding**

Distance (ft): **27.2**  
 Structural Grade: **0**  
 O&M Grade: **2**  
 Clock Start/From: **1**  
 Clock To:  
 1st Value: **4.000**  
 2nd Value: **1.000**  
 Value Percent:  
 Continuous Index:  
 Within 8" of Joint: **NO**  
 Remarks:

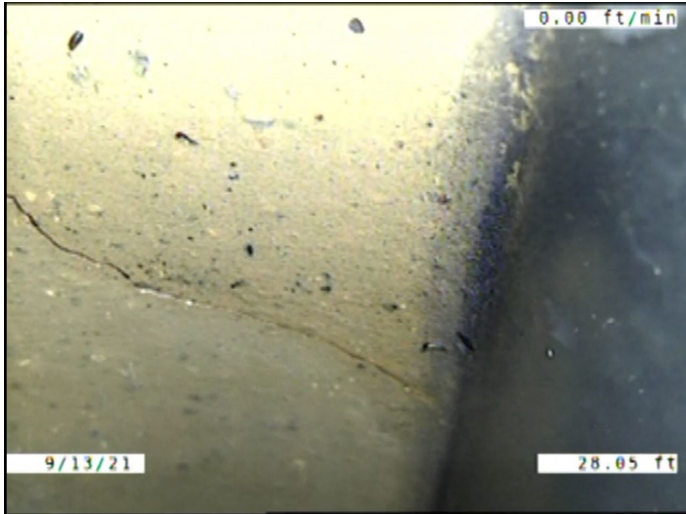
Code: **FS**  
Description: **Fracture Spiral**

Distance (ft): **28.0**  
Structural Grade: **3**  
O&M Grade: **0**  
Clock Start/From: **2**  
Clock To: **4**  
1st Value:  
2nd Value:  
Value Percent:  
Continuous Index:  
Within 8" of Joint: **NO**  
Remarks:

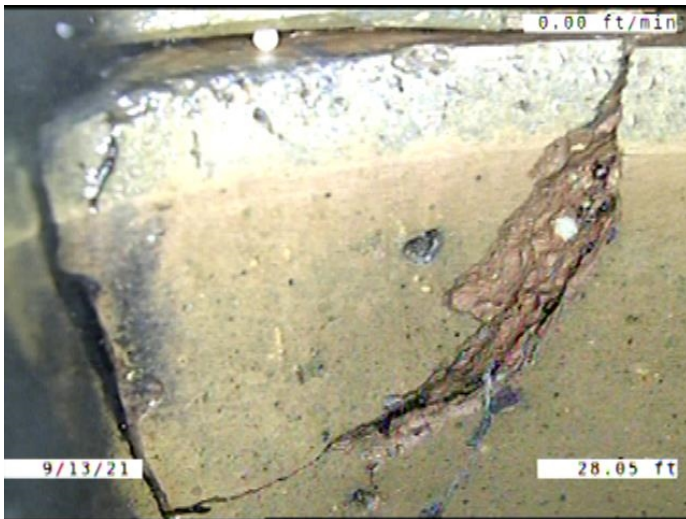
Code: **B**  
Description: **Broken**

Distance (ft): **28.0**  
Structural Grade: **4**  
O&M Grade: **0**  
Clock Start/From: **7**  
Clock To: **9**  
1st Value:  
2nd Value:  
Value Percent:  
Continuous Index:  
Within 8" of Joint: **YES**  
Remarks:

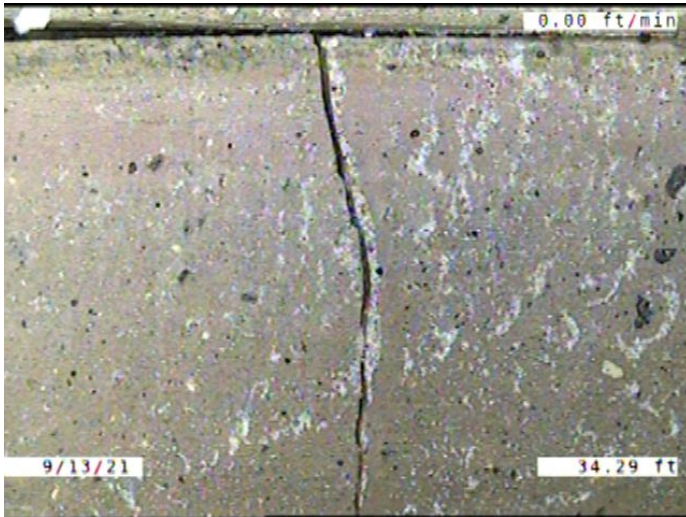
Code: **FS**  
Description: **Fracture Spiral**

Distance (ft): **34.3**  
Structural Grade: **3**  
O&M Grade: **0**  
Clock Start/From: **9**  
Clock To: **11**  
1st Value:  
2nd Value:  
Value Percent:  
Continuous Index:  
Within 8" of Joint: **YES**  
Remarks:

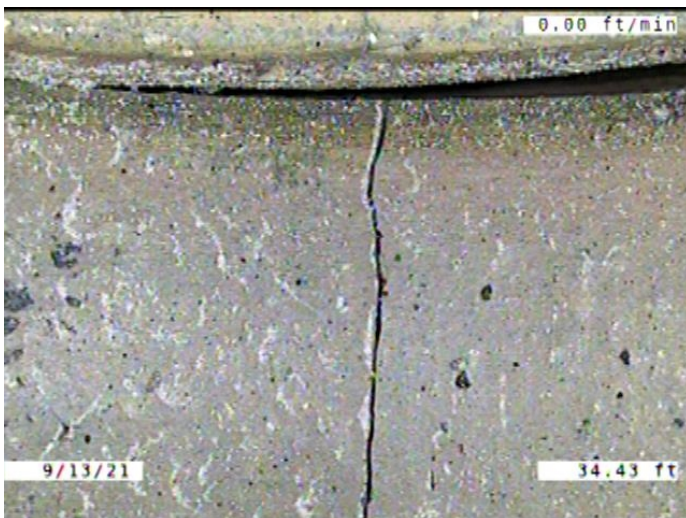
Code: **CL**  
Description: **Crack Longitudinal**

Distance (ft): **34.4**  
Structural Grade: **2**  
O&M Grade: **0**  
Clock Start/From: **1**  
Clock To:  
1st Value:  
2nd Value:  
Value Percent:  
Continuous Index:  
Within 8" of Joint: **YES**  
Remarks:

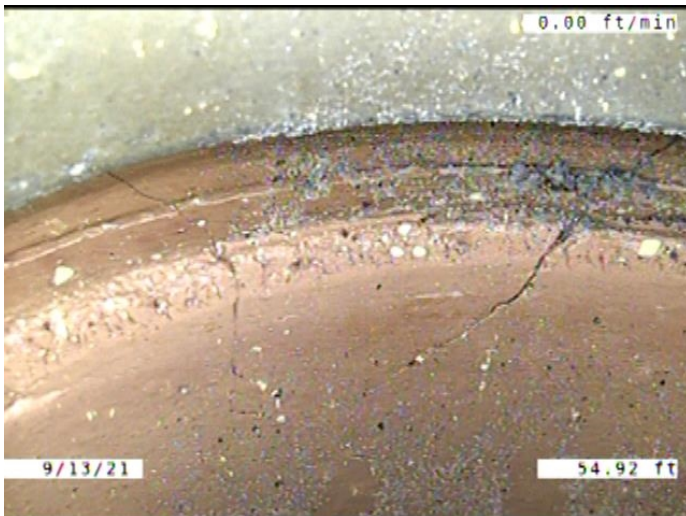
Code: **CS**  
 Description: **Crack Spiral**

Distance (ft): **54.9**  
 Structural Grade: **2**  
 O&M Grade: **0**  
 Clock Start/From: **9**  
 Clock To: **10**  
 1st Value:  
 2nd Value:  
 Value Percent:  
 Continuous Index:  
 Within 8" of Joint: **YES**  
 Remarks:

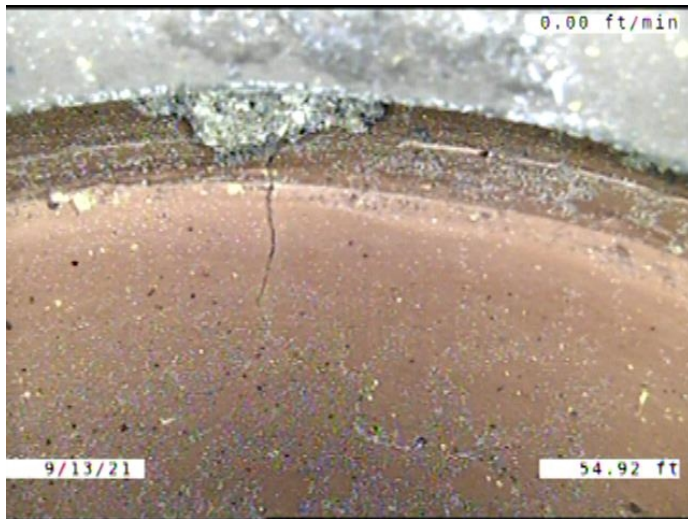
Code: **CL**  
 Description: **Crack Longitudinal**

Distance (ft): **54.9**  
 Structural Grade: **2**  
 O&M Grade: **0**  
 Clock Start/From: **1**  
 Clock To:  
 1st Value:  
 2nd Value:  
 Value Percent:  
 Continuous Index:  
 Within 8" of Joint: **YES**  
 Remarks:

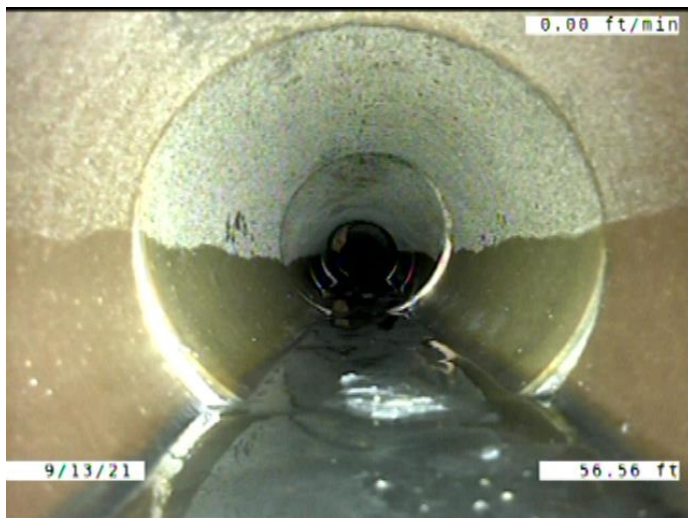
Code: **MWLS**  
 Description: **Miscellaneous Water Level Sag**

Distance (ft): **56.6**  
 Structural Grade: **2**  
 O&M Grade: **0**  
 Clock Start/From:  
 Clock To:  
 1st Value:  
 2nd Value:  
 Value Percent: **5.000**  
 Continuous Index: **F02**  
 Within 8" of Joint: **NO**  
 Remarks:

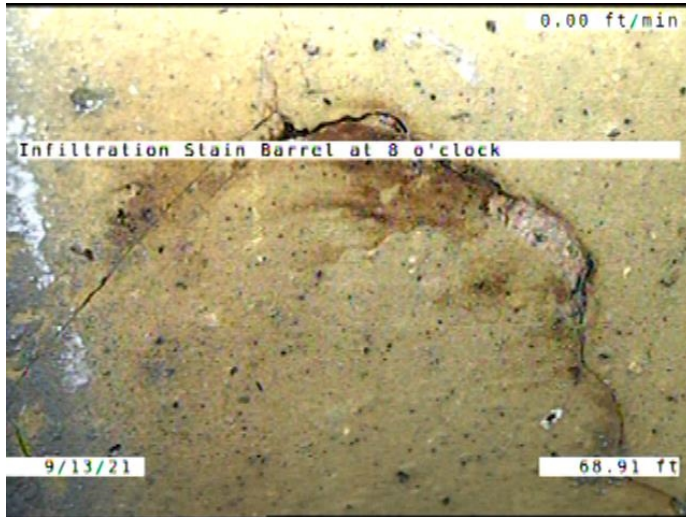
Code: **ISB**  
 Description: **Infiltration Stain Barrel**

Distance (ft): **68.9**  
 Structural Grade: **0**  
 O&M Grade: **1**  
 Clock Start/From: **8**  
 Clock To:  
 1st Value:  
 2nd Value:  
 Value Percent:  
 Continuous Index:  
 Within 8" of Joint: **NO**  
 Remarks:

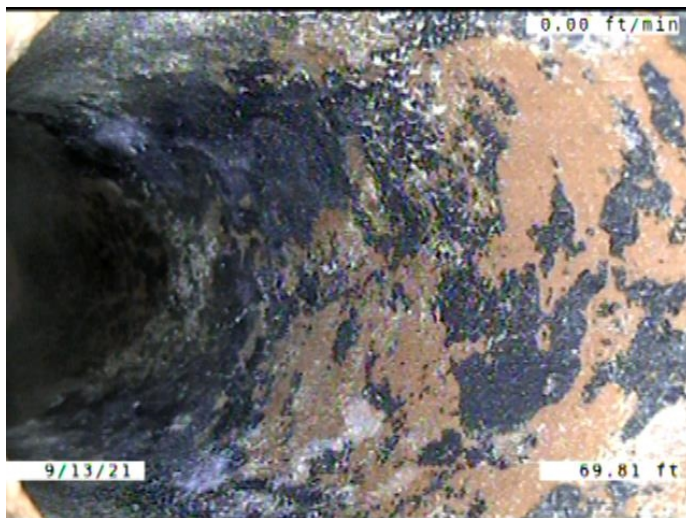
Code: **TBI**  
 Description: **Tap Break-in Intruding**

Distance (ft): **69.8**  
 Structural Grade: **0**  
 O&M Grade: **2**  
 Clock Start/From: **10**  
 Clock To:  
 1st Value: **4.000**  
 2nd Value: **2.000**  
 Value Percent:  
 Continuous Index:  
 Within 8" of Joint: **NO**  
 Remarks:

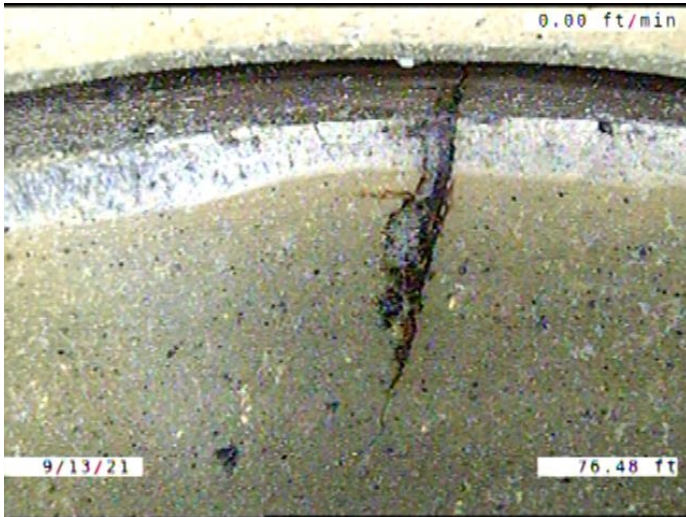
Code: **CL**  
 Description: **Crack Longitudinal**

Distance (ft): **76.5**  
 Structural Grade: **2**  
 O&M Grade: **0**  
 Clock Start/From: **11**  
 Clock To:  
 1st Value:  
 2nd Value:  
 Value Percent:  
 Continuous Index:  
 Within 8" of Joint: **YES**  
 Remarks:

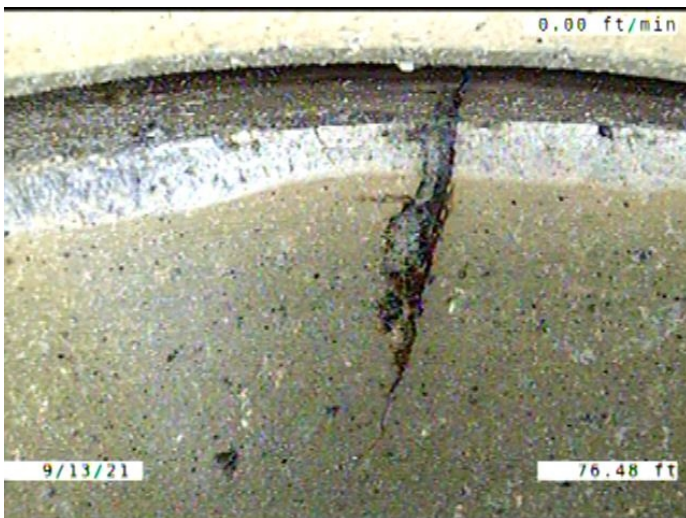
Code: **ISB**  
 Description: **Infiltration Stain Barrel**

Distance (ft): **76.5**  
 Structural Grade: **0**  
 O&M Grade: **1**  
 Clock Start/From: **11**  
 Clock To:  
 1st Value:  
 2nd Value:  
 Value Percent:  
 Continuous Index:  
 Within 8" of Joint: **YES**  
 Remarks:

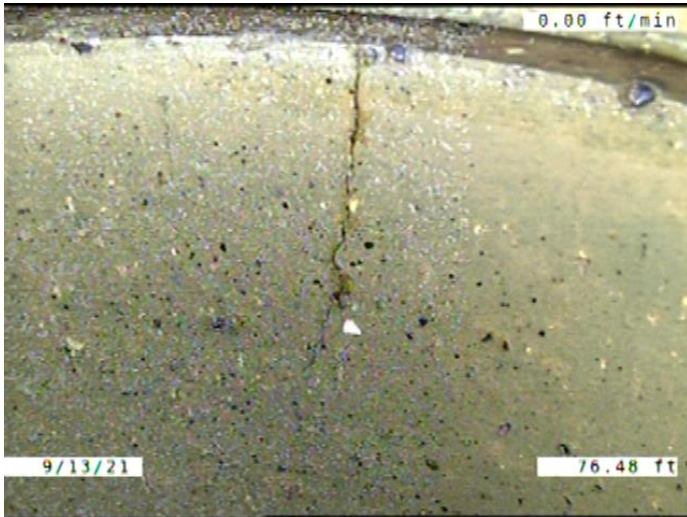
Code: **CL**  
 Description: **Crack Longitudinal**

Distance (ft): **76.5**  
 Structural Grade: **2**  
 O&M Grade: **0**  
 Clock Start/From: **2**  
 Clock To:  
 1st Value:  
 2nd Value:  
 Value Percent:  
 Continuous Index:  
 Within 8" of Joint: **YES**  
 Remarks:

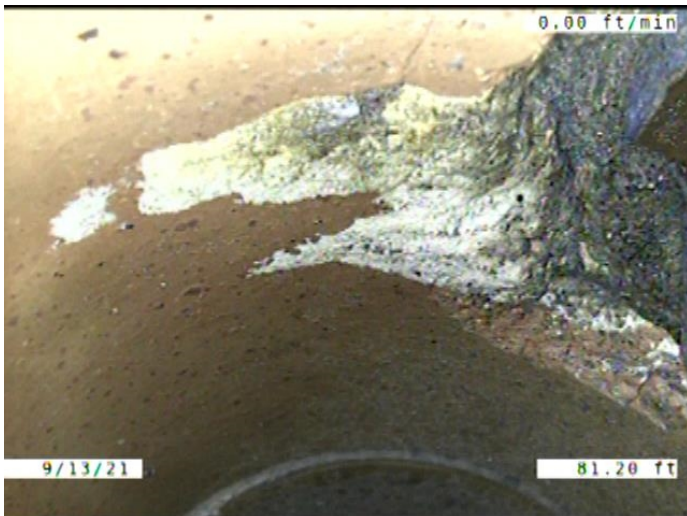
Code: **DAE**  
 Description: **Deposits Attached Encrustation**

Distance (ft): **81.2**  
 Structural Grade: **0**  
 O&M Grade: **2**  
 Clock Start/From: **10**  
 Clock To: **2**  
 1st Value:  
 2nd Value:  
 Value Percent: **5.000**  
 Continuous Index:  
 Within 8" of Joint: **NO**  
 Remarks:

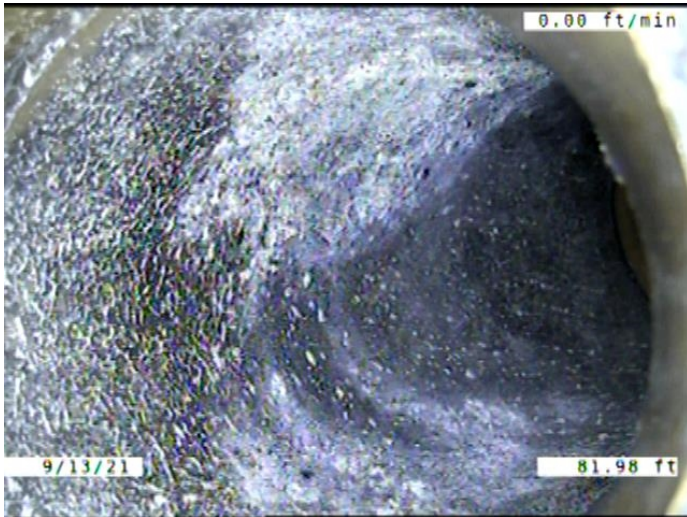
Code: **TBI**  
 Description: **Tap Break-in Intruding**

Distance (ft): **82.0**  
 Structural Grade: **0**  
 O&M Grade: **2**  
 Clock Start/From: **1**  
 Clock To:  
 1st Value: **4.000**  
 2nd Value: **1.000**  
 Value Percent:  
 Continuous Index:  
 Within 8" of Joint: **NO**  
 Remarks:

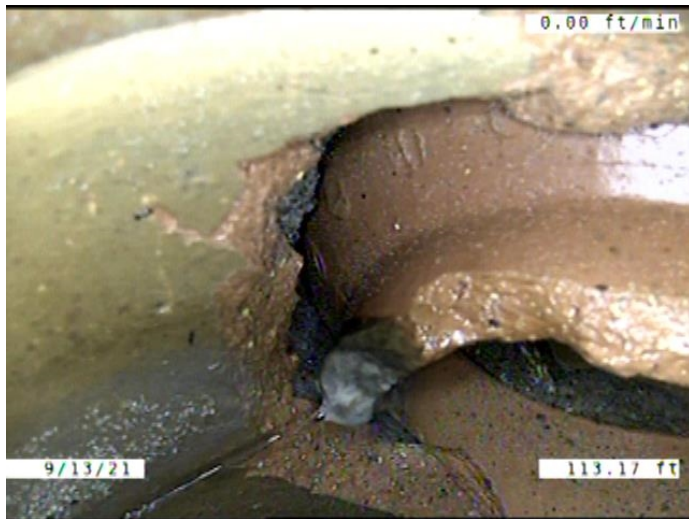
Code: **B**  
 Description: **Broken**

Distance (ft): **113.2**  
 Structural Grade: **4**  
 O&M Grade: **0**  
 Clock Start/From: **10**  
 Clock To: **1**  
 1st Value:  
 2nd Value:  
 Value Percent:  
 Continuous Index:  
 Within 8" of Joint: **YES**  
 Remarks:

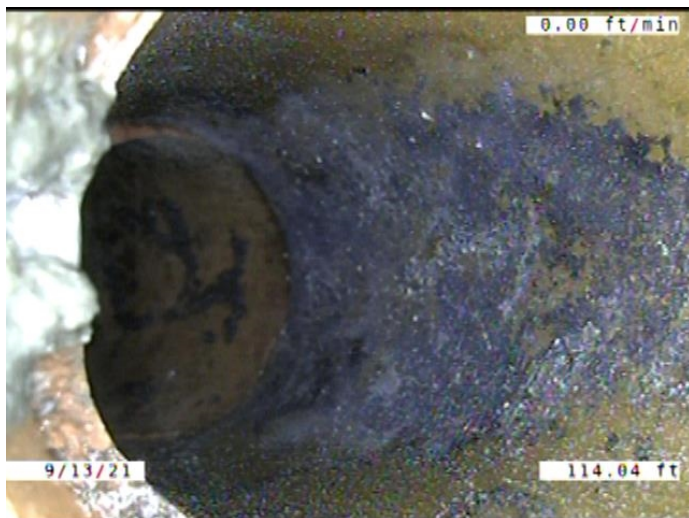
Code: **TBI**  
 Description: **Tap Break-in Intruding**

Distance (ft): **114.0**  
 Structural Grade: **0**  
 O&M Grade: **2**  
 Clock Start/From: **11**  
 Clock To:  
 1st Value: **4.000**  
 2nd Value: **1.000**  
 Value Percent:  
 Continuous Index:  
 Within 8" of Joint: **YES**  
 Remarks:

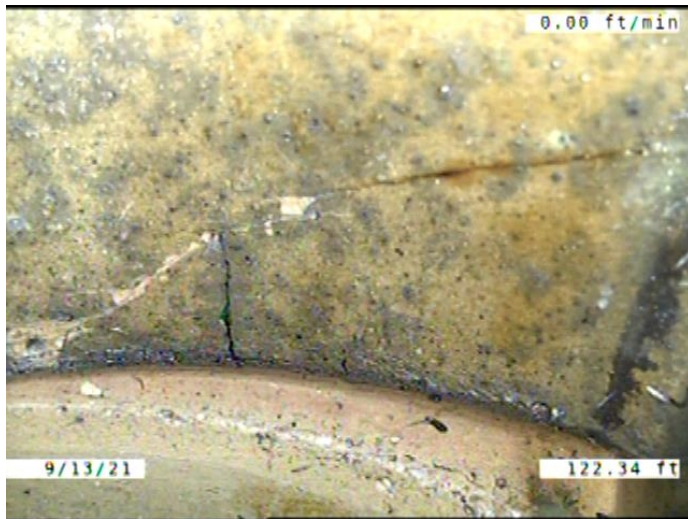
Code: **FM**  
 Description: **Fracture Multiple**

Distance (ft): **122.3**  
 Structural Grade: **4**  
 O&M Grade: **0**  
 Clock Start/From: **9**  
 Clock To: **4**  
 1st Value:  
 2nd Value:  
 Value Percent:  
 Continuous Index:  
 Within 8" of Joint: **YES**  
 Remarks:

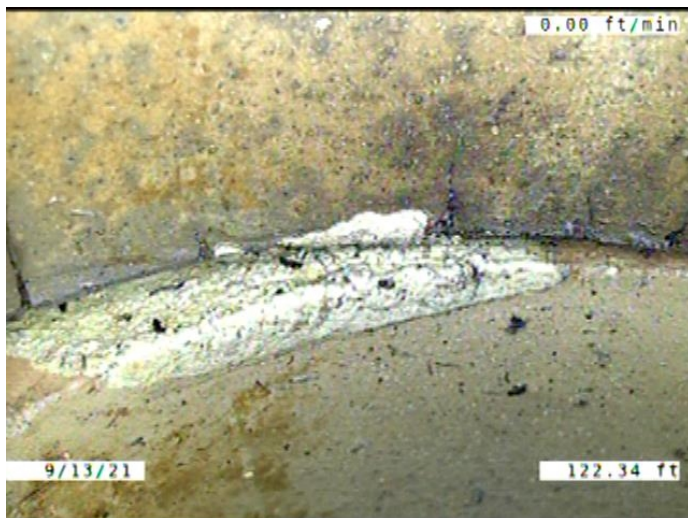
Code: **DAE**  
 Description: **Deposits Attached Encrustation**

Distance (ft): **122.3**  
 Structural Grade: **0**  
 O&M Grade: **2**  
 Clock Start/From: **10**  
 Clock To:  
 1st Value:  
 2nd Value:  
 Value Percent: **5.000**  
 Continuous Index:  
 Within 8" of Joint: **YES**  
 Remarks:

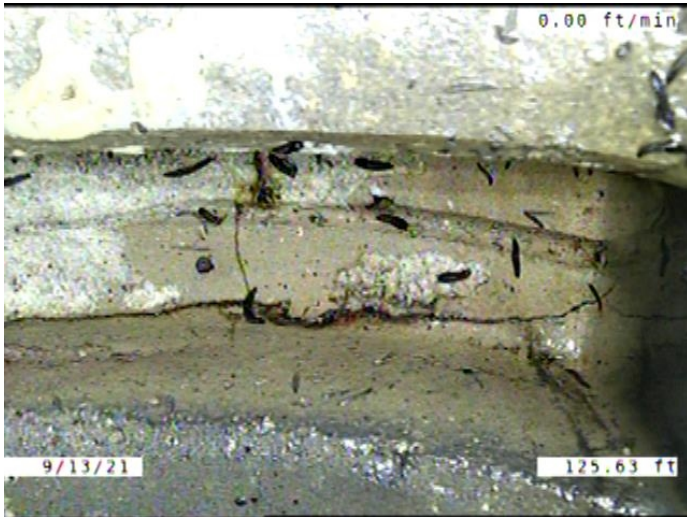
Code: **CM**  
 Description: **Crack Multiple**

Distance (ft): **125.6**  
 Structural Grade: **3**  
 O&M Grade: **0**  
 Clock Start/From: **1**  
 Clock To: **3**  
 1st Value:  
 2nd Value:  
 Value Percent:  
 Continuous Index:  
 Within 8" of Joint: **YES**  
 Remarks:

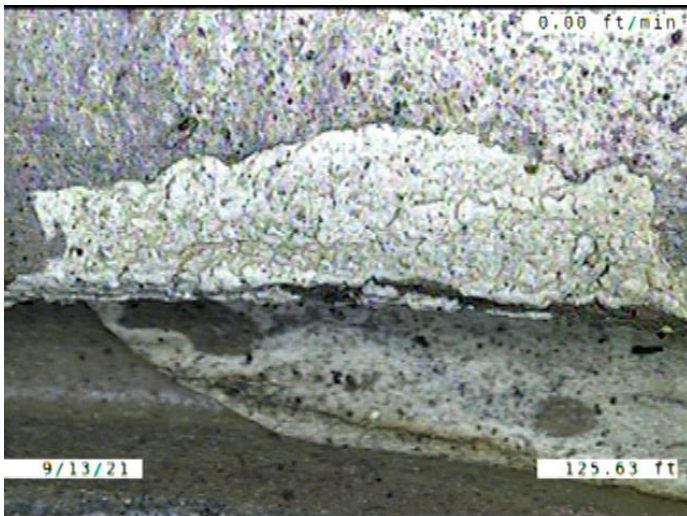
Code: **DAE**  
 Description: **Deposits Attached Encrustation**

Distance (ft): **125.6**  
 Structural Grade: **0**  
 O&M Grade: **2**  
 Clock Start/From: **1**  
 Clock To: **3**  
 1st Value:  
 2nd Value:  
 Value Percent: **5.000**  
 Continuous Index:  
 Within 8" of Joint: **YES**  
 Remarks:

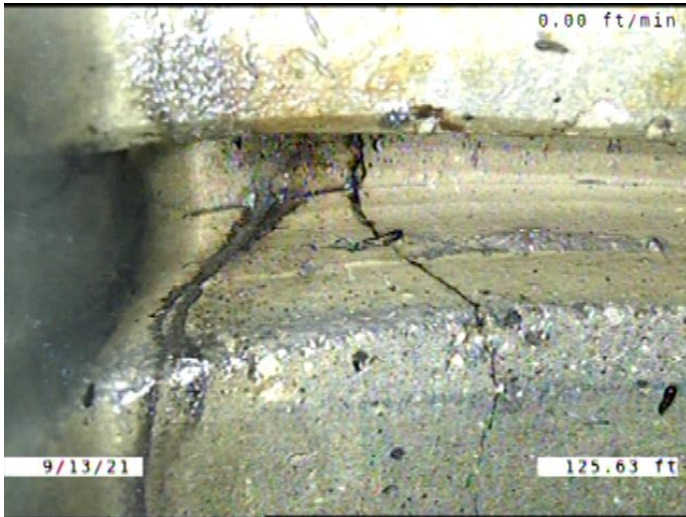
Code: **CM**  
 Description: **Crack Multiple**

Distance (ft): **125.6**  
 Structural Grade: **3**  
 O&M Grade: **0**  
 Clock Start/From: **8**  
 Clock To: **9**  
 1st Value:  
 2nd Value:  
 Value Percent:  
 Continuous Index:  
 Within 8" of Joint: **YES**  
 Remarks:

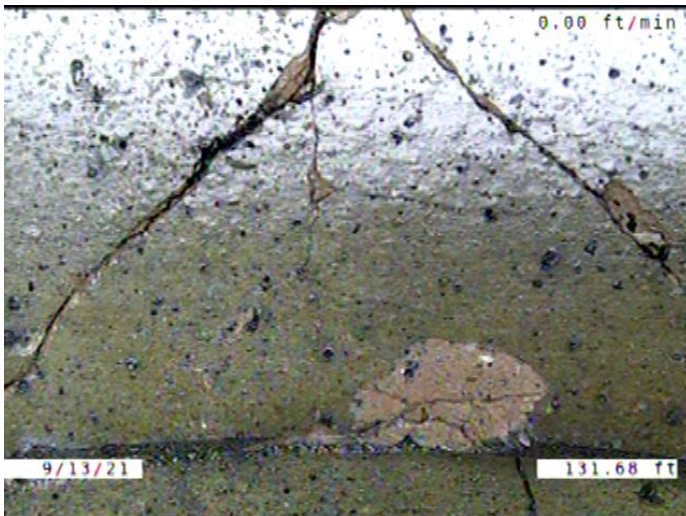
Code: **FM**  
 Description: **Fracture Multiple**

Distance (ft): **131.7**  
 Structural Grade: **4**  
 O&M Grade: **0**  
 Clock Start/From: **11**  
 Clock To: **2**  
 1st Value:  
 2nd Value:  
 Value Percent:  
 Continuous Index:  
 Within 8" of Joint: **YES**  
 Remarks:

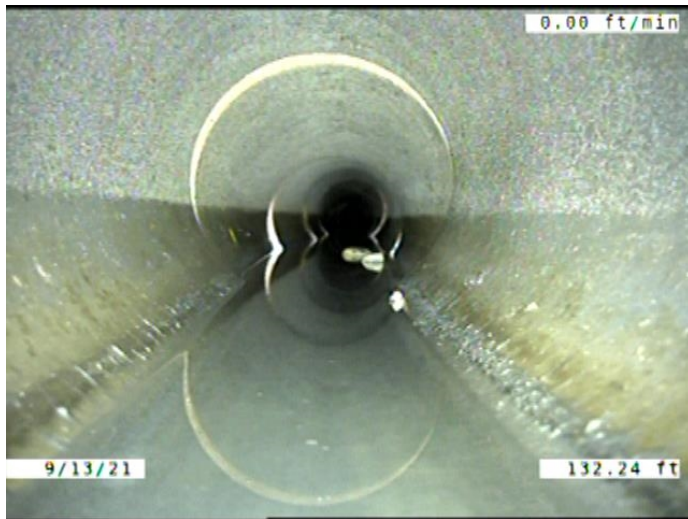
Code: **MWLS**  
 Description: **Miscellaneous Water Level Sag**

Distance (ft): **132.2**  
 Structural Grade: **2**  
 O&M Grade: **0**  
 Clock Start/From:  
 Clock To:  
 1st Value:  
 2nd Value:  
 Value Percent: **5.000**  
 Continuous Index: **F03**  
 Within 8" of Joint: **NO**  
 Remarks:

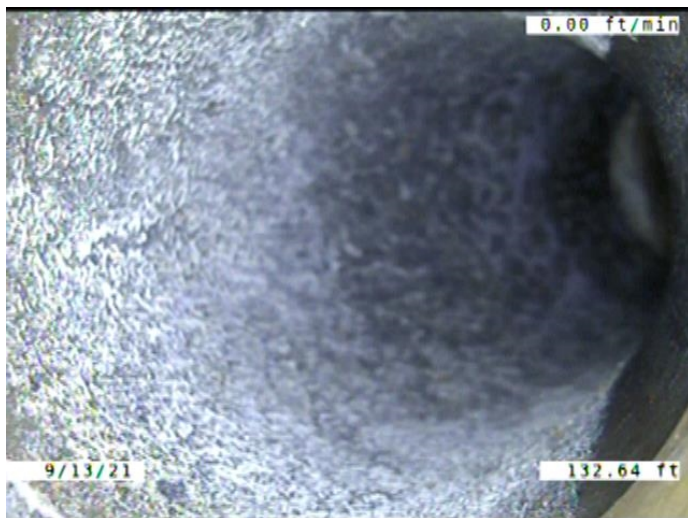
Code: **TBI**  
 Description: **Tap Break-in Intruding**

Distance (ft): **132.6**  
 Structural Grade: **0**  
 O&M Grade: **2**  
 Clock Start/From: **1**  
 Clock To:  
 1st Value: **4.000**  
 2nd Value: **1.000**  
 Value Percent:  
 Continuous Index:  
 Within 8" of Joint: **YES**  
 Remarks:

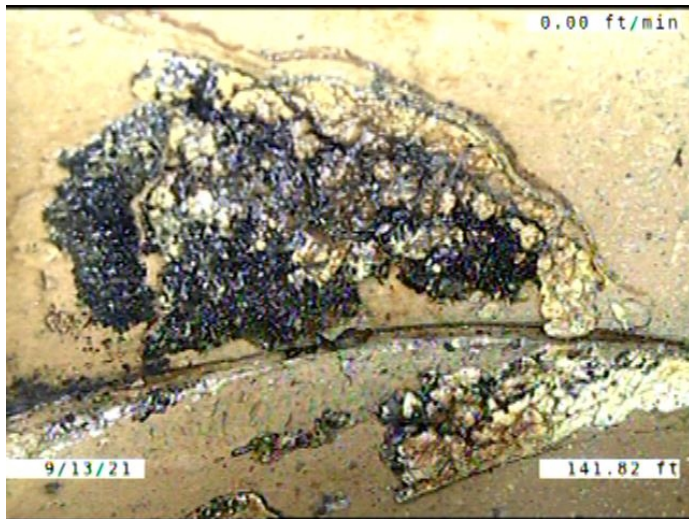
Code: **DAE**  
 Description: **Deposits Attached Encrustation**

Distance (ft): **141.8**  
 Structural Grade: **0**  
 O&M Grade: **2**  
 Clock Start/From: **8**  
 Clock To: **10**  
 1st Value:  
 2nd Value:  
 Value Percent: **5.000**  
 Continuous Index:  
 Within 8" of Joint: **YES**  
 Remarks:

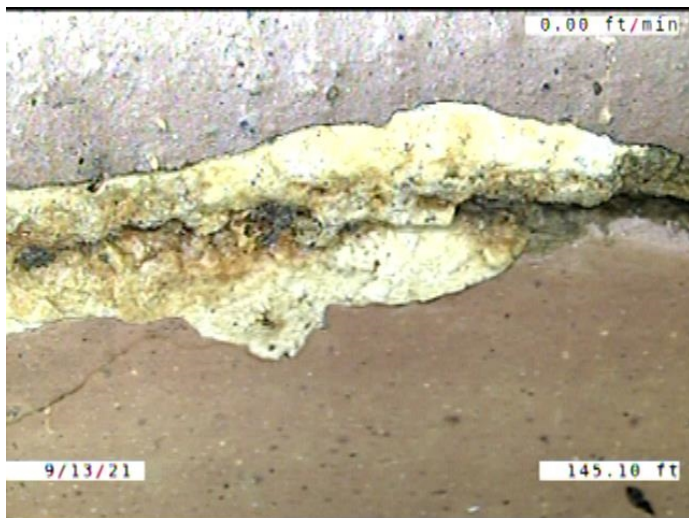
Code: **DAE**  
 Description: **Deposits Attached Encrustation**

Distance (ft): **145.1**  
 Structural Grade: **0**  
 O&M Grade: **2**  
 Clock Start/From: **8**  
 Clock To: **3**  
 1st Value:  
 2nd Value:  
 Value Percent: **5.000**  
 Continuous Index:  
 Within 8" of Joint: **YES**  
 Remarks:

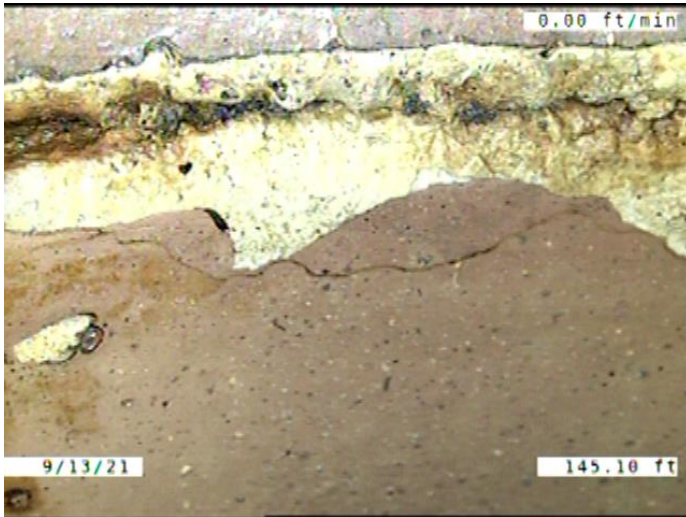
Code: **CS**  
 Description: **Crack Spiral**

Distance (ft): **145.1**  
 Structural Grade: **2**  
 O&M Grade: **0**  
 Clock Start/From: **7**  
 Clock To: **12**  
 1st Value:  
 2nd Value:  
 Value Percent:  
 Continuous Index:  
 Within 8" of Joint: **YES**  
 Remarks:

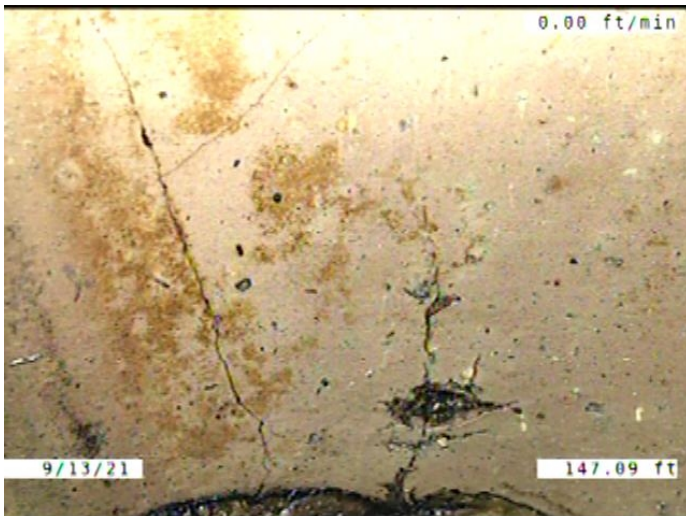
Code: **CM**  
 Description: **Crack Multiple**

Distance (ft): **147.1**  
 Structural Grade: **3**  
 O&M Grade: **0**  
 Clock Start/From: **7**  
 Clock To: **10**  
 1st Value:  
 2nd Value:  
 Value Percent:  
 Continuous Index:  
 Within 8" of Joint: **YES**  
 Remarks:

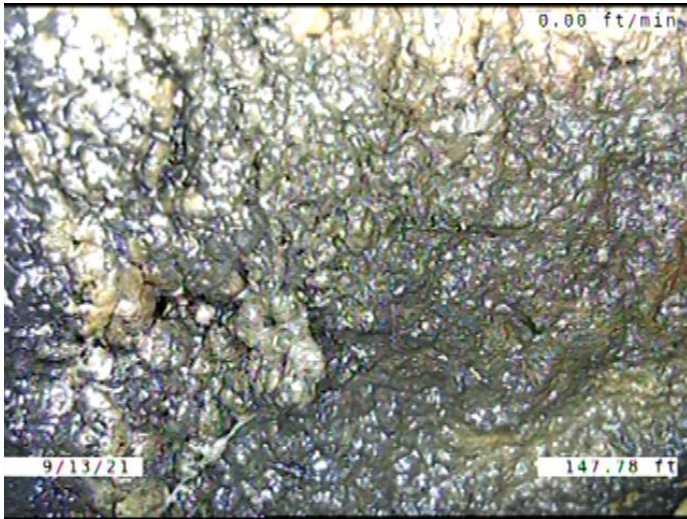
Code: **DAE**  
 Description: **Deposits Attached Encrustation**

Distance (ft): **147.8**  
 Structural Grade: **0**  
 O&M Grade: **2**  
 Clock Start/From: **8**  
 Clock To: **2**  
 1st Value:  
 2nd Value:  
 Value Percent: **5.000**  
 Continuous Index:  
 Within 8" of Joint: **YES**  
 Remarks:

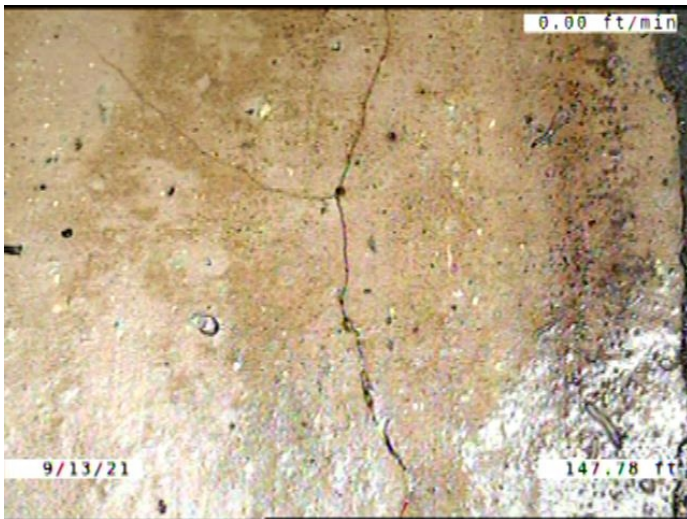
Code: **CM**  
 Description: **Crack Multiple**

Distance (ft): **147.8**  
 Structural Grade: **3**  
 O&M Grade: **0**  
 Clock Start/From: **3**  
 Clock To: **4**  
 1st Value:  
 2nd Value:  
 Value Percent:  
 Continuous Index:  
 Within 8" of Joint: **YES**  
 Remarks:

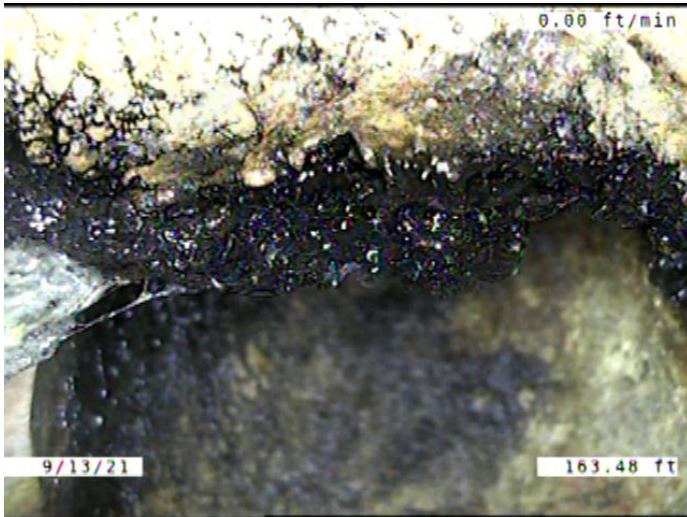
Code: **IWC**  
 Description: **Infiltration Weeper Connection**

Distance (ft): **163.5**  
 Structural Grade: **0**  
 O&M Grade: **2**  
 Clock Start/From: **10**  
 Clock To:  
 1st Value:  
 2nd Value:  
 Value Percent:  
 Continuous Index:  
 Within 8" of Joint: **YES**  
 Remarks:

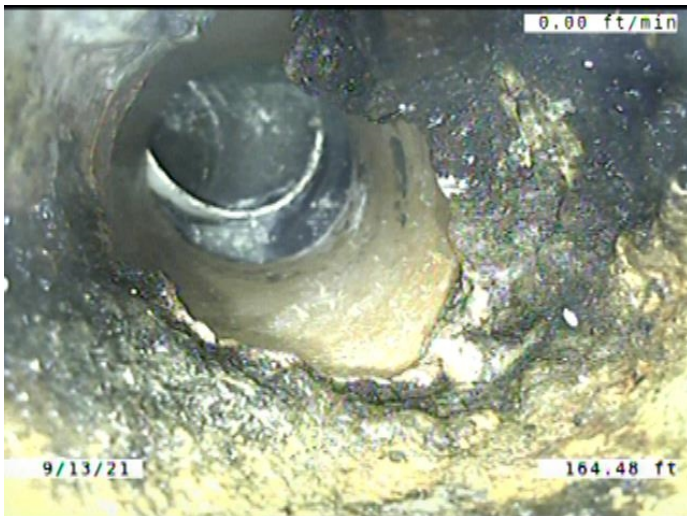
Code: **TFD**  
 Description: **Tap Factory Defective**

Distance (ft): **164.5**  
 Structural Grade: **0**  
 O&M Grade: **3**  
 Clock Start/From: **11**  
 Clock To:  
 1st Value: **4.000**  
 2nd Value:  
 Value Percent:  
 Continuous Index:  
 Within 8" of Joint: **YES**  
 Remarks: **ENCRUSTATION IN THE TAP**

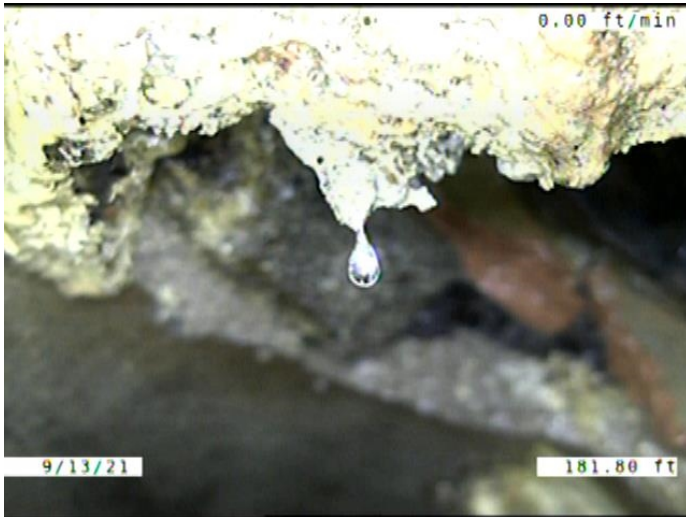
Code: **IWC**  
Description: **Infiltration Weeper Connection**

Distance (ft): **181.8**  
Structural Grade: **0**  
O&M Grade: **2**  
Clock Start/From: **12**  
Clock To:  
1st Value:  
2nd Value:  
Value Percent:  
Continuous Index:  
Within 8" of Joint: **YES**  
Remarks:

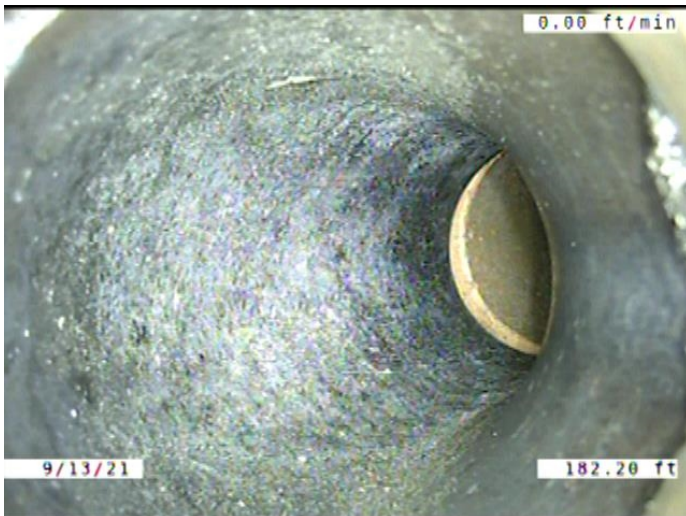
Code: **TBD**  
Description: **Tap Break-in/Hammer Defective**

Distance (ft): **182.2**  
Structural Grade: **0**  
O&M Grade: **3**  
Clock Start/From: **1**  
Clock To:  
1st Value: **4.000**  
2nd Value:  
Value Percent:  
Continuous Index:  
Within 8" of Joint: **NO**  
Remarks: **Defective**

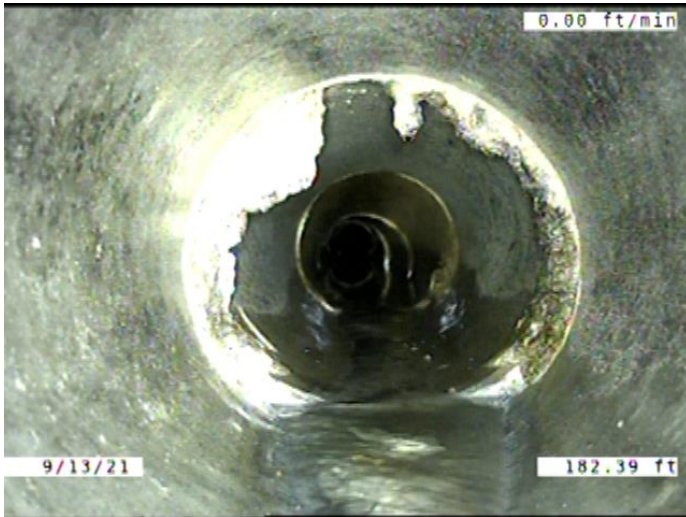
Code: **MWLS**  
 Description: **Miscellaneous Water Level Sag**

Distance (ft): **182.4**  
 Structural Grade: **2**  
 O&M Grade: **0**  
 Clock Start/From:  
 Clock To:  
 1st Value:  
 2nd Value:  
 Value Percent: **15.000**  
 Continuous Index: **F04**  
 Within 8" of Joint: **NO**  
 Remarks:

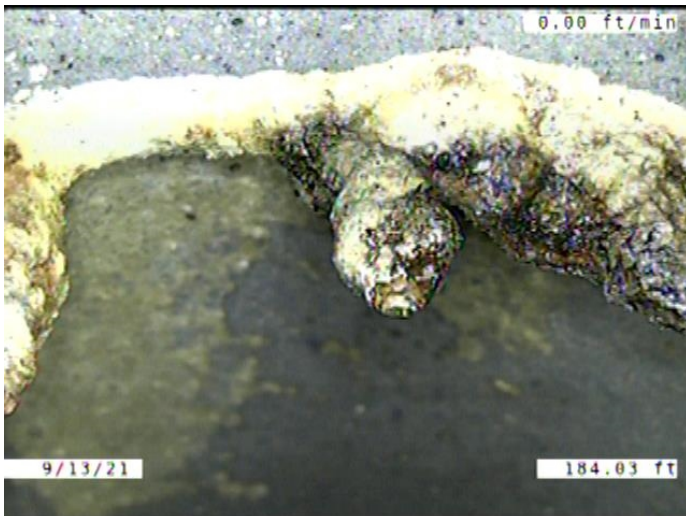
Code: **IWJ**  
 Description: **Infiltration Weeper Joint**

Distance (ft): **184.0**  
 Structural Grade: **0**  
 O&M Grade: **2**  
 Clock Start/From: **12**  
 Clock To:  
 1st Value:  
 2nd Value:  
 Value Percent:  
 Continuous Index:  
 Within 8" of Joint: **YES**  
 Remarks:

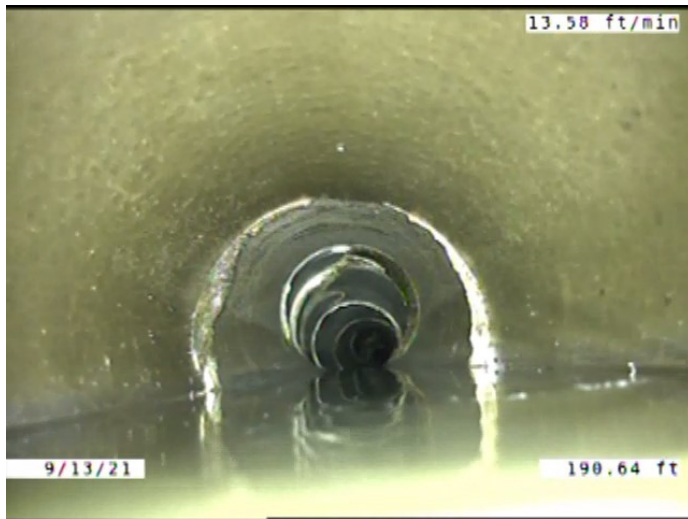
Code: **MWLS**  
 Description: **Miscellaneous Water Level Sag**

Distance (ft): **190.0**  
 Structural Grade: **2**  
 O&M Grade: **0**  
 Clock Start/From:  
 Clock To:  
 1st Value:  
 2nd Value:  
 Value Percent: **10.000**  
 Continuous Index:  
 Within 8" of Joint: **NO**  
 Remarks:

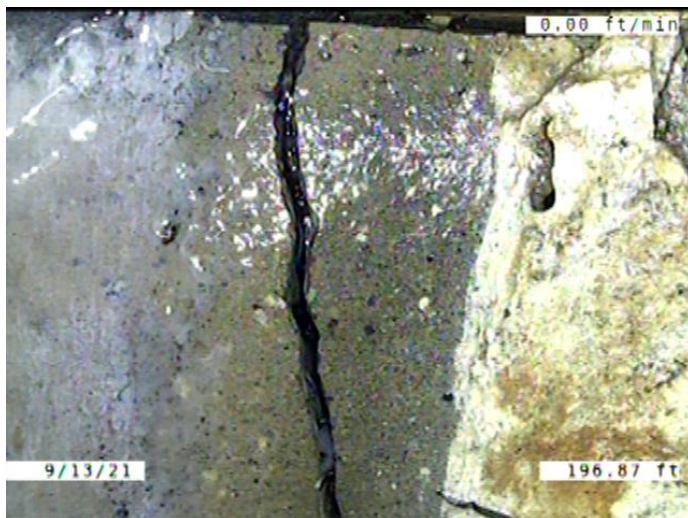
Code: **FM**  
 Description: **Fracture Multiple**

Distance (ft): **196.6**  
 Structural Grade: **4**  
 O&M Grade: **0**  
 Clock Start/From: **7**  
 Clock To: **1**  
 1st Value:  
 2nd Value:  
 Value Percent:  
 Continuous Index: **S06**  
 Within 8" of Joint: **NO**  
 Remarks:

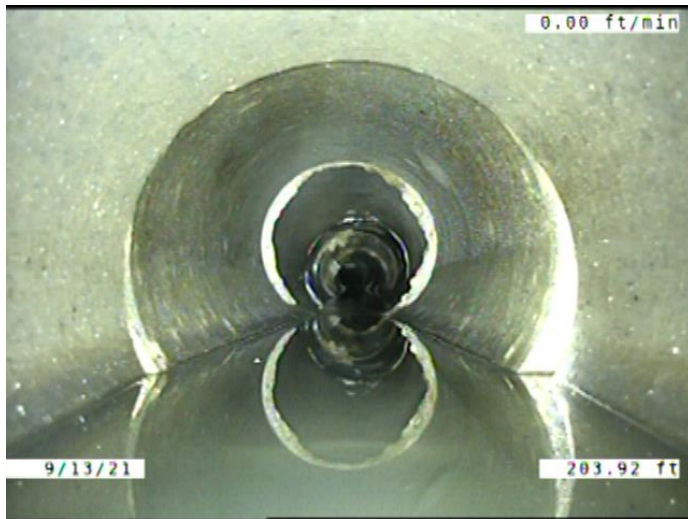
Code: **FM**  
 Description: **Fracture Multiple**

Distance (ft): **203.9**  
 Structural Grade: **4**  
 O&M Grade: **0**  
 Clock Start/From: **7**  
 Clock To: **1**  
 1st Value:  
 2nd Value:  
 Value Percent:  
 Continuous Index: **F06**  
 Within 8" of Joint: **YES**  
 Remarks:

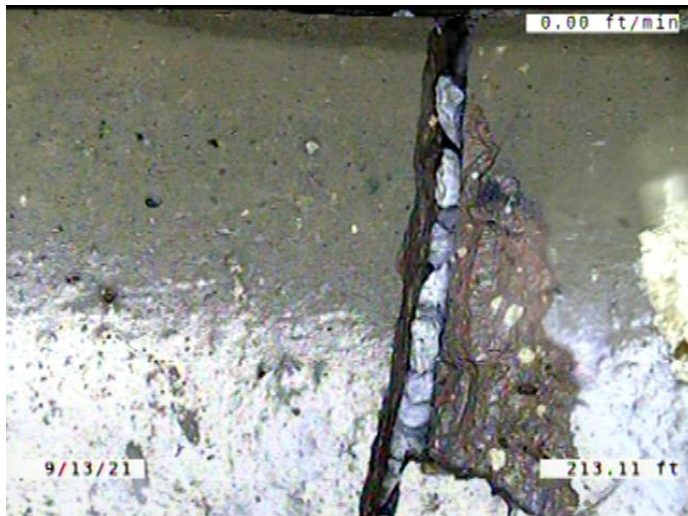
Code: **FM**  
 Description: **Fracture Multiple**

Distance (ft): **211.8**  
 Structural Grade: **4**  
 O&M Grade: **0**  
 Clock Start/From: **6**  
 Clock To: **4**  
 1st Value:  
 2nd Value:  
 Value Percent:  
 Continuous Index: **S07**  
 Within 8" of Joint: **YES**  
 Remarks:

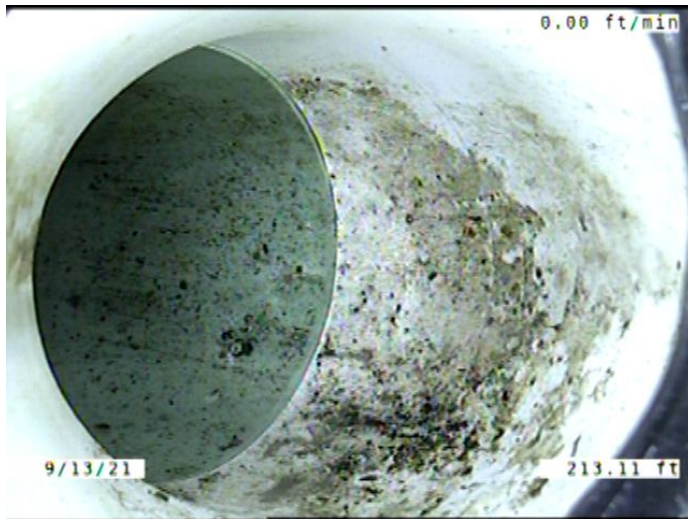
Code: **TBD**  
 Description: **Tap Break-in/Hammer Defective**

Distance (ft): **213.1**  
 Structural Grade: **0**  
 O&M Grade: **3**  
 Clock Start/From: **12**  
 Clock To:  
 1st Value: **4.000**  
 2nd Value:  
 Value Percent:  
 Continuous Index:  
 Within 8" of Joint: **YES**  
 Remarks: **Defective**
