# Profile/Photo Observation Report

Date:	09/13/2021	Weather:		Coding:	PACP 7.0
Pipe Length (ft):	311.0	Owner:	City of Hobart	Pre Clean:	Light Cleaning
P.O.#:	YES502259	Surveyor:	S. Bucklin	PSR:	P-504-059-058
Customer:	City of Hobart	Clean Date:	09/07/2021	Shape:	C

Street:	North Wilson Street	Flow Control:	Not Controlled
City:	Hobart, IN	Year Renewed:	
Location:		Tape/Media #:	
Purpose:	Routine Assessment	Dia/Height:	10"
Use:	Sanitary Sewage Pipe	Material:	VCP
Drain Area:		Lining:	None
Category:	NA		
Comment:			
Location Details:		Direction of Survey:	Downstream
US MH:	M-504-058	DS MH:	M-504-059
		Total Length Surveyed (ft):	311.0

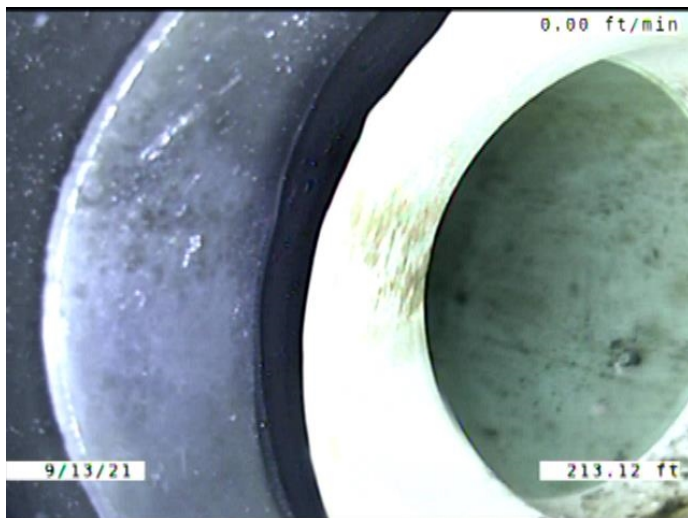
Code: **IRC**  
 Description: **Infiltration Runner Connection**

Distance (ft): **213.1**  
 Structural Grade: **0**  
 O&M Grade: **4**  
 Clock Start/From: **11**  
 Clock To:  
 1st Value:  
 2nd Value:  
 Value Percent:  
 Continuous Index:  
 Within 8" of Joint: **YES**  
 Remarks:

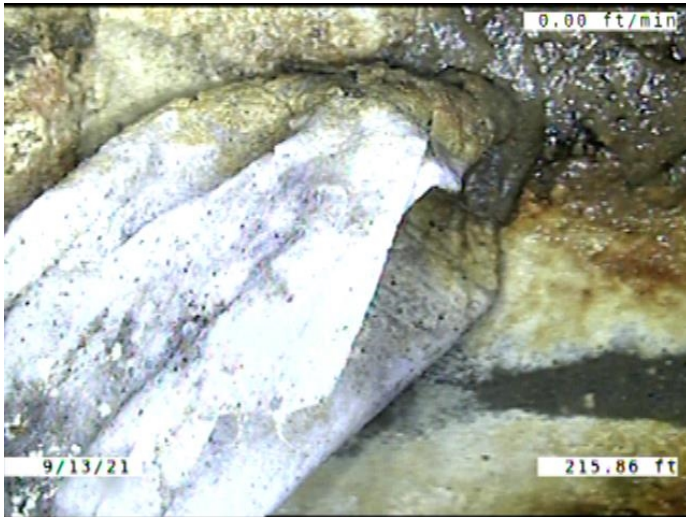
Code:	<b>DAR</b>
Description:	<b>Deposits Attached Ragging</b>
Distance (ft):	<b>215.9</b>
Structural Grade:	<b>0</b>
O&M Grade:	<b>2</b>
Clock Start/From:	<b>9</b>
Clock To:	<b>10</b>
1st Value:	
2nd Value:	
Value Percent:	<b>5.000</b>
Continuous Index:	
Within 8" of Joint:	<b>YES</b>
Remarks:

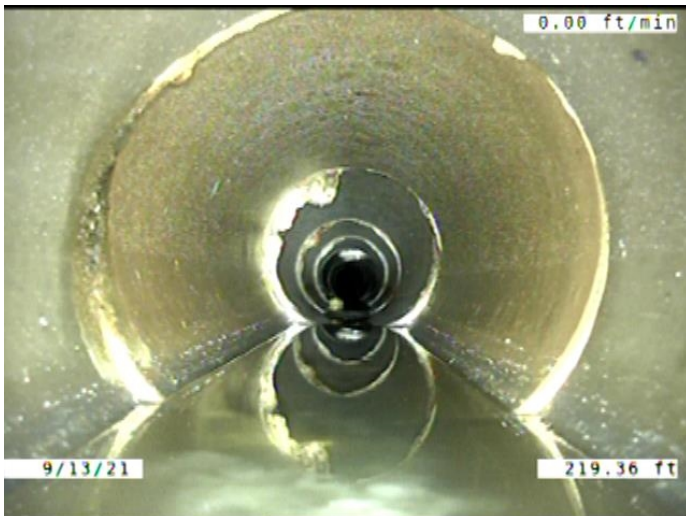
Code:	<b>FM</b>
Description:	<b>Fracture Multiple</b>
Distance (ft):	<b>219.4</b>
Structural Grade:	<b>4</b>
O&M Grade:	<b>0</b>
Clock Start/From:	<b>6</b>
Clock To:	<b>4</b>
1st Value:	
2nd Value:	
Value Percent:	
Continuous Index:	<b>F07</b>
Within 8" of Joint:	<b>YES</b>
Remarks:

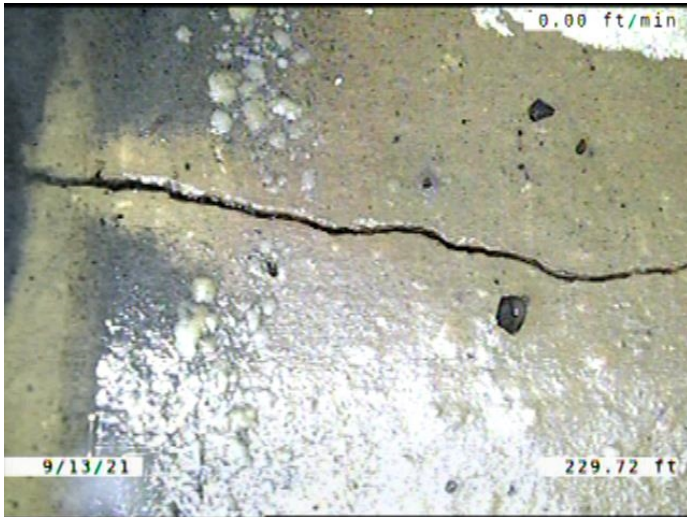
Code: **FM**  
 Description: **Fracture Multiple**

Distance (ft): **229.7**  
 Structural Grade: **4**  
 O&M Grade: **0**  
 Clock Start/From: **7**  
 Clock To: **5**  
 1st Value:  
 2nd Value:  
 Value Percent:  
 Continuous Index:  
 Within 8" of Joint: **YES**  
 Remarks:

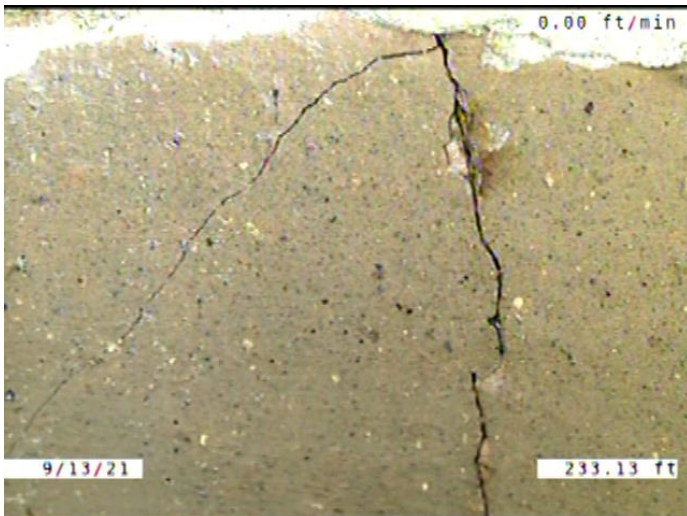
Code: **FM**  
 Description: **Fracture Multiple**

Distance (ft): **233.1**  
 Structural Grade: **4**  
 O&M Grade: **0**  
 Clock Start/From: **12**  
 Clock To: **3**  
 1st Value:  
 2nd Value:  
 Value Percent:  
 Continuous Index:  
 Within 8" of Joint: **YES**  
 Remarks:

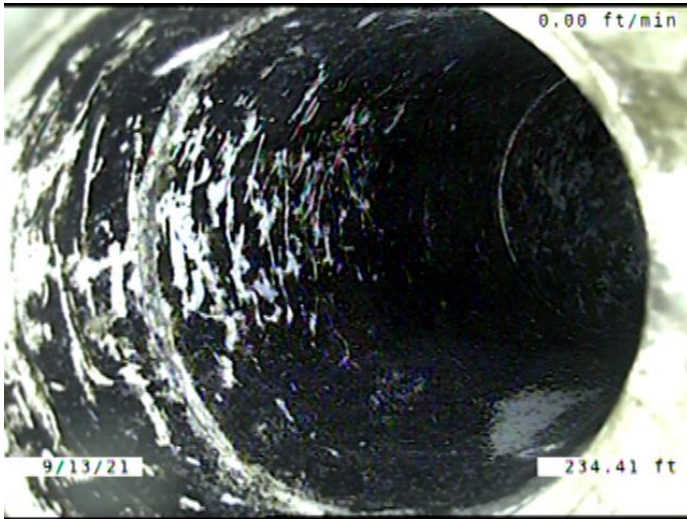
Code: **TBI**  
 Description: **Tap Break-in Intruding**

Distance (ft): **234.4**  
 Structural Grade: **0**  
 O&M Grade: **2**  
 Clock Start/From: **12**  
 Clock To:  
 1st Value: **4.000**  
 2nd Value: **1.000**  
 Value Percent:  
 Continuous Index:  
 Within 8" of Joint: **YES**  
 Remarks:

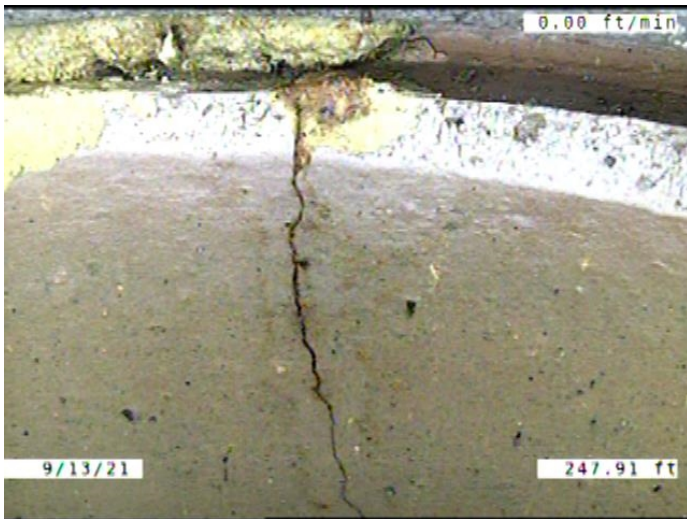
Code: **CM**  
 Description: **Crack Multiple**

Distance (ft): **247.9**  
 Structural Grade: **3**  
 O&M Grade: **0**  
 Clock Start/From: **10**  
 Clock To: **1**  
 1st Value:  
 2nd Value:  
 Value Percent:  
 Continuous Index:  
 Within 8" of Joint: **YES**  
 Remarks:

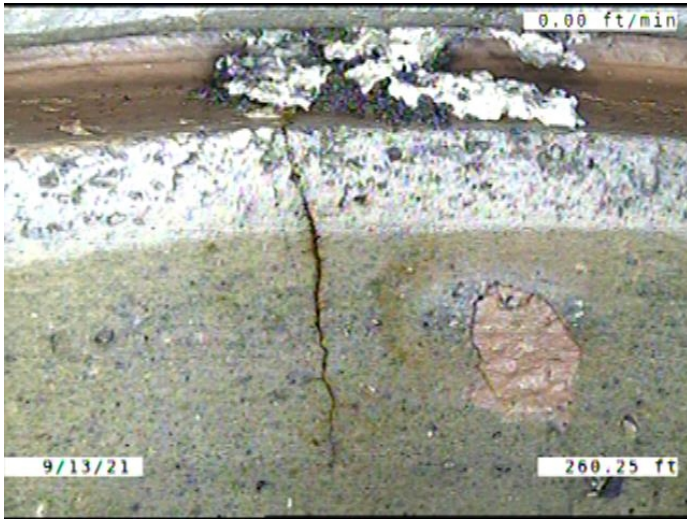
Code: **CL**  
 Description: **Crack Longitudinal**

Distance (ft): **260.2**  
 Structural Grade: **2**  
 O&M Grade: **0**  
 Clock Start/From: **10**  
 Clock To:  
 1st Value:  
 2nd Value:  
 Value Percent:  
 Continuous Index:  
 Within 8" of Joint: **YES**  
 Remarks:

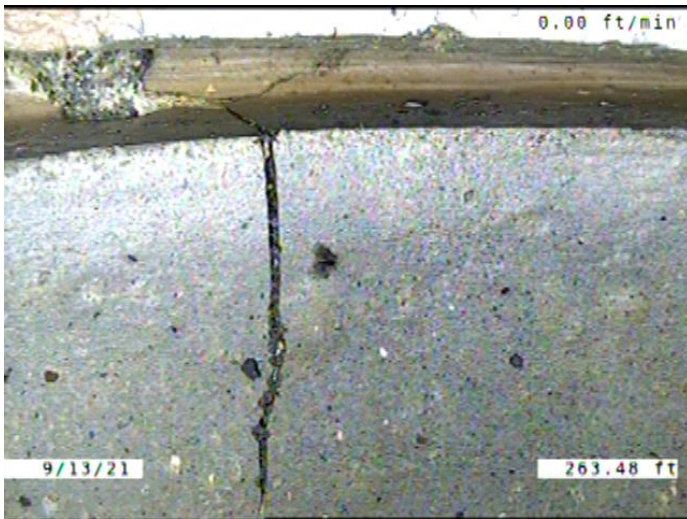
Code: **FM**  
 Description: **Fracture Multiple**

Distance (ft): **263.5**  
 Structural Grade: **4**  
 O&M Grade: **0**  
 Clock Start/From: **12**  
 Clock To: **12**  
 1st Value:  
 2nd Value:  
 Value Percent:  
 Continuous Index:  
 Within 8" of Joint: **YES**  
 Remarks:

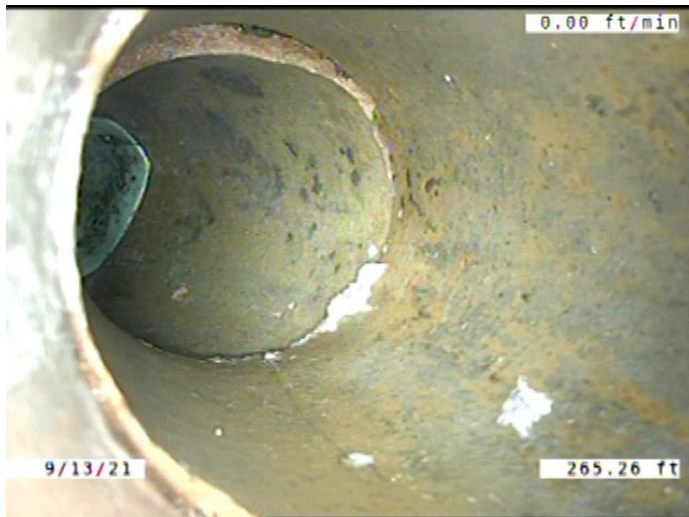
Code: **TBI**  
 Description: **Tap Break-in Intruding**

Distance (ft): **265.3**  
 Structural Grade: **0**  
 O&M Grade: **2**  
 Clock Start/From: **11**  
 Clock To:  
 1st Value: **4.000**  
 2nd Value: **1.000**  
 Value Percent:  
 Continuous Index:  
 Within 8" of Joint: **YES**  
 Remarks:

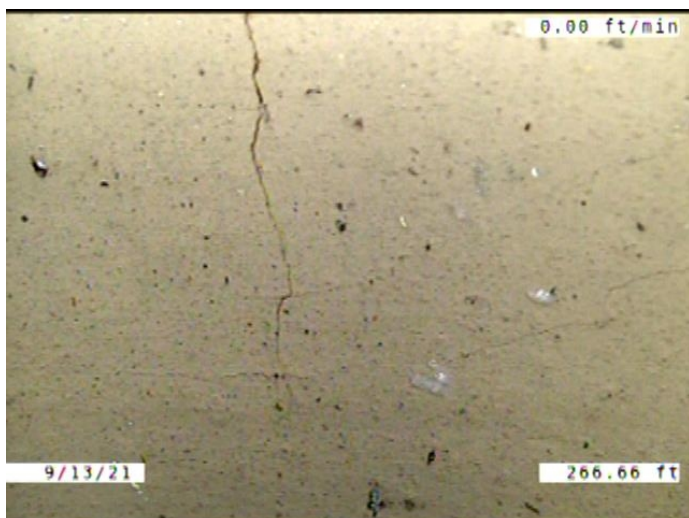
Code: **CM**  
 Description: **Crack Multiple**

Distance (ft): **266.7**  
 Structural Grade: **3**  
 O&M Grade: **0**  
 Clock Start/From: **1**  
 Clock To: **4**  
 1st Value:  
 2nd Value:  
 Value Percent:  
 Continuous Index:  
 Within 8" of Joint: **YES**  
 Remarks:

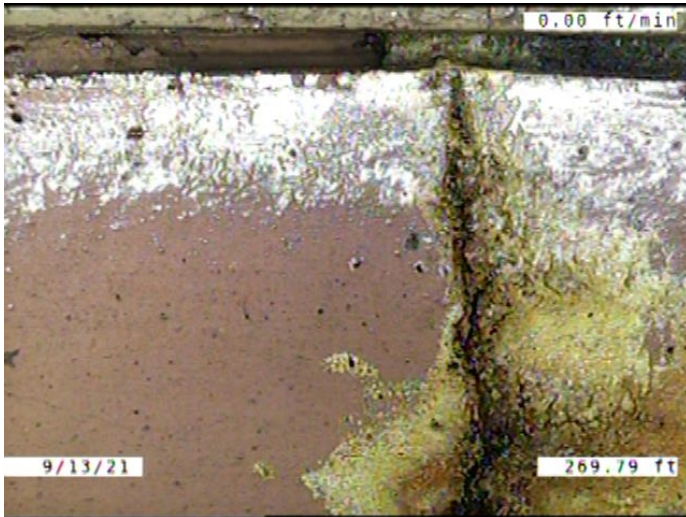
Code: **FM**  
 Description: **Fracture Multiple**

Distance (ft): **269.8**  
 Structural Grade: **4**  
 O&M Grade: **0**  
 Clock Start/From: **11**  
 Clock To: **2**  
 1st Value:  
 2nd Value:  
 Value Percent:  
 Continuous Index:  
 Within 8" of Joint: **YES**  
 Remarks:

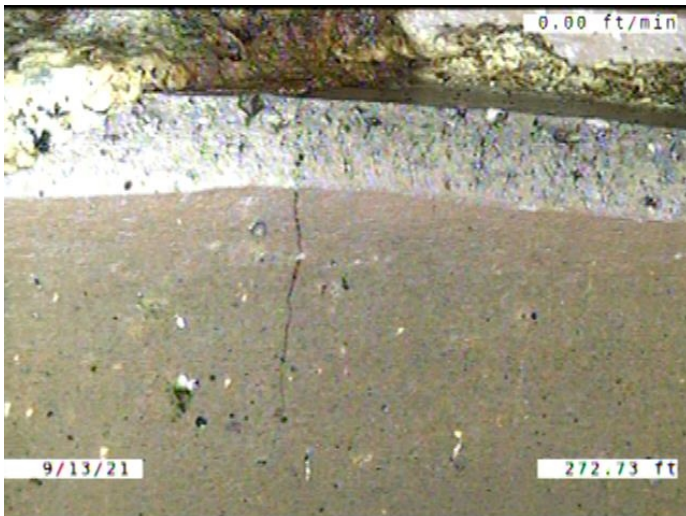
Code: **CL**  
 Description: **Crack Longitudinal**

Distance (ft): **272.7**  
 Structural Grade: **2**  
 O&M Grade: **0**  
 Clock Start/From: **10**  
 Clock To:  
 1st Value:  
 2nd Value:  
 Value Percent:  
 Continuous Index:  
 Within 8" of Joint: **YES**  
 Remarks:

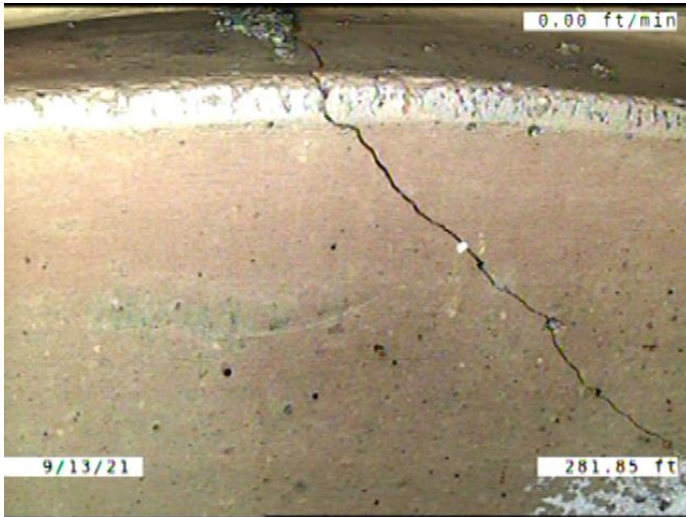
Code: **FS**  
Description: **Fracture Spiral**

Distance (ft): **281.8**  
Structural Grade: **3**  
O&M Grade: **0**  
Clock Start/From: **8**  
Clock To: **12**  
1st Value:  
2nd Value:  
Value Percent:  
Continuous Index:  
Within 8" of Joint: **YES**  
Remarks:

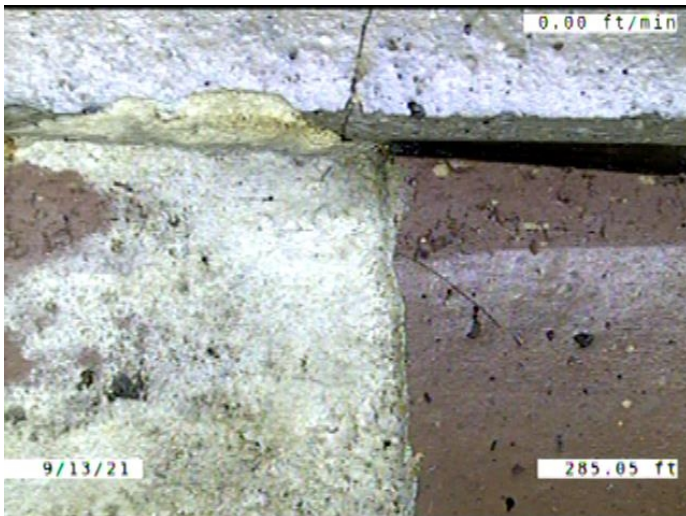
Code: **B**  
Description: **Broken**

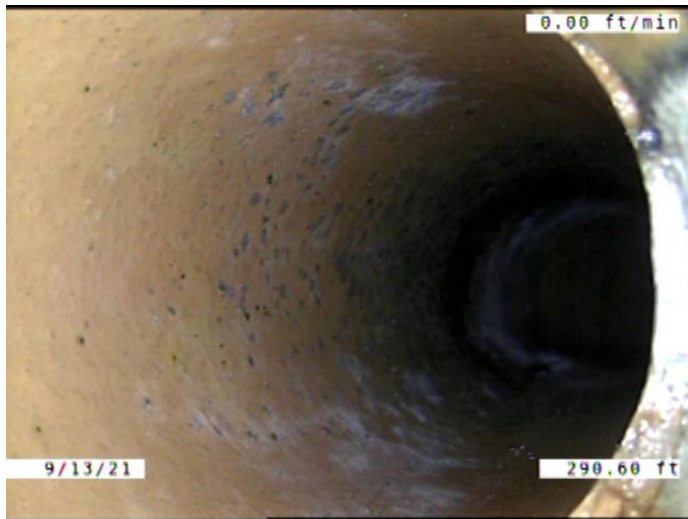
Code: **TBI**  
 Description: **Tap Break-in Intruding**

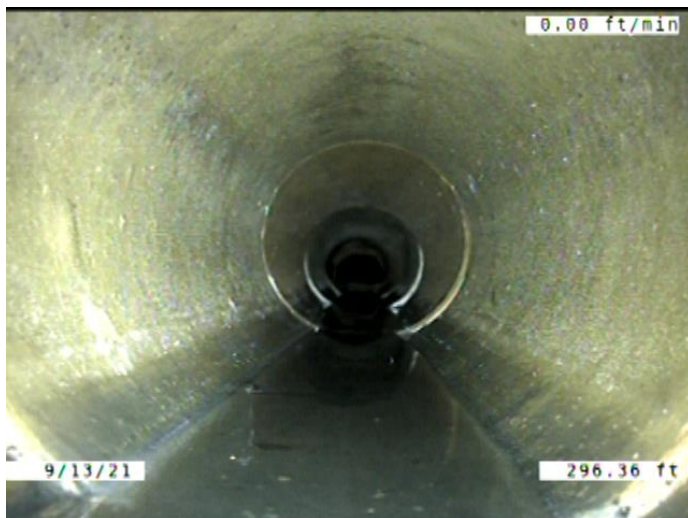
Code: **DAE**  
 Description: **Deposits Attached Encrustation**

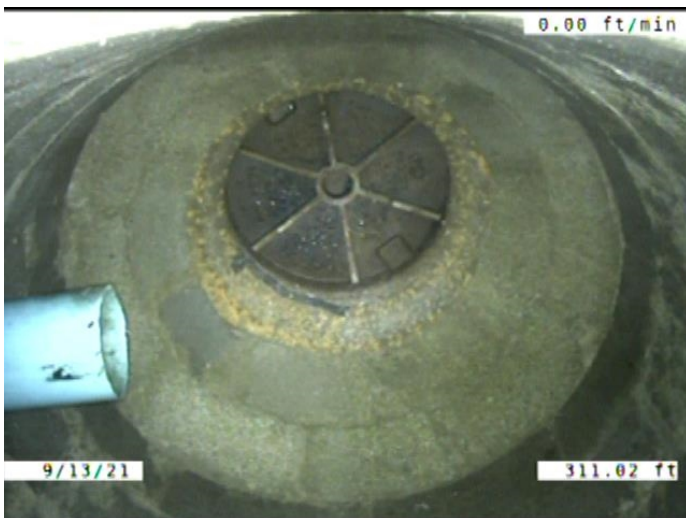
Code: **AMH**  
 Description: **Manhole**
