Profile/Photo Observation Report

Date:	04/08/2018	Weather:		Coding:	PACP 6.0
Pipe Length (ft):		Owner:	City of Hobart	Pre Clean:	No Pre-Cleaning
P.O.#:	20-1	Surveyor:	M. Pielacha	PSR:	M-504-065-M-504-064
Customer:	City of Hobart	Clean Date:		Shape:	C

Street:	Old Ridge Road	Flow Control:	Not Controlled
City:	Hobart, IN	Year Renewed:	
Location:	Light Highway	Tape/Media #:	DEP 20
Purpose:	Routine Assessment	Dia/Height:	24"
Use:	Sanitary	Material:	CP
Drain Area:		Lining:

US MH: **M-504-065** DS MH: **M-504-064** Total Length Surveyed (ft): **315.8**

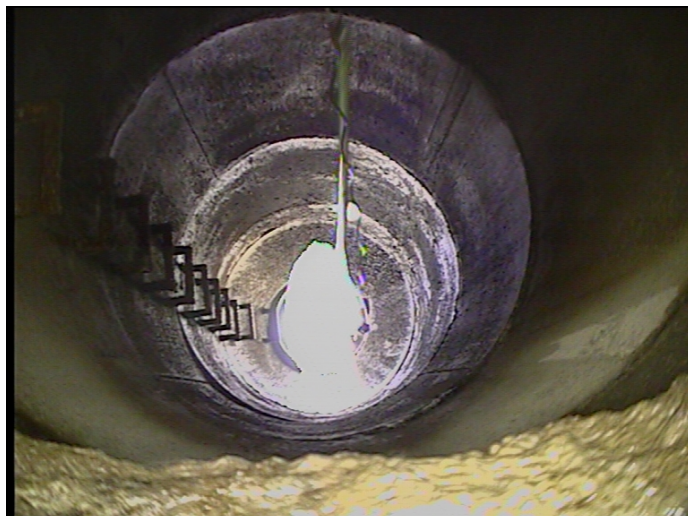
Code: **AMH**
Description: **Manhole**

Distance (ft): **.0**
Structural Grade: **0**
O&M Grade: **0**
Clock Start/From:
Clock To:
1st Value:
2nd Value:
Value Percent:
Continuous Index:
Within 8" of Joint: **NO**
Remarks: **M-504-064**

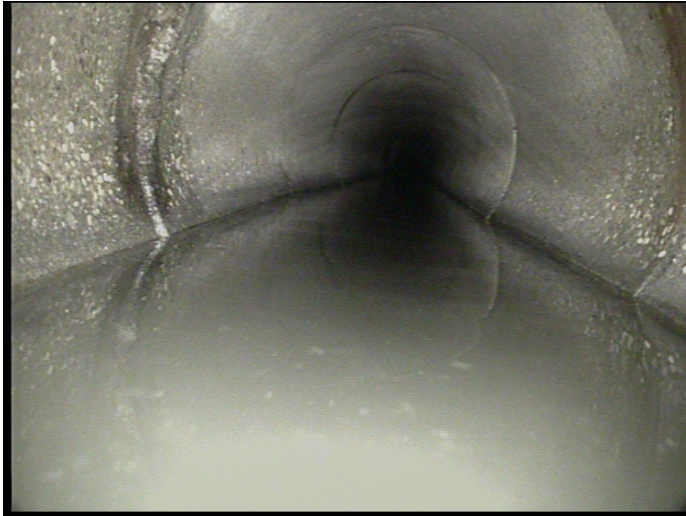
Code: **MWL**
Description: **Water Level**

Distance (ft): **.0**
Structural Grade: **0**
O&M Grade: **0**
Clock Start/From:
Clock To:
1st Value:
2nd Value:
Value Percent: **10.000**
Continuous Index:
Within 8" of Joint: **NO**
Remarks:

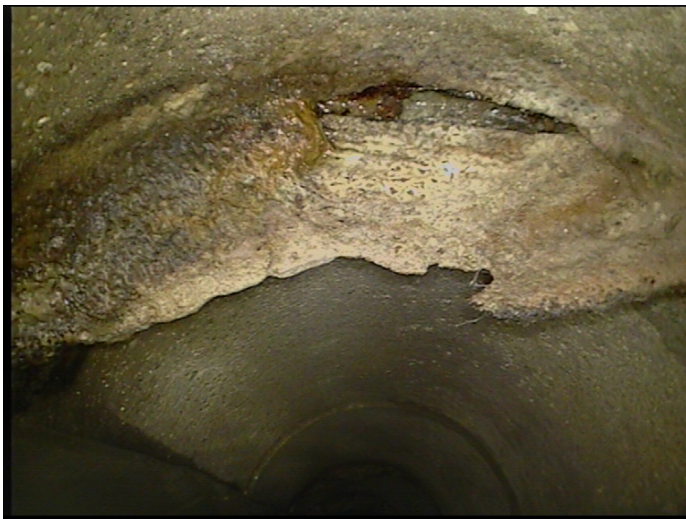
Code: **DAE**
Description: **Deposits Attached Encrustation**

Distance (ft): **28.7**
Structural Grade: **0**
O&M Grade: **2**
Clock Start/From: **7**
Clock To: **11**
1st Value:
2nd Value:
Value Percent: **5.000**
Continuous Index: **S01**
Within 8" of Joint: **YES**
Remarks:

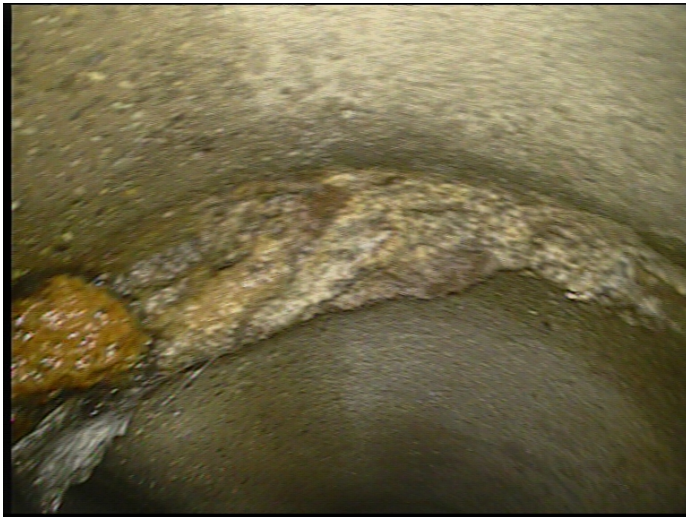
Code:	DAE
Description:	Deposits Attached Encrustation
Distance (ft):	41.4
Structural Grade:	0
O&M Grade:	2
Clock Start/From:	7
Clock To:	11
1st Value:	
2nd Value:	
Value Percent:	5.000
Continuous Index:	F01
Within 8" of Joint:	NO
Remarks:

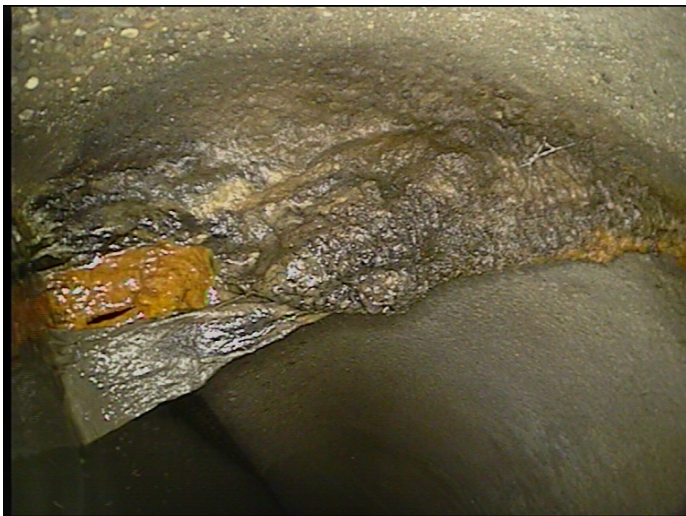
Code:	DAE
Description:	Deposits Attached Encrustation
Distance (ft):	110.7
Structural Grade:	0
O&M Grade:	2
Clock Start/From:	7
Clock To:	11
1st Value:	
2nd Value:	
Value Percent:	10.000
Continuous Index:	
Within 8" of Joint:	YES
Remarks:

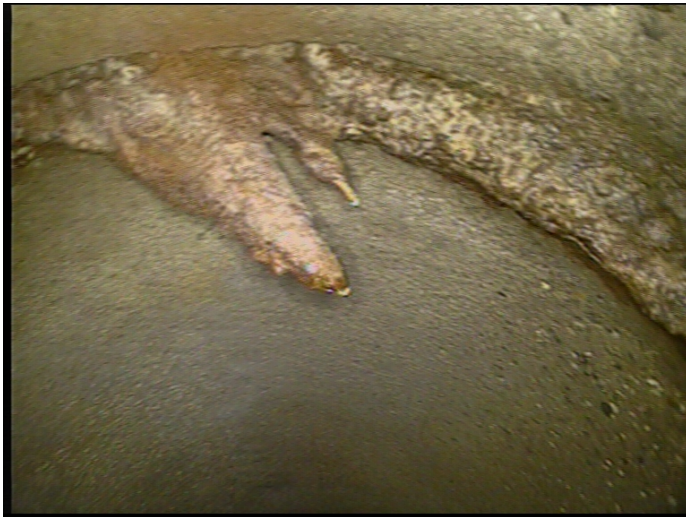
Code:	DAE
Description:	Deposits Attached Encrustation
Distance (ft):	269.2
Structural Grade:	0
O&M Grade:	2
Clock Start/From:	8
Clock To:	4
1st Value:	
2nd Value:	
Value Percent:	5.000
Continuous Index:	S02
Within 8" of Joint:	YES
Remarks:

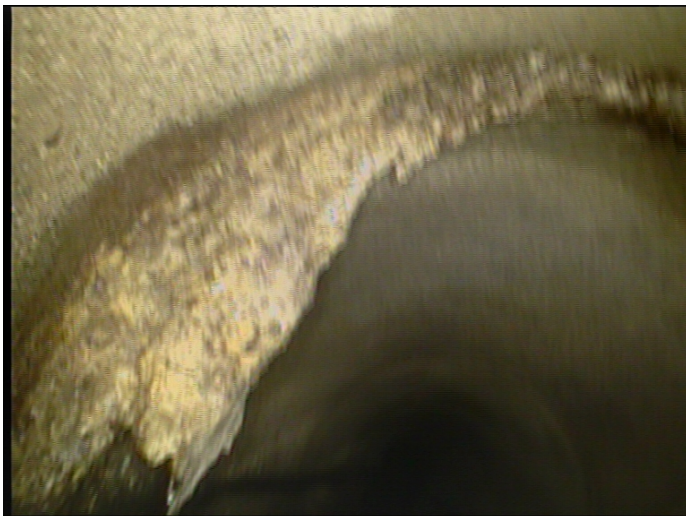
Code:	DAE
Description:	Deposits Attached Encrustation
Distance (ft):	278.9
Structural Grade:	0
O&M Grade:	2
Clock Start/From:	8
Clock To:	4
1st Value:	
2nd Value:	
Value Percent:	5.000
Continuous Index:	F02
Within 8" of Joint:	NO
Remarks:

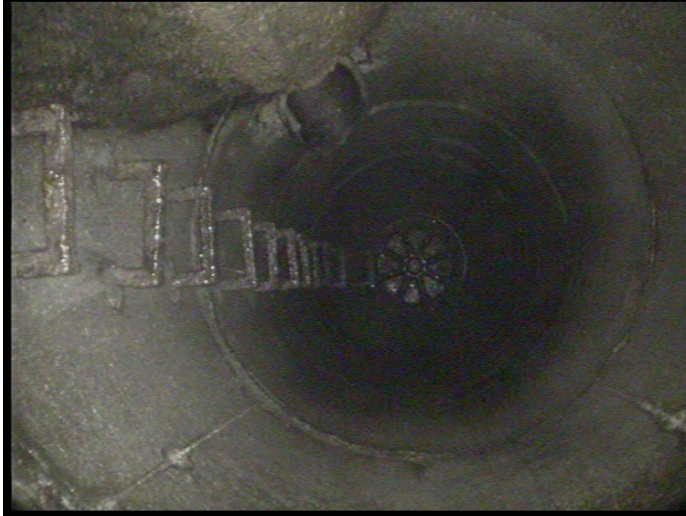
Code:	AMH
Description:	Manhole
Distance (ft):	315.8
Structural Grade:	0
O&M Grade:	0
Clock Start/From:	
Clock To:	
1st Value:	
2nd Value:	
Value Percent:	
Continuous Index:	
Within 8" of Joint:	NO
Remarks:	M-504-065
