Profile/Photo Observation Report

Street:	W OLD RIDGE RD & N GUYER ST	Flow Control:	Not Controlled
City:	Hobart, IN	Year Renewed:	
Location:	Light Highway	Tape/Media #:	
Purpose:	Not Known	Dia/Height:	10"
Use:	Sanitary	Material:	VCP
Drain Area:	NA	Lining:	
Category:	NA		
Comment:

Location Details:		Direction of Survey:	Downstream
US MH:	M-504-065.1	DS MH:	M-504-065
		Total Length Surveyed (ft):	179.4

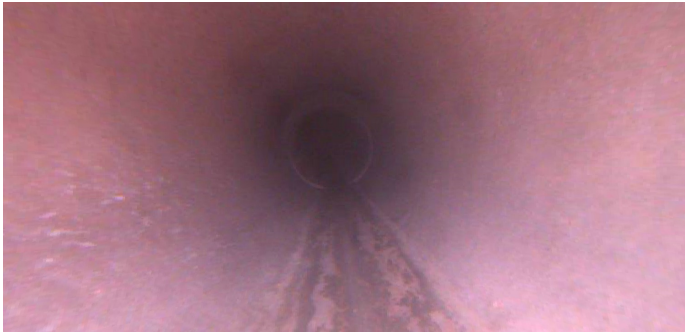
Code:	MWL
Description:	Water Level

Distance (ft):	.0
Structural Grade:	0
O&M Grade:	0
Clock Start/From:	
Clock To:	
1st Value:	
2nd Value:	
Value Percent:	5.000
Continuous Index:	
Within 8" of Joint:	NO
Remarks:

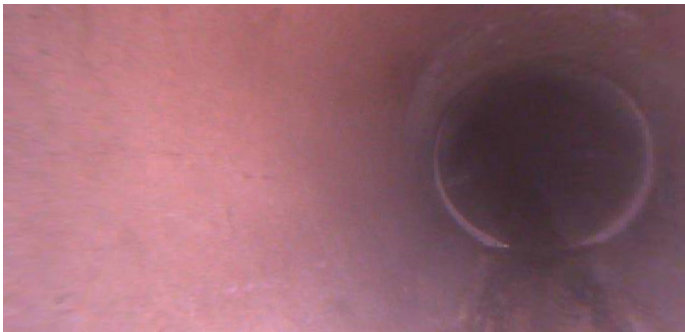
Code:	CL
Description:	Crack Longitudinal

Distance (ft):	2.3
Structural Grade:	2
O&M Grade:	0
Clock Start/From:	9
Clock To:	
1st Value:	
2nd Value:	
Value Percent:	
Continuous Index:	
Within 8" of Joint:	
Remarks:

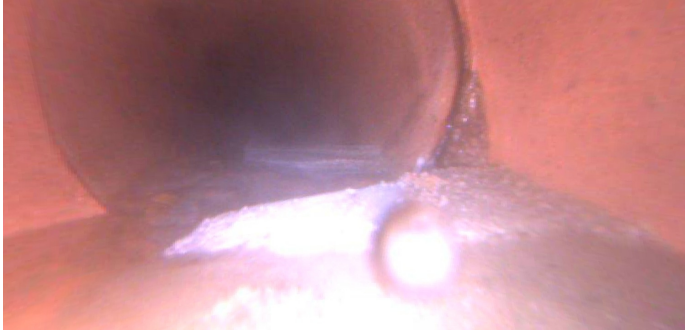
Code: **DSZ**
Description: **Deposits Settled Other**

Distance (ft): **137.8**
Structural Grade: **0**
O&M Grade: **3**
Clock Start/From: **6**
Clock To:
1st Value:
2nd Value:
Value Percent: **15.000**
Continuous Index:
Within 8" of Joint: **NO**
Remarks: **debris/sediments**

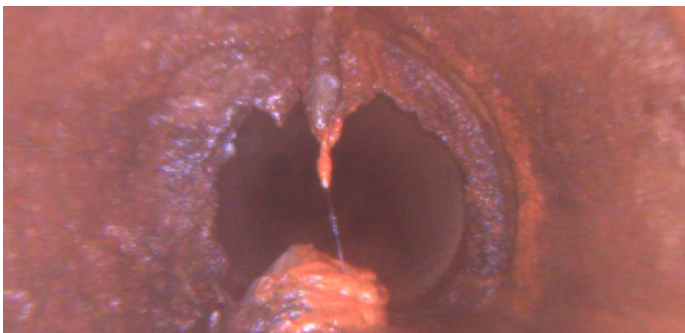
Code: **DAE**
Description: **Deposits Attached Encrustation**

Distance (ft): **167.9**
Structural Grade: **0**
O&M Grade: **4**
Clock Start/From: **7**
Clock To: **5**
1st Value:
2nd Value:
Value Percent: **25.000**
Continuous Index:
Within 8" of Joint: **YES**
Remarks:

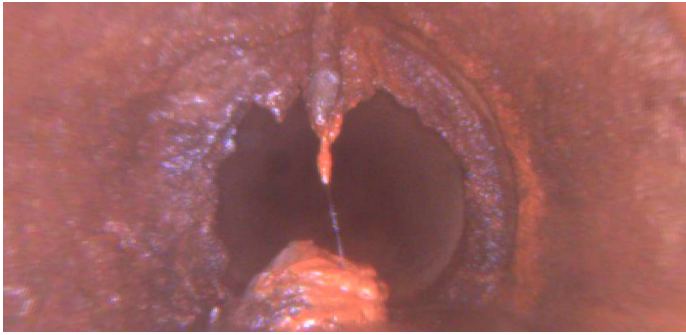
Code: **IR**
Description: **Infil Runner**

Distance (ft): **167.9**
Structural Grade: **0**
O&M Grade: **4**
Clock Start/From: **12**
Clock To:
1st Value:
2nd Value:
Value Percent:
Continuous Index:
Within 8" of Joint: **YES**
Remarks:

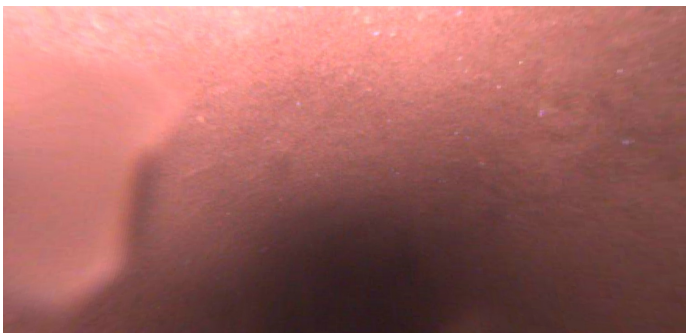
Code: **MSA**
Description: **Abandoned Survey**

Distance (ft): **179.4**
Structural Grade: **0**
O&M Grade: **0**
Clock Start/From:
Clock To:
1st Value:
2nd Value:
Value Percent:
Continuous Index:
Within 8" of Joint: **NO**
Remarks: **camera stuck/no blockage**
