## Profile/Photo Observation Report

| Street: | <b>Summerlin</b> | Flow Control: | <b>Not Controlled</b> |
| US MH: | <b>M-504-065.1</b> | DS MH: | <b>M-504-065.2</b> |

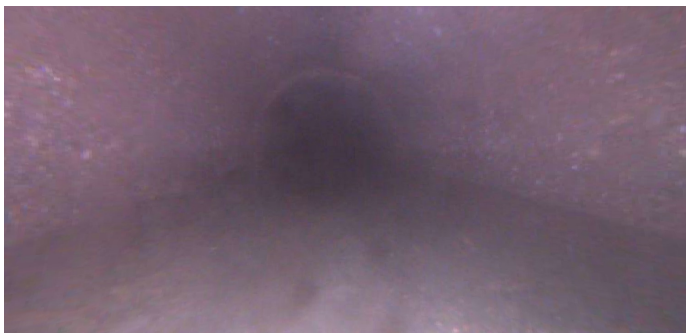
Code: **AMH**  
Description: **Manhole**

Distance (ft): **.0**  
Structural Grade: **0**  
O&M Grade: **0**  
Clock Start/From:  
Clock To:  
1st Value:  
2nd Value:  
Value Percent:  
Continuous Index:  
Within 8" of Joint: **NO**  
Remarks: **M-504-065.1**

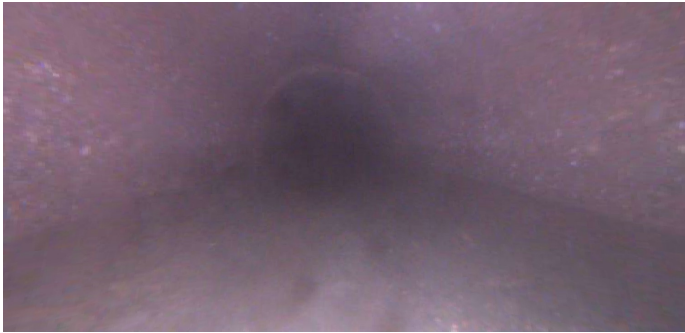
| Code: | <b>MWL</b> |
| Description: | <b>Water Level</b> |

| Value Percent: | <b>25.000</b> |

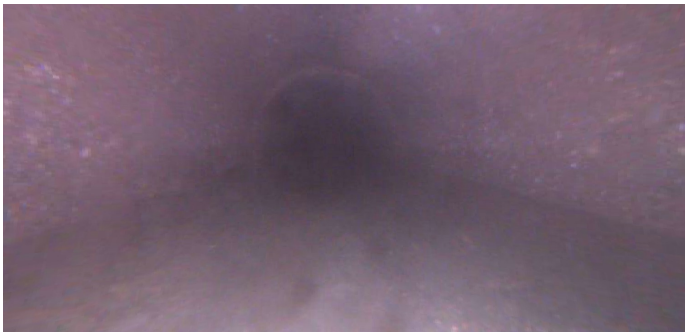
| Code: | <b>MGO</b> |
| Description: | <b>General Observation</b> |

| Remarks: | <b>steam</b> |

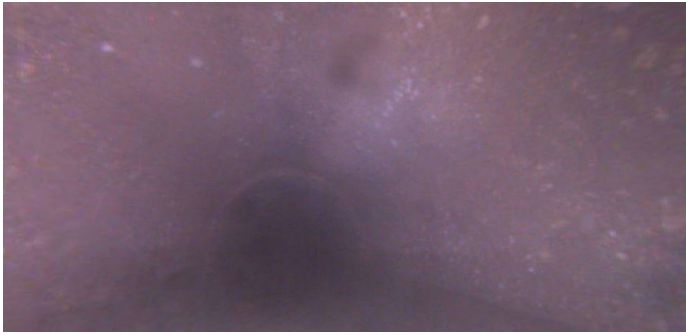
Code: **SAV**  
Description: **Surface Aggregate Visible**

Distance (ft): **.0**  
Structural Grade: **3**  
O&M Grade: **0**  
Clock Start/From: **8**  
Clock To: **4**  
1st Value:  
2nd Value:  
Value Percent:  
Continuous Index: **S02**  
Within 8" of Joint:  
Remarks:

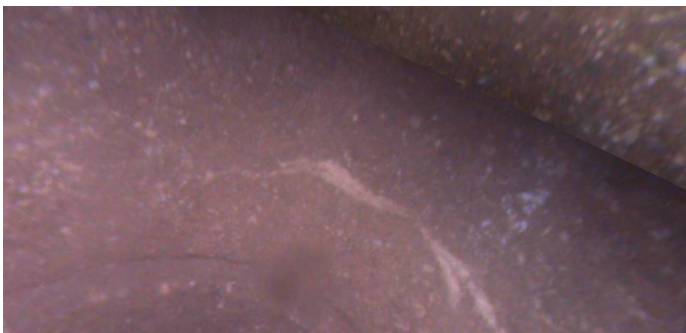
Code: **CC**  
Description: **Crack Circumferential**

Distance (ft): **17.6**  
Structural Grade: **1**  
O&M Grade: **0**  
Clock Start/From: **8**  
Clock To: **4**  
1st Value:  
2nd Value:  
Value Percent:  
Continuous Index:  
Within 8" of Joint:  
Remarks:

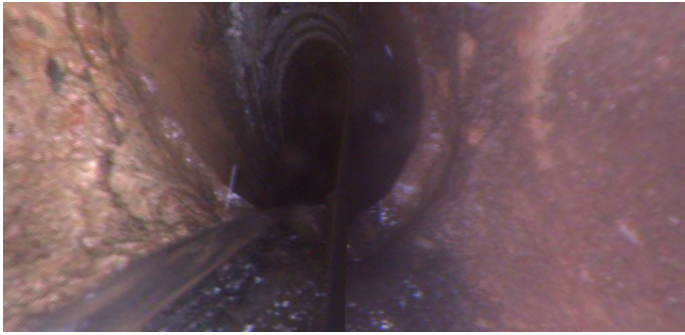
Code: **TBA**  
Description: **Tap Break-in Active**

Distance (ft): **20.4**  
Structural Grade: **0**  
O&M Grade: **0**  
Clock Start/From: **10**  
Clock To:  
1st Value: **4.000**  
2nd Value:  
Value Percent:  
Continuous Index:  
Within 8" of Joint: **YES**  
Remarks:

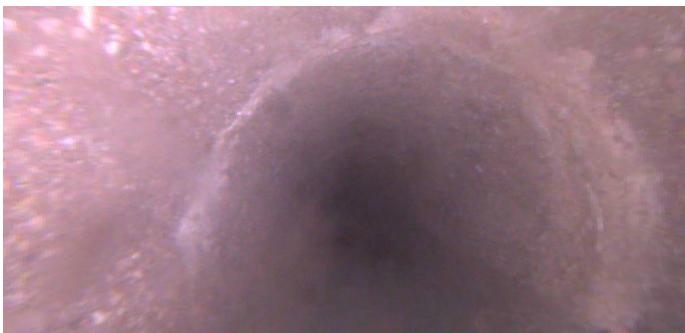
Code: **CC**  
Description: **Crack Circumferential**

Distance (ft): **30.9**  
Structural Grade: **1**  
O&M Grade: **0**  
Clock Start/From: **8**  
Clock To: **4**  
1st Value:  
2nd Value:  
Value Percent:  
Continuous Index: **S01**  
Within 8" of Joint:  
Remarks: **thru out pipe**

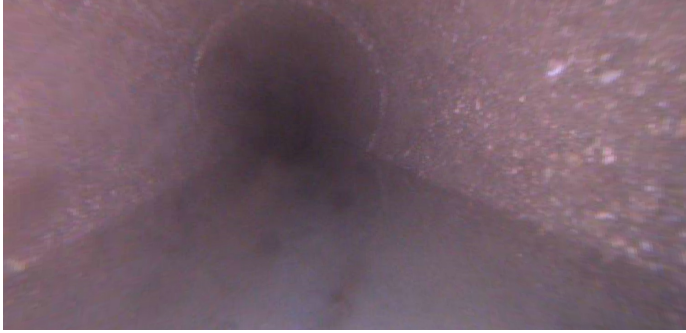
Code: **MWL**  
Description: **Water Level**

Distance (ft): **47.0**  
Structural Grade: **0**  
O&M Grade: **0**  
Clock Start/From:  
Clock To:  
1st Value:  
2nd Value:  
Value Percent: **5.000**  
Continuous Index:  
Within 8" of Joint: **NO**  
Remarks:

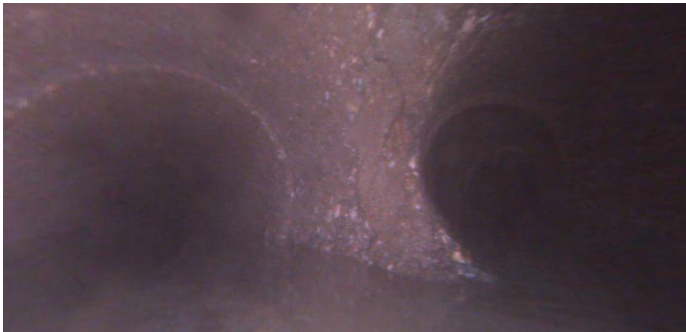
Code: **TF**  
Description: **Tap Factory**

Distance (ft): **65.4**  
Structural Grade: **0**  
O&M Grade: **0**  
Clock Start/From: **3**  
Clock To:  
1st Value: **4.000**  
2nd Value:  
Value Percent:  
Continuous Index:  
Within 8" of Joint: **YES**  
Remarks:

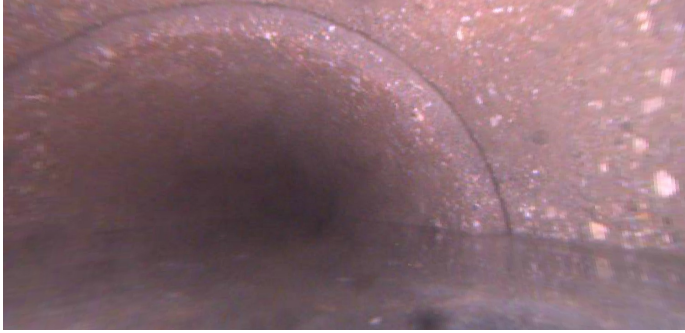
Code: **MWL**  
Description: **Water Level**

Distance (ft): **117.8**  
Structural Grade: **0**  
O&M Grade: **0**  
Clock Start/From:  
Clock To:  
1st Value:  
2nd Value:  
Value Percent: **50.000**  
Continuous Index:  
Within 8" of Joint: **NO**  
Remarks:

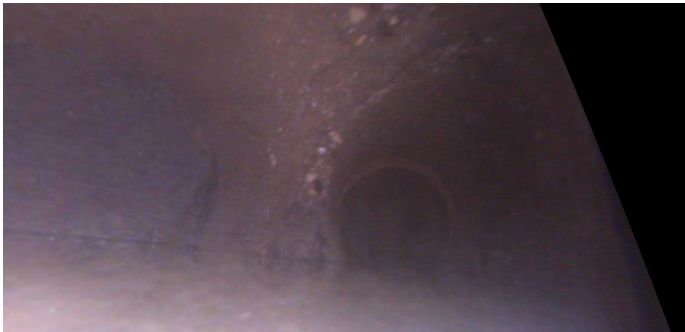
Code: **TF**  
Description: **Tap Factory**

Distance (ft): **122.6**  
Structural Grade: **0**  
O&M Grade: **0**  
Clock Start/From: **3**  
Clock To:  
1st Value: **4.000**  
2nd Value:  
Value Percent:  
Continuous Index:  
Within 8" of Joint: **YES**  
Remarks:

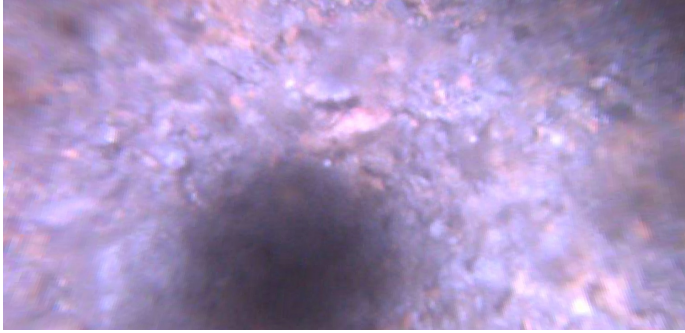
Code: **AEP**  
Description: **End of Pipe**

Distance (ft): **124.1**  
Structural Grade: **0**  
O&M Grade: **0**  
Clock Start/From:  
Clock To:  
1st Value:  
2nd Value:  
Value Percent:  
Continuous Index:  
Within 8" of Joint: **NO**  
Remarks: **M-504-065.2**

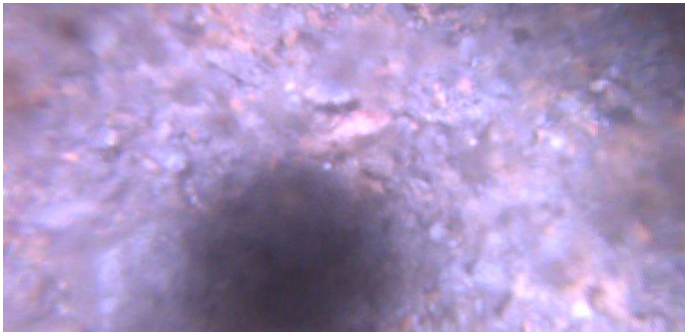
Code: **CC**  
Description: **Crack Circumferential**

Distance (ft): **124.1**  
Structural Grade: **1**  
O&M Grade: **0**  
Clock Start/From: **8**  
Clock To: **4**  
1st Value:  
2nd Value:  
Value Percent:  
Continuous Index: **F01**  
Within 8" of Joint:  
Remarks: **thru out pipe**

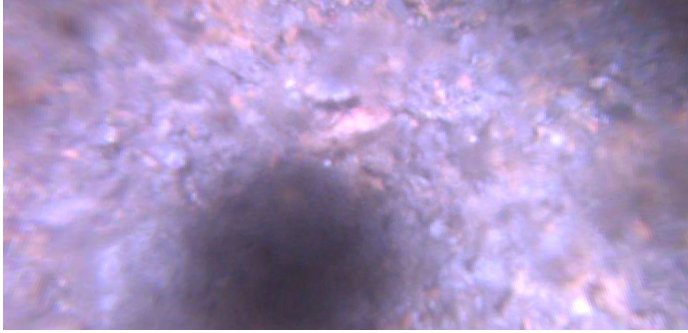
| Code: | <b>SAV</b> |
| Description: | <b>Surface Aggregate Visible</b> |
| Structural Grade: | <b>3</b> |
