Profile/Photo Observation Report

Date: **PACP 7.0** 09/13/2021 Weather: Coding: Pipe Length (ft): 124.0 Owner: **City of Hobart** Pre Clean: **Light Cleaning** P.O.#: S. Bucklin PSR: P-504-065.2-065.1 YES502259 Surveyor:

Street: North Guyer Street Flow Control: Not Controlled

US MH: M-504-065.1 DS MH: M-504-065.2 Total Length Surveyed (ft): 124.0

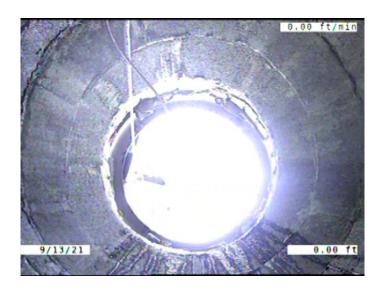
Code: AMH
Description: Manhole

Distance (ft): .0
Structural Grade: 0
O&M Grade: 0

Remarks: M-504-065.2

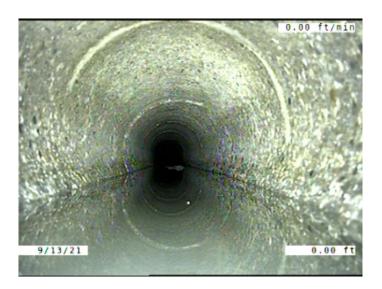
Code: MWL

Description: Miscellaneous Water Level

Distance (ft): .0
Structural Grade: 0
O&M Grade: 0

Value Percent: 10.000

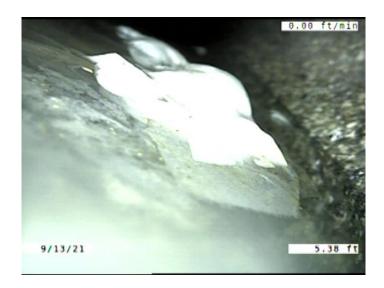
Code: DAR

Description: Deposits Attached Ragging

Distance (ft): 5.4
Structural Grade: 0

O&M Grade: 2

Clock Start/From: 5

Clock To: 7

Value Percent: 5.000

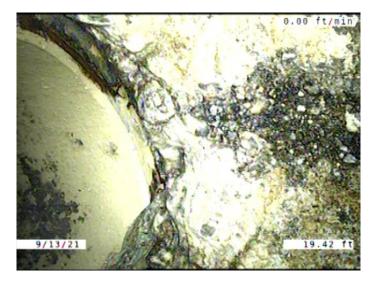
Code: B

Description: Broken

Distance (ft): 19.4
Structural Grade: 4

Clock Start/From: 10

Clock To: 12

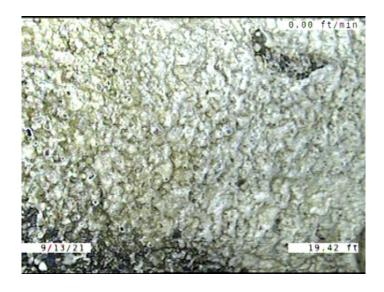
Code: DAE

Description: Deposits Attached Encrustation

Distance (ft): 19.4
Structural Grade: 0

O&M Grade: 2

Value Percent: 5.000

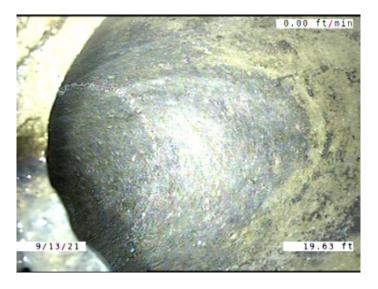
Code: TB

Description: Tap Break-in/Hammer

Distance (ft): 19.6
Structural Grade: 0

Clock Start/From: 11

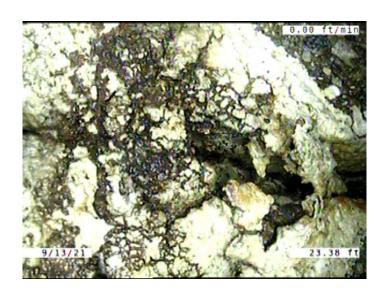
Code: DAE

Description: Deposits Attached Encrustation

Distance (ft): 23.4
Structural Grade: 0

O&M Grade: 2

Value Percent: 5.000
Continuous Index: S01
Within 8" of Joint: YES

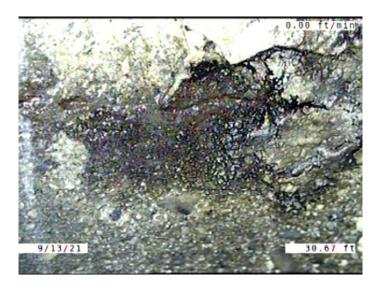
Code: FS

Description: Fracture Spiral

Distance (ft): 30.7
Structural Grade: 3

Clock Start/From: 12

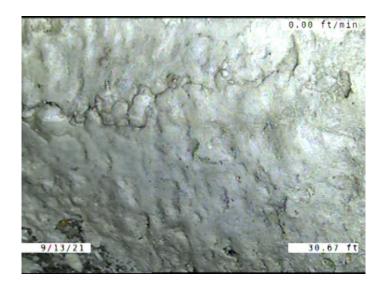
Code: DAE

Description: Deposits Attached Encrustation

Distance (ft): 30.7
Structural Grade: 0

O&M Grade: 2

Value Percent: 5.000

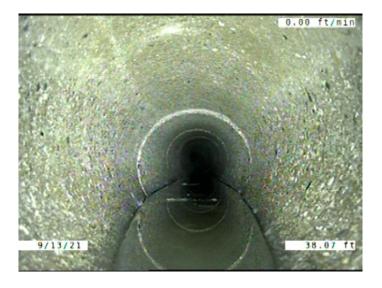
Code: MWLS

Description: Miscellaneous Water Level Sag

Distance (ft): 38.1
Structural Grade: 2
O&M Grade: 0

Value Percent: 10.000
Continuous Index: S02
Within 8" of Joint: NO

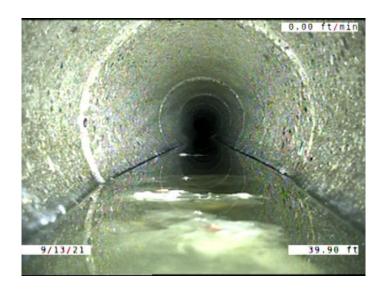
Code: **DSF**

Description: Deposits Settled Fine

Distance (ft): 39.9
Structural Grade: 0
O&M Grade: 2
Clock Start/From: 5
Clock To: 7

Value Percent: 5.000
Continuous Index: S03
Within 8" of Joint: YES

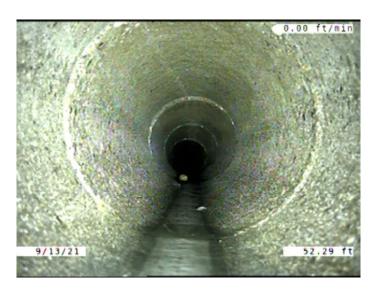
Code: MWLS

Description: Miscellaneous Water Level Sag

Distance (ft): 52.3
Structural Grade: 2
O&M Grade: 0

Value Percent: 10.000
Continuous Index: F02
Within 8" of Joint: NO

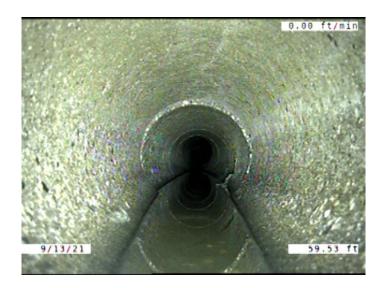
Code: MWLS

Description: Miscellaneous Water Level Sag

Distance (ft): 59.5
Structural Grade: 2
O&M Grade: 0

Value Percent: 10.000
Continuous Index: S04
Within 8" of Joint: NO

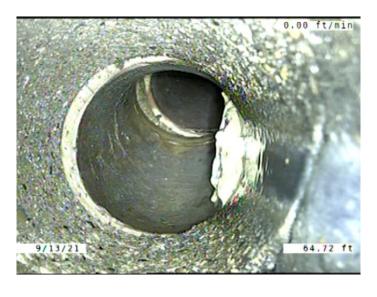
Code: **TF**

Description: Tap Factory

Distance (ft): 64.7
Structural Grade: 0

1st Value: **4.000**

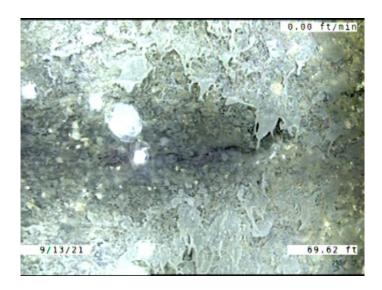
Code: **FS**

Description: Fracture Spiral

Distance (ft): 69.6
Structural Grade: 3
O&M Grade: 0
Clock Start/From: 12
Clock To: 12

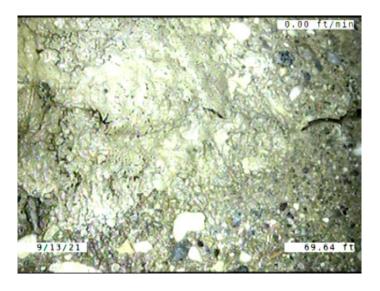
Code: DAE

Description: Deposits Attached Encrustation

Distance (ft): 69.6
Structural Grade: 0

O&M Grade: 2

Value Percent: 5.000

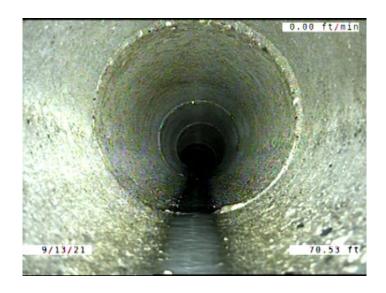
Code: **MWLS**

Description: **Miscellaneous Water Level Sag**

Distance (ft): 70.5 Structural Grade: 2 0 O&M Grade:

Value Percent: 10.000 Continuous Index: F04 Within 8" of Joint: NO

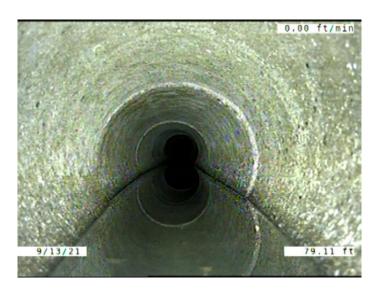
Code: **MWLS**

Description: **Miscellaneous Water Level Sag**

Distance (ft): 79.1 Structural Grade: 2 O&M Grade: 0

Value Percent: 10.000 Continuous Index: **S05** Within 8" of Joint: NO

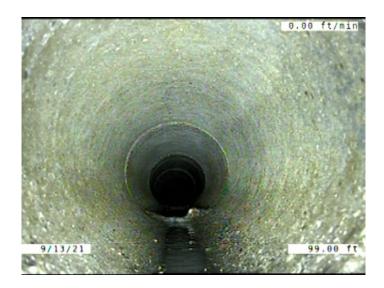
Code: MWLS

Description: Miscellaneous Water Level Sag

Distance (ft): 99.0 Structural Grade: 2
O&M Grade: 0

Value Percent: 10.000
Continuous Index: F05
Within 8" of Joint: NO

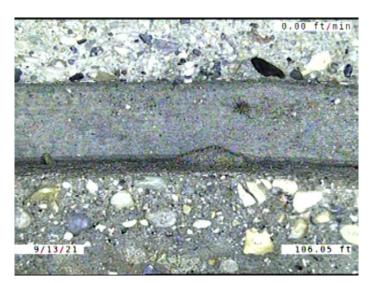
Code: JSM

Description: Joint Separated Medium

Distance (ft): 106.0
Structural Grade: 3
O&M Grade: 0

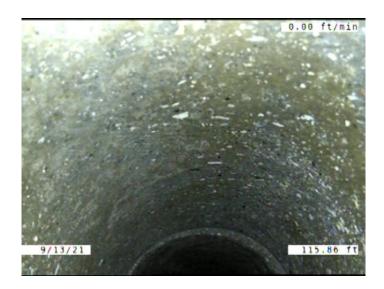
Code: MWL

Description: Miscellaneous Water Level

Distance (ft): 115.9
Structural Grade: 0

Value Percent: 15.000

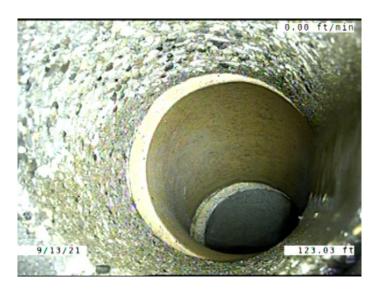
Code: **TF**

Description: Tap Factory

Distance (ft): 123.0
Structural Grade: 0
O&M Grade: 0
Clock Start/From: 3

1st Value: **4.000**

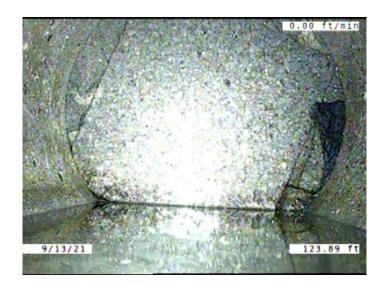
Code: **DSF**

Description: Deposits Settled Fine

Distance (ft): 123.9
Structural Grade: 0
O&M Grade: 2
Clock Start/From: 5
Clock To: 7

Value Percent: 5.000
Continuous Index: F03
Within 8" of Joint: YES

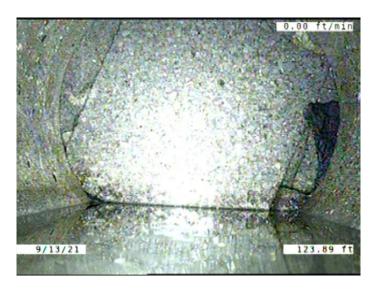
Code: DAE

Description: Deposits Attached Encrustation

Distance (ft): 123.9
Structural Grade: 0
O&M Grade: 2
Clock Start/From: 3
Clock To: 9
1st Value:

Value Percent: 5.000
Continuous Index: F01
Within 8" of Joint: YES

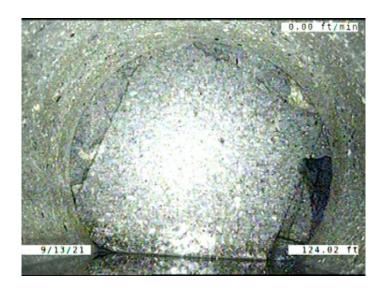
Code: AEP

Description: Access Point End of Pipe

Distance (ft): 124.0
Structural Grade: 0
O&M Grade: 0

Remarks: M-504-065.1
