## Profile/Photo Observation Report

Street:	<b>ALLEY BETWEEN N WISCONSIN ST &amp;</b>	Flow Control:	<b>Not Controlled</b>
City:	<b>Hobart, IN</b>	Year Renewed:	
Location:	<b>Light Highway</b>	Tape/Media #:	
Purpose:	<b>Not Known</b>	Dia/Height:	<b>12"</b>
Use:	<b>Sanitary</b>	Material:	<b>VCP</b>
Drain Area:	<b>NA</b>	Lining:	
Category:	<b>NA</b>		
Comment:

Location Details:		Direction of Survey:	<b>Upstream</b>
US MH:	<b>M-504-068</b>	DS MH:	<b>M-504-080</b>
		Total Length Surveyed (ft):	<b>206.5</b>

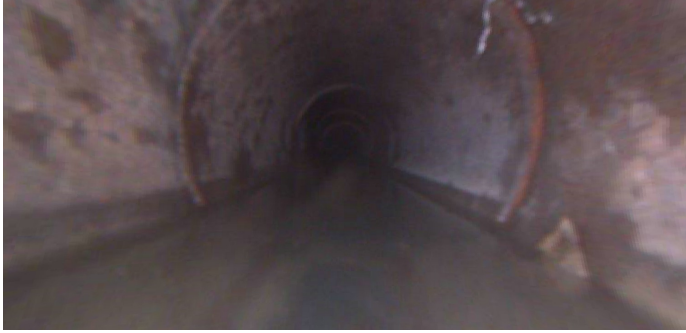
Code: **AMH**  
Description: **Manhole**

Distance (ft): **.0**  
Structural Grade: **0**  
O&M Grade: **0**  
Clock Start/From:  
Clock To:  
1st Value:  
2nd Value:  
Value Percent:  
Continuous Index:  
Within 8" of Joint: **NO**  
Remarks: **M-504-068**

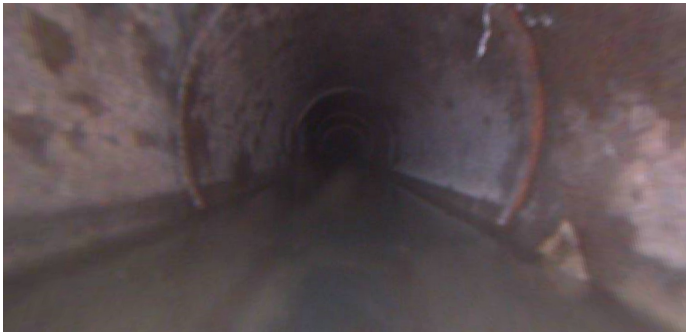
Code: **MWL**  
Description: **Water Level**

Distance (ft): **.0**  
Structural Grade: **0**  
O&M Grade: **0**  
Clock Start/From:  
Clock To:  
1st Value:  
2nd Value:  
Value Percent: **5.000**  
Continuous Index:  
Within 8" of Joint: **NO**  
Remarks:

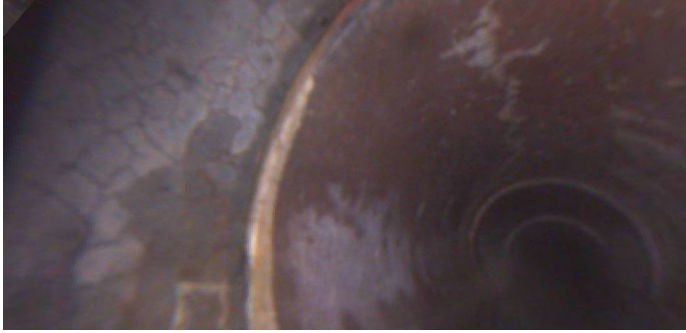
Code: **CM**  
Description: **Crack Multiple**

Distance (ft): **3.8**  
Structural Grade: **3**  
O&M Grade: **0**  
Clock Start/From: **7**  
Clock To: **5**  
1st Value:  
2nd Value:  
Value Percent:  
Continuous Index: **S01**  
Within 8" of Joint: **YES**  
Remarks: **wandering**

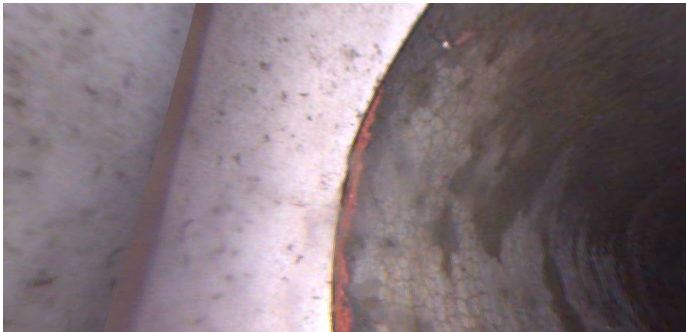
Code: **MMC**  
Description: **Material Change**

Distance (ft): **8.1**  
Structural Grade: **0**  
O&M Grade: **0**  
Clock Start/From:  
Clock To:  
1st Value:  
2nd Value:  
Value Percent:  
Continuous Index:  
Within 8" of Joint: **NO**  
Remarks: **pvc**

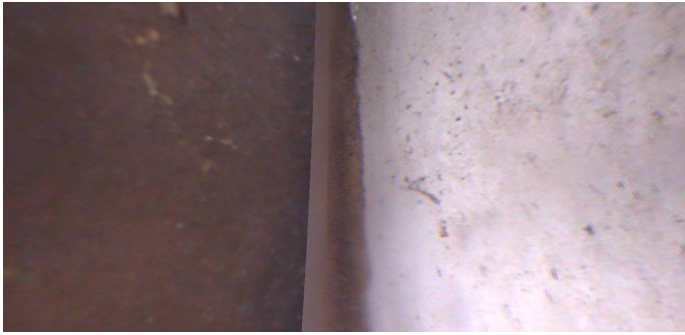
Code: **MMC**  
Description: **Material Change**

Distance (ft): **27.9**  
Structural Grade: **0**  
O&M Grade: **0**  
Clock Start/From:  
Clock To:  
1st Value:  
2nd Value:  
Value Percent:  
Continuous Index:  
Within 8" of Joint: **NO**  
Remarks: **vcp**

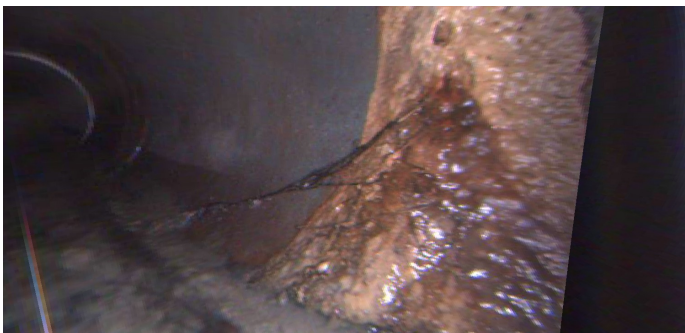
Code: **DAZ**  
Description: **Deposits Attached Other**

Distance (ft): **32.1**  
Structural Grade: **0**  
O&M Grade: **2**  
Clock Start/From: **7**  
Clock To: **5**  
1st Value:  
2nd Value:  
Value Percent: **5.000**  
Continuous Index: **S03**  
Within 8" of Joint: **YES**  
Remarks: **wandering**

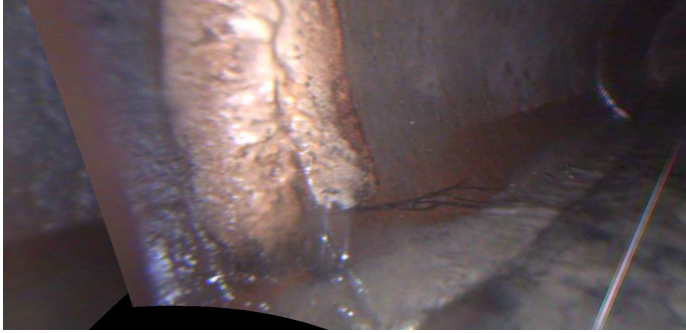
Code: **RFJ**  
Description: **Roots Fine Joint**

Distance (ft): **32.1**  
Structural Grade: **0**  
O&M Grade: **1**  
Clock Start/From: **7**  
Clock To: **5**  
1st Value:  
2nd Value:  
Value Percent:  
Continuous Index: **S02**  
Within 8" of Joint: **YES**  
Remarks: **wandering**

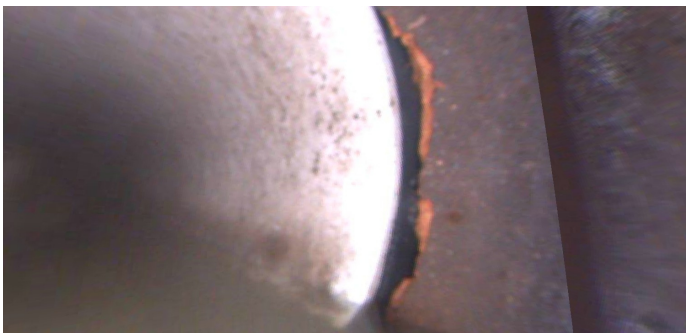
Code: **MMC**  
Description: **Material Change**

Distance (ft): **47.6**  
Structural Grade: **0**  
O&M Grade: **0**  
Clock Start/From:  
Clock To:  
1st Value:  
2nd Value:  
Value Percent:  
Continuous Index:  
Within 8" of Joint: **NO**  
Remarks: **pvc**

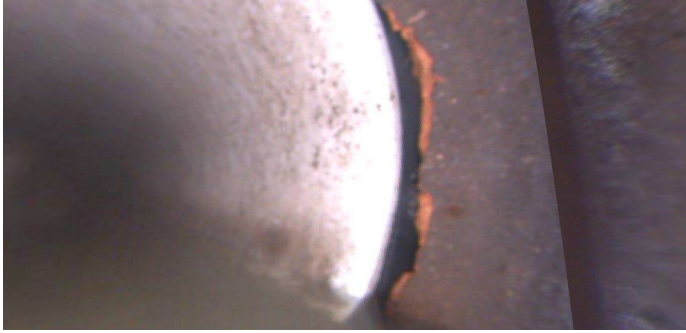
Code: **MGO**  
Description: **General Observation**

Distance (ft): **47.6**  
Structural Grade: **0**  
O&M Grade: **0**  
Clock Start/From:  
Clock To:  
1st Value:  
2nd Value:  
Value Percent:  
Continuous Index:  
Within 8" of Joint: **NO**  
Remarks: **chipped at joint**

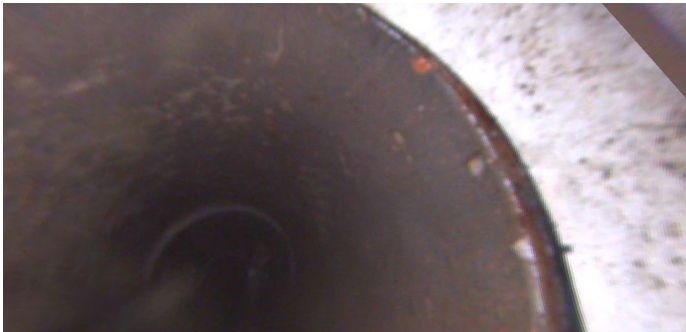
Code: **MMC**  
Description: **Material Change**

Distance (ft): **60.1**  
Structural Grade: **0**  
O&M Grade: **0**  
Clock Start/From:  
Clock To:  
1st Value:  
2nd Value:  
Value Percent:  
Continuous Index:  
Within 8" of Joint: **NO**  
Remarks: **vcp**

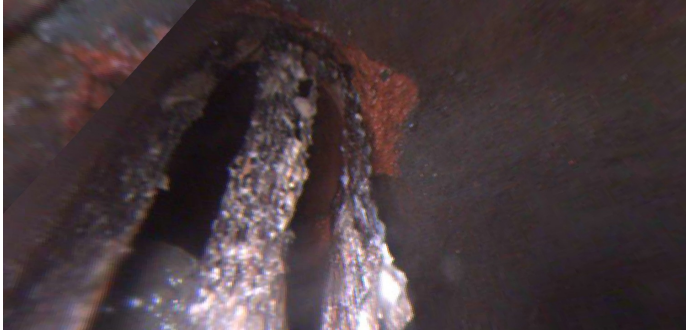
Code: **TB**  
Description: **Tap Break-in**

Distance (ft): **64.2**  
Structural Grade: **0**  
O&M Grade: **0**  
Clock Start/From: **2**  
Clock To:  
1st Value: **4.000**  
2nd Value:  
Value Percent:  
Continuous Index:  
Within 8" of Joint:  
Remarks:

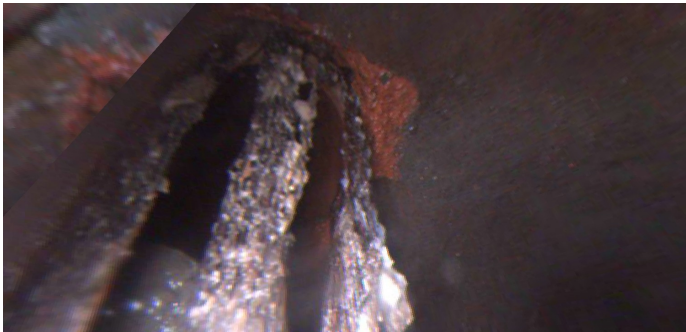
Code: **RMC**  
Description: **Roots Medium Connection**

Distance (ft): **64.2**  
Structural Grade: **0**  
O&M Grade: **3**  
Clock Start/From: **12**  
Clock To: **12**  
1st Value:  
2nd Value:  
Value Percent: **10.000**  
Continuous Index:  
Within 8" of Joint: **NO**  
Remarks: **around tap**

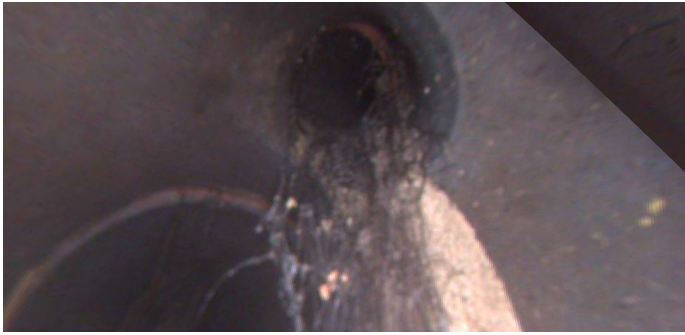
Code: **TF**  
Description: **Tap Factory**

Distance (ft): **73.2**  
Structural Grade: **0**  
O&M Grade: **0**  
Clock Start/From: **1**  
Clock To:  
1st Value: **4.000**  
2nd Value:  
Value Percent:  
Continuous Index:  
Within 8" of Joint: **YES**  
Remarks:

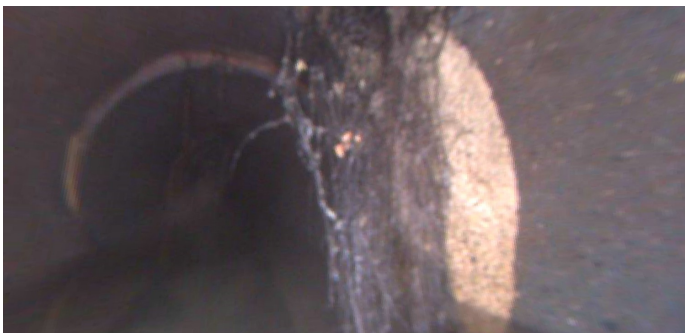
Code: **RML**  
Description: **Roots Medium Lateral**

Distance (ft): **73.2**  
Structural Grade: **0**  
O&M Grade: **3**  
Clock Start/From: **2**  
Clock To: **5**  
1st Value:  
2nd Value:  
Value Percent: **10.000**  
Continuous Index: **S04**  
Within 8" of Joint: **NO**  
Remarks: **wandering in position from taps**

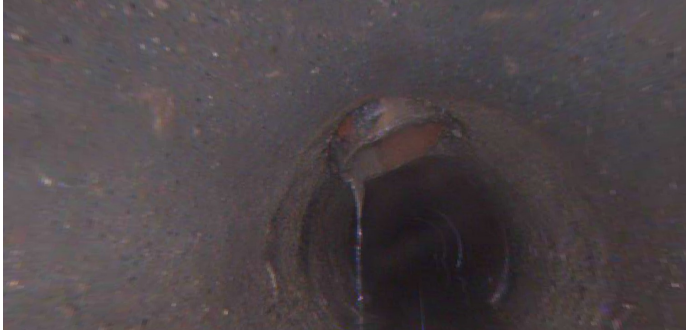
Code: **TBI**  
Description: **Tap Break-in Intruding**

Distance (ft): **100.9**  
Structural Grade: **0**  
O&M Grade: **2**  
Clock Start/From: **1**  
Clock To:  
1st Value: **4.000**  
2nd Value: **1.000**  
Value Percent:  
Continuous Index:  
Within 8" of Joint:  
Remarks:

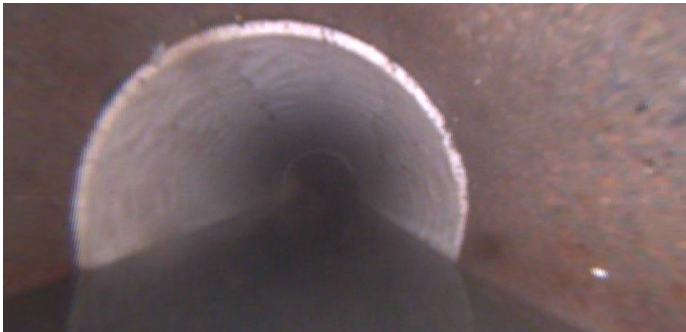
Code: **MMC**  
Description: **Material Change**

Distance (ft): **121.9**  
Structural Grade: **0**  
O&M Grade: **0**  
Clock Start/From:  
Clock To:  
1st Value:  
2nd Value:  
Value Percent:  
Continuous Index:  
Within 8" of Joint: **NO**  
Remarks: **pvc**

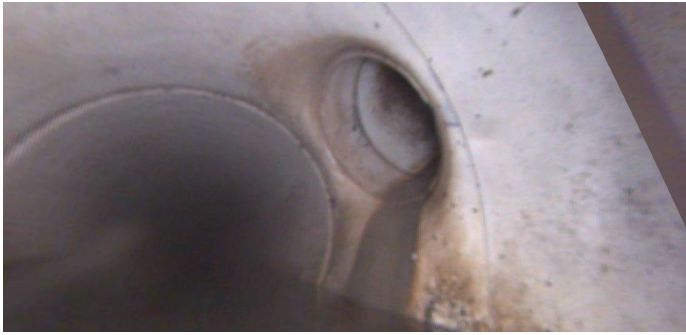
Code: **TF**  
Description: **Tap Factory**

Distance (ft): **124.9**  
Structural Grade: **0**  
O&M Grade: **0**  
Clock Start/From: **2**  
Clock To:  
1st Value: **4.000**  
2nd Value:  
Value Percent:  
Continuous Index:  
Within 8" of Joint: **YES**  
Remarks:

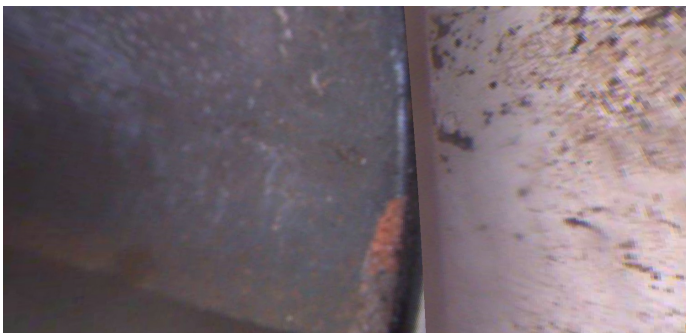
Code: **MMC**  
Description: **Material Change**

Distance (ft): **141.1**  
Structural Grade: **0**  
O&M Grade: **0**  
Clock Start/From:  
Clock To:  
1st Value:  
2nd Value:  
Value Percent:  
Continuous Index:  
Within 8" of Joint: **NO**  
Remarks: **vcp**

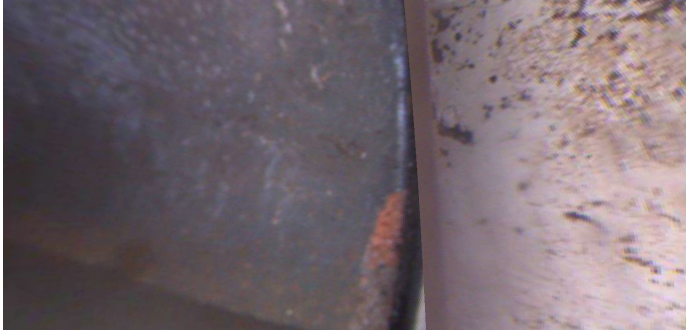
Code: **MGO**  
Description: **General Observation**

Distance (ft): **141.1**  
Structural Grade: **0**  
O&M Grade: **0**  
Clock Start/From:  
Clock To:  
1st Value:  
2nd Value:  
Value Percent:  
Continuous Index:  
Within 8" of Joint: **NO**  
Remarks: **chipped at joint**

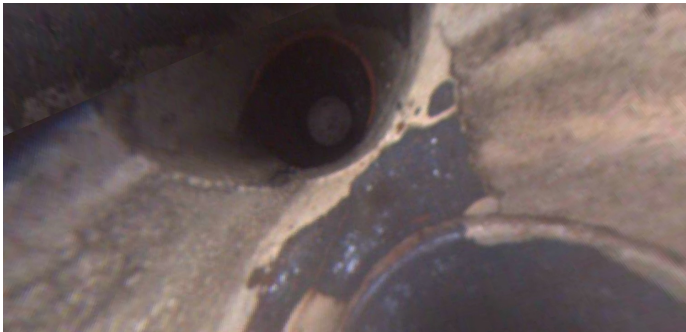
Code: **TF**  
Description: **Tap Factory**

Distance (ft): **150.5**  
Structural Grade: **0**  
O&M Grade: **0**  
Clock Start/From: **11**  
Clock To:  
1st Value: **4.000**  
2nd Value:  
Value Percent:  
Continuous Index:  
Within 8" of Joint: **YES**  
Remarks:

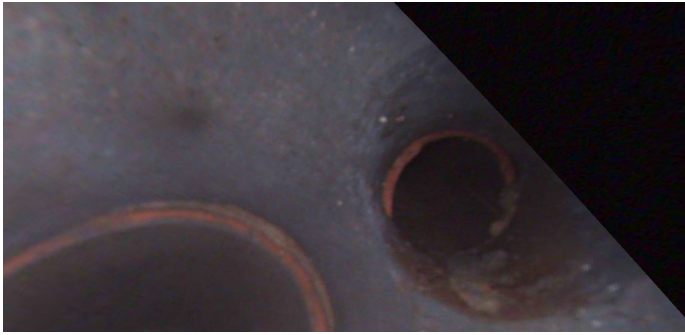
Code: **TF**  
Description: **Tap Factory**

Distance (ft): **160.3**  
Structural Grade: **0**  
O&M Grade: **0**  
Clock Start/From: **2**  
Clock To:  
1st Value: **4.000**  
2nd Value:  
Value Percent:  
Continuous Index:  
Within 8" of Joint: **YES**  
Remarks:

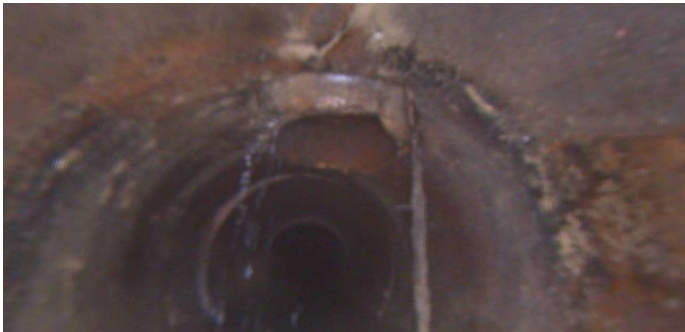
Code: **TBA**  
Description: **Tap Break-in Active**

Distance (ft): **167.7**  
Structural Grade: **0**  
O&M Grade: **0**  
Clock Start/From: **12**  
Clock To:  
1st Value: **4.000**  
2nd Value:  
Value Percent:  
Continuous Index:  
Within 8" of Joint:  
Remarks:

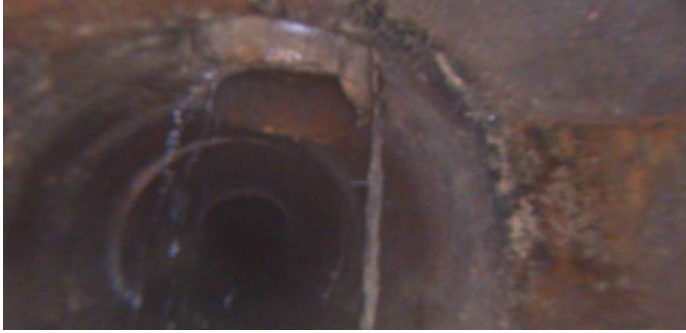
Code: **RFC**  
Description: **Roots Fine Connection**

Distance (ft): **167.7**  
Structural Grade: **0**  
O&M Grade: **1**  
Clock Start/From: **2**  
Clock To:  
1st Value:  
2nd Value:  
Value Percent:  
Continuous Index:  
Within 8" of Joint: **NO**  
Remarks:

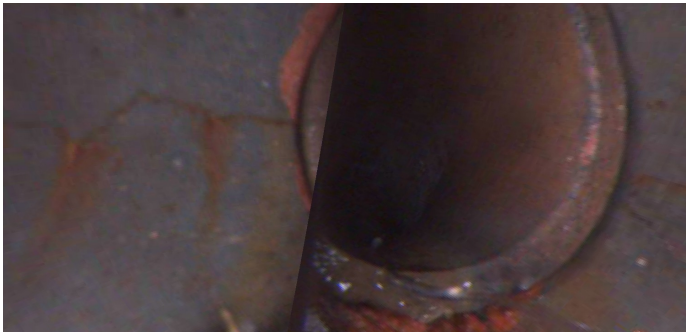
Code: **TB**  
Description: **Tap Break-in**

Distance (ft): **176.3**  
Structural Grade: **0**  
O&M Grade: **0**  
Clock Start/From: **1**  
Clock To:  
1st Value: **4.000**  
2nd Value:  
Value Percent:  
Continuous Index:  
Within 8" of Joint:  
Remarks:

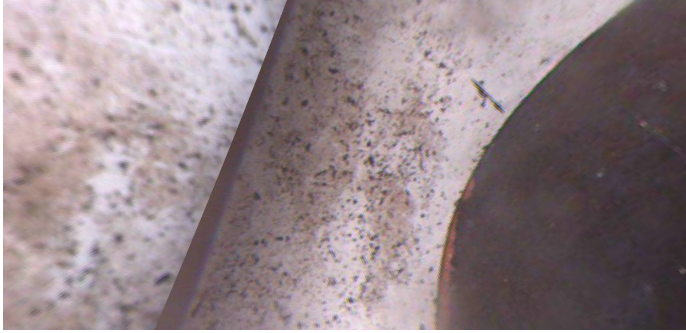
Code: **MMC**  
Description: **Material Change**

Distance (ft): **191.8**  
Structural Grade: **0**  
O&M Grade: **0**  
Clock Start/From:  
Clock To:  
1st Value:  
2nd Value:  
Value Percent:  
Continuous Index:  
Within 8" of Joint: **NO**  
Remarks: **pvc**

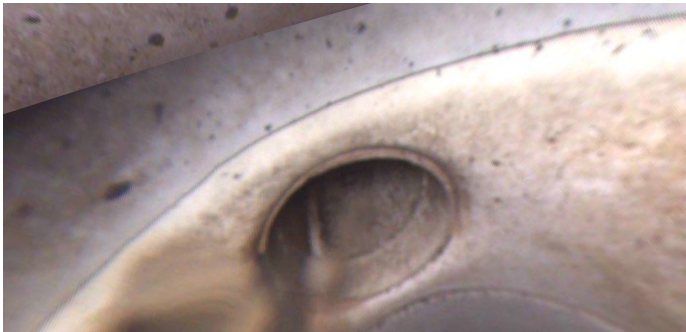
Code: **TF**  
Description: **Tap Factory**

Distance (ft): **194.3**  
Structural Grade: **0**  
O&M Grade: **0**  
Clock Start/From: **11**  
Clock To:  
1st Value: **4.000**  
2nd Value:  
Value Percent:  
Continuous Index:  
Within 8" of Joint: **YES**  
Remarks:

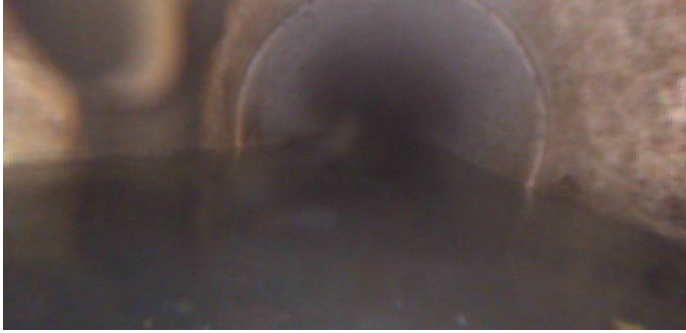
Code: **MWL**  
Description: **Water Level**

Distance (ft): **194.3**  
Structural Grade: **0**  
O&M Grade: **0**  
Clock Start/From:  
Clock To:  
1st Value:  
2nd Value:  
Value Percent: **25.000**  
Continuous Index:  
Within 8" of Joint: **NO**  
Remarks:

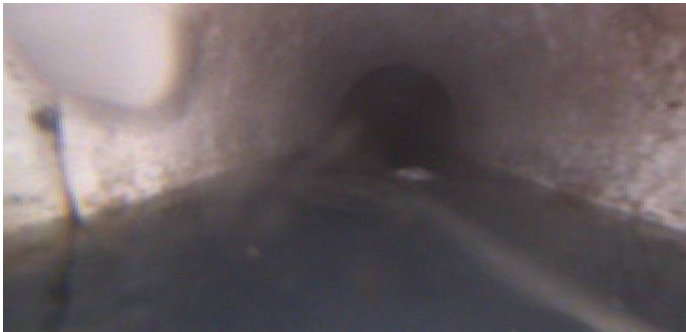
Code: **MSA**  
Description: **Abandoned Survey**

Distance (ft): **206.5**  
Structural Grade: **0**  
O&M Grade: **0**  
Clock Start/From:  
Clock To:  
1st Value:  
2nd Value:  
Value Percent:  
Continuous Index:  
Within 8" of Joint: **NO**  
Remarks: **no blockage**

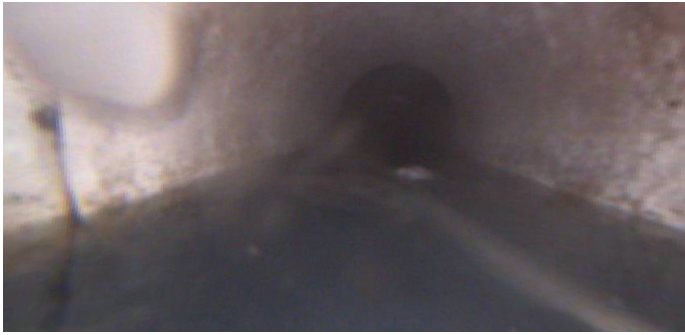
Code: **RML**  
Description: **Roots Medium Lateral**

Distance (ft): **206.5**  
Structural Grade: **0**  
O&M Grade: **3**  
Clock Start/From: **2**  
Clock To: **5**  
1st Value:  
2nd Value:  
Value Percent: **10.000**  
Continuous Index: **F04**  
Within 8" of Joint: **NO**  
Remarks: **wandering in position from taps**

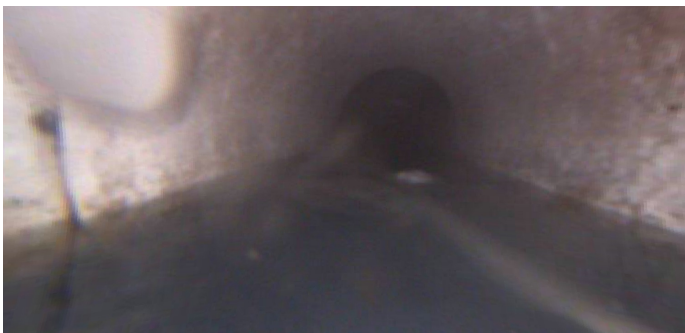
Code: **DAZ**  
Description: **Deposits Attached Other**

Distance (ft): **206.5**  
Structural Grade: **0**  
O&M Grade: **2**  
Clock Start/From: **7**  
Clock To: **5**  
1st Value:  
2nd Value:  
Value Percent: **5.000**  
Continuous Index: **F03**  
Within 8" of Joint: **YES**  
Remarks: **wandering**

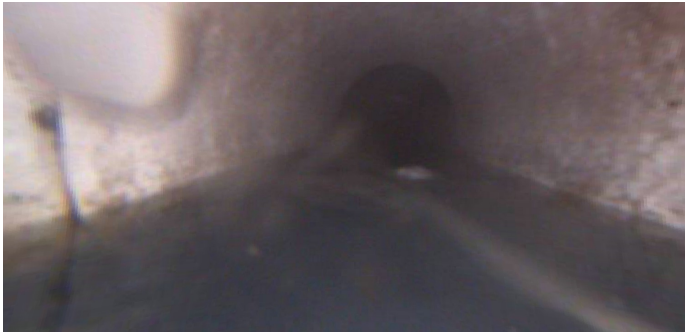
Code: **RFJ**  
Description: **Roots Fine Joint**

Distance (ft): **206.5**  
Structural Grade: **0**  
O&M Grade: **1**  
Clock Start/From: **7**  
Clock To: **5**  
1st Value:  
2nd Value:  
Value Percent:  
Continuous Index: **F02**  
Within 8" of Joint: **YES**  
Remarks: **wandering**

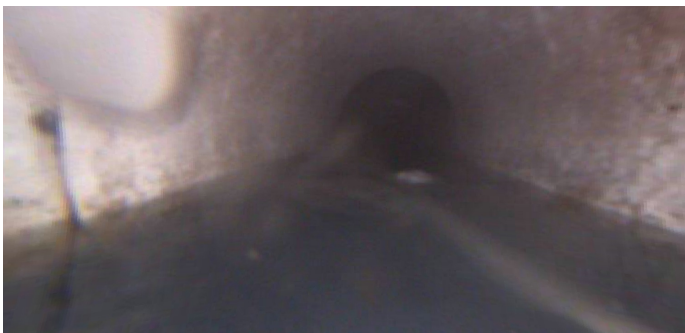
Code: **CM**  
Description: **Crack Multiple**

Distance (ft): **206.5**  
Structural Grade: **3**  
O&M Grade: **0**  
Clock Start/From: **7**  
Clock To: **5**  
1st Value:  
2nd Value:  
Value Percent:  
Continuous Index: **F01**  
Within 8" of Joint: **YES**  
Remarks: **wandering**
