Profile/Photo Observation Report

Date:	04/20/2018	Weather:		Coding:	PACP 6.0
Pipe Length (ft):	211.5	Owner:	NA	Pre Clean:	Not Known
P.O.#:		Surveyor:	Byrd Fitzgerald	PSR:	P-504-080-068
Customer:		Clean Date:	01/01/1900	Shape:	C

Street:	Summerlin	Flow Control:	Not Controlled
City:	Hobart, IN	Year Renewed:	
Location:	Light Highway	Tape/Media #:	
Purpose:	Not Known	Dia/Height:	12"
Use:	Sanitary	Material:	VCP
Drain Area:	NA	Lining:	
Category:	NA		
Comment:

Location Details:		Direction of Survey:	Upstream
US MH:	M-504-068	DS MH:	M-504-080
		Total Length Surveyed (ft):	206.5

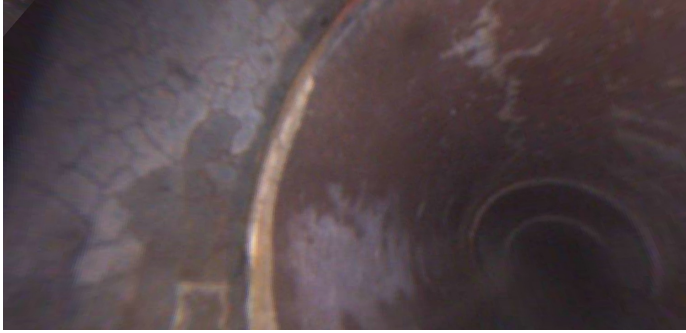
Code: **CM**
Description: **Crack Multiple**

Distance (ft): **3.8**
Structural Grade: **3**
O&M Grade: **0**
Clock Start/From: **7**
Clock To: **5**
1st Value:
2nd Value:
Value Percent:
Continuous Index: **S01**
Within 8" of Joint: **YES**
Remarks: **wandering**

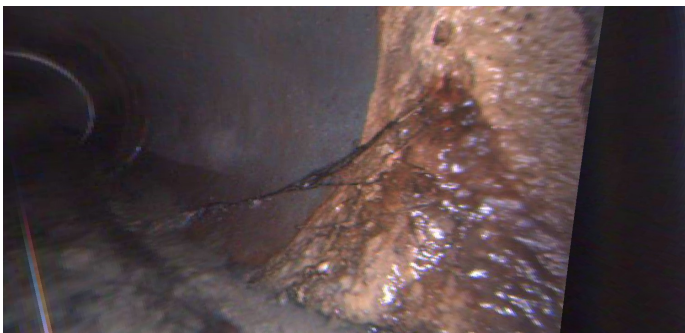
Code: **DAZ**
Description: **Deposits Attached Other**

Distance (ft): **32.1**
Structural Grade: **0**
O&M Grade: **2**
Clock Start/From: **7**
Clock To: **5**
1st Value:
2nd Value:
Value Percent: **5.000**
Continuous Index: **S03**
Within 8" of Joint: **YES**
Remarks: **wandering**

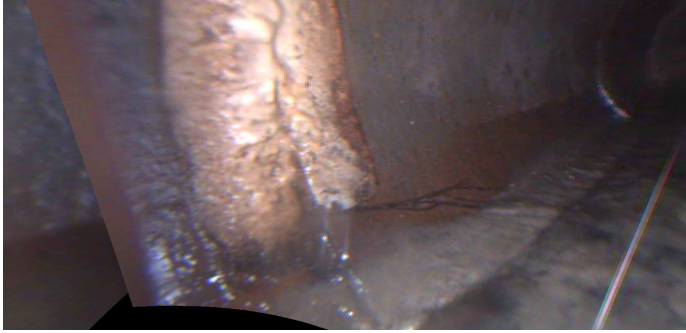
Code: **RFJ**
Description: **Roots Fine Joint**

Distance (ft): **32.1**
Structural Grade: **0**
O&M Grade: **1**
Clock Start/From: **7**
Clock To: **5**
1st Value:
2nd Value:
Value Percent:
Continuous Index: **S02**
Within 8" of Joint: **YES**
Remarks: **wandering**

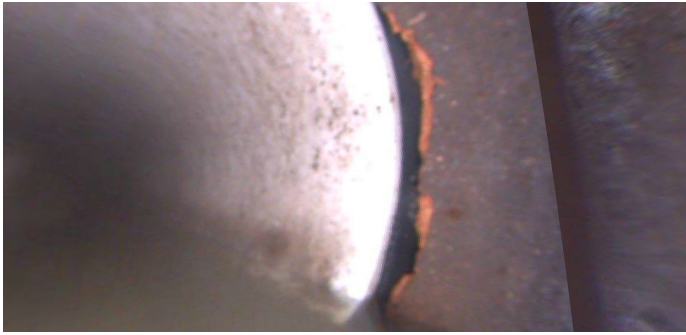
Code: **MGO**
Description: **General Observation**

Distance (ft): **47.6**
Structural Grade: **0**
O&M Grade: **0**
Clock Start/From:
Clock To:
1st Value:
2nd Value:
Value Percent:
Continuous Index:
Within 8" of Joint: **NO**
Remarks: **chipped at joint**

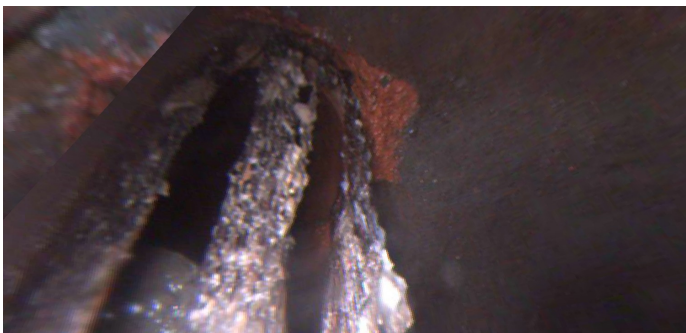
Code: **RMC**
Description: **Roots Medium Connection**

Distance (ft): **64.2**
Structural Grade: **0**
O&M Grade: **3**
Clock Start/From: **12**
Clock To: **12**
1st Value:
2nd Value:
Value Percent: **10.000**
Continuous Index:
Within 8" of Joint: **NO**
Remarks: **around tap**

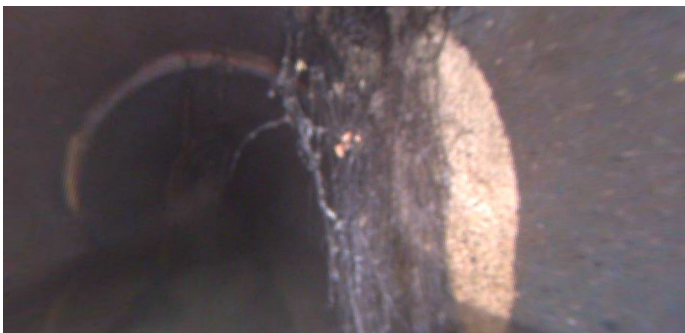
Code: **RML**
Description: **Roots Medium Lateral**

Distance (ft): **73.2**
Structural Grade: **0**
O&M Grade: **3**
Clock Start/From: **2**
Clock To: **5**
1st Value:
2nd Value:
Value Percent: **10.000**
Continuous Index: **S04**
Within 8" of Joint: **NO**
Remarks: **wandering in position from taps**

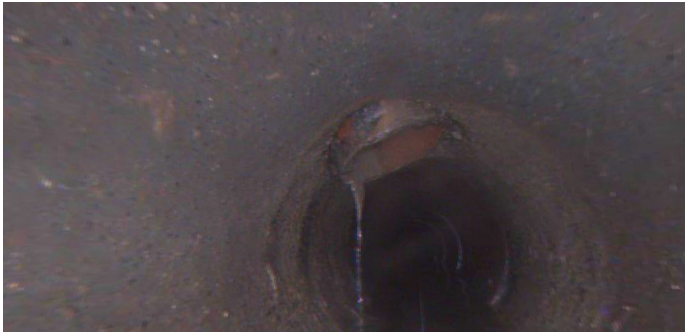
Code: **TBI**
Description: **Tap Break-in Intruding**

Distance (ft): **100.9**
Structural Grade: **0**
O&M Grade: **2**
Clock Start/From: **1**
Clock To:
1st Value: **4.000**
2nd Value: **1.000**
Value Percent:
Continuous Index:
Within 8" of Joint:
Remarks:

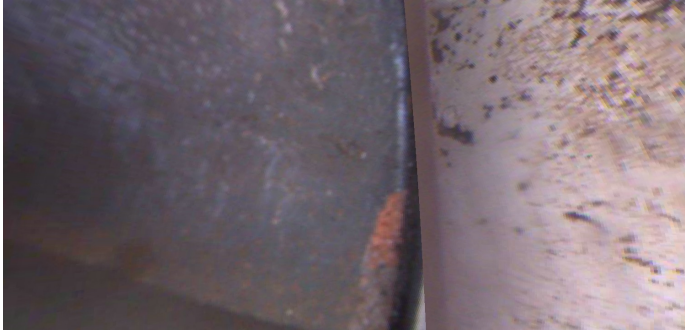
Code: **MGO**
Description: **General Observation**

Distance (ft): **141.1**
Structural Grade: **0**
O&M Grade: **0**
Clock Start/From:
Clock To:
1st Value:
2nd Value:
Value Percent:
Continuous Index:
Within 8" of Joint: **NO**
Remarks: **chipped at joint**

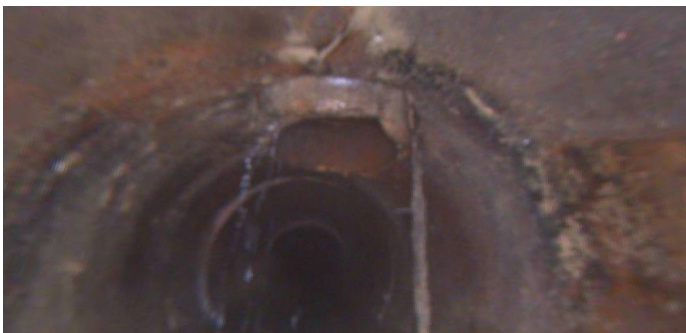
Code: **TBA**
Description: **Tap Break-in Active**

Distance (ft): **167.7**
Structural Grade: **0**
O&M Grade: **0**
Clock Start/From: **12**
Clock To:
1st Value: **4.000**
2nd Value:
Value Percent:
Continuous Index:
Within 8" of Joint:
Remarks:

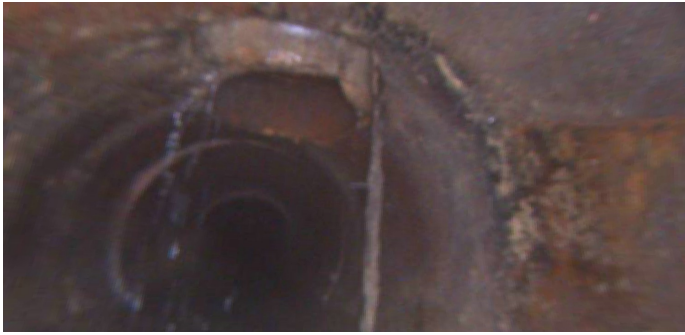
Code: **RFC**
Description: **Roots Fine Connection**

Distance (ft): **167.7**
Structural Grade: **0**
O&M Grade: **1**
Clock Start/From: **2**
Clock To:
1st Value:
2nd Value:
Value Percent:
Continuous Index:
Within 8" of Joint: **NO**
Remarks:

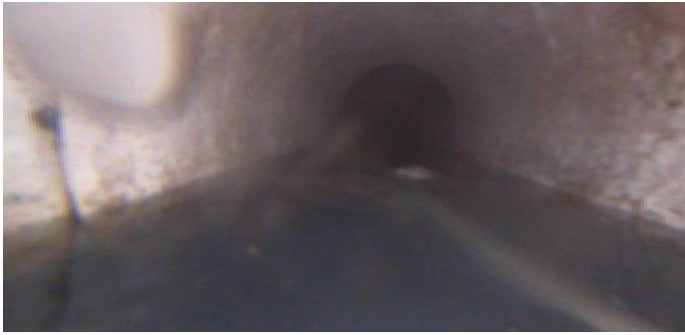
Code: **RML**
Description: **Roots Medium Lateral**

Distance (ft): **206.5**
Structural Grade: **0**
O&M Grade: **3**
Clock Start/From: **2**
Clock To: **5**
1st Value:
2nd Value:
Value Percent: **10.000**
Continuous Index: **F04**
Within 8" of Joint: **NO**
Remarks: **wandering in position from taps**

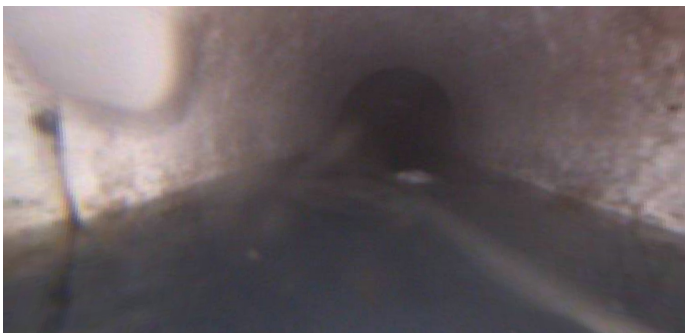
Code: **DAZ**
Description: **Deposits Attached Other**

Distance (ft): **206.5**
Structural Grade: **0**
O&M Grade: **2**
Clock Start/From: **7**
Clock To: **5**
1st Value:
2nd Value:
Value Percent: **5.000**
Continuous Index: **F03**
Within 8" of Joint: **YES**
Remarks: **wandering**

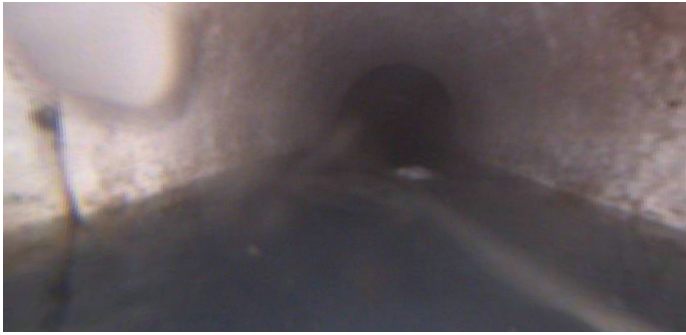
Code: **RFJ**
Description: **Roots Fine Joint**

Distance (ft): **206.5**
Structural Grade: **0**
O&M Grade: **1**
Clock Start/From: **7**
Clock To: **5**
1st Value:
2nd Value:
Value Percent:
Continuous Index: **F02**
Within 8" of Joint: **YES**
Remarks: **wandering**

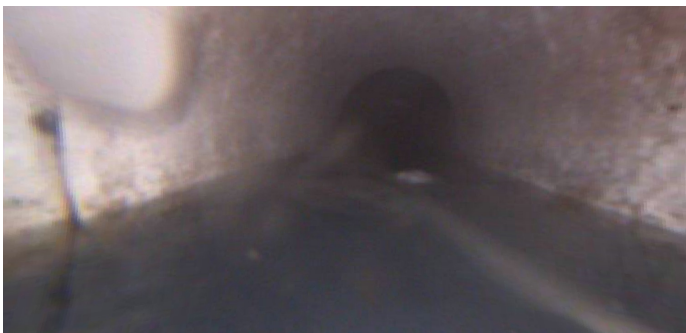
Code: **CM**
Description: **Crack Multiple**

Distance (ft): **206.5**
Structural Grade: **3**
O&M Grade: **0**
Clock Start/From: **7**
Clock To: **5**
1st Value:
2nd Value:
Value Percent:
Continuous Index: **F01**
Within 8" of Joint: **YES**
Remarks: **wandering**
