Profile/Photo Observation Report

Date:	04/11/2018	Weather:		Coding:	PACP 6.0
Pipe Length (ft):		Owner:	City of Hobart	Pre Clean:	No Pre-Cleaning
P.O.#:	26-2	Surveyor:	M. Pielacha	PSR:	M-504-069-M-504-068
Customer:	City of Hobart	Clean Date:		Shape:	C

Street:	Off Virginia Street	Flow Control:	Not Controlled
City:	Hobart, IN	Year Renewed:	
Location:	Light Highway	Tape/Media #:	DEP 25
Purpose:	Routine Assessment	Dia/Height:	18"
Use:	Sanitary	Material:	VCP
Drain Area:		Lining:	
Category:	NA		
Comment:			
Location Details:		Direction of Survey:	Downstream
US MH:	M-504-069	DS MH:	M-504-068
		Total Length Surveyed (ft):	74.3

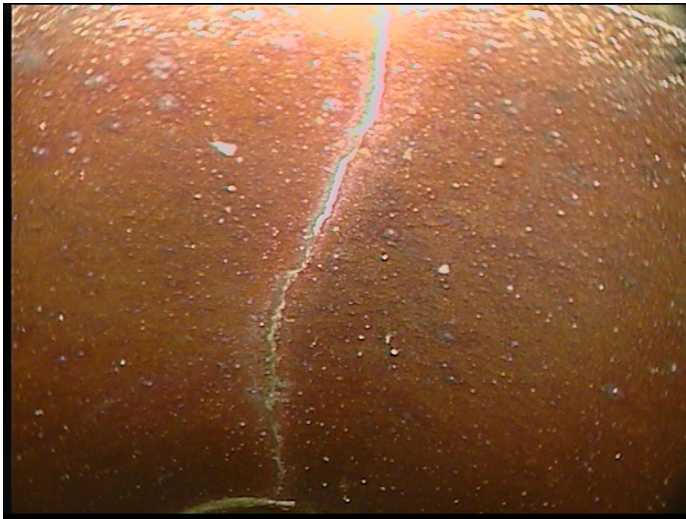
Code: **CL**
Description: **Crack Longitudinal**

Distance (ft): **48.2**
Structural Grade: **2**
O&M Grade: **0**
Clock Start/From: **12**
Clock To:
1st Value:
2nd Value:
Value Percent:
Continuous Index: **S02**
Within 8" of Joint: **YES**
Remarks:

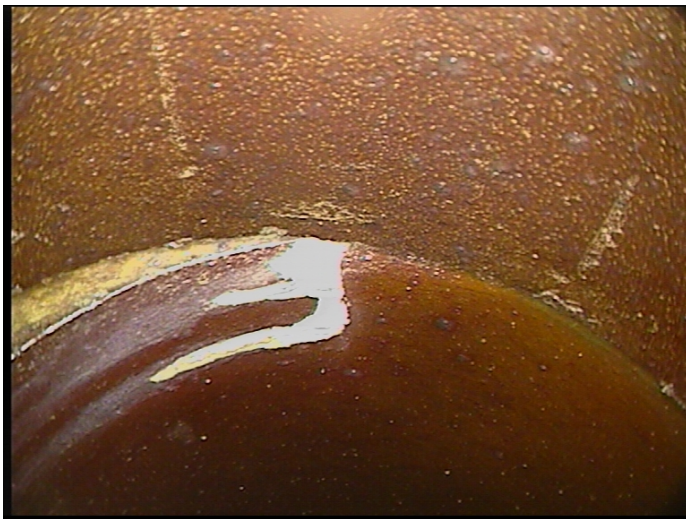
Code: **CL**
Description: **Crack Longitudinal**

Distance (ft): **59.5**
Structural Grade: **2**
O&M Grade: **0**
Clock Start/From: **12**
Clock To:
1st Value:
2nd Value:
Value Percent:
Continuous Index: **F02**
Within 8" of Joint: **NO**
Remarks:
