Profile/Photo Observation Report

Date:	04/11/2018	Weather:		Coding:	PACP 6.0
Pipe Length (ft):		Owner:	City of Hobart	Pre Clean:	No Pre-Cleaning
P.O.#:	26-2	Surveyor:	M. Pielacha	PSR:	M-504-069-M-504-068
Customer:	City of Hobart	Clean Date:		Shape:	C

Street:	Off Virginia Street	Flow Control:	Not Controlled
City:	Hobart, IN	Year Renewed:	
Location:	Light Highway	Tape/Media #:	DEP 25
Purpose:	Routine Assessment	Dia/Height:	18"
Use:	Sanitary	Material:	VCP
Drain Area:		Lining:

US MH: **M-504-069** DS MH: **M-504-068** Total Length Surveyed (ft): **74.3**

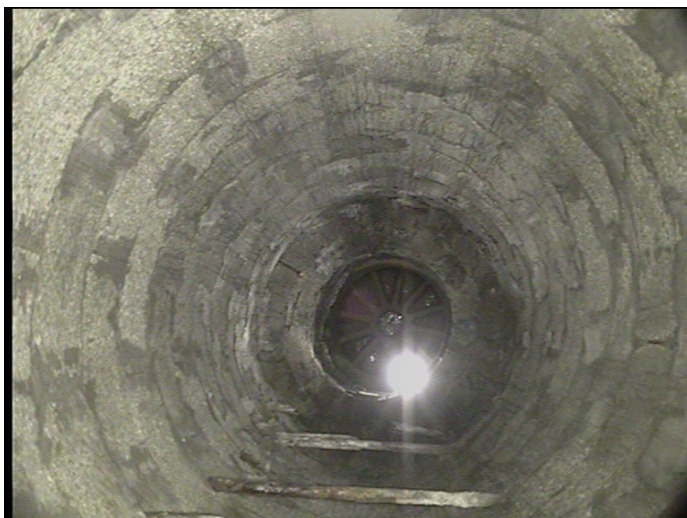
Code: **AMH**
Description: **Manhole**

Distance (ft): **.0**
Structural Grade: **0**
O&M Grade: **0**
Clock Start/From:
Clock To:
1st Value:
2nd Value:
Value Percent:
Continuous Index:
Within 8" of Joint: **NO**
Remarks: **M-504-069**

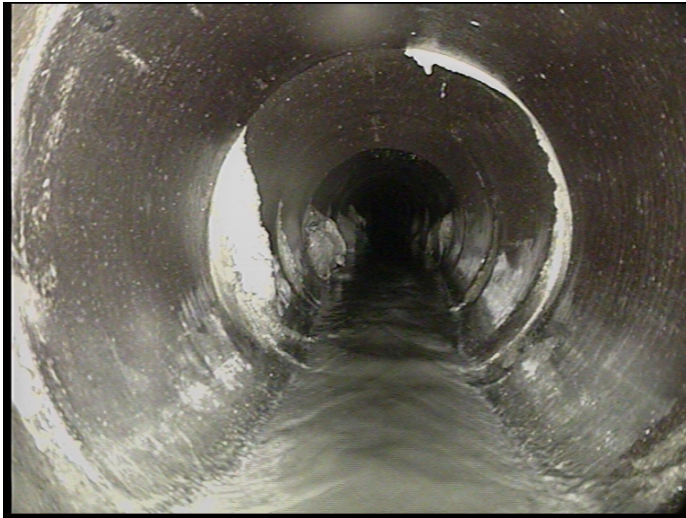
Code: **MWL**
Description: **Water Level**

Distance (ft): **.0**
Structural Grade: **0**
O&M Grade: **0**
Clock Start/From:
Clock To:
1st Value:
2nd Value:
Value Percent: **5.000**
Continuous Index:
Within 8" of Joint: **NO**
Remarks:

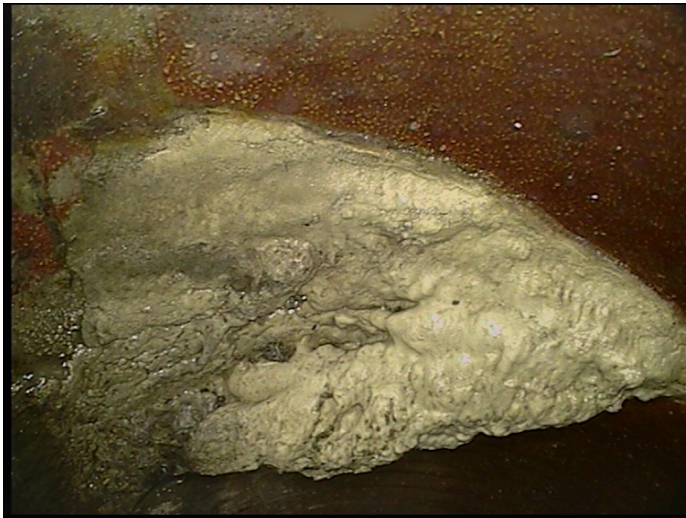
Code: **DAE**
Description: **Deposits Attached Encrustation**

Distance (ft): **2.5**
Structural Grade: **0**
O&M Grade: **2**
Clock Start/From: **7**
Clock To: **10**
1st Value:
2nd Value:
Value Percent: **10.000**
Continuous Index: **S01**
Within 8" of Joint: **YES**
Remarks:

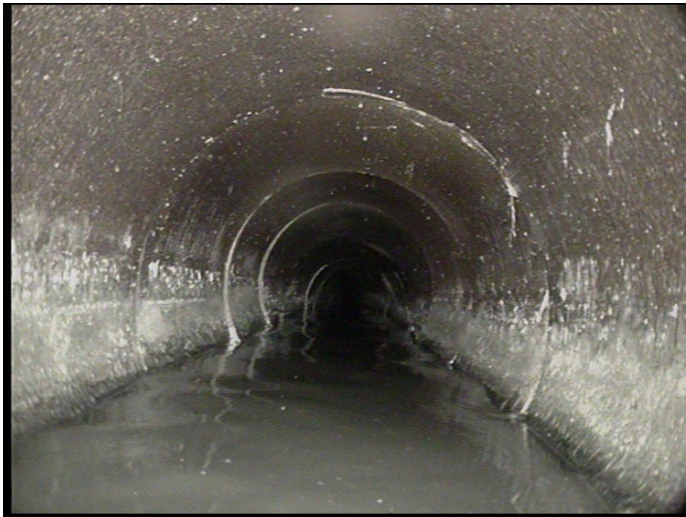
Code: **DAE**
Description: **Deposits Attached Encrustation**

Distance (ft): **31.2**
Structural Grade: **0**
O&M Grade: **2**
Clock Start/From: **7**
Clock To: **10**
1st Value:
2nd Value:
Value Percent: **10.000**
Continuous Index: **F01**
Within 8" of Joint: **NO**
Remarks:

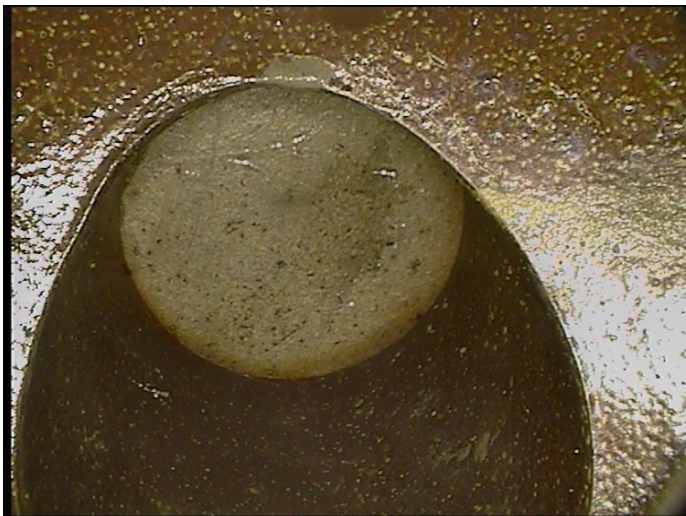
Code: **TFC**
Description: **Tap Factory Capped**

Distance (ft): **41.2**
Structural Grade: **0**
O&M Grade: **0**
Clock Start/From: **2**
Clock To:
1st Value: **4.000**
2nd Value:
Value Percent:
Continuous Index:
Within 8" of Joint: **NO**
Remarks:

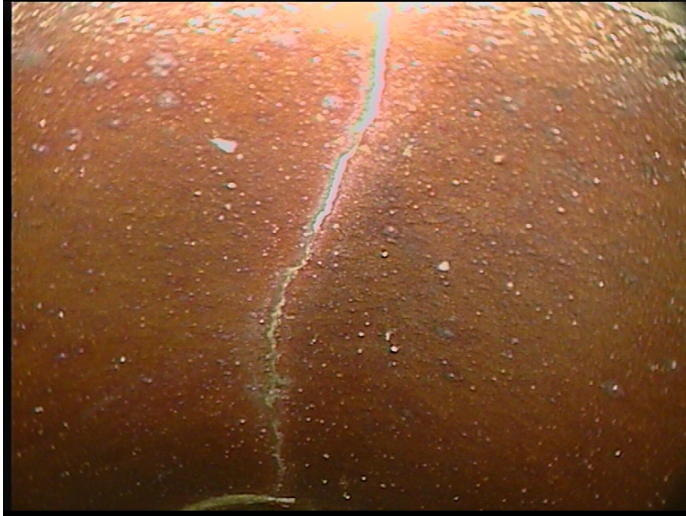
Code: **CL**
Description: **Crack Longitudinal**

Distance (ft): **48.2**
Structural Grade: **2**
O&M Grade: **0**
Clock Start/From: **12**
Clock To:
1st Value:
2nd Value:
Value Percent:
Continuous Index: **S02**
Within 8" of Joint: **YES**
Remarks:

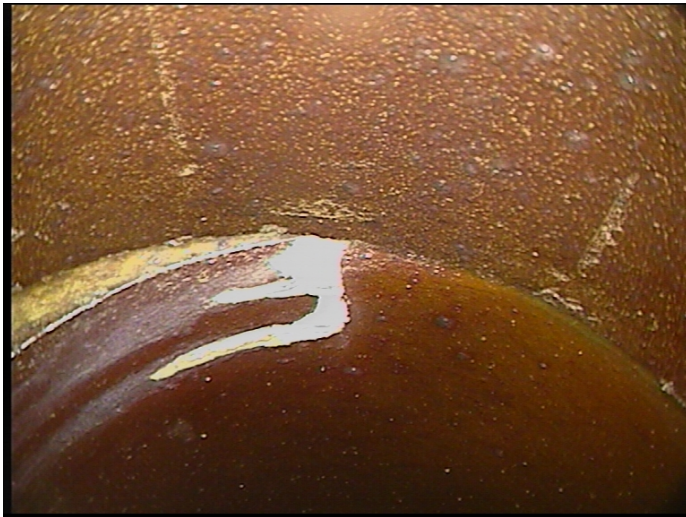
Code: **CL**
Description: **Crack Longitudinal**

Distance (ft): **59.5**
Structural Grade: **2**
O&M Grade: **0**
Clock Start/From: **12**
Clock To:
1st Value:
2nd Value:
Value Percent:
Continuous Index: **F02**
Within 8" of Joint: **NO**
Remarks:

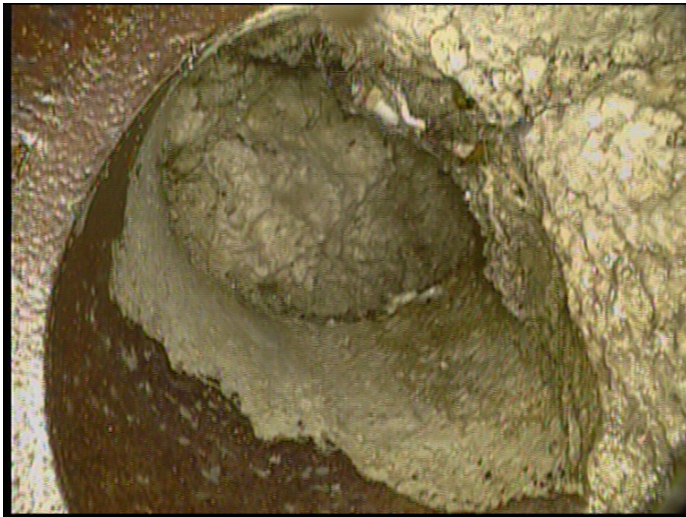
Code: **TFC**
Description: **Tap Factory Capped**

Distance (ft): **63.9**
Structural Grade: **0**
O&M Grade: **0**
Clock Start/From: **2**
Clock To:
1st Value: **4.000**
2nd Value:
Value Percent:
Continuous Index:
Within 8" of Joint: **NO**
Remarks:

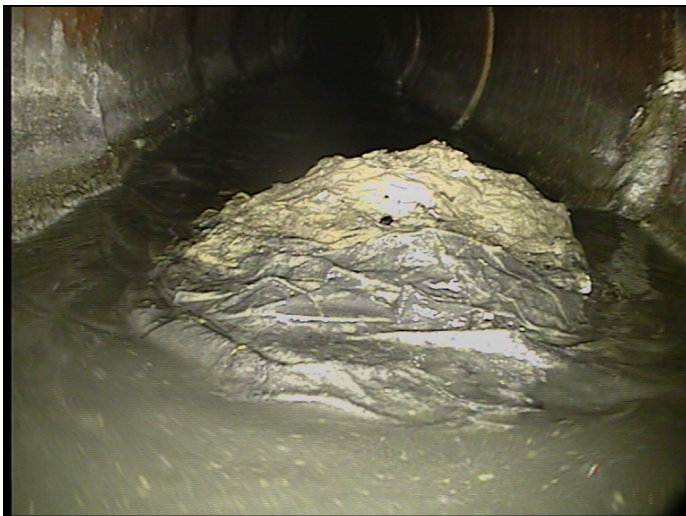
Code: **OBZ**
Description: **Obstacle Other**

Distance (ft): **73.1**
Structural Grade: **0**
O&M Grade: **3**
Clock Start/From: **5**
Clock To: **7**
1st Value:
2nd Value:
Value Percent: **20.000**
Continuous Index:
Within 8" of Joint: **NO**
Remarks: **Debris**

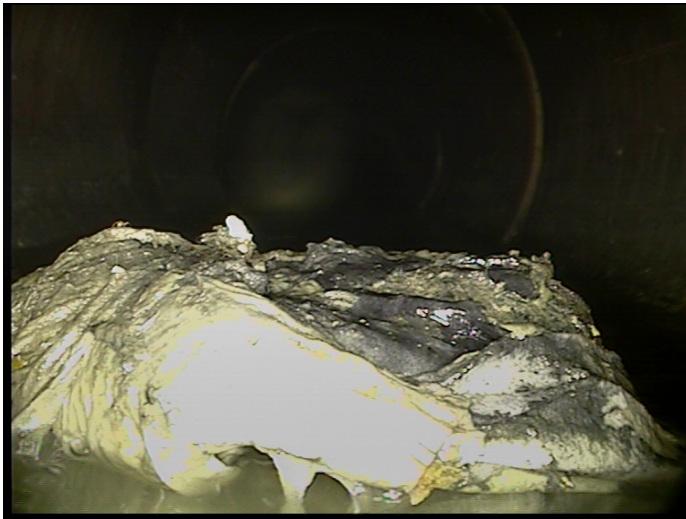
Code:	MSA
Description:	Abandoned Survey
Distance (ft):	74.3
Structural Grade:	0
O&M Grade:	0
Clock Start/From:	
Clock To:	
1st Value:	
2nd Value:	
Value Percent:	
Continuous Index:	
Within 8" of Joint:	NO
Remarks:	debris
