## Profile/Photo Observation Report

Date:	<b>04/11/2018</b>	Weather:		Coding:	<b>PACP 6.0</b>
Pipe Length (ft):		Owner:	<b>City of Hobart</b>	Pre Clean:	<b>No Pre-Cleaning</b>
P.O.#:	<b>28-1</b>	Surveyor:	<b>M. Pielacha</b>	PSR:	<b>M-504-069-M-504-068</b>
Customer:	<b>City of Hobart</b>	Clean Date:		Shape:	<b>C</b>

Street:	<b>Off Old Ridge Road</b>	Flow Control:	<b>Not Controlled</b>
City:	<b>Hobart, IN</b>	Year Renewed:	
Location:	<b>Yard</b>	Tape/Media #:	<b>DEP 28</b>
Purpose:	<b>Routine Assessment</b>	Dia/Height:	<b>18"</b>
Use:	<b>Sanitary</b>	Material:	<b>VCP</b>
Drain Area:		Lining:	
Category:	<b>NA</b>		
Comment:			
Location Details:		Direction of Survey:	<b>Upstream</b>
US MH:	<b>M-504-069</b>	DS MH:	<b>M-504-068</b>
		Total Length Surveyed (ft):	<b>90.5</b>

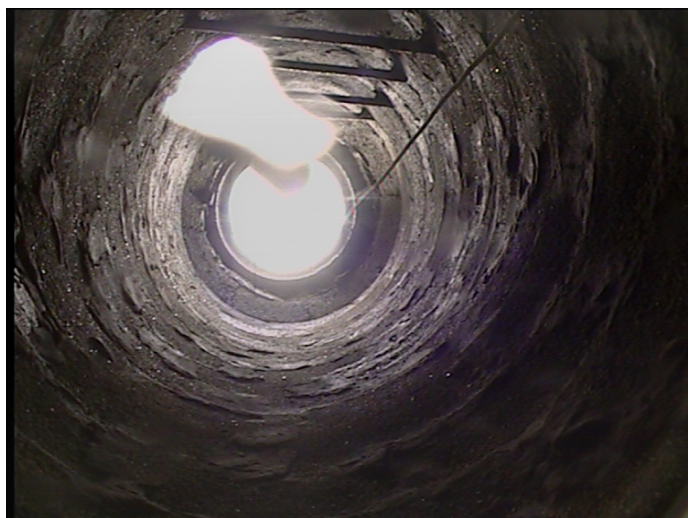
Code: **AMH**  
 Description: **Manhole**

Distance (ft): **.0**  
 Structural Grade: **0**  
 O&M Grade: **0**  
 Clock Start/From:  
 Clock To:  
 1st Value:  
 2nd Value:  
 Value Percent:  
 Continuous Index:  
 Within 8" of Joint: **NO**  
 Remarks: **M-504-068**

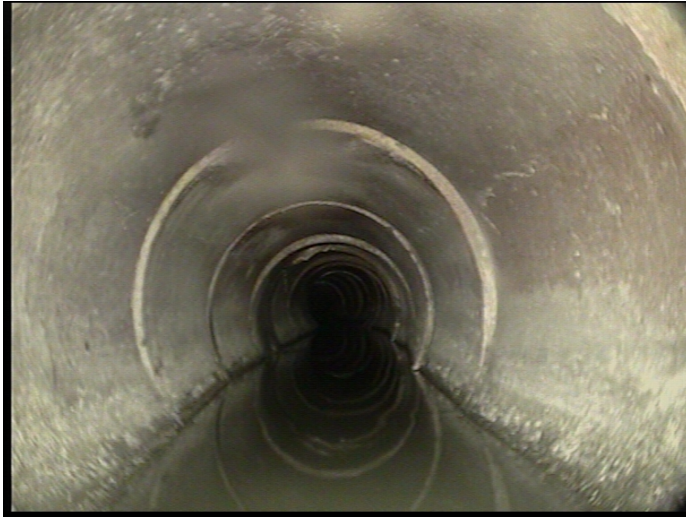
Code: **MWL**  
Description: **Water Level**

Distance (ft): **.0**  
Structural Grade: **0**  
O&M Grade: **0**  
Clock Start/From:  
Clock To:  
1st Value:  
2nd Value:  
Value Percent: **10.000**  
Continuous Index:  
Within 8" of Joint: **NO**  
Remarks:

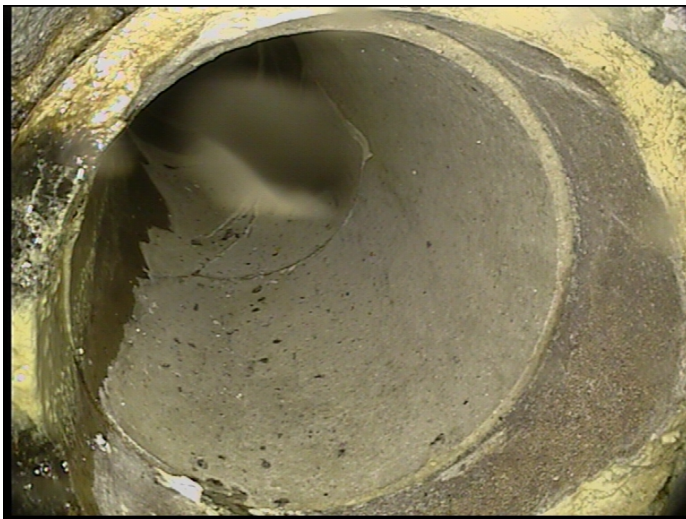
Code: **TB**  
Description: **Tap Break-in**

Distance (ft): **7.6**  
Structural Grade: **0**  
O&M Grade: **0**  
Clock Start/From: **10**  
Clock To:  
1st Value: **4.000**  
2nd Value:  
Value Percent:  
Continuous Index:  
Within 8" of Joint: **NO**  
Remarks:

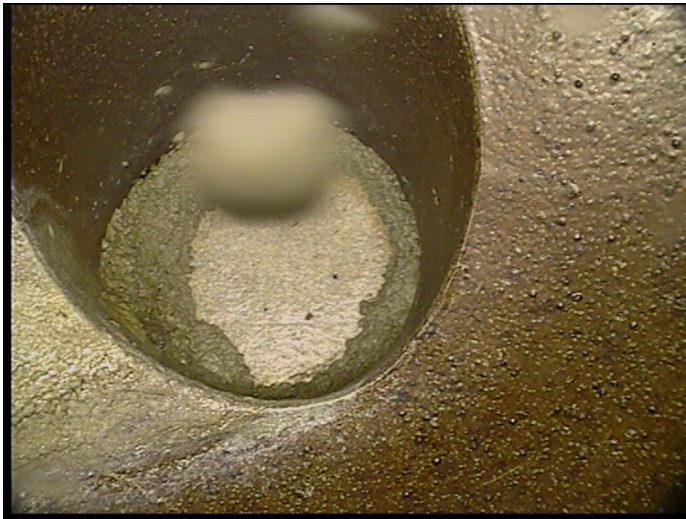
Code: **TFC**  
Description: **Tap Factory Capped**

Distance (ft): **26.6**  
Structural Grade: **0**  
O&M Grade: **0**  
Clock Start/From: **11**  
Clock To:  
1st Value: **4.000**  
2nd Value:  
Value Percent:  
Continuous Index:  
Within 8" of Joint: **NO**  
Remarks:

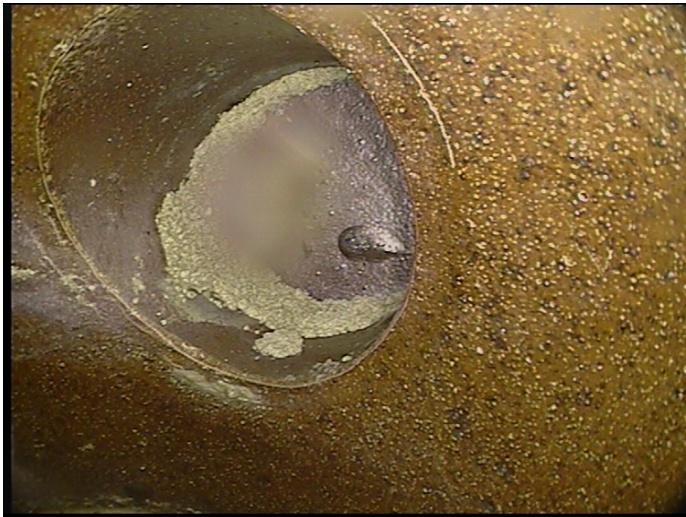
Code: **TFC**  
Description: **Tap Factory Capped**

Distance (ft): **48.7**  
Structural Grade: **0**  
O&M Grade: **0**  
Clock Start/From: **10**  
Clock To:  
1st Value: **4.000**  
2nd Value:  
Value Percent:  
Continuous Index:  
Within 8" of Joint: **NO**  
Remarks:

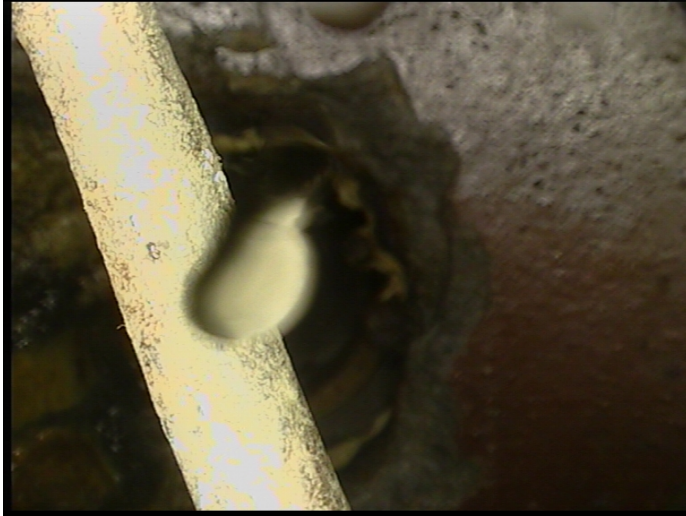
Code: **TB**  
Description: **Tap Break-in**

Distance (ft): **75.9**  
Structural Grade: **0**  
O&M Grade: **0**  
Clock Start/From: **10**  
Clock To:  
1st Value: **4.000**  
2nd Value:  
Value Percent:  
Continuous Index:  
Within 8" of Joint: **NO**  
Remarks:

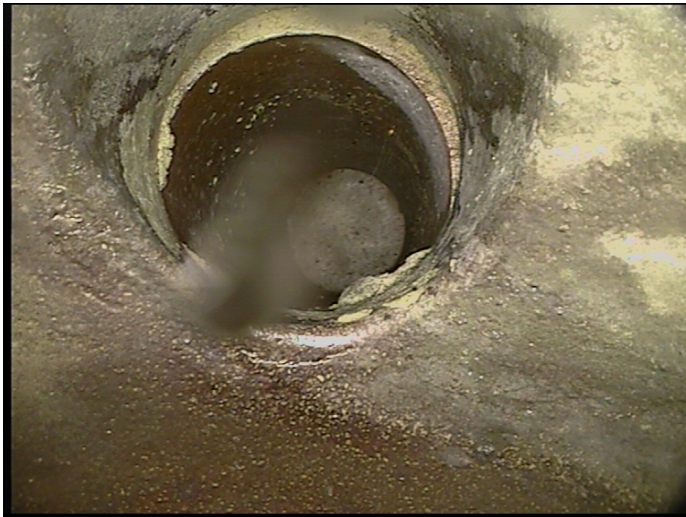
Code: **TFC**  
Description: **Tap Factory Capped**

Distance (ft): **80.0**  
Structural Grade: **0**  
O&M Grade: **0**  
Clock Start/From: **2**  
Clock To:  
1st Value: **4.000**  
2nd Value:  
Value Percent:  
Continuous Index:  
Within 8" of Joint: **NO**  
Remarks:

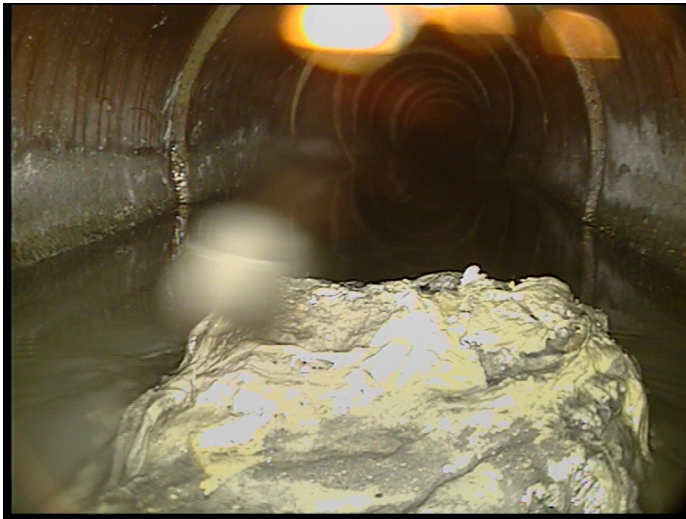
Code:	<b>MSA</b>
Description:	<b>Abandoned Survey</b>
Distance (ft):	<b>90.5</b>
Structural Grade:	<b>0</b>
O&M Grade:	<b>0</b>
Clock Start/From:	
Clock To:	
1st Value:	
2nd Value:	
Value Percent:	
Continuous Index:	
Within 8" of Joint:	<b>NO</b>
Remarks:	<b>reverse complete</b>
