Profile/Photo Observation Report

Date:	04/18/2018	Weather:		Coding:	PACP 6.0
Pipe Length (ft):	193.1	Owner:	NA	Pre Clean:	Not Known
P.O.#:		Surveyor:	Byrd Fitzgerald	PSR:	P-504-086-070
Customer:		Clean Date:	01/01/1900	Shape:	C

Street:	ALLEY BETWEEN N VIRGINIA ST & N	Flow Control:	Not Controlled
City:	Hobart, IN	Year Renewed:	
Location:	Light Highway	Tape/Media #:	
Purpose:	Not Known	Dia/Height:	12"
Use:	Sanitary	Material:	PVC
Drain Area:	NA	Lining:	
Category:	NA		
Comment:

Location Details:		Direction of Survey:	Downstream
US MH:	M-504-070	DS MH:	M-504-086
		Total Length Surveyed (ft):	185.8

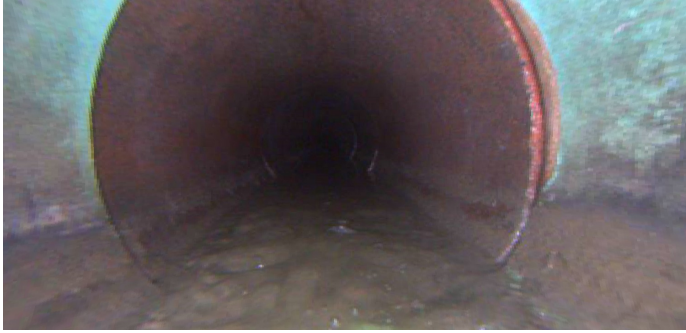
Code: **AMH**
Description: **Manhole**

Distance (ft): **.0**
Structural Grade: **0**
O&M Grade: **0**
Clock Start/From:
Clock To:
1st Value:
2nd Value:
Value Percent:
Continuous Index:
Within 8" of Joint: **NO**
Remarks: **M-504-070**

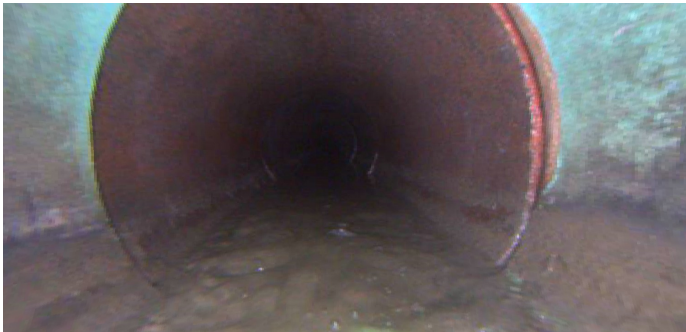
Code: **MWL**
Description: **Water Level**

Distance (ft): **.0**
Structural Grade: **0**
O&M Grade: **0**
Clock Start/From:
Clock To:
1st Value:
2nd Value:
Value Percent: **5.000**
Continuous Index:
Within 8" of Joint: **NO**
Remarks:

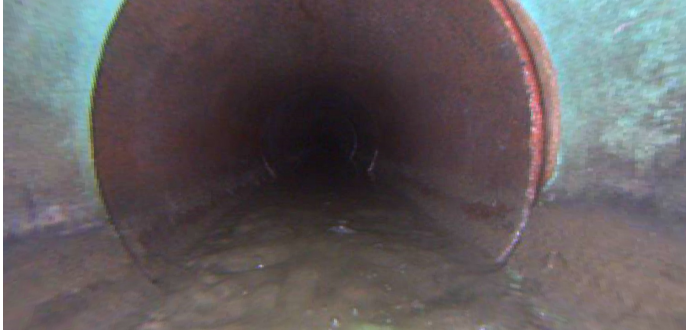
Code: **MMC**
Description: **Material Change**

Distance (ft): **.0**
Structural Grade: **0**
O&M Grade: **0**
Clock Start/From:
Clock To:
1st Value:
2nd Value:
Value Percent:
Continuous Index:
Within 8" of Joint: **NO**
Remarks: **vcp**

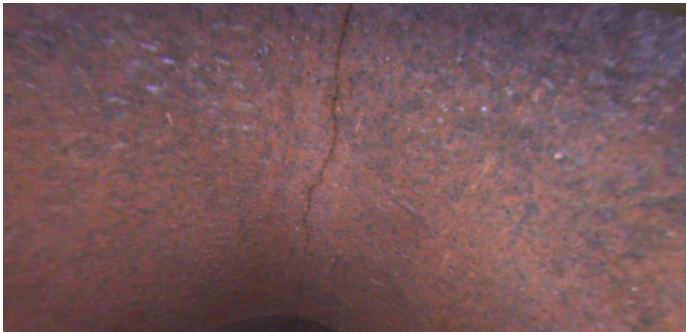
Code: **FL**
Description: **Fracture Longitudinal**

Distance (ft): **2.7**
Structural Grade: **3**
O&M Grade: **0**
Clock Start/From: **12**
Clock To:
1st Value:
2nd Value:
Value Percent:
Continuous Index:
Within 8" of Joint:
Remarks:

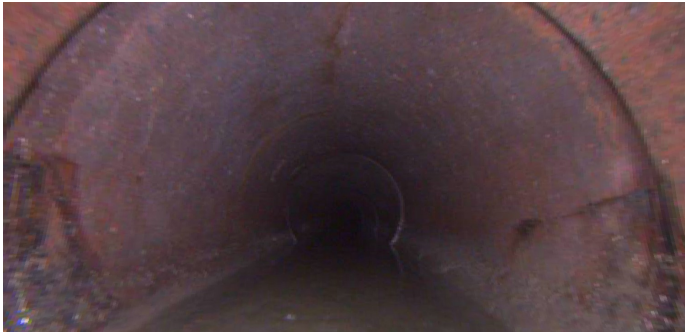
Code: **FM**
Description: **Fracture Multiple**

Distance (ft): **3.5**
Structural Grade: **4**
O&M Grade: **0**
Clock Start/From: **9**
Clock To: **3**
1st Value:
2nd Value:
Value Percent:
Continuous Index: **S01**
Within 8" of Joint: **YES**
Remarks: **wandering**

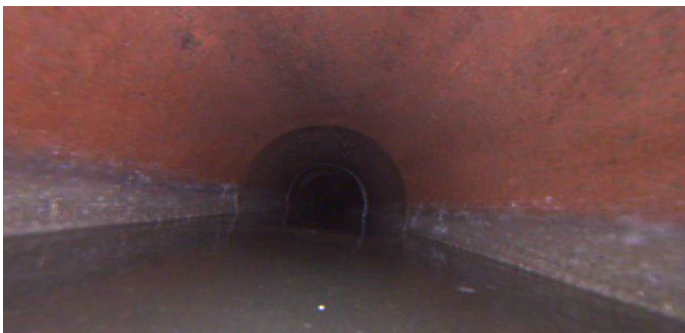
Code: **MWL**
Description: **Water Level**

Distance (ft): **8.5**
Structural Grade: **0**
O&M Grade: **0**
Clock Start/From:
Clock To:
1st Value:
2nd Value:
Value Percent: **20.000**
Continuous Index:
Within 8" of Joint: **NO**
Remarks:

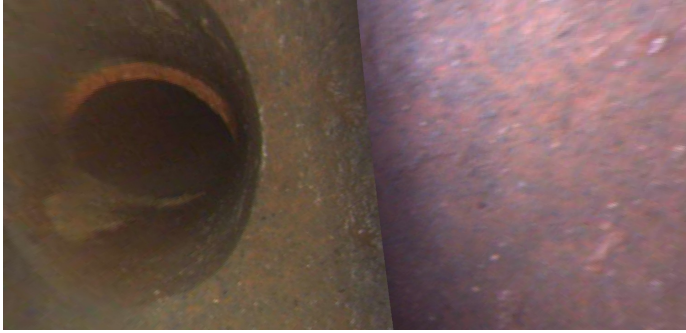
Code: **TF**
Description: **Tap Factory**

Distance (ft): **13.4**
Structural Grade: **0**
O&M Grade: **0**
Clock Start/From: **11**
Clock To:
1st Value: **4.000**
2nd Value:
Value Percent:
Continuous Index:
Within 8" of Joint:
Remarks:

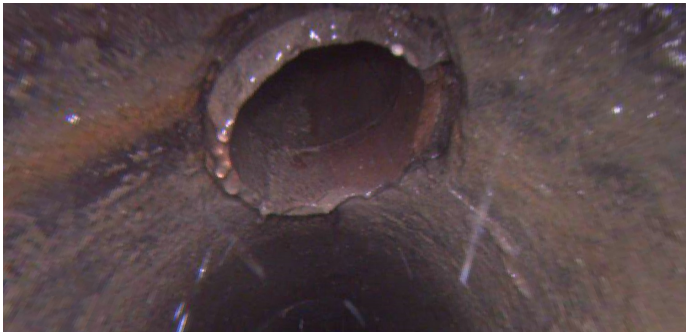
Code: **TBI**
Description: **Tap Break-in Intruding**

Distance (ft): **18.3**
Structural Grade: **0**
O&M Grade: **2**
Clock Start/From: **12**
Clock To:
1st Value: **4.000**
2nd Value: **1.000**
Value Percent:
Continuous Index:
Within 8" of Joint:
Remarks:

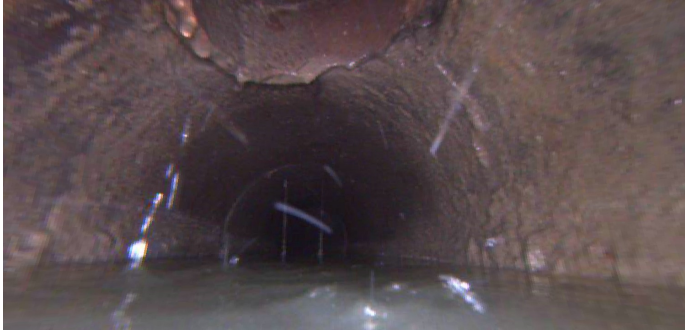
Code: **DAGS**
Description: **Deposits Attached Grease**

Distance (ft): **18.3**
Structural Grade: **0**
O&M Grade: **2**
Clock Start/From: **8**
Clock To: **4**
1st Value:
2nd Value:
Value Percent: **5.000**
Continuous Index:
Within 8" of Joint: **NO**
Remarks:

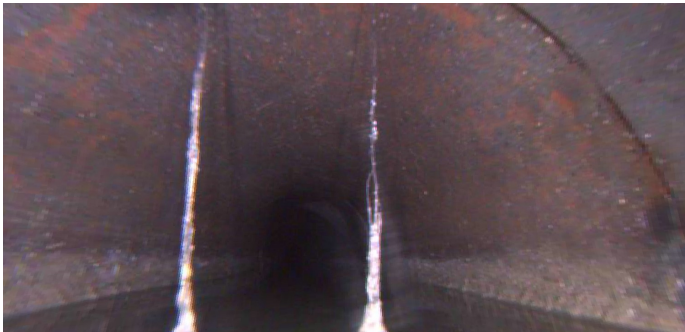
Code: **RFJ**
Description: **Roots Fine Joint**

Distance (ft): **19.9**
Structural Grade: **0**
O&M Grade: **1**
Clock Start/From: **12**
Clock To:
1st Value:
2nd Value:
Value Percent:
Continuous Index:
Within 8" of Joint: **YES**
Remarks:

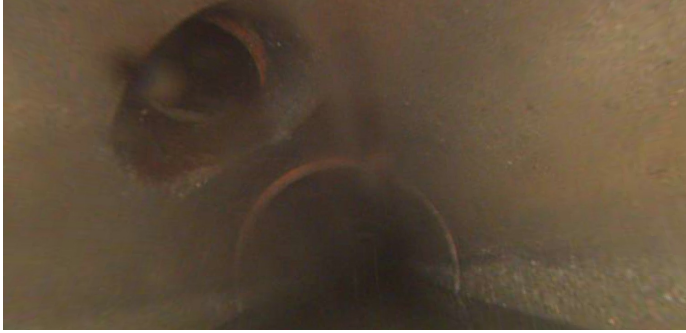
Code: **TF**
Description: **Tap Factory**

Distance (ft): **23.7**
Structural Grade: **0**
O&M Grade: **0**
Clock Start/From: **1**
Clock To:
1st Value: **4.000**
2nd Value:
Value Percent:
Continuous Index:
Within 8" of Joint:
Remarks:

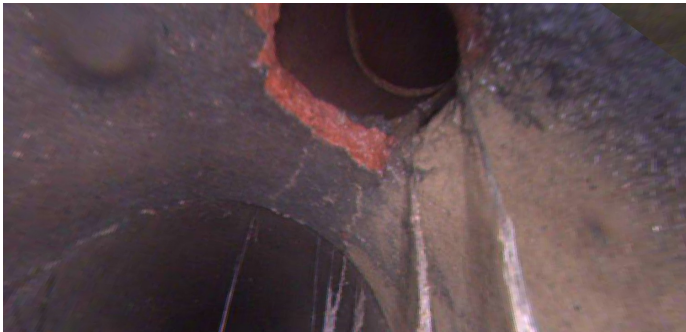
Code: **TB**
Description: **Tap Break-in**

Distance (ft): **29.3**
Structural Grade: **0**
O&M Grade: **0**
Clock Start/From: **1**
Clock To:
1st Value: **4.000**
2nd Value:
Value Percent:
Continuous Index:
Within 8" of Joint:
Remarks:

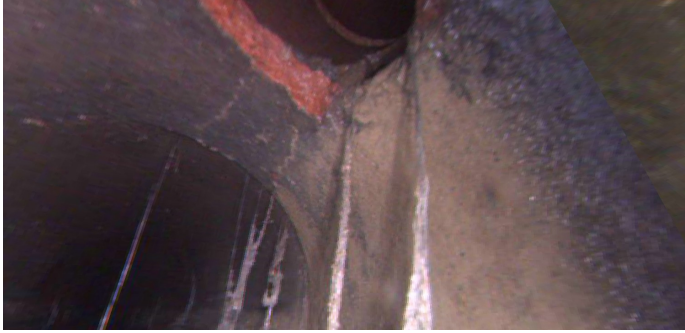
Code: **RFC**
Description: **Roots Fine Connection**

Distance (ft): **29.3**
Structural Grade: **0**
O&M Grade: **1**
Clock Start/From: **2**
Clock To:
1st Value:
2nd Value:
Value Percent:
Continuous Index:
Within 8" of Joint: **NO**
Remarks:

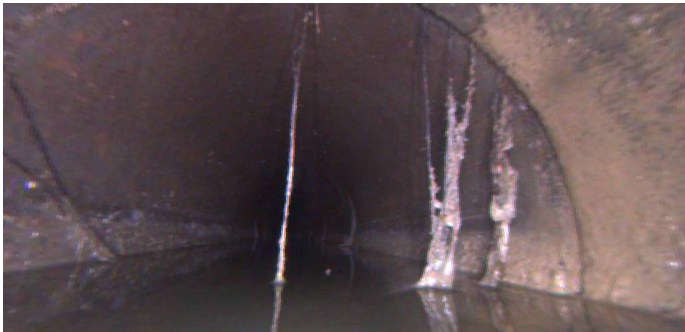
Code: **RFJ**
Description: **Roots Fine Joint**

Distance (ft): **29.8**
Structural Grade: **0**
O&M Grade: **1**
Clock Start/From: **10**
Clock To: **2**
1st Value:
2nd Value:
Value Percent:
Continuous Index: **S02**
Within 8" of Joint: **YES**
Remarks: **wandering**

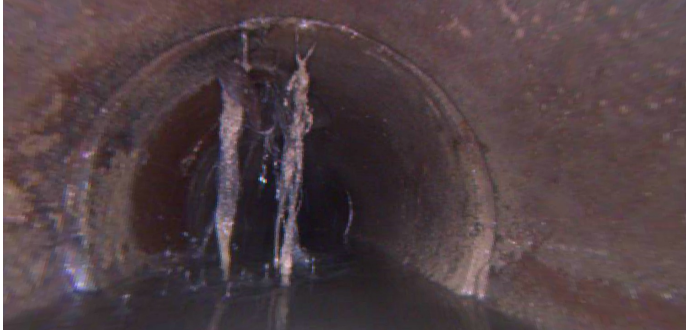
Code: **RMJ**
Description: **Roots Medium Joint**

Distance (ft): **65.8**
Structural Grade: **0**
O&M Grade: **3**
Clock Start/From: **12**
Clock To:
1st Value:
2nd Value:
Value Percent: **5.000**
Continuous Index:
Within 8" of Joint: **YES**
Remarks:

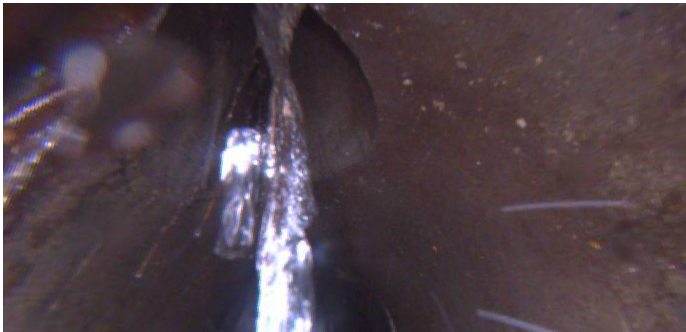
Code: **TFD**
Description: **Tap Factory Defective**

Distance (ft): **66.6**
Structural Grade: **0**
O&M Grade: **2**
Clock Start/From: **11**
Clock To:
1st Value: **4.000**
2nd Value:
Value Percent:
Continuous Index:
Within 8" of Joint:
Remarks: **roots**

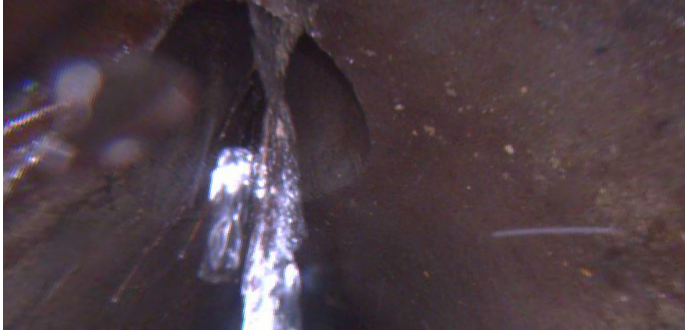
Code: **RFL**
Description: **Roots Fine Lateral**

Distance (ft): **66.6**
Structural Grade: **0**
O&M Grade: **1**
Clock Start/From: **12**
Clock To:
1st Value:
2nd Value:
Value Percent:
Continuous Index:
Within 8" of Joint: **NO**
Remarks:

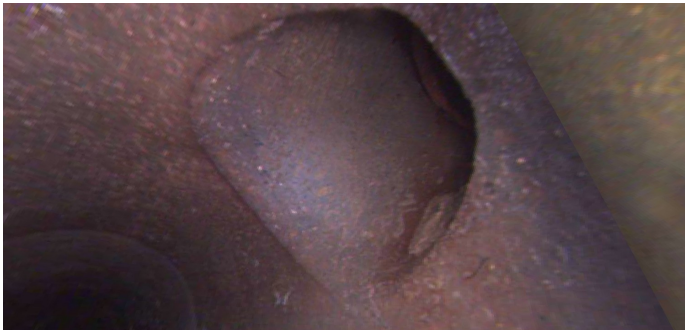
Code: **TF**
Description: **Tap Factory**

Distance (ft): **76.9**
Structural Grade: **0**
O&M Grade: **0**
Clock Start/From: **2**
Clock To:
1st Value: **4.000**
2nd Value:
Value Percent:
Continuous Index:
Within 8" of Joint:
Remarks:

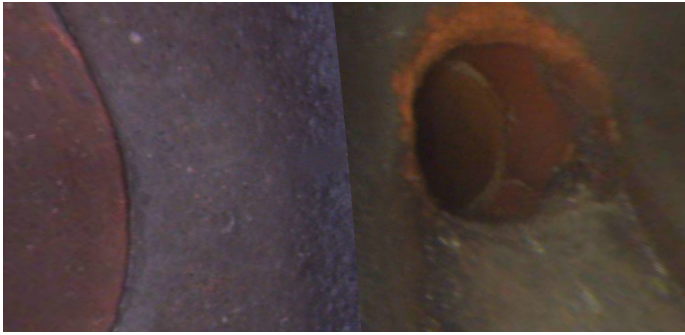
Code: **TB**
Description: **Tap Break-in**

Distance (ft): **82.2**
Structural Grade: **0**
O&M Grade: **0**
Clock Start/From: **2**
Clock To:
1st Value: **4.000**
2nd Value:
Value Percent:
Continuous Index:
Within 8" of Joint:
Remarks:

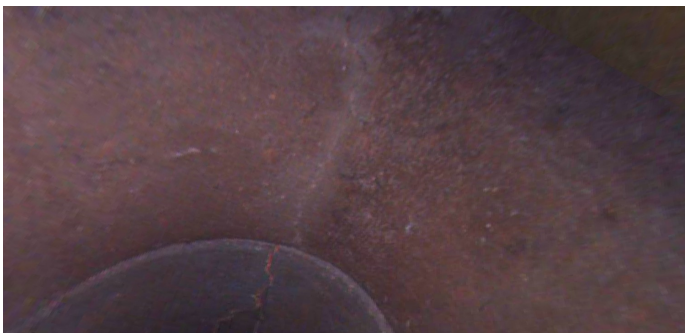
Code: **CL**
Description: **Crack Longitudinal**

Distance (ft): **106.0**
Structural Grade: **2**
O&M Grade: **0**
Clock Start/From: **12**
Clock To:
1st Value:
2nd Value:
Value Percent:
Continuous Index: **S03**
Within 8" of Joint:
Remarks:

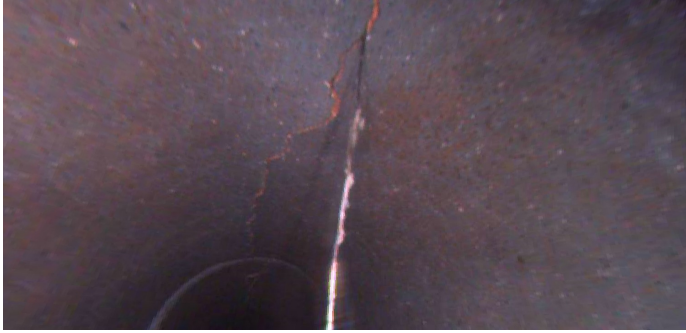
Code: **RFB**
Description: **Roots Fine Barrel**

Distance (ft): **106.9**
Structural Grade: **0**
O&M Grade: **2**
Clock Start/From: **12**
Clock To:
1st Value:
2nd Value:
Value Percent:
Continuous Index:
Within 8" of Joint: **NO**
Remarks:

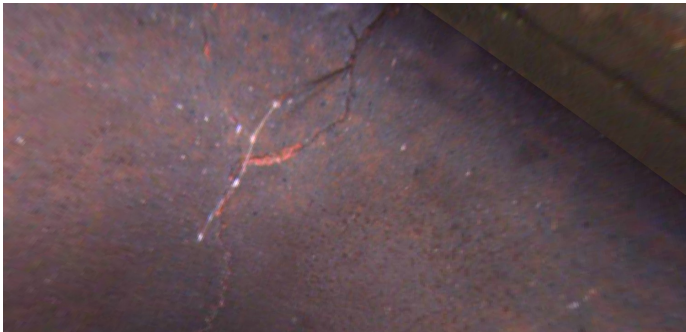
Code: **RFB**
Description: **Roots Fine Barrel**

Distance (ft): **108.9**
Structural Grade: **0**
O&M Grade: **2**
Clock Start/From: **12**
Clock To:
1st Value:
2nd Value:
Value Percent:
Continuous Index:
Within 8" of Joint: **NO**
Remarks:

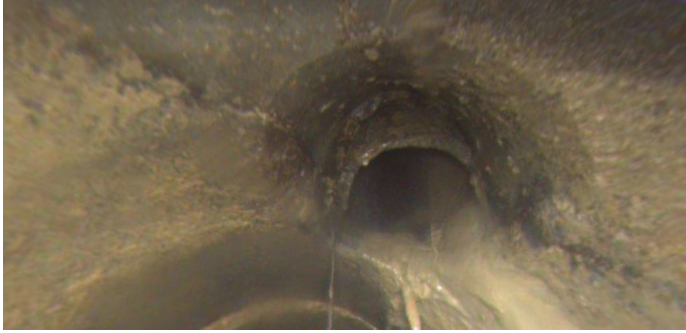
Code: **TFD**
Description: **Tap Factory Defective**

Distance (ft): **116.0**
Structural Grade: **0**
O&M Grade: **2**
Clock Start/From: **11**
Clock To:
1st Value: **4.000**
2nd Value:
Value Percent:
Continuous Index:
Within 8" of Joint:
Remarks: **fractured, roots**

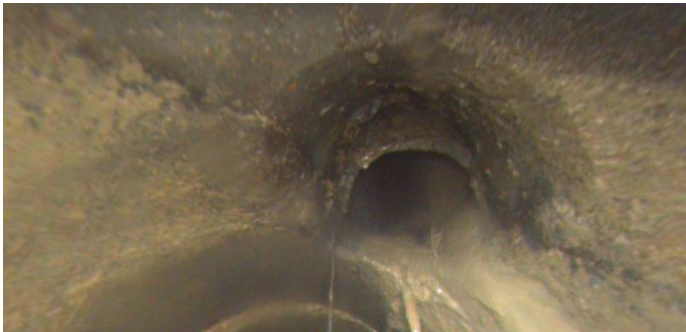
Code: **RFL**
Description: **Roots Fine Lateral**

Distance (ft): **116.0**
Structural Grade: **0**
O&M Grade: **1**
Clock Start/From: **11**
Clock To:
1st Value:
2nd Value:
Value Percent:
Continuous Index:
Within 8" of Joint: **NO**
Remarks:

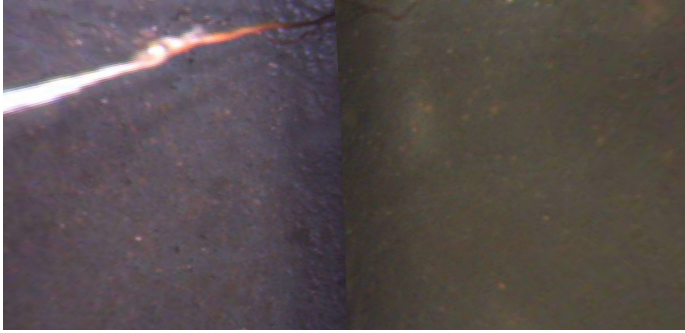
Code: **RFB**
Description: **Roots Fine Barrel**

Distance (ft): **119.7**
Structural Grade: **0**
O&M Grade: **2**
Clock Start/From: **12**
Clock To:
1st Value:
2nd Value:
Value Percent:
Continuous Index:
Within 8" of Joint: **NO**
Remarks:

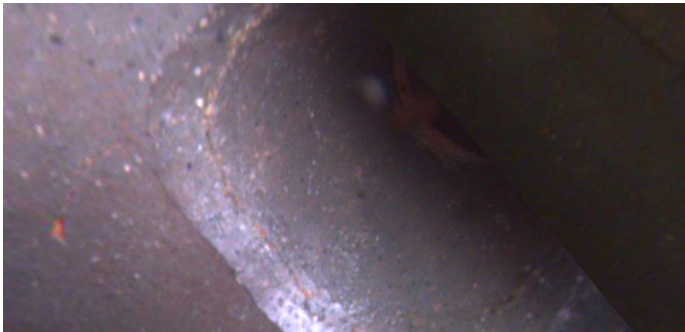
Code: **TF**
Description: **Tap Factory**

Distance (ft): **127.4**
Structural Grade: **0**
O&M Grade: **0**
Clock Start/From: **1**
Clock To:
1st Value: **4.000**
2nd Value:
Value Percent:
Continuous Index:
Within 8" of Joint: **YES**
Remarks:

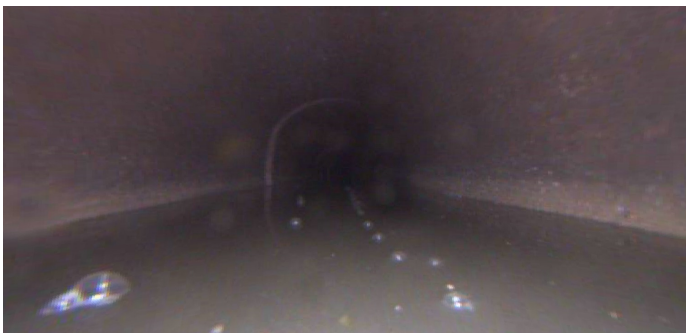
Code: **MCU**
Description: **Camera Underwater**

Distance (ft): **147.1**
Structural Grade: **0**
O&M Grade: **4**
Clock Start/From:
Clock To:
1st Value:
2nd Value:
Value Percent:
Continuous Index: **F04**
Within 8" of Joint: **NO**
Remarks:

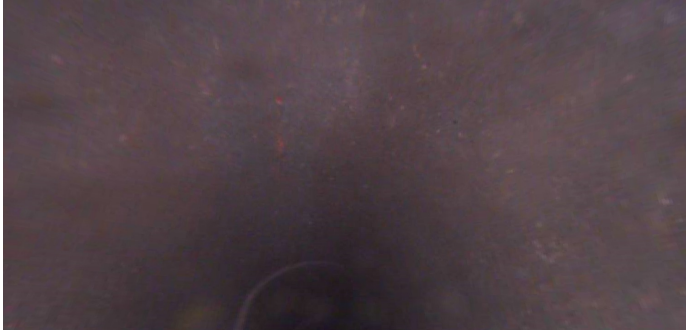
Code: **CL**
Description: **Crack Longitudinal**

Distance (ft): **147.1**
Structural Grade: **2**
O&M Grade: **0**
Clock Start/From: **12**
Clock To:
1st Value:
2nd Value:
Value Percent:
Continuous Index: **F03**
Within 8" of Joint:
Remarks:

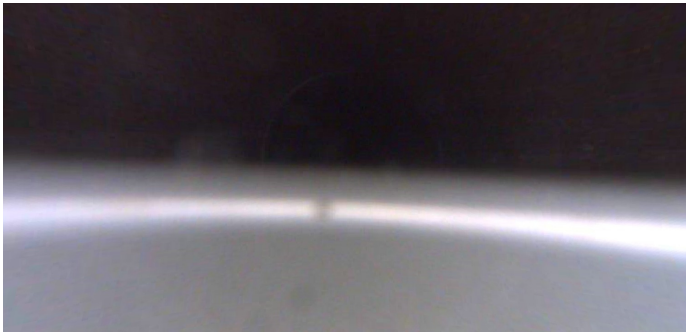
Code: **MWL**
Description: **Water Level**

Distance (ft): **165.6**
Structural Grade: **0**
O&M Grade: **0**
Clock Start/From:
Clock To:
1st Value:
2nd Value:
Value Percent: **40.000**
Continuous Index:
Within 8" of Joint: **NO**
Remarks:

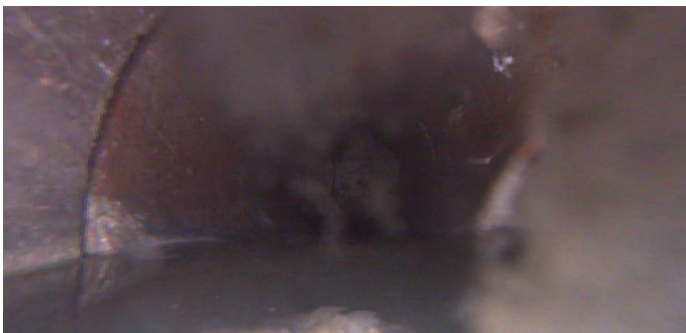
Code: **MCU**
Description: **Camera Underwater**

Distance (ft): **182.8**
Structural Grade: **0**
O&M Grade: **4**
Clock Start/From:
Clock To:
1st Value:
2nd Value:
Value Percent:
Continuous Index: **F05**
Within 8" of Joint: **NO**
Remarks:

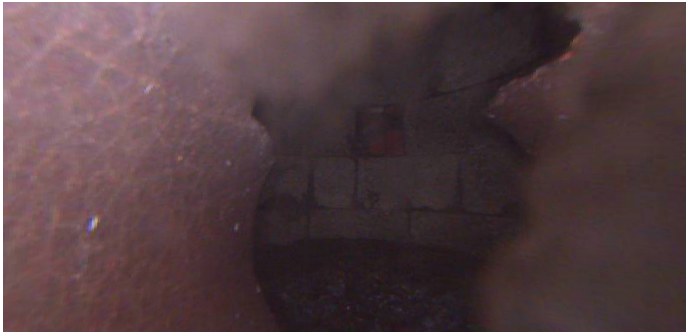
Code: **FM**
Description: **Fracture Multiple**

Distance (ft): **184.4**
Structural Grade: **4**
O&M Grade: **0**
Clock Start/From: **9**
Clock To: **3**
1st Value:
2nd Value:
Value Percent:
Continuous Index: **F01**
Within 8" of Joint: **YES**
Remarks: **wandering**

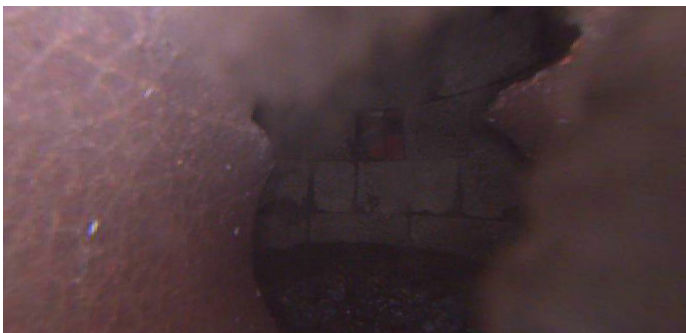
Code: **RFJ**
Description: **Roots Fine Joint**

Distance (ft): **184.4**
Structural Grade: **0**
O&M Grade: **1**
Clock Start/From: **10**
Clock To: **2**
1st Value:
2nd Value:
Value Percent:
Continuous Index: **F02**
Within 8" of Joint: **YES**
Remarks: **wandering**

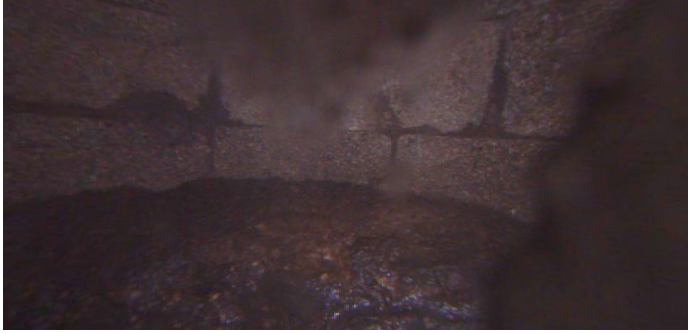
Code:	AMH
Description:	Manhole
Distance (ft):	185.8
Structural Grade:	0
O&M Grade:	0
Clock Start/From:	
Clock To:	
1st Value:	
2nd Value:	
Value Percent:	
Continuous Index:	
Within 8" of Joint:	NO
Remarks:	M-504-086
