Profile/Photo Observation Report

Date:	04/18/2018	Weather:		Coding:	PACP 6.0
Pipe Length (ft):	193.1	Owner:	NA	Pre Clean:	Not Known
P.O.#:		Surveyor:	Byrd Fitzgerald	PSR:	P-504-086-070
Customer:		Clean Date:	01/01/1900	Shape:	C

Street:	Summerlin	Flow Control:	Not Controlled
City:	Hobart, IN	Year Renewed:	
Location:	Light Highway	Tape/Media #:	
Purpose:	Not Known	Dia/Height:	12"
Use:	Sanitary	Material:	PVC
Drain Area:	NA	Lining:	
Category:	NA		
Comment:

Location Details:		Direction of Survey:	Downstream
US MH:	M-504-070	DS MH:	M-504-086
		Total Length Surveyed (ft):	185.8

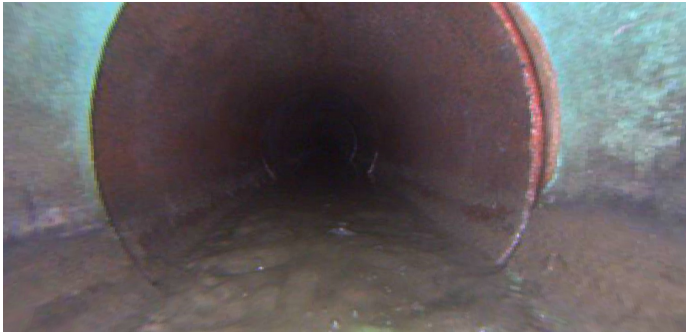
Code: **AMH**
Description: **Manhole**

Distance (ft): **.0**
Structural Grade: **0**
O&M Grade: **0**
Clock Start/From:
Clock To:
1st Value:
2nd Value:
Value Percent:
Continuous Index:
Within 8" of Joint: **NO**
Remarks: **M-504-070**

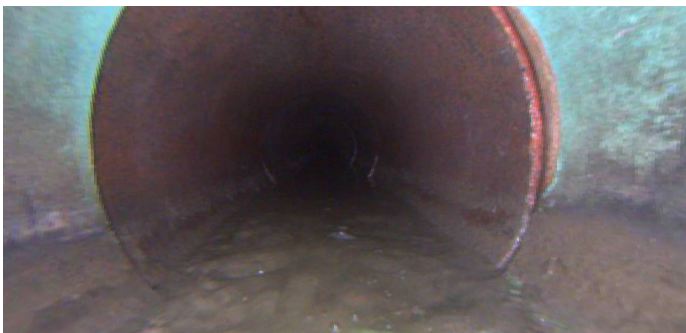
Code: **MWL**
Description: **Water Level**

Distance (ft): **.0**
Structural Grade: **0**
O&M Grade: **0**
Clock Start/From:
Clock To:
1st Value:
2nd Value:
Value Percent: **5.000**
Continuous Index:
Within 8" of Joint: **NO**
Remarks:

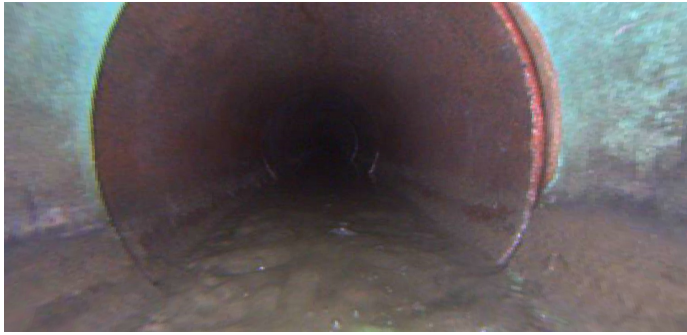
Code:	MMC
Description:	Material Change
Distance (ft):	.0
Structural Grade:	0
O&M Grade:	0
Clock Start/From:	
Clock To:	
1st Value:	
2nd Value:	
Value Percent:	
Continuous Index:	
Within 8" of Joint:	NO
Remarks:	vcp

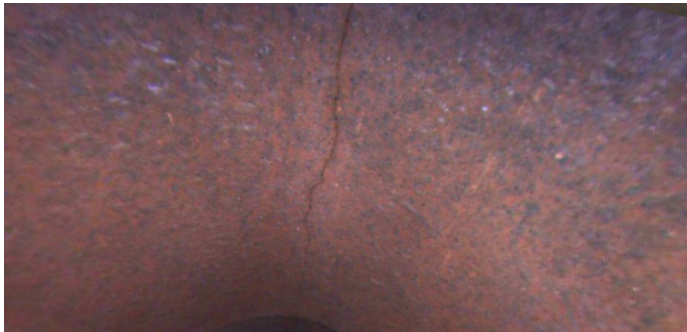
Code:	FL
Description:	Fracture Longitudinal
Distance (ft):	2.7
Structural Grade:	3
O&M Grade:	0
Clock Start/From:	12
Clock To:	
1st Value:	
2nd Value:	
Value Percent:	
Continuous Index:	
Within 8" of Joint:	
Remarks:

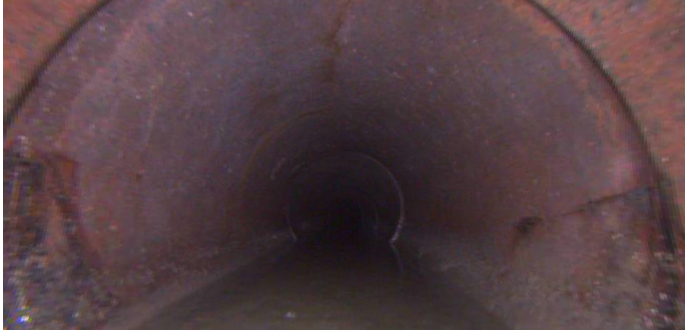
Code: **FM**
Description: **Fracture Multiple**

Distance (ft): **3.5**
Structural Grade: **4**
O&M Grade: **0**
Clock Start/From: **9**
Clock To: **3**
1st Value:
2nd Value:
Value Percent:
Continuous Index: **S01**
Within 8" of Joint: **YES**
Remarks: **wandering**

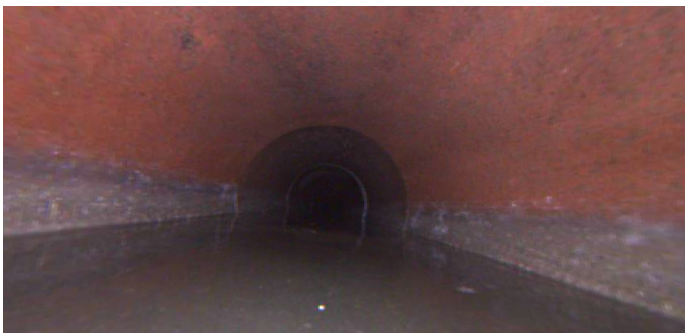
Code: **MWL**
Description: **Water Level**

Distance (ft): **8.5**
Structural Grade: **0**
O&M Grade: **0**
Clock Start/From:
Clock To:
1st Value:
2nd Value:
Value Percent: **20.000**
Continuous Index:
Within 8" of Joint: **NO**
Remarks:

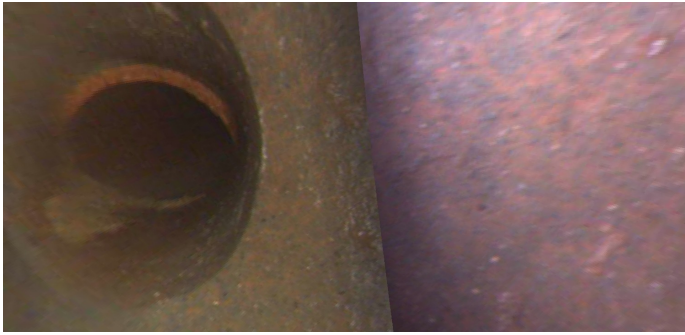
Code: **TF**
Description: **Tap Factory**

Distance (ft): **13.4**
Structural Grade: **0**
O&M Grade: **0**
Clock Start/From: **11**
Clock To:
1st Value: **4.000**
2nd Value:
Value Percent:
Continuous Index:
Within 8" of Joint:
Remarks:

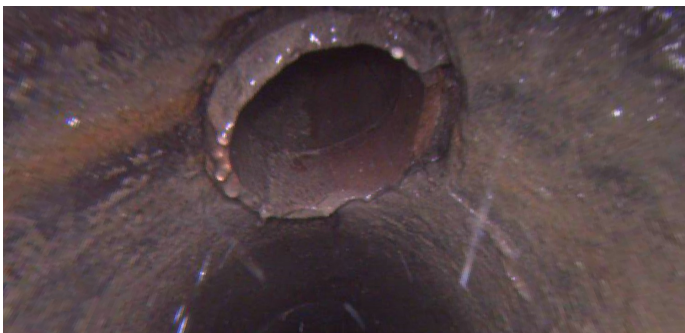
Code: **TBI**
Description: **Tap Break-in Intruding**

Distance (ft): **18.3**
Structural Grade: **0**
O&M Grade: **2**
Clock Start/From: **12**
Clock To:
1st Value: **4.000**
2nd Value: **1.000**
Value Percent:
Continuous Index:
Within 8" of Joint:
Remarks:

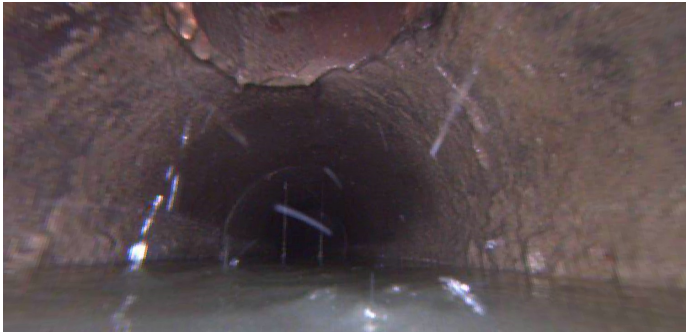
Code: **DAGS**
Description: **Deposits Attached Grease**

Distance (ft): **18.3**
Structural Grade: **0**
O&M Grade: **2**
Clock Start/From: **8**
Clock To: **4**
1st Value:
2nd Value:
Value Percent: **5.000**
Continuous Index:
Within 8" of Joint: **NO**
Remarks:

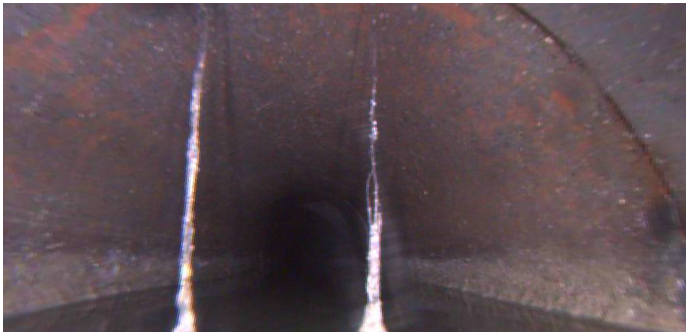
Code: **RFJ**
Description: **Roots Fine Joint**

Distance (ft): **19.9**
Structural Grade: **0**
O&M Grade: **1**
Clock Start/From: **12**
Clock To:
1st Value:
2nd Value:
Value Percent:
Continuous Index:
Within 8" of Joint: **YES**
Remarks:

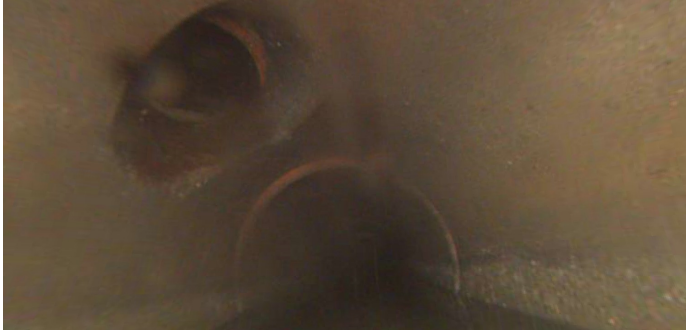
Code: **TF**
Description: **Tap Factory**

Distance (ft): **23.7**
Structural Grade: **0**
O&M Grade: **0**
Clock Start/From: **1**
Clock To:
1st Value: **4.000**
2nd Value:
Value Percent:
Continuous Index:
Within 8" of Joint:
Remarks:

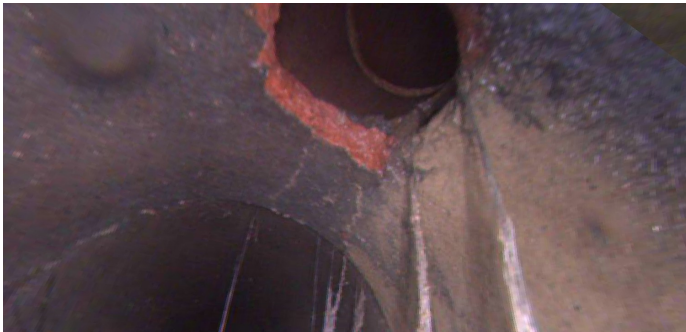
Code: **TB**
Description: **Tap Break-in**

Distance (ft): **29.3**
Structural Grade: **0**
O&M Grade: **0**
Clock Start/From: **1**
Clock To:
1st Value: **4.000**
2nd Value:
Value Percent:
Continuous Index:
Within 8" of Joint:
Remarks:

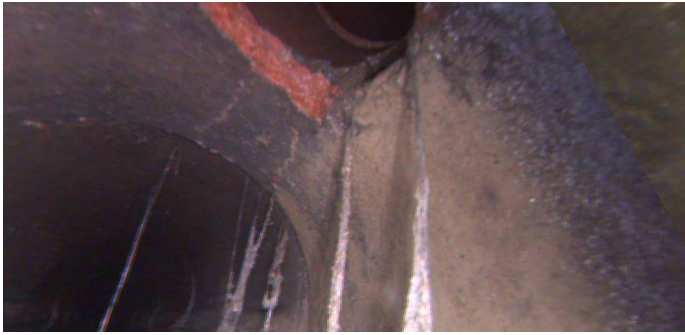
Code: **RFC**
Description: **Roots Fine Connection**

Distance (ft): **29.3**
Structural Grade: **0**
O&M Grade: **1**
Clock Start/From: **2**
Clock To:
1st Value:
2nd Value:
Value Percent:
Continuous Index:
Within 8" of Joint: **NO**
Remarks:

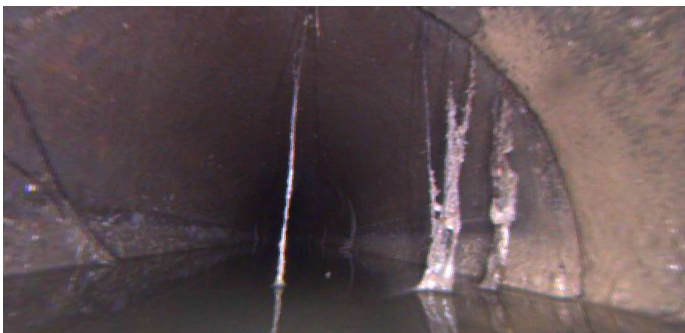
Code: **RFJ**
Description: **Roots Fine Joint**

Distance (ft): **29.8**
Structural Grade: **0**
O&M Grade: **1**
Clock Start/From: **10**
Clock To: **2**
1st Value:
2nd Value:
Value Percent:
Continuous Index: **S02**
Within 8" of Joint: **YES**
Remarks: **wandering**

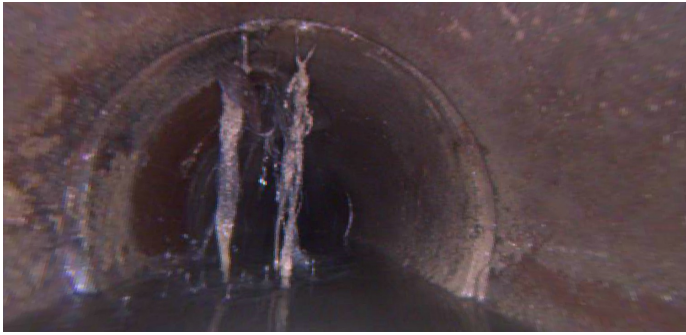
Code: **RMJ**
Description: **Roots Medium Joint**

Distance (ft): **65.8**
Structural Grade: **0**
O&M Grade: **3**
Clock Start/From: **12**
Clock To:
1st Value:
2nd Value:
Value Percent: **5.000**
Continuous Index:
Within 8" of Joint: **YES**
Remarks:

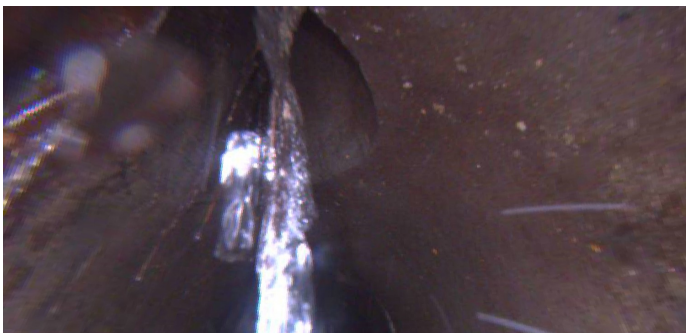
Code: **TFD**
Description: **Tap Factory Defective**

Distance (ft): **66.6**
Structural Grade: **0**
O&M Grade: **2**
Clock Start/From: **11**
Clock To:
1st Value: **4.000**
2nd Value:
Value Percent:
Continuous Index:
Within 8" of Joint:
Remarks: **roots**

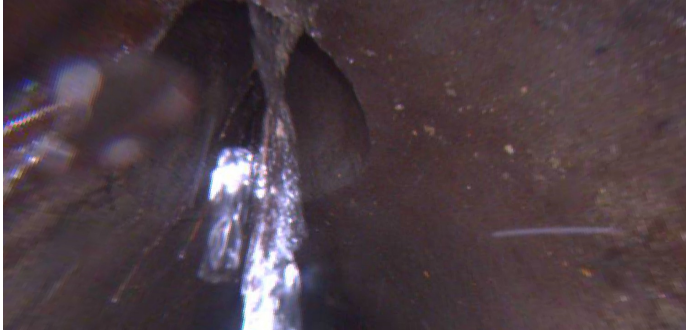
Code: **RFL**
Description: **Roots Fine Lateral**

Distance (ft): **66.6**
Structural Grade: **0**
O&M Grade: **1**
Clock Start/From: **12**
Clock To:
1st Value:
2nd Value:
Value Percent:
Continuous Index:
Within 8" of Joint: **NO**
Remarks:

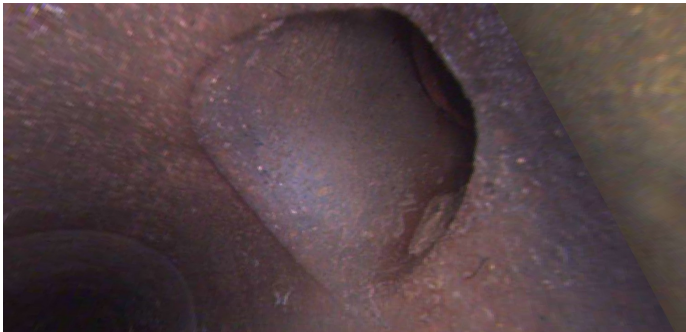
Code: **TF**
Description: **Tap Factory**

Distance (ft): **76.9**
Structural Grade: **0**
O&M Grade: **0**
Clock Start/From: **2**
Clock To:
1st Value: **4.000**
2nd Value:
Value Percent:
Continuous Index:
Within 8" of Joint:
Remarks:

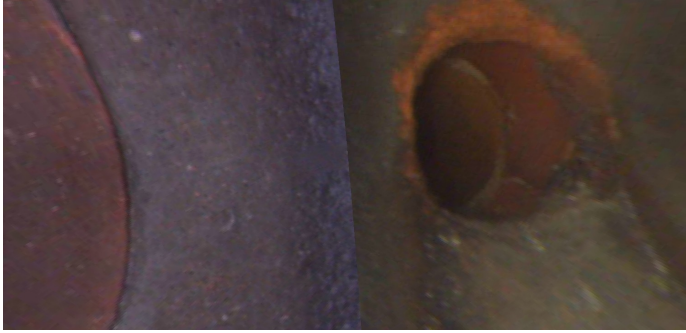
Code: **TB**
Description: **Tap Break-in**

Distance (ft): **82.2**
Structural Grade: **0**
O&M Grade: **0**
Clock Start/From: **2**
Clock To:
1st Value: **4.000**
2nd Value:
Value Percent:
Continuous Index:
Within 8" of Joint:
Remarks:

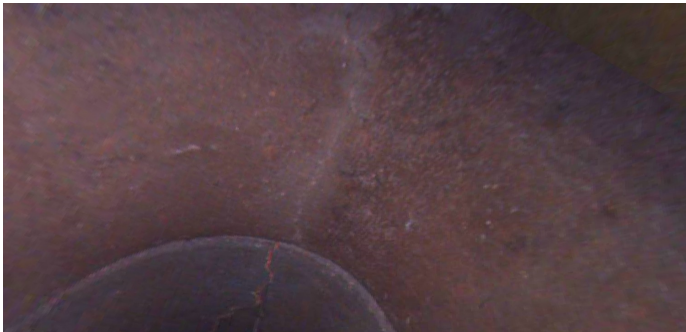
Code: **CL**
Description: **Crack Longitudinal**

Distance (ft): **106.0**
Structural Grade: **2**
O&M Grade: **0**
Clock Start/From: **12**
Clock To:
1st Value:
2nd Value:
Value Percent:
Continuous Index: **S03**
Within 8" of Joint:
Remarks:

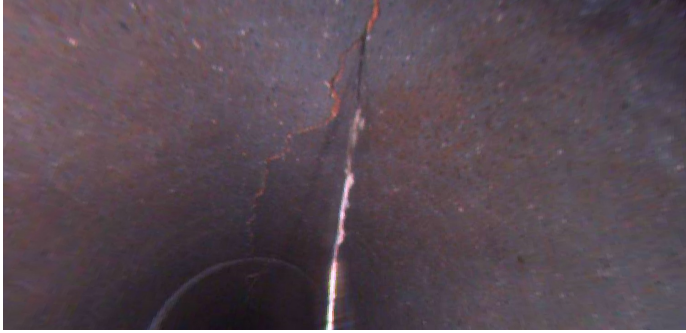
Code: **RFB**
Description: **Roots Fine Barrel**

Distance (ft): **106.9**
Structural Grade: **0**
O&M Grade: **2**
Clock Start/From: **12**
Clock To:
1st Value:
2nd Value:
Value Percent:
Continuous Index:
Within 8" of Joint: **NO**
Remarks:

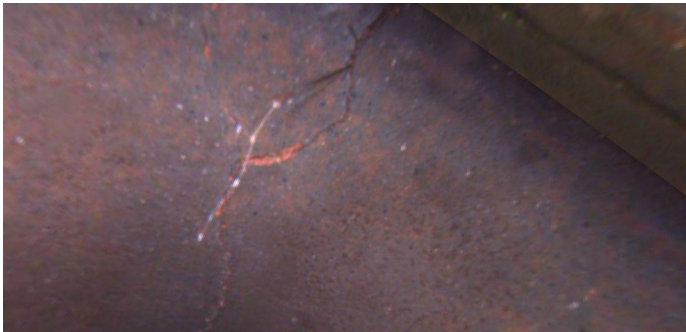
Code: **RFB**
Description: **Roots Fine Barrel**

Distance (ft): **108.9**
Structural Grade: **0**
O&M Grade: **2**
Clock Start/From: **12**
Clock To:
1st Value:
2nd Value:
Value Percent:
Continuous Index:
Within 8" of Joint: **NO**
Remarks:

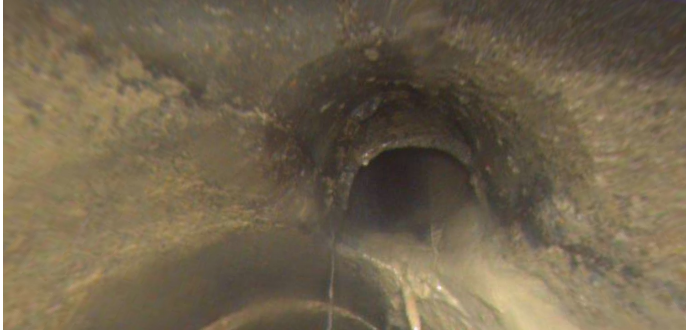
Code: **TFD**
Description: **Tap Factory Defective**

Distance (ft): **116.0**
Structural Grade: **0**
O&M Grade: **2**
Clock Start/From: **11**
Clock To:
1st Value: **4.000**
2nd Value:
Value Percent:
Continuous Index:
Within 8" of Joint:
Remarks: **fractured, roots**

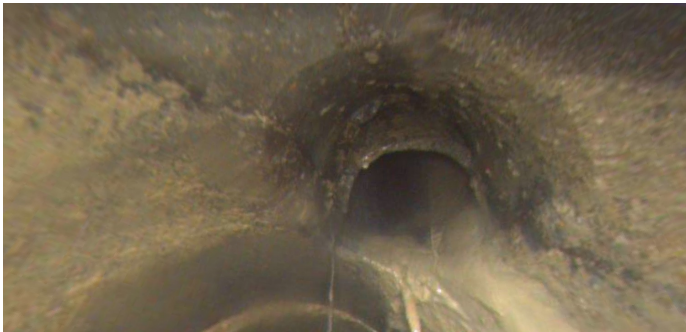
Code: **RFL**
Description: **Roots Fine Lateral**

Distance (ft): **116.0**
Structural Grade: **0**
O&M Grade: **1**
Clock Start/From: **11**
Clock To:
1st Value:
2nd Value:
Value Percent:
Continuous Index:
Within 8" of Joint: **NO**
Remarks:

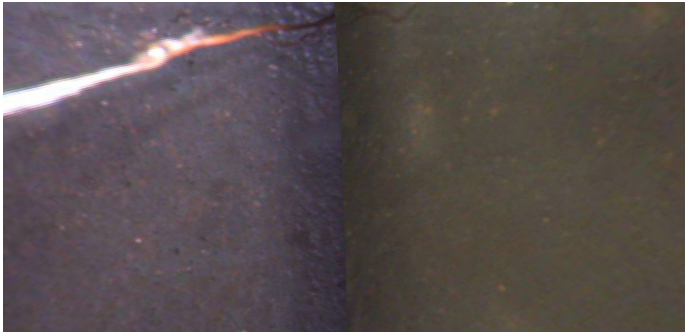
Code: **RFB**
Description: **Roots Fine Barrel**

Distance (ft): **119.7**
Structural Grade: **0**
O&M Grade: **2**
Clock Start/From: **12**
Clock To:
1st Value:
2nd Value:
Value Percent:
Continuous Index:
Within 8" of Joint: **NO**
Remarks:

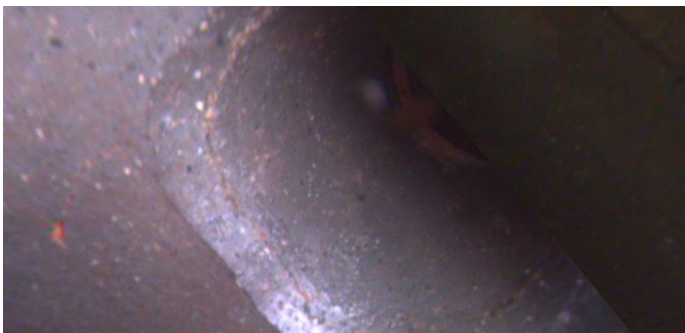
Code: **TF**
Description: **Tap Factory**

Distance (ft): **127.4**
Structural Grade: **0**
O&M Grade: **0**
Clock Start/From: **1**
Clock To:
1st Value: **4.000**
2nd Value:
Value Percent:
Continuous Index:
Within 8" of Joint: **YES**
Remarks:

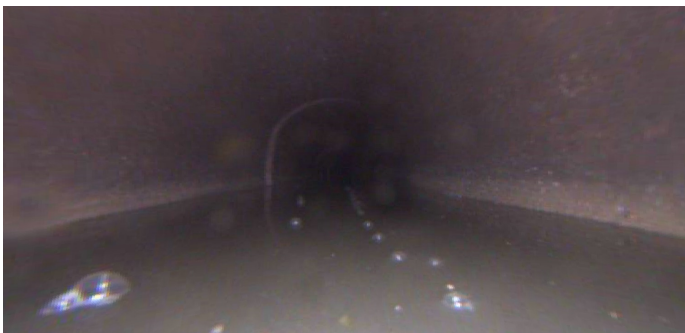
Code: **MCU**
Description: **Camera Underwater**

Distance (ft): **147.1**
Structural Grade: **0**
O&M Grade: **4**
Clock Start/From:
Clock To:
1st Value:
2nd Value:
Value Percent:
Continuous Index: **F04**
Within 8" of Joint: **NO**
Remarks:

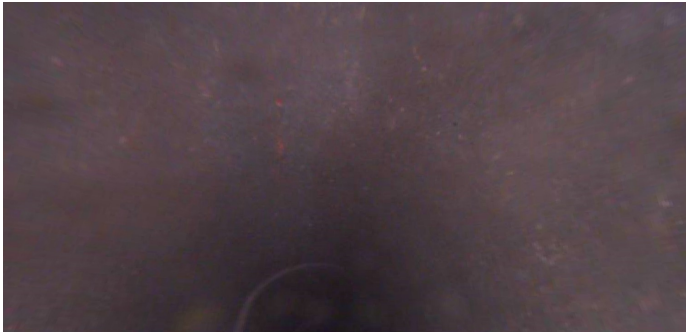
Code: **CL**
Description: **Crack Longitudinal**

Distance (ft): **147.1**
Structural Grade: **2**
O&M Grade: **0**
Clock Start/From: **12**
Clock To:
1st Value:
2nd Value:
Value Percent:
Continuous Index: **F03**
Within 8" of Joint:
Remarks:

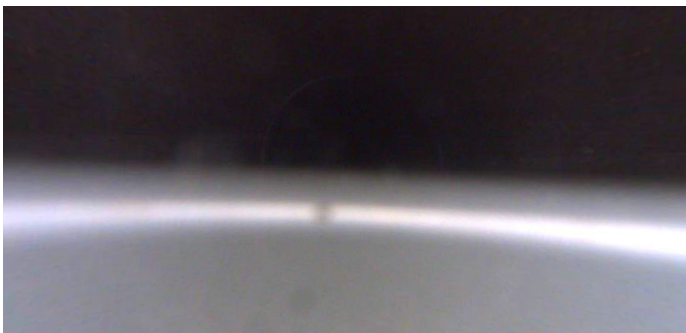
Code: **MWL**
Description: **Water Level**

Distance (ft): **165.6**
Structural Grade: **0**
O&M Grade: **0**
Clock Start/From:
Clock To:
1st Value:
2nd Value:
Value Percent: **40.000**
Continuous Index:
Within 8" of Joint: **NO**
Remarks:

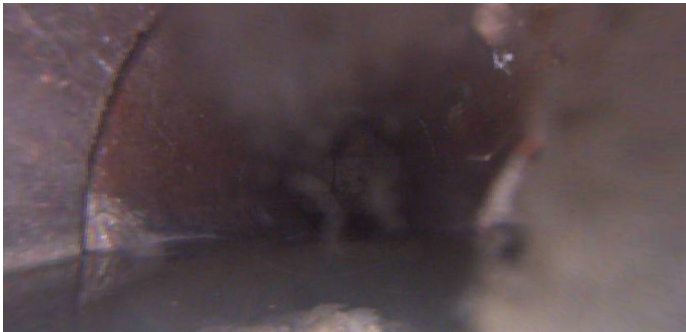
Code: **MCU**
Description: **Camera Underwater**

Distance (ft): **182.8**
Structural Grade: **0**
O&M Grade: **4**
Clock Start/From:
Clock To:
1st Value:
2nd Value:
Value Percent:
Continuous Index: **F05**
Within 8" of Joint: **NO**
Remarks:

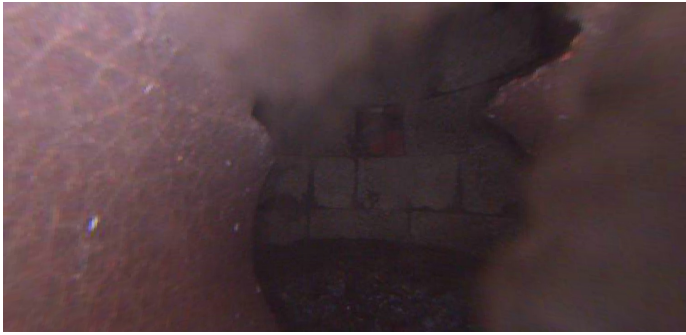
Code: **FM**
Description: **Fracture Multiple**

Distance (ft): **184.4**
Structural Grade: **4**
O&M Grade: **0**
Clock Start/From: **9**
Clock To: **3**
1st Value:
2nd Value:
Value Percent:
Continuous Index: **F01**
Within 8" of Joint: **YES**
Remarks: **wandering**

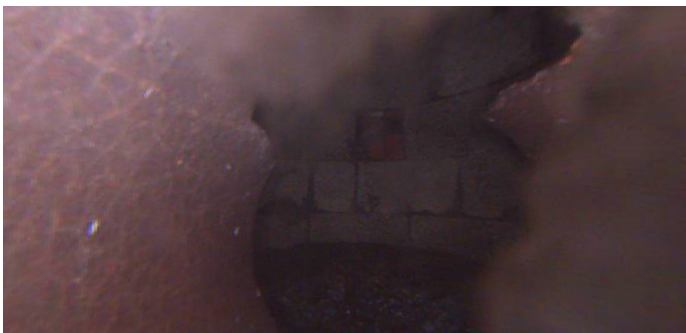
Code: **RFJ**
Description: **Roots Fine Joint**

Distance (ft): **184.4**
Structural Grade: **0**
O&M Grade: **1**
Clock Start/From: **10**
Clock To: **2**
1st Value:
2nd Value:
Value Percent:
Continuous Index: **F02**
Within 8" of Joint: **YES**
Remarks: **wandering**

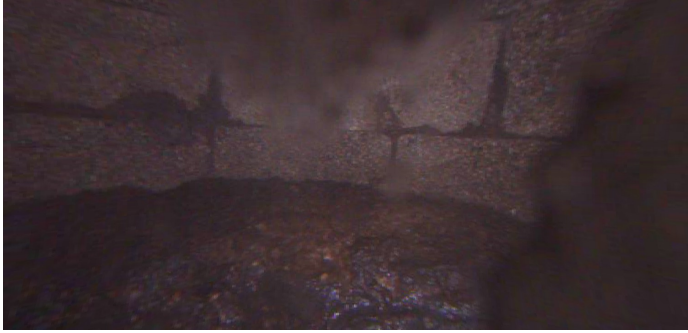
Code:	AMH
Description:	Manhole
Distance (ft):	185.8
Structural Grade:	0
O&M Grade:	0
Clock Start/From:	
Clock To:	
1st Value:	
2nd Value:	
Value Percent:	
Continuous Index:	
Within 8" of Joint:	NO
Remarks:	M-504-086
