## Profile/Photo Observation Report

Street:	<b>Virginia Street</b>	Flow Control:	<b>Not Controlled</b>
City:	<b>Hobart, IN</b>	Year Renewed:	
Location:	<b>Light Highway</b>	Tape/Media #:	<b>DEP 24</b>
Purpose:	<b>Routine Assessment</b>	Dia/Height:	<b>18"</b>
Use:	<b>Sanitary</b>	Material:	<b>VCP</b>
Drain Area:		Lining:

US MH: **M-504-071** DS MH: **M-504-070** Total Length Surveyed (ft): **91.5**

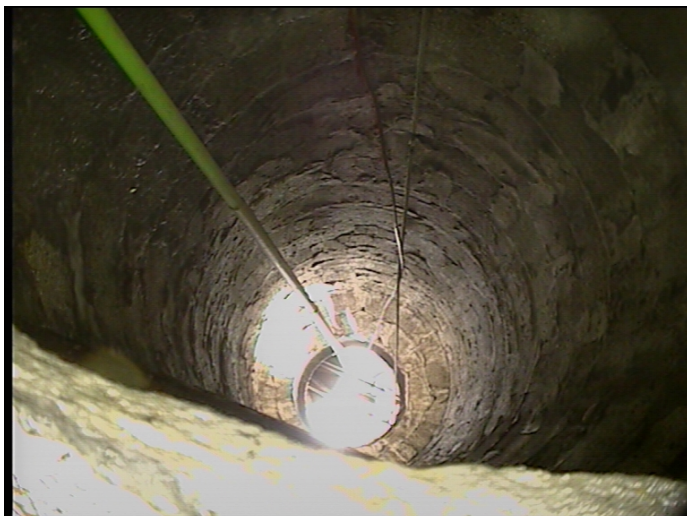
Code: **AMH**  
 Description: **Manhole**

Distance (ft): **.0**  
 Structural Grade: **0**  
 O&M Grade: **0**  
 Clock Start/From:  
 Clock To:  
 1st Value:  
 2nd Value:  
 Value Percent:  
 Continuous Index:  
 Within 8" of Joint: **NO**  
 Remarks: **M-504-071**

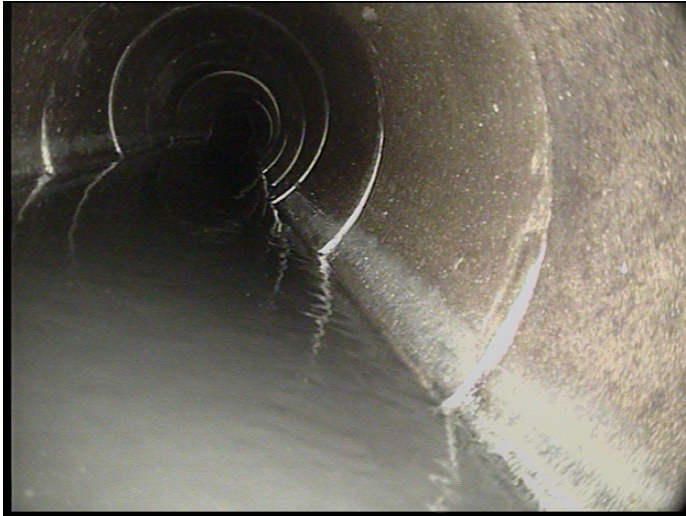
Code: **MWL**  
Description: **Water Level**

Distance (ft): **.0**  
Structural Grade: **0**  
O&M Grade: **0**  
Clock Start/From:  
Clock To:  
1st Value:  
2nd Value:  
Value Percent: **10.000**  
Continuous Index:  
Within 8" of Joint: **NO**  
Remarks:

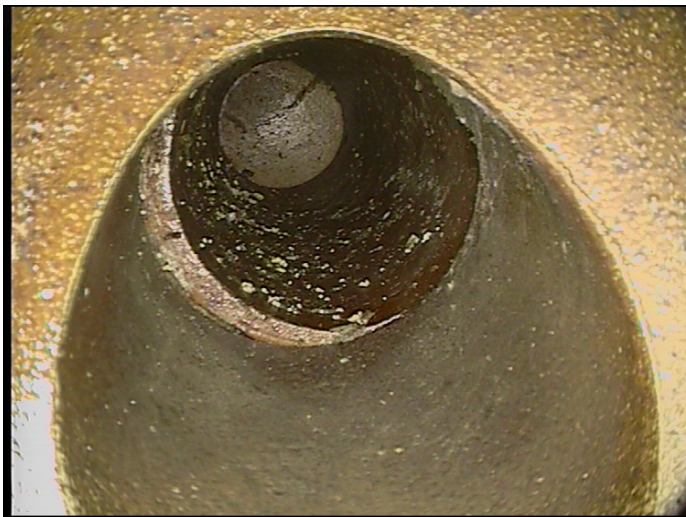
Code: **TFC**  
Description: **Tap Factory Capped**

Distance (ft): **40.7**  
Structural Grade: **0**  
O&M Grade: **0**  
Clock Start/From: **2**  
Clock To:  
1st Value: **4.000**  
2nd Value:  
Value Percent:  
Continuous Index:  
Within 8" of Joint: **NO**  
Remarks:

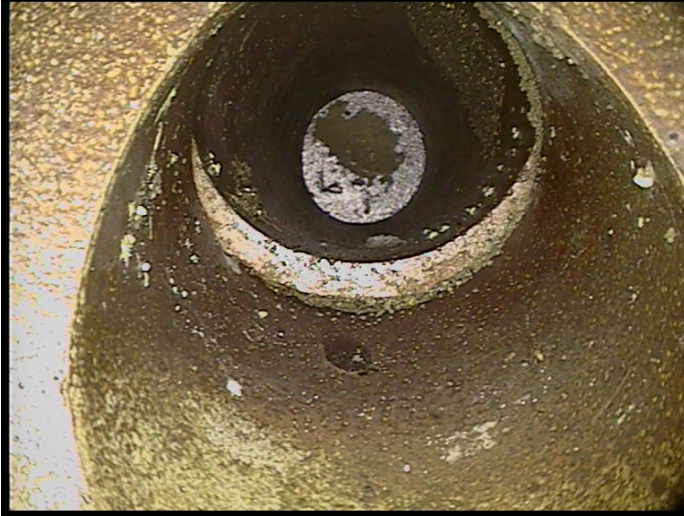
Code:	<b>TFC</b>
Description:	<b>Tap Factory Capped</b>
Distance (ft):	<b>64.5</b>
Structural Grade:	<b>0</b>
O&M Grade:	<b>0</b>
Clock Start/From:	<b>2</b>
Clock To:	
1st Value:	<b>4.000</b>
2nd Value:	
Value Percent:	
Continuous Index:	
Within 8" of Joint:	<b>NO</b>
Remarks:

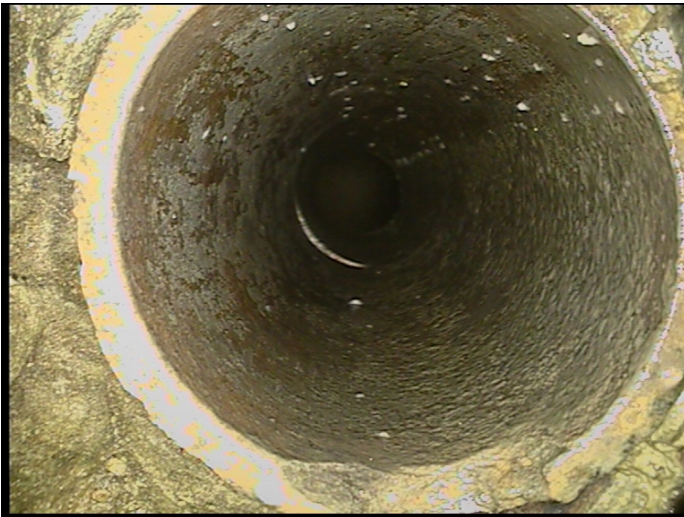
Code:	<b>TB</b>
Description:	<b>Tap Break-in</b>
Distance (ft):	<b>70.8</b>
Structural Grade:	<b>0</b>
O&M Grade:	<b>0</b>
Clock Start/From:	<b>12</b>
Clock To:	
1st Value:	<b>4.000</b>
2nd Value:	
Value Percent:	
Continuous Index:	
Within 8" of Joint:	<b>NO</b>
Remarks:

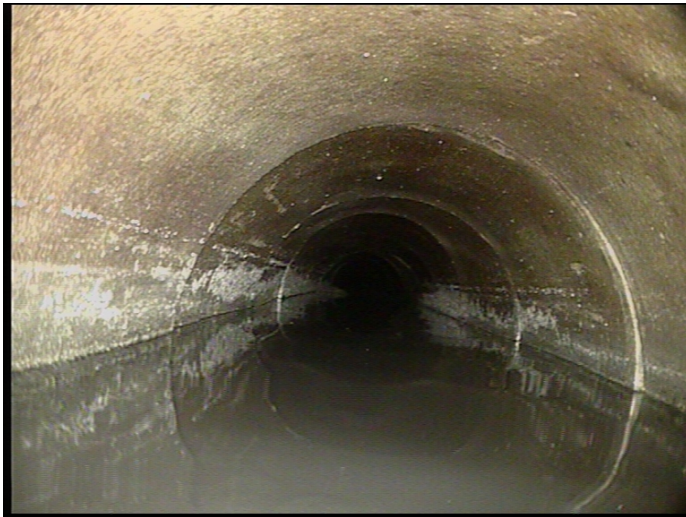
Code:	<b>MWL</b>
Description:	<b>Water Level</b>
Distance (ft):	<b>79.1</b>
Structural Grade:	<b>0</b>
O&M Grade:	<b>0</b>
Clock Start/From:	
Clock To:	
1st Value:	
2nd Value:	
Value Percent:	<b>35.000</b>
Continuous Index:	
Within 8" of Joint:	<b>NO</b>
Remarks:

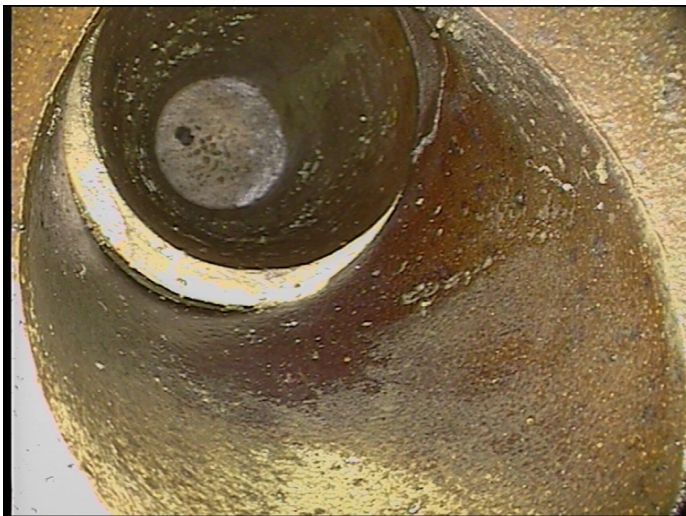
Code:	<b>TFC</b>
Description:	<b>Tap Factory Capped</b>
Distance (ft):	<b>90.9</b>
Structural Grade:	<b>0</b>
O&M Grade:	<b>0</b>
Clock Start/From:	<b>2</b>
Clock To:	
1st Value:	<b>4.000</b>
2nd Value:	
Value Percent:	
Continuous Index:	
Within 8" of Joint:	<b>NO</b>
Remarks:

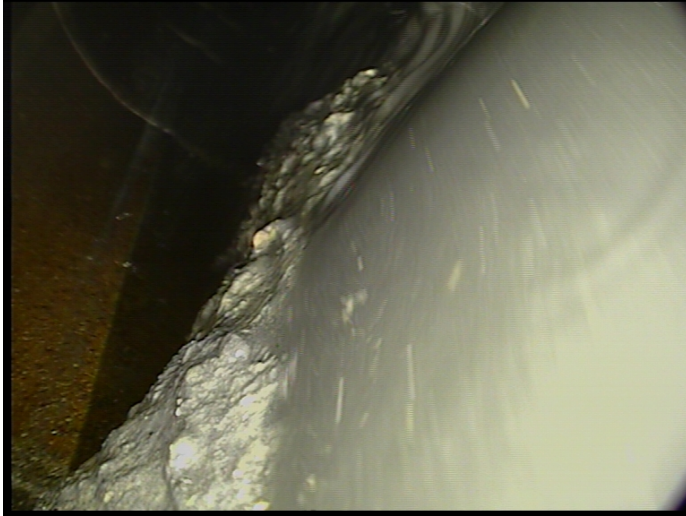
Code: **OBZ**  
Description: **Obstacle Other**

Distance (ft): **90.9**  
Structural Grade: **0**  
O&M Grade: **4**  
Clock Start/From: **4**  
Clock To: **8**  
1st Value:  
2nd Value:  
Value Percent: **25.000**  
Continuous Index:  
Within 8" of Joint: **NO**  
Remarks: **Debris**

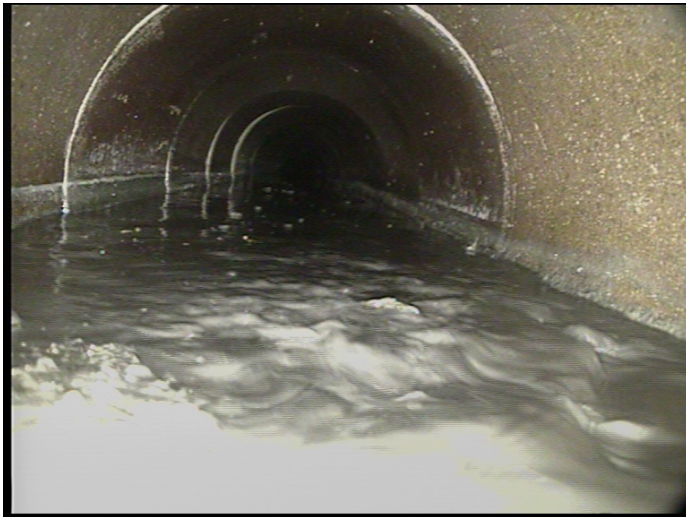
Code: **MSA**  
Description: **Abandoned Survey**

Distance (ft): **91.5**  
Structural Grade: **0**  
O&M Grade: **0**  
Clock Start/From:  
Clock To:  
1st Value:  
2nd Value:  
Value Percent:  
Continuous Index:  
Within 8" of Joint: **NO**  
Remarks: **debris**
