# Profile/Photo Observation Report

Date:	<b>04/10/2018</b>	Weather:		Coding:	<b>PACP 6.0</b>
Pipe Length (ft):		Owner:	<b>City of Hobart</b>	Pre Clean:	<b>No Pre-Cleaning</b>
P.O.#:	<b>24-1</b>	Surveyor:	<b>M. Pielacha</b>	PSR:	<b>M-504-071-M-504-070</b>
Customer:	<b>City of Hobart</b>	Clean Date:		Shape:	<b>C</b>

Street:	<b>Virginia Street</b>	Flow Control:	<b>Not Controlled</b>
City:	<b>Hobart, IN</b>	Year Renewed:	
Location:	<b>Light Highway</b>	Tape/Media #:	<b>DEP 24</b>
Purpose:	<b>Routine Assessment</b>	Dia/Height:	<b>18"</b>
Use:	<b>Sanitary</b>	Material:	<b>VCP</b>
Drain Area:		Lining:	
Category:	<b>NA</b>		
Comment:			
Location Details:		Direction of Survey:	<b>Downstream</b>
US MH:	<b>M-504-071</b>	DS MH:	<b>M-504-070</b>
		Total Length Surveyed (ft):	<b>91.5</b>

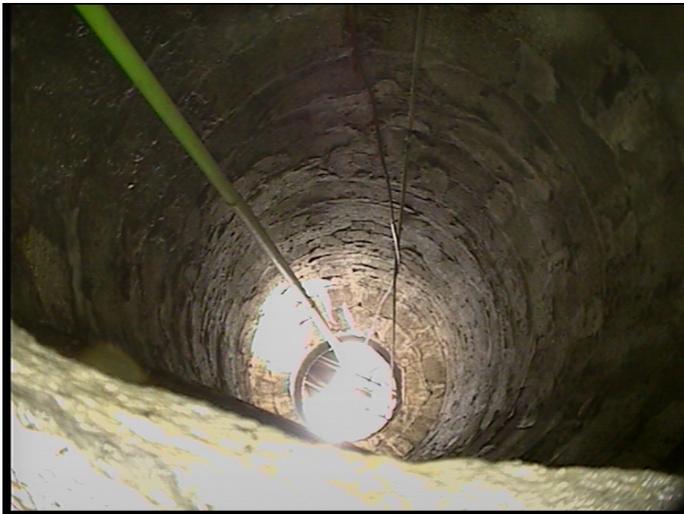
Code: **AMH**  
Description: **Manhole**

Distance (ft): **.0**  
Structural Grade: **0**  
O&M Grade: **0**  
Clock Start/From:  
Clock To:  
1st Value:  
2nd Value:  
Value Percent:  
Continuous Index:  
Within 8" of Joint: **NO**  
Remarks: **M-504-071**

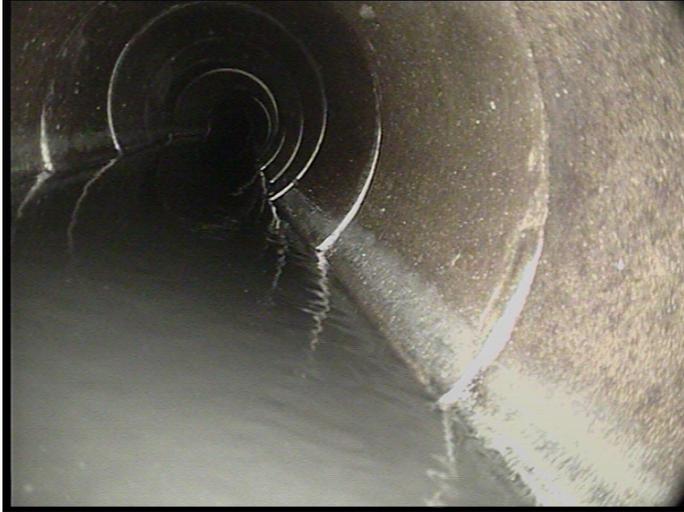
Code: **MWL**  
Description: **Water Level**

Distance (ft): **.0**  
Structural Grade: **0**  
O&M Grade: **0**  
Clock Start/From:  
Clock To:  
1st Value:  
2nd Value:  
Value Percent: **10.000**  
Continuous Index:  
Within 8" of Joint: **NO**  
Remarks:

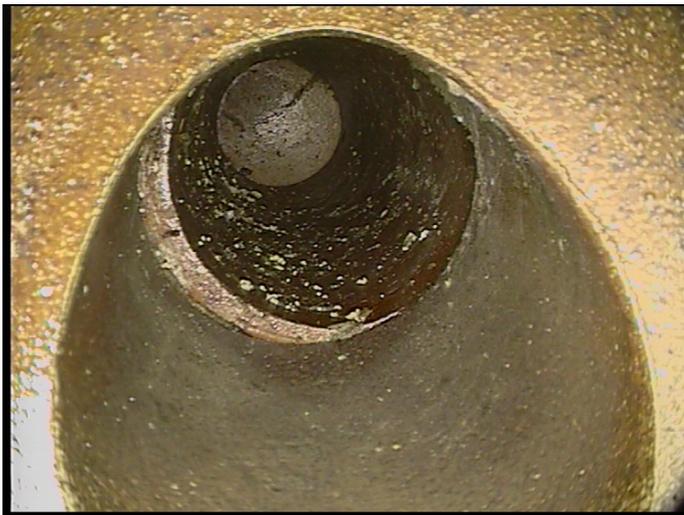
Code: **TFC**  
Description: **Tap Factory Capped**

Distance (ft): **40.7**  
Structural Grade: **0**  
O&M Grade: **0**  
Clock Start/From: **2**  
Clock To:  
1st Value: **4.000**  
2nd Value:  
Value Percent:  
Continuous Index:  
Within 8" of Joint: **NO**  
Remarks:

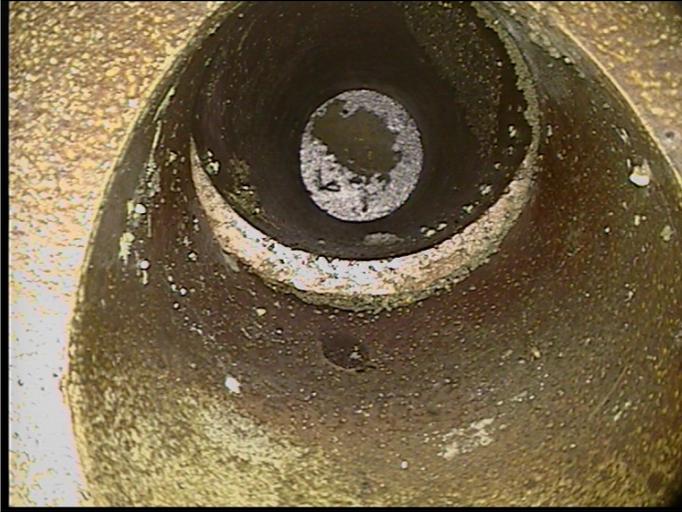
Code: **TFC**  
Description: **Tap Factory Capped**

Distance (ft): **64.5**  
Structural Grade: **0**  
O&M Grade: **0**  
Clock Start/From: **2**  
Clock To:  
1st Value: **4.000**  
2nd Value:  
Value Percent:  
Continuous Index:  
Within 8" of Joint: **NO**  
Remarks:

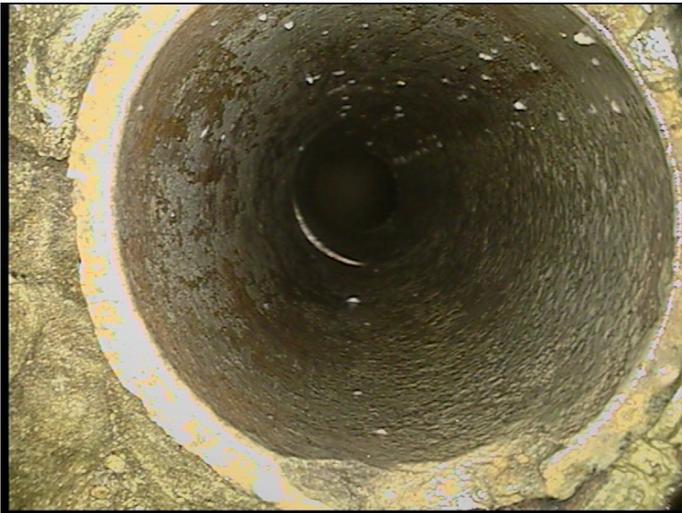
Code: **TB**  
Description: **Tap Break-in**

Distance (ft): **70.8**  
Structural Grade: **0**  
O&M Grade: **0**  
Clock Start/From: **12**  
Clock To:  
1st Value: **4.000**  
2nd Value:  
Value Percent:  
Continuous Index:  
Within 8" of Joint: **NO**  
Remarks:

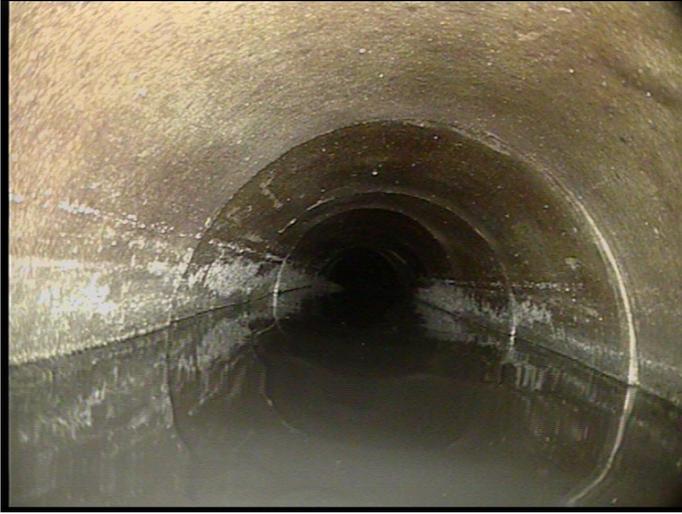
Code: **MWL**  
Description: **Water Level**

Distance (ft): **79.1**  
Structural Grade: **0**  
O&M Grade: **0**  
Clock Start/From:  
Clock To:  
1st Value:  
2nd Value:  
Value Percent: **35.000**  
Continuous Index:  
Within 8" of Joint: **NO**  
Remarks:

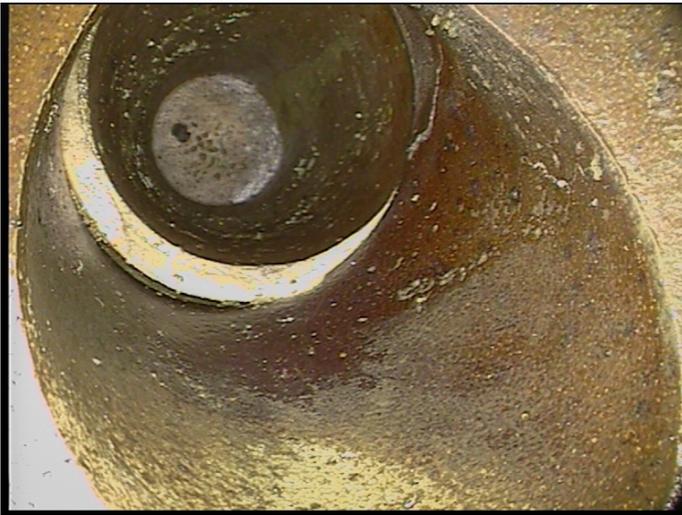
Code: **TFC**  
Description: **Tap Factory Capped**

Distance (ft): **90.9**  
Structural Grade: **0**  
O&M Grade: **0**  
Clock Start/From: **2**  
Clock To:  
1st Value: **4.000**  
2nd Value:  
Value Percent:  
Continuous Index:  
Within 8" of Joint: **NO**  
Remarks:

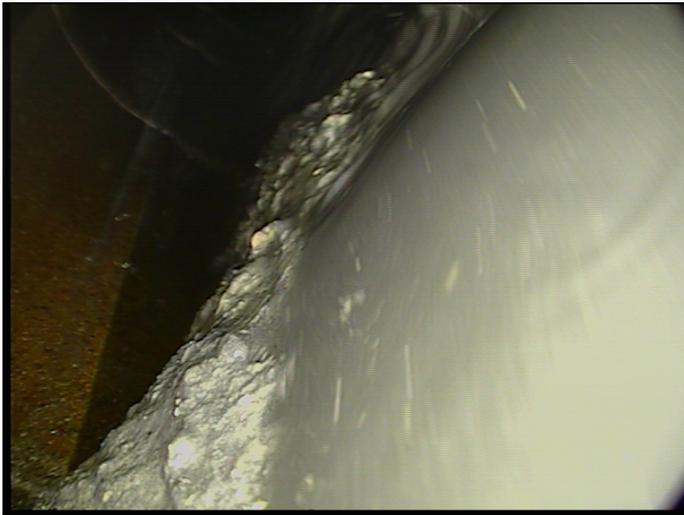
Code: **OBZ**  
Description: **Obstacle Other**

Distance (ft): **90.9**  
Structural Grade: **0**  
O&M Grade: **4**  
Clock Start/From: **4**  
Clock To: **8**  
1st Value:  
2nd Value:  
Value Percent: **25.000**  
Continuous Index:  
Within 8" of Joint: **NO**  
Remarks: **Debris**

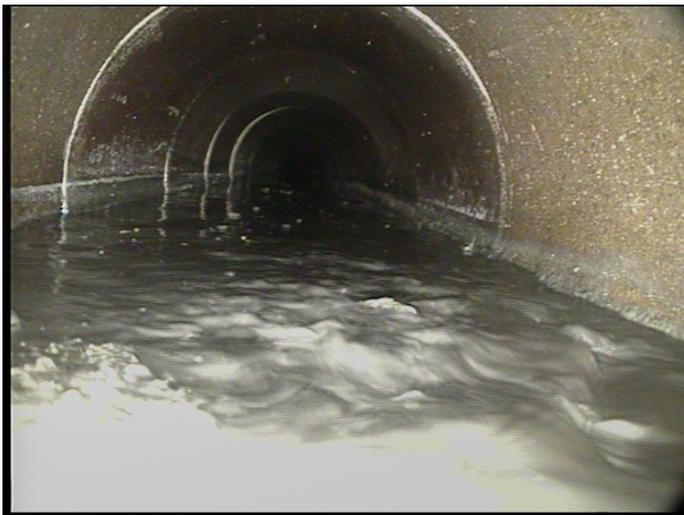
Code: **MSA**  
Description: **Abandoned Survey**

Distance (ft): **91.5**  
Structural Grade: **0**  
O&M Grade: **0**  
Clock Start/From:  
Clock To:  
1st Value:  
2nd Value:  
Value Percent:  
Continuous Index:  
Within 8" of Joint: **NO**  
Remarks: **debris**
