Profile/Photo Observation Report

Date:	04/10/2018	Weather:		Coding:	PACP 6.0
Pipe Length (ft):		Owner:	City of Hobart	Pre Clean:	No Pre-Cleaning
P.O.#:	25-1	Surveyor:	M. Pielacha	PSR:	M-504-071-M-504-070
Customer:	City of Hobart	Clean Date:		Shape:	C

Street:	Off Virginia Street	Flow Control:	Not Controlled
City:	Hobart, IN	Year Renewed:	
Location:	Light Highway	Tape/Media #:	DEP 25
Purpose:	Routine Assessment	Dia/Height:	18"
Use:	Sanitary	Material:	VCP
Drain Area:		Lining:	
Category:	NA		
Comment:			
Location Details:		Direction of Survey:	Upstream
US MH:	M-504-071	DS MH:	M-504-070
		Total Length Surveyed (ft):	3.8

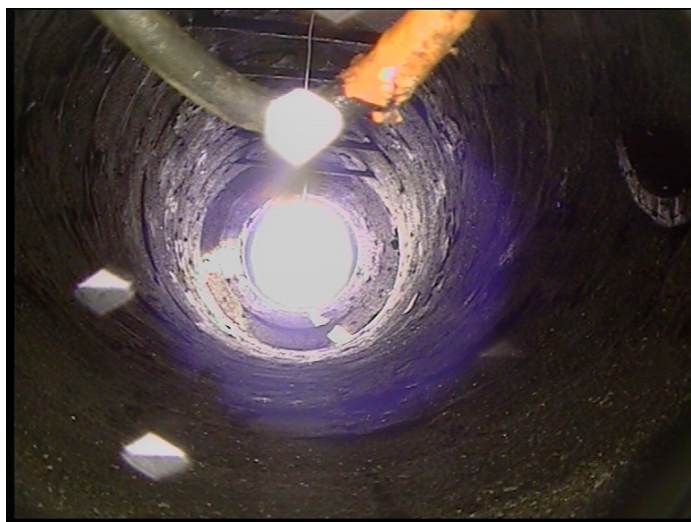
Code: **AMH**
Description: **Manhole**

Distance (ft): **.0**
Structural Grade: **0**
O&M Grade: **0**
Clock Start/From:
Clock To:
1st Value:
2nd Value:
Value Percent:
Continuous Index:
Within 8" of Joint: **NO**
Remarks: **M-504-070**

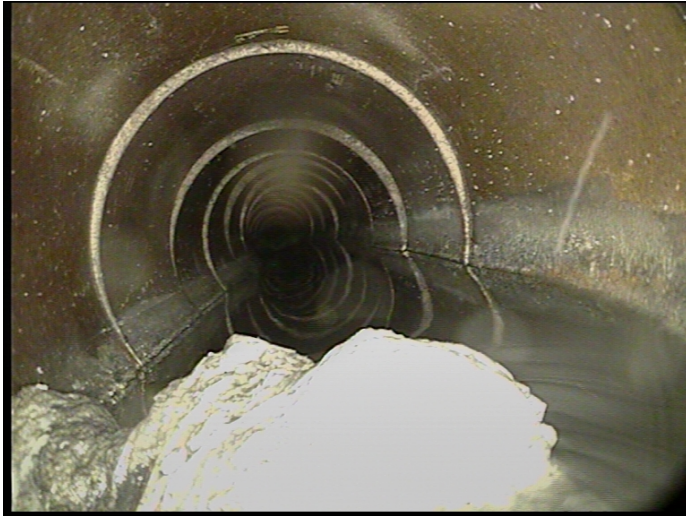
Code: **MWL**
Description: **Water Level**

Distance (ft): **.0**
Structural Grade: **0**
O&M Grade: **0**
Clock Start/From:
Clock To:
1st Value:
2nd Value:
Value Percent: **15.000**
Continuous Index:
Within 8" of Joint: **NO**
Remarks:

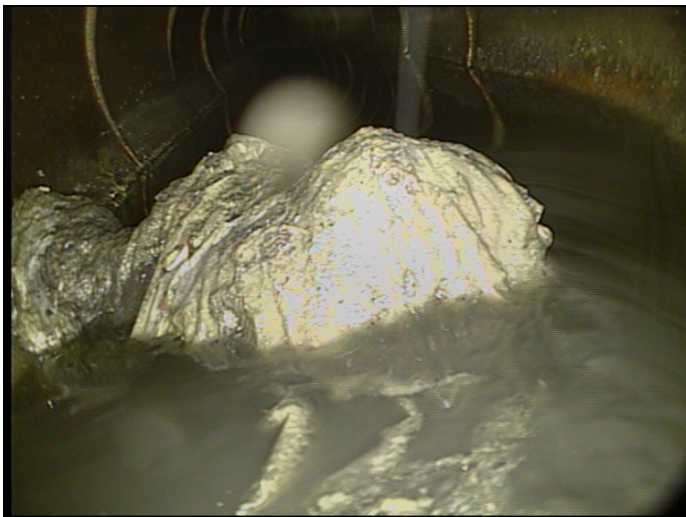
Code: **OBZ**
Description: **Obstacle Other**

Distance (ft): **.0**
Structural Grade: **0**
O&M Grade: **3**
Clock Start/From: **5**
Clock To: **7**
1st Value:
2nd Value:
Value Percent: **20.000**
Continuous Index:
Within 8" of Joint: **NO**
Remarks: **Debris**

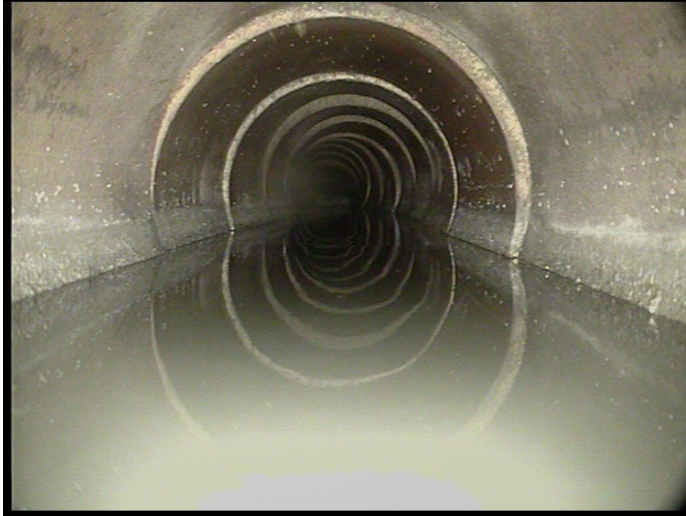
Code:	MSA
Description:	Abandoned Survey
Distance (ft):	3.8
Structural Grade:	0
O&M Grade:	0
Clock Start/From:	
Clock To:	
1st Value:	
2nd Value:	
Value Percent:	
Continuous Index:	
Within 8" of Joint:	NO
Remarks:	debris
