Profile/Photo Observation Report

Date:	08/10/2022	Weather:		Coding:	PACP 7.0
Pipe Length (ft):	168.0	Owner:	City of Hobart	Pre Clean:	Heavy Cleaning
P.O.#:	YES502259	Surveyor:	S. Bucklin	PSR:	P-504-071-070
Customer:	City of Hobart	Clean Date:	07/30/2022	Shape:	C

Street:	North Virginia Street	Flow Control:	Not Controlled
City:	Hobart, IN	Year Renewed:	
Location:	Alley	Tape/Media #:	
Purpose:	Routine Assessment	Dia/Height:	18"
Use:	Sanitary Sewage Pipe	Material:	VCP
Drain Area:		Lining:	None
Category:	NA		
Comment:

Location Details:		Direction of Survey:	Downstream
US MH:	M-504-071	DS MH:	M-504-070
		Total Length Surveyed (ft):	171.7

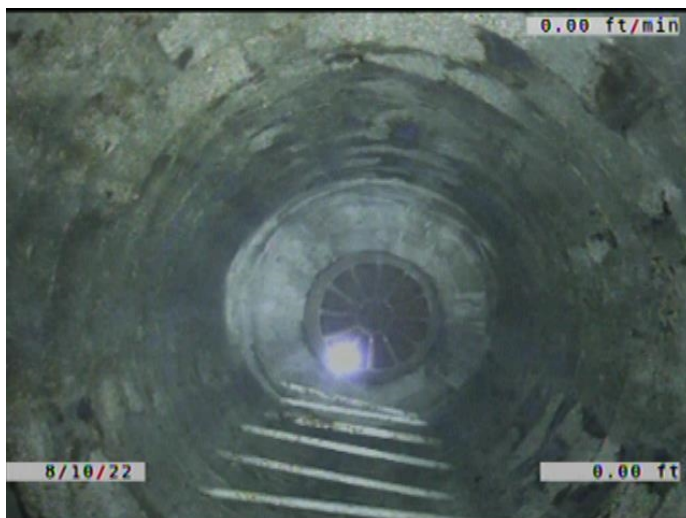
Code: **AMH**
Description: **Manhole**

Distance (ft): **.0**
Structural Grade: **0**
O&M Grade: **0**
Clock Start/From:
Clock To:
1st Value:
2nd Value:
Value Percent:
Continuous Index:
Within 8" of Joint: **NO**
Remarks: **M-504-071**

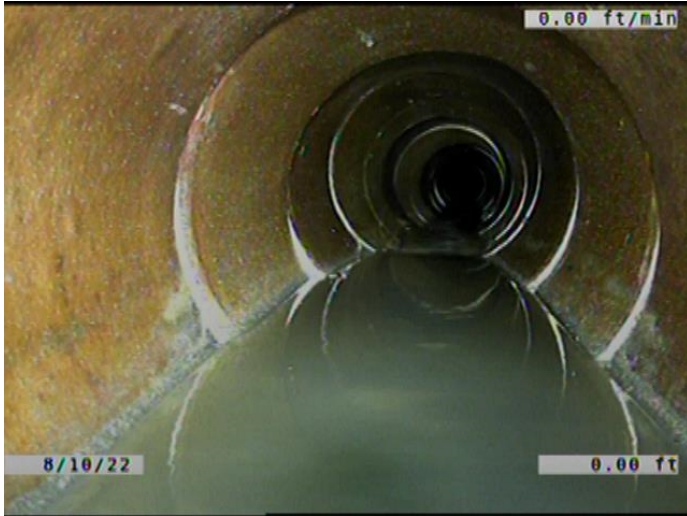
Code:	MWL
Description:	Miscellaneous Water Level
Distance (ft):	.0
Structural Grade:	0
O&M Grade:	0
Clock Start/From:	
Clock To:	
1st Value:	
2nd Value:	
Value Percent:	10.000
Continuous Index:	
Within 8" of Joint:	NO
Remarks:

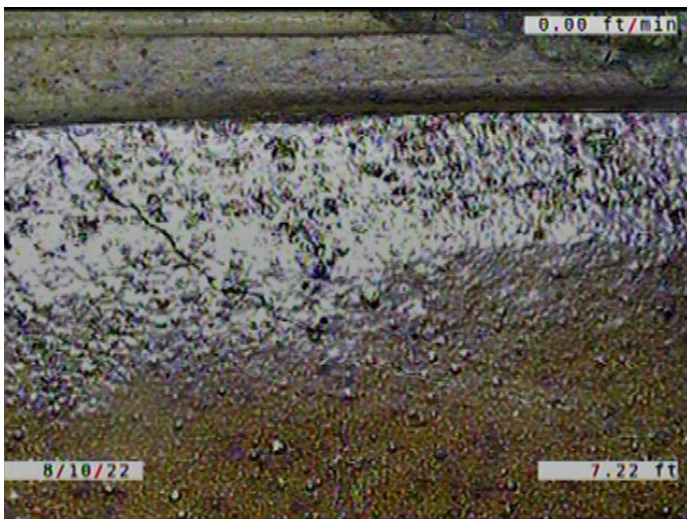
Code:	CS
Description:	Crack Spiral
Distance (ft):	7.2
Structural Grade:	2
O&M Grade:	0
Clock Start/From:	12
Clock To:	3
1st Value:	
2nd Value:	
Value Percent:	
Continuous Index:	
Within 8" of Joint:	YES
Remarks:

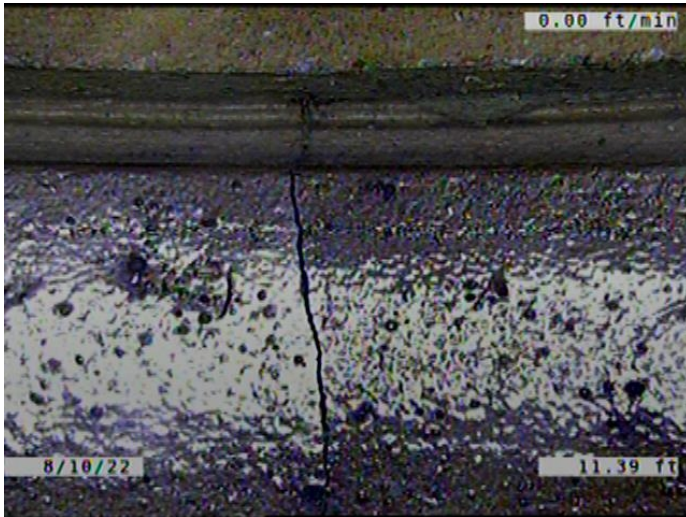
Code: **CL**
Description: **Crack Longitudinal**

Distance (ft): **11.4**
Structural Grade: **2**
O&M Grade: **0**
Clock Start/From: **9**
Clock To:
1st Value:
2nd Value:
Value Percent:
Continuous Index:
Within 8" of Joint: **YES**
Remarks:

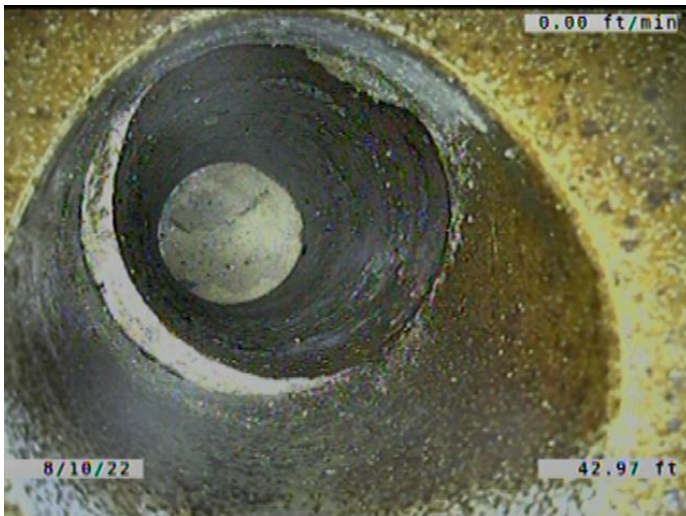
Code: **TFC**
Description: **Tap Factory Capped**

Distance (ft): **43.0**
Structural Grade: **0**
O&M Grade: **0**
Clock Start/From: **1**
Clock To:
1st Value: **6.000**
2nd Value:
Value Percent:
Continuous Index:
Within 8" of Joint: **YES**
Remarks: **SERVICE OFFSET.**

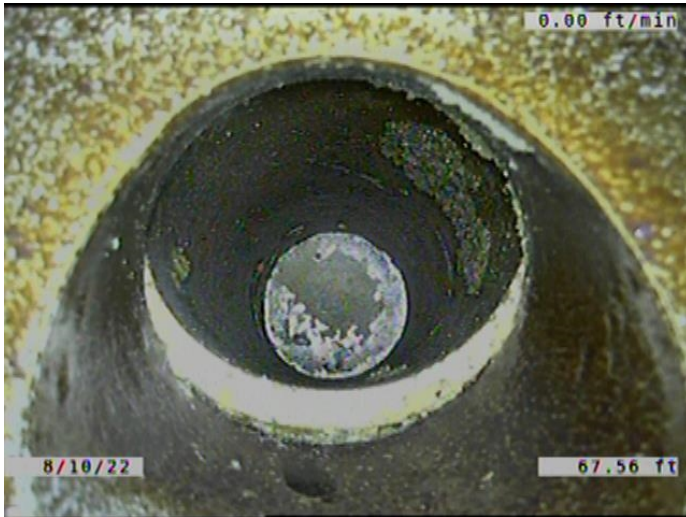
Code: **TFC**
Description: **Tap Factory Capped**

Distance (ft): **67.6**
Structural Grade: **0**
O&M Grade: **0**
Clock Start/From: **1**
Clock To:
1st Value: **6.000**
2nd Value:
Value Percent:
Continuous Index:
Within 8" of Joint: **YES**
Remarks: **SERVICE OFFSET. SOIL VISIBLE.**

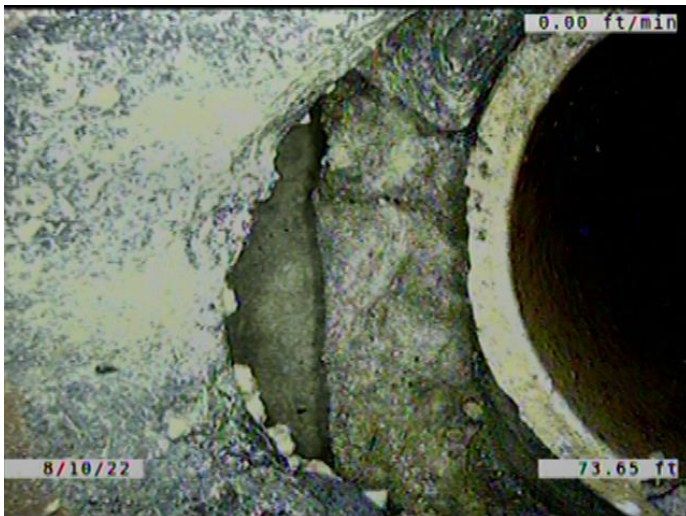
Code: **RPP**
Description: **Point Repair Patch**

Distance (ft): **73.7**
Structural Grade: **0**
O&M Grade: **0**
Clock Start/From: **10**
Clock To: **1**
1st Value:
2nd Value:
Value Percent:
Continuous Index:
Within 8" of Joint: **YES**
Remarks: **Concrete**

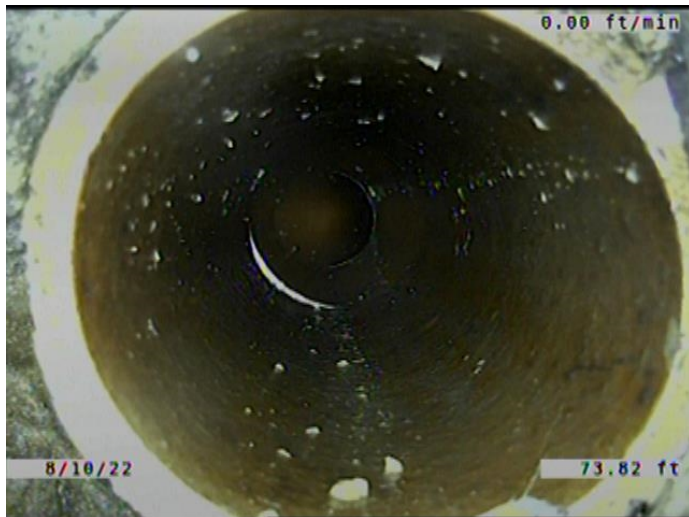
Code: **TBD**
 Description: **Tap Break-in/Hammer Defective**

Distance (ft): **73.8**
 Structural Grade: **0**
 O&M Grade: **3**
 Clock Start/From: **12**
 Clock To:
 1st Value: **6.000**
 2nd Value:
 Value Percent:
 Continuous Index:
 Within 8" of Joint: **YES**
 Remarks: **DEFECTIVE**

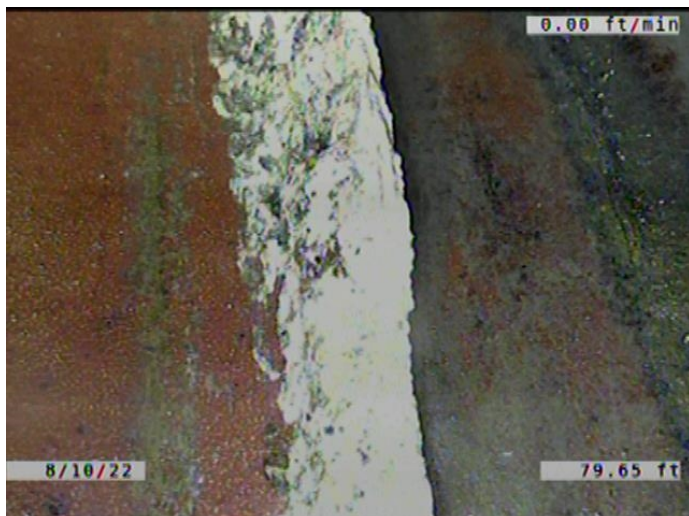
Code: **DAE**
 Description: **Deposits Attached Encrustation**

Distance (ft): **79.6**
 Structural Grade: **0**
 O&M Grade: **2**
 Clock Start/From: **8**
 Clock To:
 1st Value:
 2nd Value:
 Value Percent: **5.000**
 Continuous Index:
 Within 8" of Joint: **YES**
 Remarks:

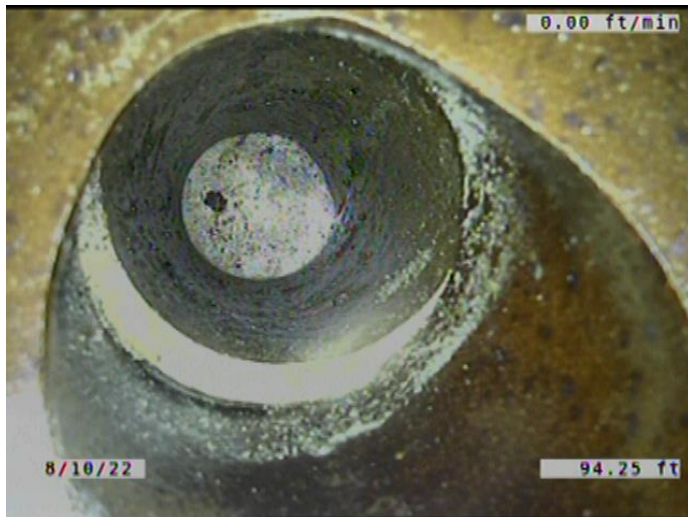
Code: **TFC**
 Description: **Tap Factory Capped**

Distance (ft): **94.3**
 Structural Grade: **0**
 O&M Grade: **0**
 Clock Start/From: **1**
 Clock To:
 1st Value: **6.000**
 2nd Value:
 Value Percent:
 Continuous Index:
 Within 8" of Joint: **YES**
 Remarks: **SERVICE OFFSET.**

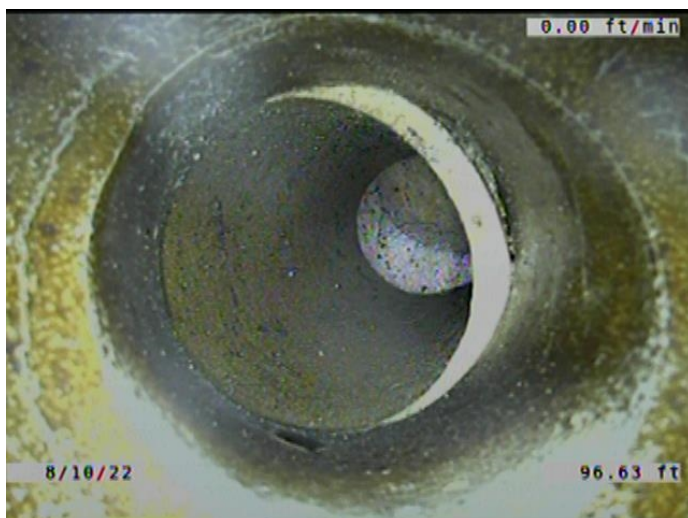
Code: **TFC**
 Description: **Tap Factory Capped**

Distance (ft): **96.6**
 Structural Grade: **0**
 O&M Grade: **0**
 Clock Start/From: **11**
 Clock To:
 1st Value: **6.000**
 2nd Value:
 Value Percent:
 Continuous Index:
 Within 8" of Joint: **YES**
 Remarks: **SERVICE OFFSET.**

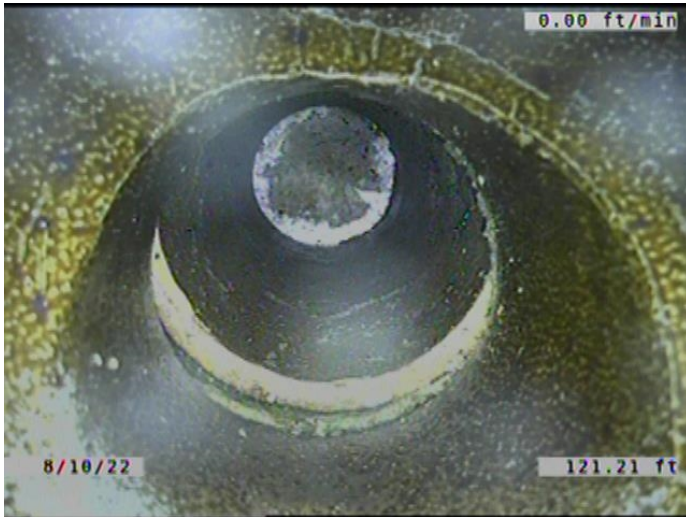
Code: **TFC**
 Description: **Tap Factory Capped**

Distance (ft): **121.2**
 Structural Grade: **0**
 O&M Grade: **0**
 Clock Start/From: **1**
 Clock To:
 1st Value: **6.000**
 2nd Value:
 Value Percent:
 Continuous Index:
 Within 8" of Joint: **YES**
 Remarks: **SERVICE OFFSET. SOIL VISIBLE.**

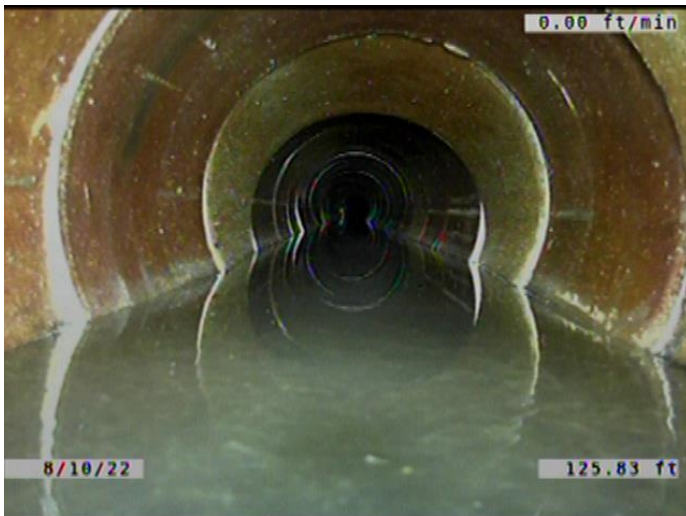
Code: **MWLS**
 Description: **Miscellaneous Water Level Sag**

Distance (ft): **125.8**
 Structural Grade: **2**
 O&M Grade: **0**
 Clock Start/From:
 Clock To:
 1st Value:
 2nd Value:
 Value Percent: **20.000**
 Continuous Index:
 Within 8" of Joint: **NO**
 Remarks:

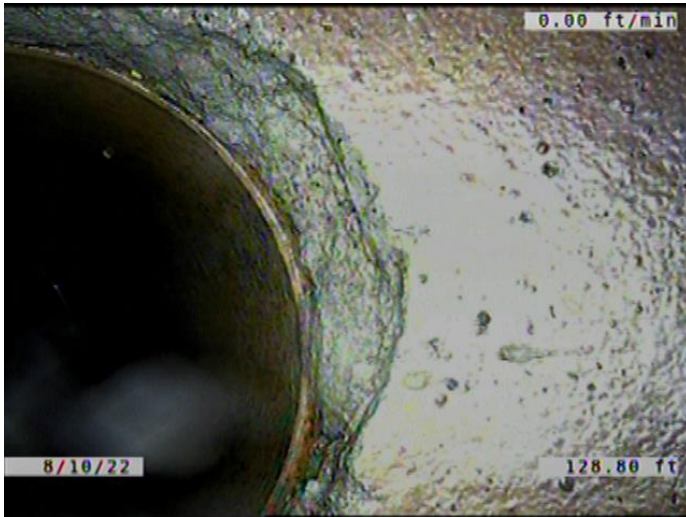
Code:	SSS
Description:	Surface Damage Surface Spalling
Distance (ft):	128.8
Structural Grade:	2
O&M Grade:	0
Clock Start/From:	11
Clock To:	1
1st Value:	
2nd Value:	
Value Percent:	
Continuous Index:	
Within 8" of Joint:	YES
Remarks:

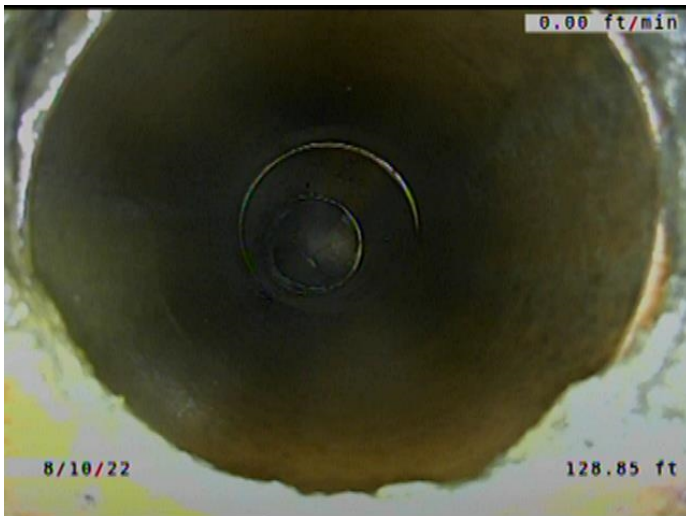
Code:	TB
Description:	Tap Break-in/Hammer
Distance (ft):	128.8
Structural Grade:	0
O&M Grade:	0
Clock Start/From:	12
Clock To:	
1st Value:	6.000
2nd Value:	
Value Percent:	
Continuous Index:	
Within 8" of Joint:	YES
Remarks:	CONSTANTLY RUNNING WATER.

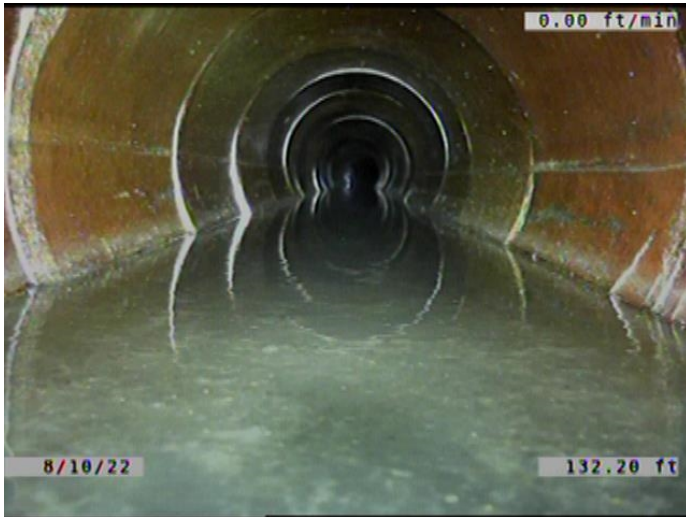
Code: **MWLS**
 Description: **Miscellaneous Water Level Sag**

Distance (ft): **132.2**
 Structural Grade: **2**
 O&M Grade: **0**
 Clock Start/From:
 Clock To:
 1st Value:
 2nd Value:
 Value Percent: **20.000**
 Continuous Index:
 Within 8" of Joint: **NO**
 Remarks:

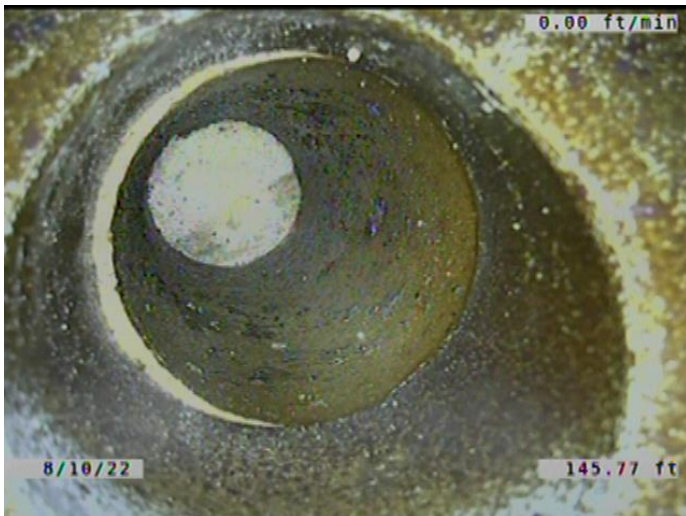
Code: **TFC**
 Description: **Tap Factory Capped**

Distance (ft): **145.8**
 Structural Grade: **0**
 O&M Grade: **0**
 Clock Start/From: **1**
 Clock To:
 1st Value: **6.000**
 2nd Value:
 Value Percent:
 Continuous Index:
 Within 8" of Joint: **YES**
 Remarks:

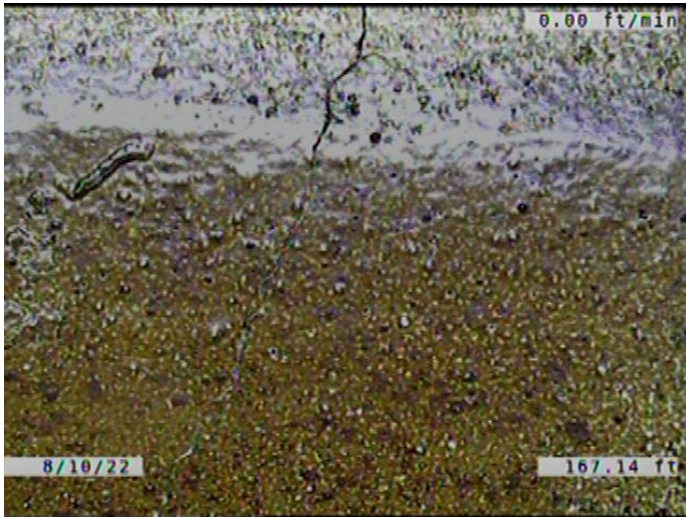
Code: **CM**
 Description: **Crack Multiple**

Distance (ft): **167.1**
 Structural Grade: **3**
 O&M Grade: **0**
 Clock Start/From: **10**
 Clock To: **1**
 1st Value:
 2nd Value:
 Value Percent:
 Continuous Index:
 Within 8" of Joint: **YES**
 Remarks:

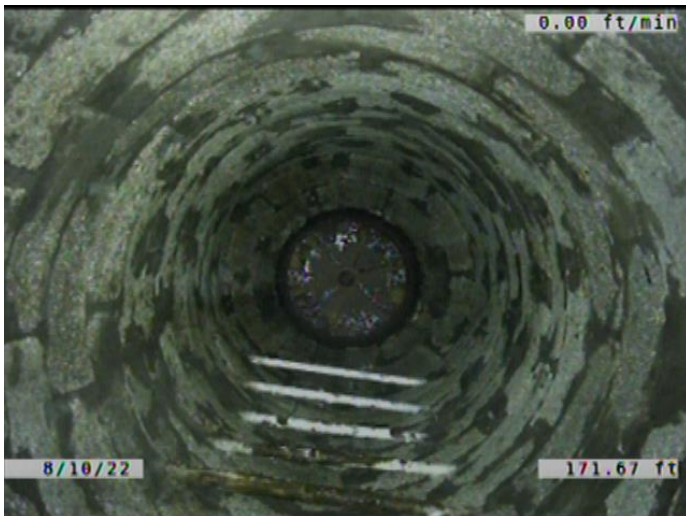
Code: **AMH**
 Description: **Manhole**

Distance (ft): **171.7**
 Structural Grade: **0**
 O&M Grade: **0**
 Clock Start/From:
 Clock To:
 1st Value:
 2nd Value:
 Value Percent:
 Continuous Index:
 Within 8" of Joint: **NO**
 Remarks: **M-504-070**
