Profile/Photo Observation Report

Date:	04/08/2018	Weather:		Coding:	PACP 6.0
Pipe Length (ft):		Owner:	City of Hobart	Pre Clean:	No Pre-Cleaning
P.O.#:	22-3	Surveyor:	M. Pielacha	PSR:	M-504-072-M-504-071
Customer:	City of Hobart	Clean Date:		Shape:	C

Street:	Off Colorado Street	Flow Control:	Not Controlled
City:	Hobart, IN	Year Renewed:	
Location:	Light Highway	Tape/Media #:	DEP 22
Purpose:	Routine Assessment	Dia/Height:	18"
Use:	Sanitary	Material:	VCP
Drain Area:		Lining:

US MH: **M-504-072** DS MH: **M-504-071** Total Length Surveyed (ft): **94.2**

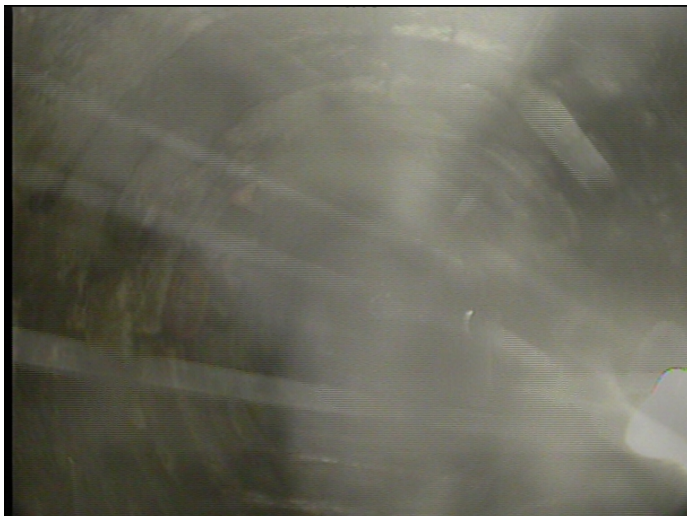
Code: **AMH**
 Description: **Manhole**

Distance (ft): **.0**
 Structural Grade: **0**
 O&M Grade: **0**
 Clock Start/From:
 Clock To:
 1st Value:
 2nd Value:
 Value Percent:
 Continuous Index:
 Within 8" of Joint: **NO**
 Remarks: **M-504-072**

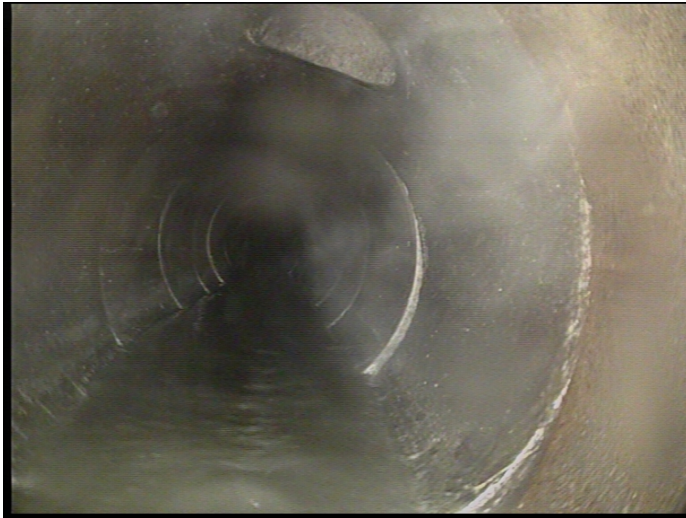
Code:	MWL
Description:	Water Level
Distance (ft):	.0
Structural Grade:	0
O&M Grade:	0
Clock Start/From:	
Clock To:	
1st Value:	
2nd Value:	
Value Percent:	5.000
Continuous Index:	
Within 8" of Joint:	NO
Remarks:

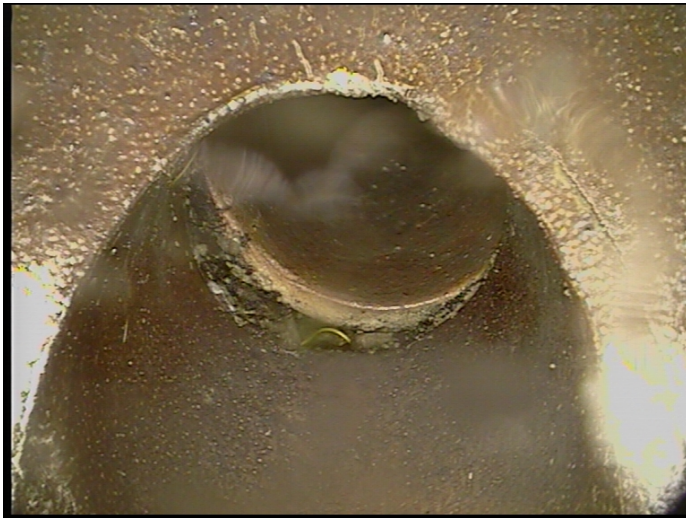
Code:	TF
Description:	Tap Factory
Distance (ft):	3.5
Structural Grade:	0
O&M Grade:	0
Clock Start/From:	2
Clock To:	
1st Value:	4.000
2nd Value:	
Value Percent:	
Continuous Index:	
Within 8" of Joint:	NO
Remarks:

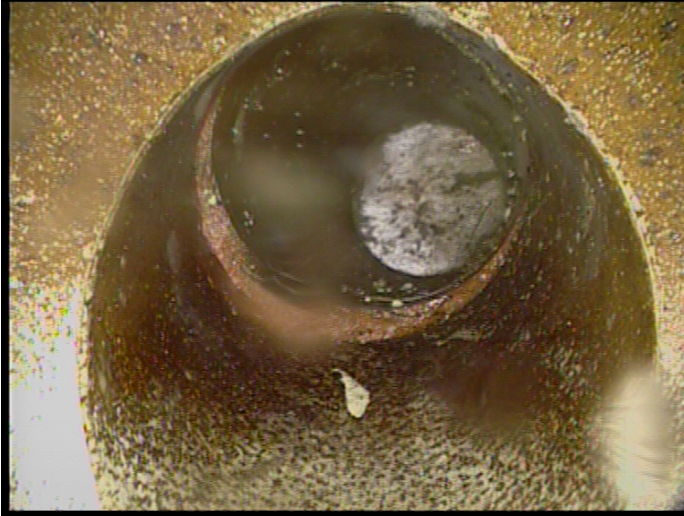
Code: **TFC**
Description: **Tap Factory Capped**

Distance (ft): **26.2**
Structural Grade: **0**
O&M Grade: **0**
Clock Start/From: **2**
Clock To:
1st Value: **4.000**
2nd Value:
Value Percent:
Continuous Index:
Within 8" of Joint: **NO**
Remarks:

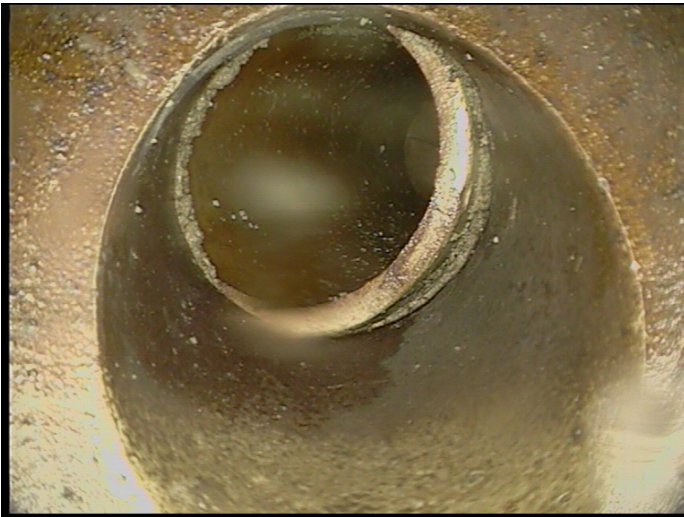
Code: **TF**
Description: **Tap Factory**

Distance (ft): **49.2**
Structural Grade: **0**
O&M Grade: **0**
Clock Start/From: **10**
Clock To:
1st Value: **4.000**
2nd Value:
Value Percent:
Continuous Index:
Within 8" of Joint: **NO**
Remarks:

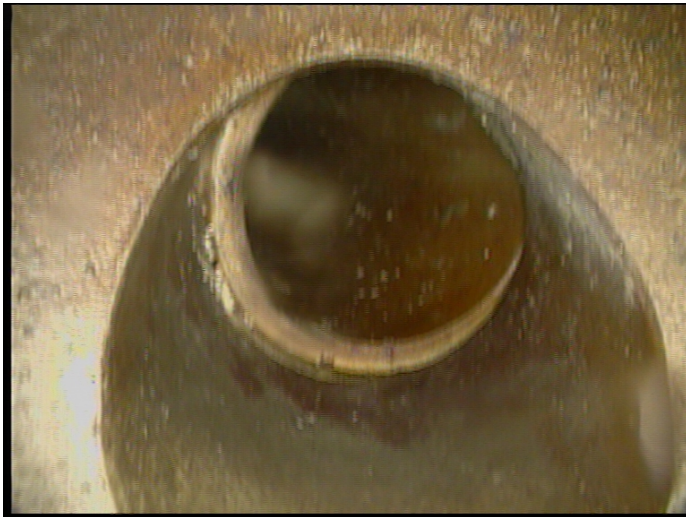
Code: **TF**
Description: **Tap Factory**

Distance (ft): **51.1**
Structural Grade: **0**
O&M Grade: **0**
Clock Start/From: **2**
Clock To:
1st Value: **4.000**
2nd Value:
Value Percent:
Continuous Index:
Within 8" of Joint: **NO**
Remarks:

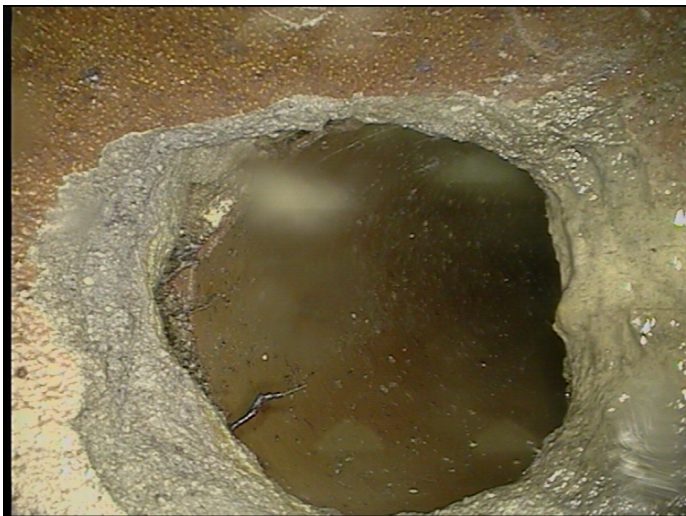
Code: **TB**
Description: **Tap Break-in**

Distance (ft): **65.1**
Structural Grade: **0**
O&M Grade: **0**
Clock Start/From: **2**
Clock To:
1st Value: **4.000**
2nd Value:
Value Percent:
Continuous Index:
Within 8" of Joint: **NO**
Remarks:

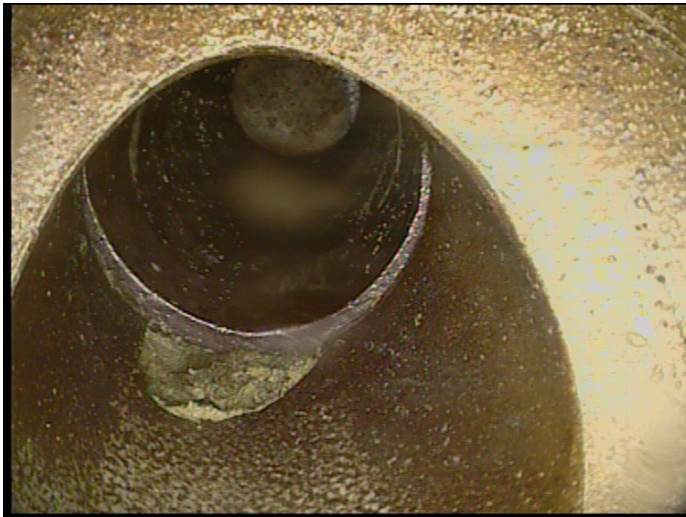
Code: **TFC**
Description: **Tap Factory Capped**

Distance (ft): **75.6**
Structural Grade: **0**
O&M Grade: **0**
Clock Start/From: **2**
Clock To:
1st Value: **4.000**
2nd Value:
Value Percent:
Continuous Index:
Within 8" of Joint: **NO**
Remarks:

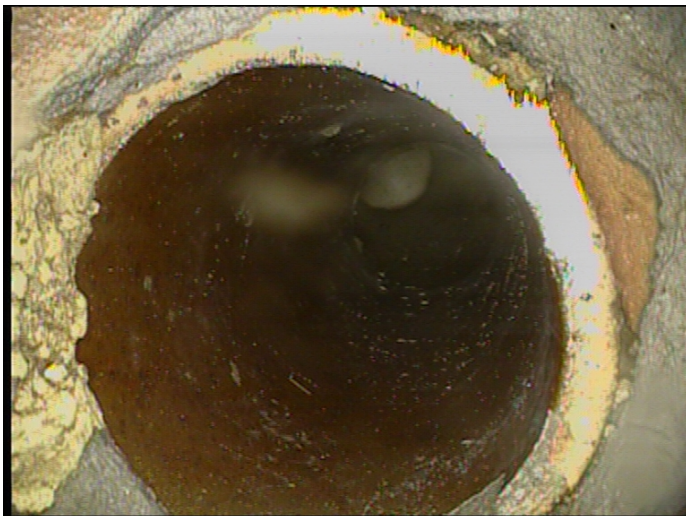
Code: **TB**
Description: **Tap Break-in**

Distance (ft): **83.5**
Structural Grade: **0**
O&M Grade: **0**
Clock Start/From: **10**
Clock To:
1st Value: **4.000**
2nd Value:
Value Percent:
Continuous Index:
Within 8" of Joint: **NO**
Remarks:

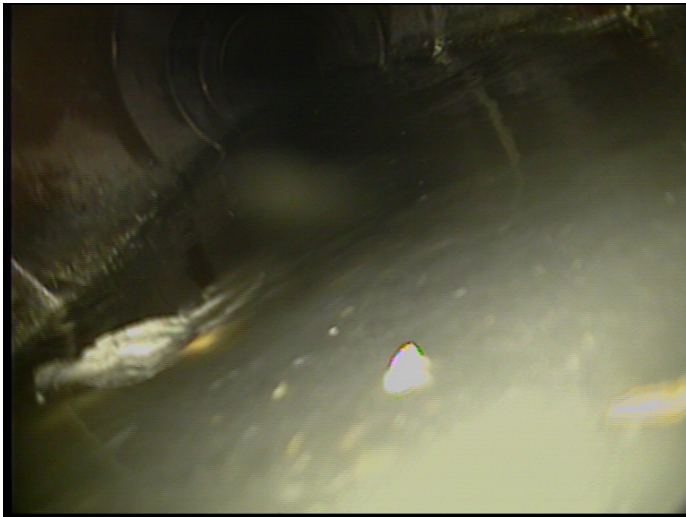
Code: **OBZ**
Description: **Obstacle Other**

Distance (ft): **93.3**
Structural Grade: **0**
O&M Grade: **3**
Clock Start/From: **5**
Clock To: **7**
1st Value:
2nd Value:
Value Percent: **15.000**
Continuous Index:
Within 8" of Joint: **NO**
Remarks: **under water debris**

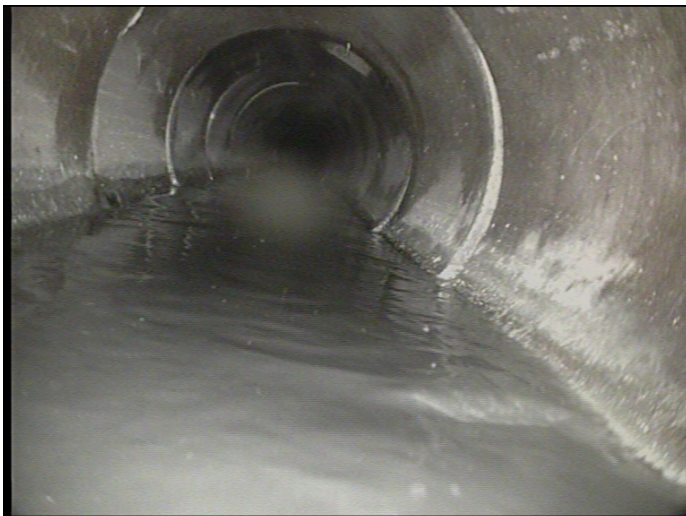
Code: **MSA**
Description: **Abandoned Survey**

Distance (ft): **94.2**
Structural Grade: **0**
O&M Grade: **0**
Clock Start/From:
Clock To:
1st Value:
2nd Value:
Value Percent:
Continuous Index:
Within 8" of Joint: **NO**
Remarks: **debris**
