Profile/Photo Observation Report

Date:	08/10/2022	Weather:		Coding:	PACP 7.0
Pipe Length (ft):	160.0	Owner:	City of Hobart	Pre Clean:	Heavy Cleaning
P.O.#:	YES502259	Surveyor:	S. Bucklin	PSR:	P-504-072-071
Customer:	City of Hobart	Clean Date:	07/30/2022	Shape:	C

Street:	North Virginia Street	Flow Control:	Not Controlled
City:	Hobart, IN	Year Renewed:	
Location:	Alley	Tape/Media #:	
Purpose:	Routine Assessment	Dia/Height:	18"
Use:	Sanitary Sewage Pipe	Material:	VCP
Drain Area:		Lining:	None
Category:	NA

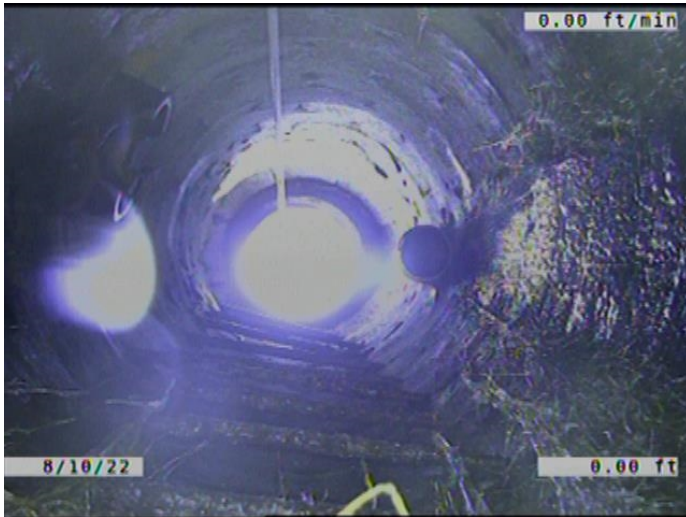
Code: **AMH**
Description: **Manhole**

Distance (ft): **.0**
Structural Grade: **0**
O&M Grade: **0**
Clock Start/From:
Clock To:
1st Value:
2nd Value:
Value Percent:
Continuous Index:
Within 8" of Joint: **NO**
Remarks: **M-504-072**

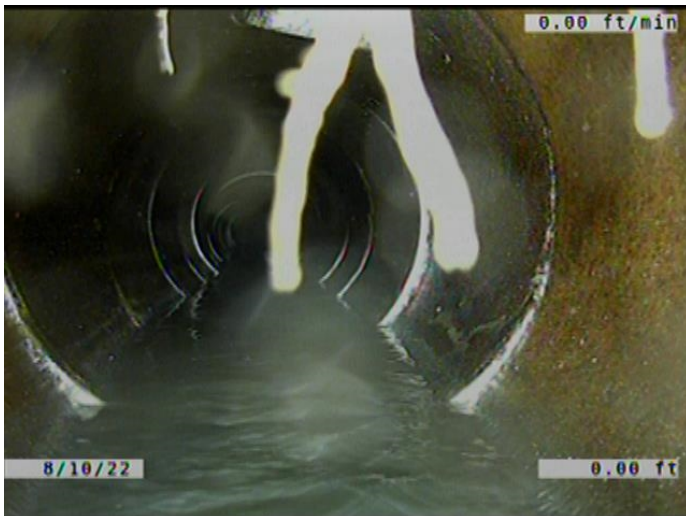
Code: **MWL**
Description: **Miscellaneous Water Level**

Distance (ft): **.0**
Structural Grade: **0**
O&M Grade: **0**
Clock Start/From:
Clock To:
1st Value:
2nd Value:
Value Percent: **10.000**
Continuous Index:
Within 8" of Joint: **NO**
Remarks:

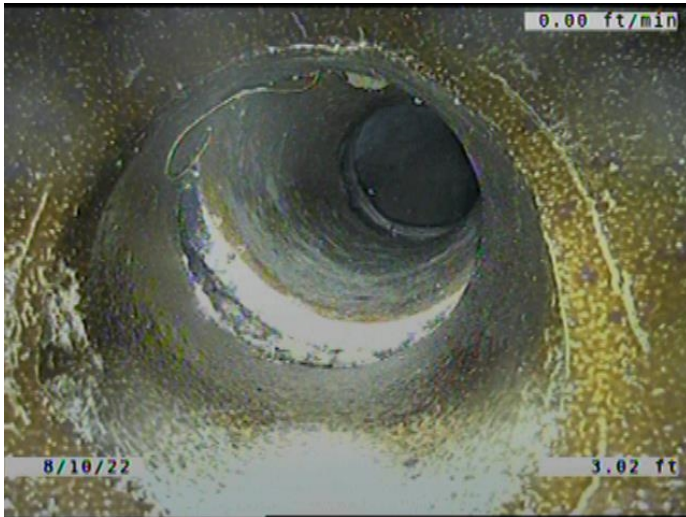
Code: **TF**
 Description: **Tap Factory**

Distance (ft): **3.0**
 Structural Grade: **0**
 O&M Grade: **0**
 Clock Start/From: **1**
 Clock To:
 1st Value: **6.000**
 2nd Value:
 Value Percent:
 Continuous Index:
 Within 8" of Joint: **YES**
 Remarks: **SERVICE LARGE OFFSET. SOIL VISIBLE.**

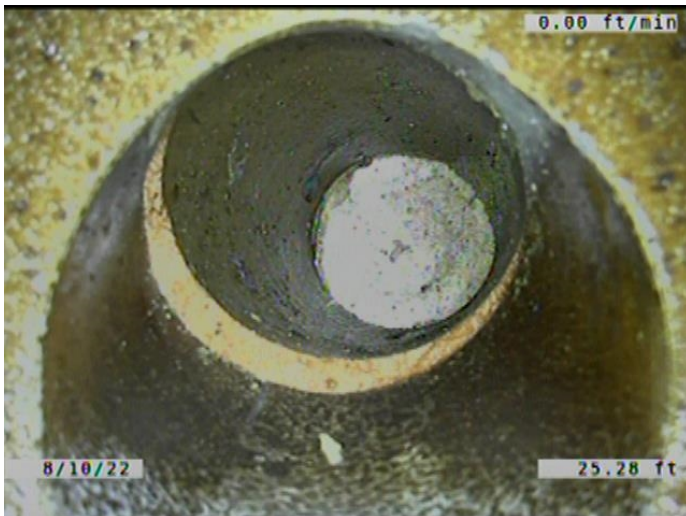
Code: **TFC**
 Description: **Tap Factory Capped**

Distance (ft): **25.3**
 Structural Grade: **0**
 O&M Grade: **0**
 Clock Start/From: **1**
 Clock To:
 1st Value: **6.000**
 2nd Value:
 Value Percent:
 Continuous Index:
 Within 8" of Joint: **YES**
 Remarks: **SERVICE OFFSET.**

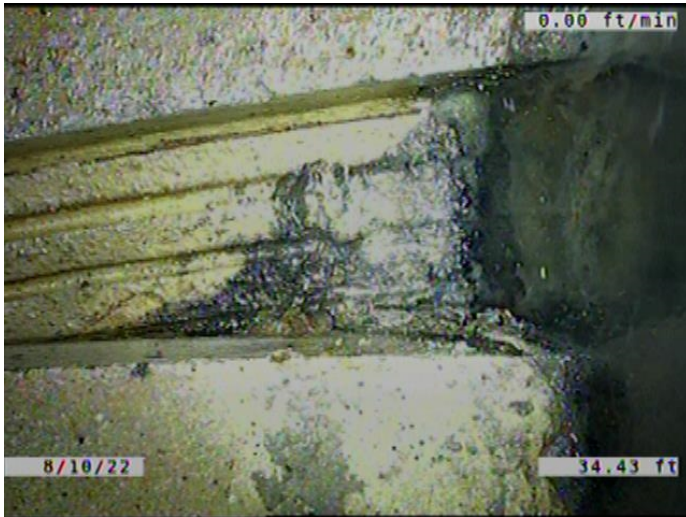
Code: **JAL**
Description: **Joint Angular Large**

Distance (ft): **34.4**
Structural Grade: **4**
O&M Grade: **0**
Clock Start/From:
Clock To:
1st Value:
2nd Value:
Value Percent:
Continuous Index:
Within 8" of Joint: **NO**
Remarks:

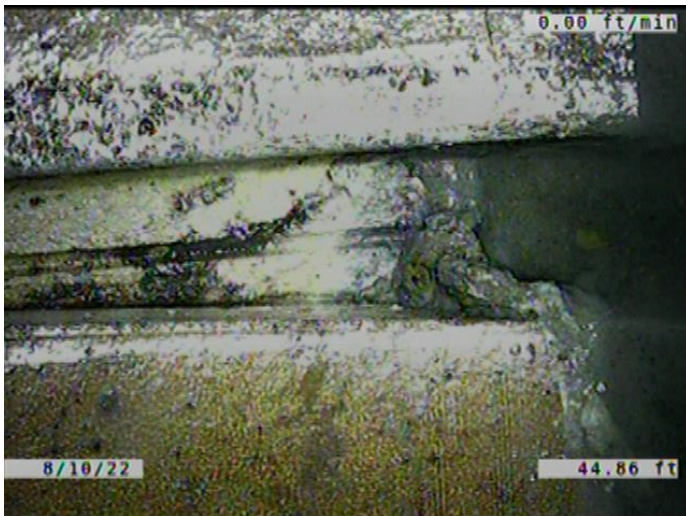
Code: **JAM**
Description: **Joint Angular Medium**

Distance (ft): **44.9**
Structural Grade: **3**
O&M Grade: **0**
Clock Start/From:
Clock To:
1st Value:
2nd Value:
Value Percent:
Continuous Index:
Within 8" of Joint: **NO**
Remarks:

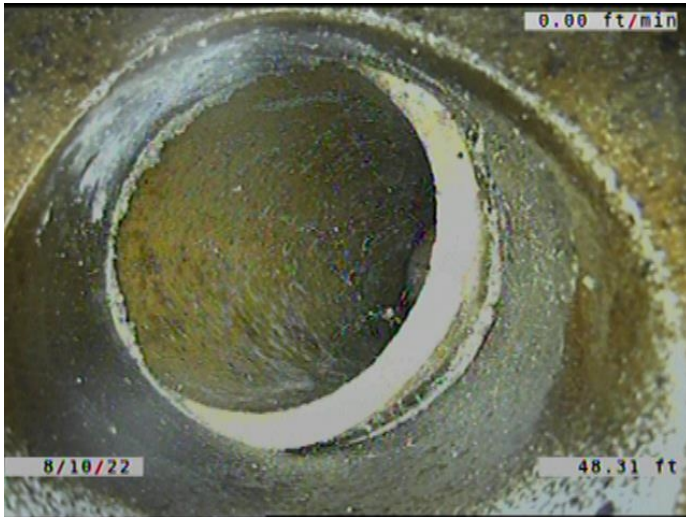
Code:	TF
Description:	Tap Factory
Distance (ft):	48.3
Structural Grade:	0
O&M Grade:	0
Clock Start/From:	11
Clock To:	
1st Value:	6.000
2nd Value:	
Value Percent:	
Continuous Index:	
Within 8" of Joint:	YES
Remarks:	LOOKS CAPPED BUT CANT TELL FOR SURE. SERVICE OFFSET AND ANGLED

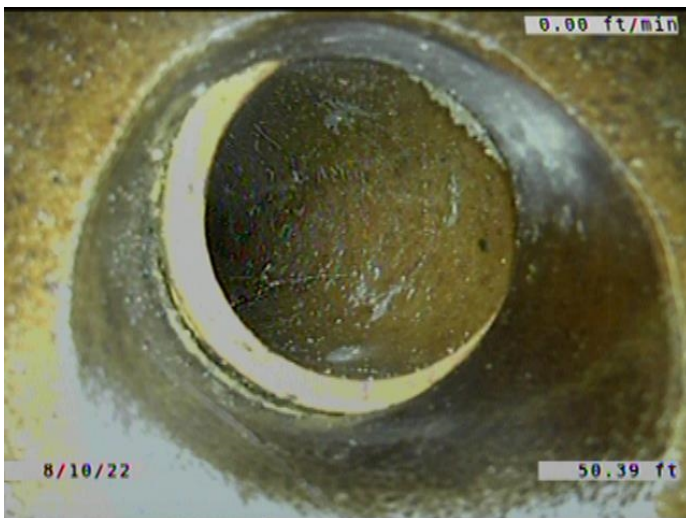
Code:	TF
Description:	Tap Factory
Distance (ft):	50.4
Structural Grade:	0
O&M Grade:	0
Clock Start/From:	1
Clock To:	
1st Value:	6.000
2nd Value:	
Value Percent:	
Continuous Index:	
Within 8" of Joint:	YES
Remarks:	SERVICE OFFSET AND ANGLED.

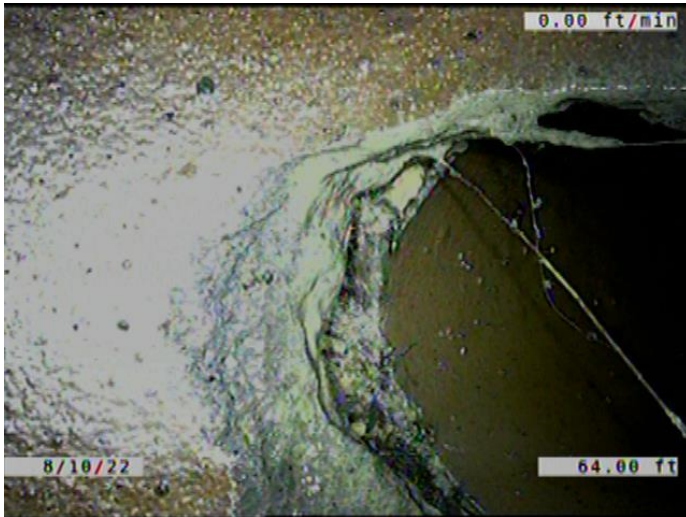
Code: **SSS**
 Description: **Surface Damage Surface Spalling**

Distance (ft): **64.0**
 Structural Grade: **2**
 O&M Grade: **0**
 Clock Start/From: **1**
 Clock To: **2**
 1st Value:
 2nd Value:
 Value Percent:
 Continuous Index:
 Within 8" of Joint: **YES**
 Remarks:

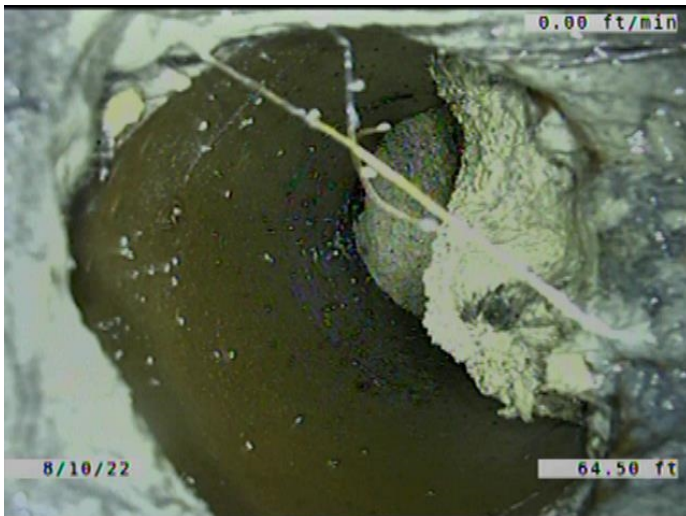
Code: **TBD**
 Description: **Tap Break-in/Hammer Defective**

Distance (ft): **64.5**
 Structural Grade: **0**
 O&M Grade: **3**
 Clock Start/From: **2**
 Clock To:
 1st Value: **4.000**
 2nd Value:
 Value Percent:
 Continuous Index:
 Within 8" of Joint: **YES**
 Remarks: **ROOTS GROWING FROM THE JOINT. SERVICE LOOKS TO BE PLUGGED WIT**

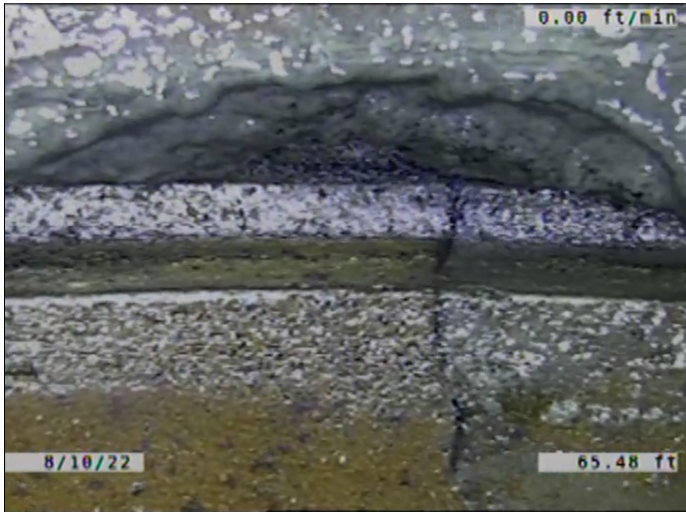
Code: **SSS**
 Description: **Surface Damage Surface Spalling**

Distance (ft): **65.5**
 Structural Grade: **2**
 O&M Grade: **0**
 Clock Start/From: **2**
 Clock To: **3**
 1st Value:
 2nd Value:
 Value Percent:
 Continuous Index:
 Within 8" of Joint: **YES**
 Remarks:

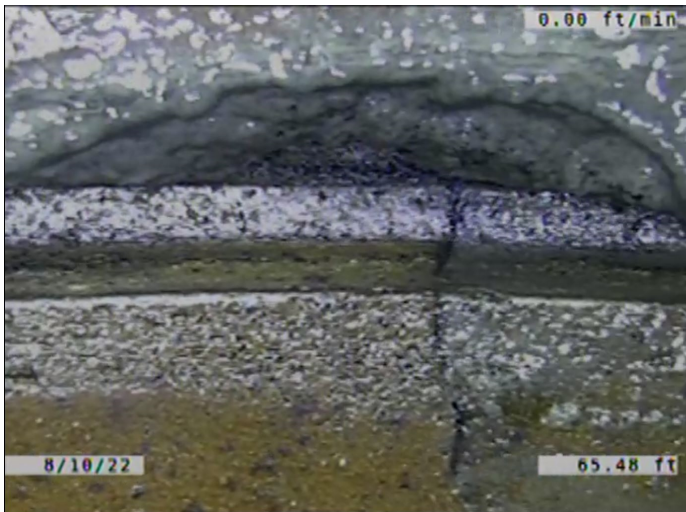
Code: **CL**
 Description: **Crack Longitudinal**

Distance (ft): **65.5**
 Structural Grade: **2**
 O&M Grade: **0**
 Clock Start/From: **3**
 Clock To:
 1st Value:
 2nd Value:
 Value Percent:
 Continuous Index:
 Within 8" of Joint: **YES**
 Remarks:

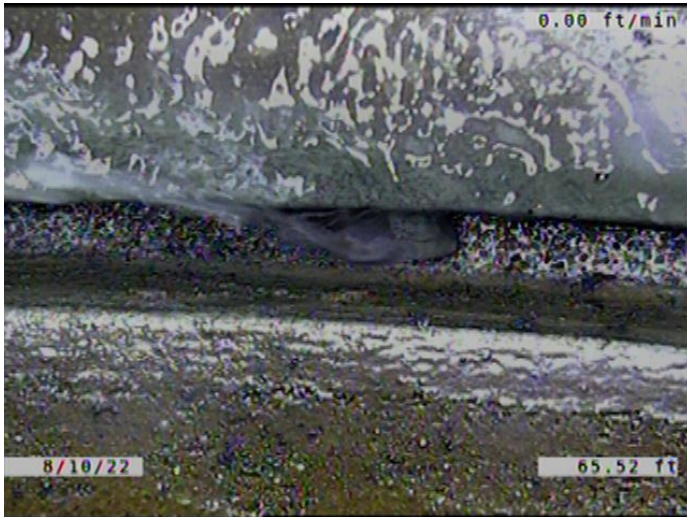
Code: **IRJ**
 Description: **Infiltration Runner Joint**

Distance (ft): **65.5**
 Structural Grade: **0**
 O&M Grade: **4**
 Clock Start/From: **11**
 Clock To: **1**
 1st Value:
 2nd Value:
 Value Percent:
 Continuous Index:
 Within 8" of Joint: **YES**
 Remarks:

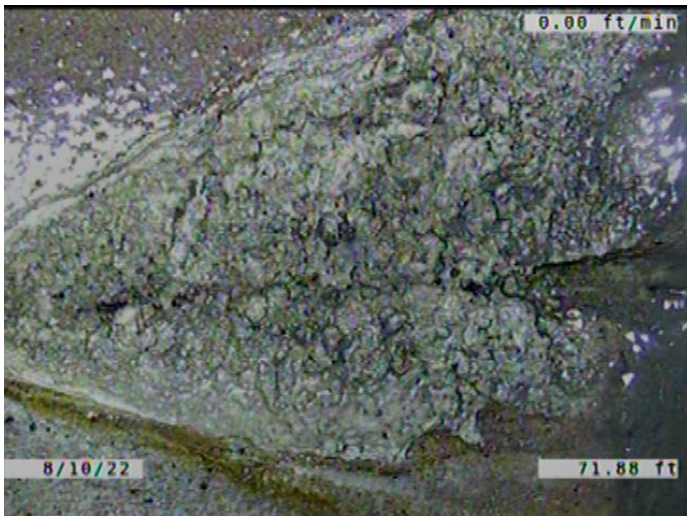
Code: **DAE**
 Description: **Deposits Attached Encrustation**

Distance (ft): **71.9**
 Structural Grade: **0**
 O&M Grade: **2**
 Clock Start/From: **7**
 Clock To: **9**
 1st Value:
 2nd Value:
 Value Percent: **5.000**
 Continuous Index:
 Within 8" of Joint: **YES**
 Remarks:

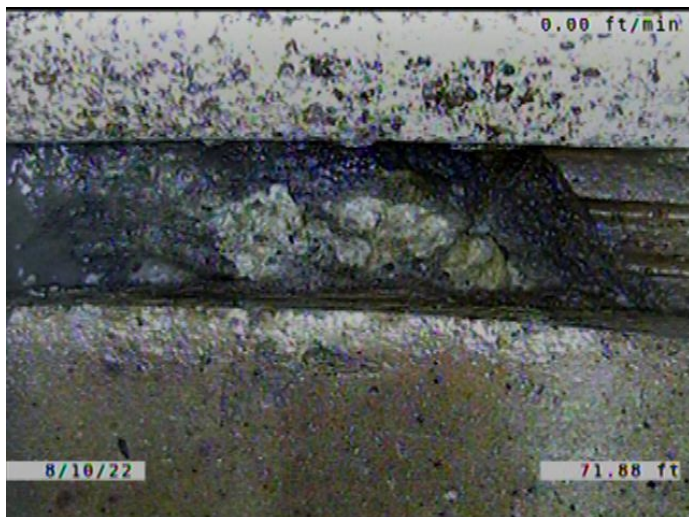
Code: **JAM**
 Description: **Joint Angular Medium**

Distance (ft): **71.9**
 Structural Grade: **3**
 O&M Grade: **0**
 Clock Start/From:
 Clock To:
 1st Value:
 2nd Value:
 Value Percent:
 Continuous Index:
 Within 8" of Joint: **NO**
 Remarks:

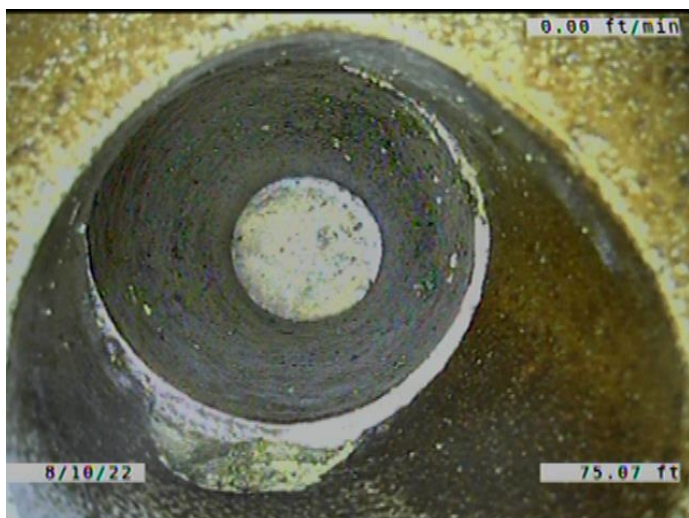
Code: **TFD**
 Description: **Tap Factory Defective**

Distance (ft): **75.1**
 Structural Grade: **0**
 O&M Grade: **3**
 Clock Start/From: **1**
 Clock To:
 1st Value: **6.000**
 2nd Value:
 Value Percent:
 Continuous Index:
 Within 8" of Joint: **YES**
 Remarks: **TAP BROKEN. PART MISSING. CAPPED.**

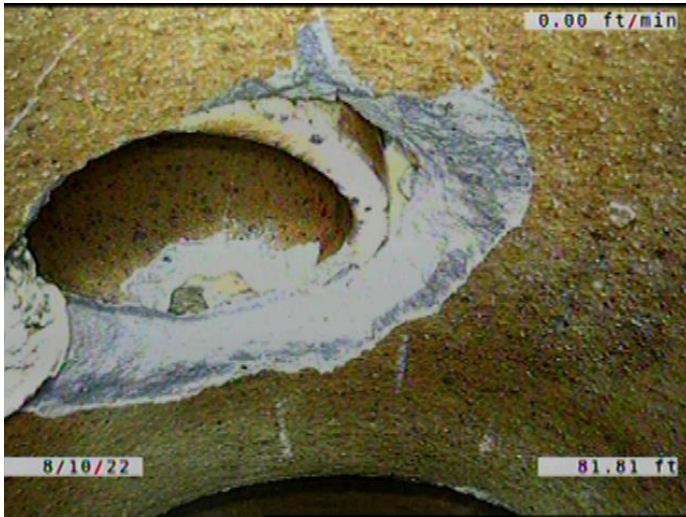
Code:	SSS
Description:	Surface Damage Surface Spalling
Distance (ft):	81.8
Structural Grade:	2
O&M Grade:	0
Clock Start/From:	11
Clock To:	1
1st Value:	
2nd Value:	
Value Percent:	
Continuous Index:	
Within 8" of Joint:	YES
Remarks:

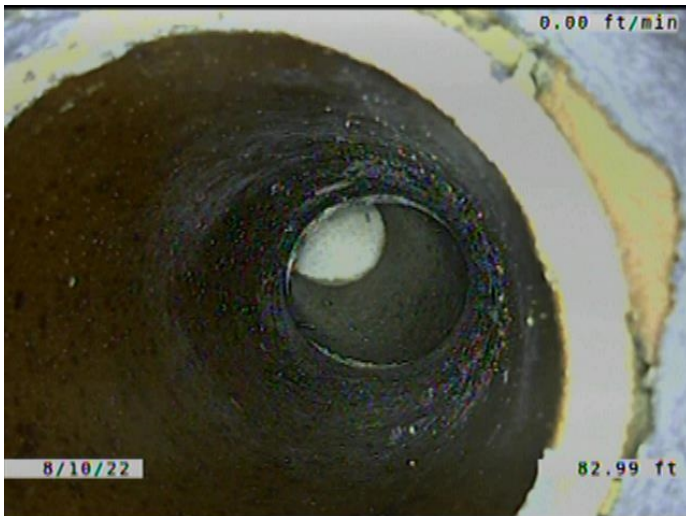
Code:	TBD
Description:	Tap Break-in/Hammer Defective
Distance (ft):	83.0
Structural Grade:	0
O&M Grade:	3
Clock Start/From:	11
Clock To:	
1st Value:	6.000
2nd Value:	
Value Percent:	
Continuous Index:	
Within 8" of Joint:	YES
Remarks:	LOOKS CAPPED BUT CANT TELL FOR SURE.

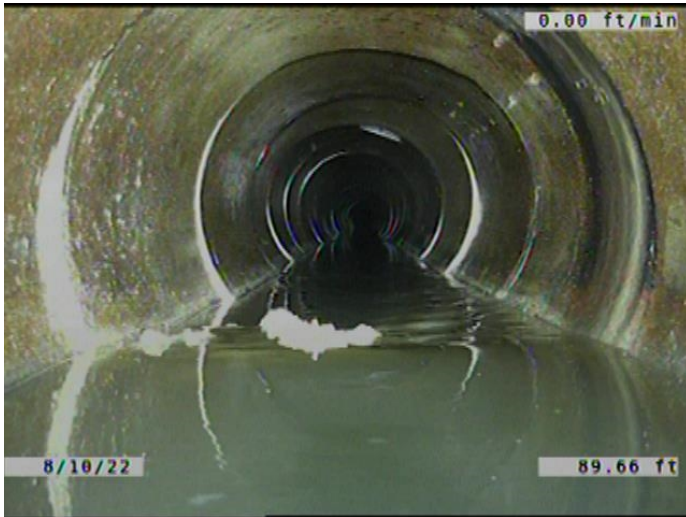
Code: **MWLS**
 Description: **Miscellaneous Water Level Sag**

Distance (ft): **89.7**
 Structural Grade: **2**
 O&M Grade: **0**
 Clock Start/From:
 Clock To:
 1st Value:
 2nd Value:
 Value Percent: **20.000**
 Continuous Index:
 Within 8" of Joint: **NO**
 Remarks:

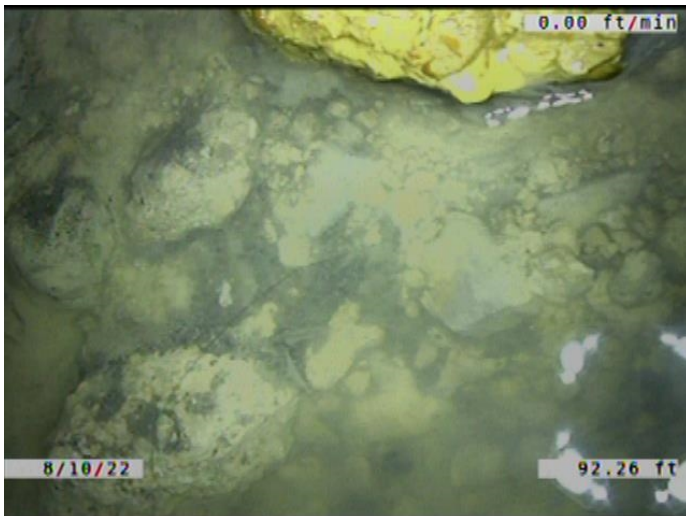
Code: **DSC**
 Description: **Deposits Settled Hard/Compacted**

Distance (ft): **92.3**
 Structural Grade: **0**
 O&M Grade: **2**
 Clock Start/From: **5**
 Clock To: **7**
 1st Value:
 2nd Value:
 Value Percent: **5.000**
 Continuous Index:
 Within 8" of Joint: **YES**
 Remarks:

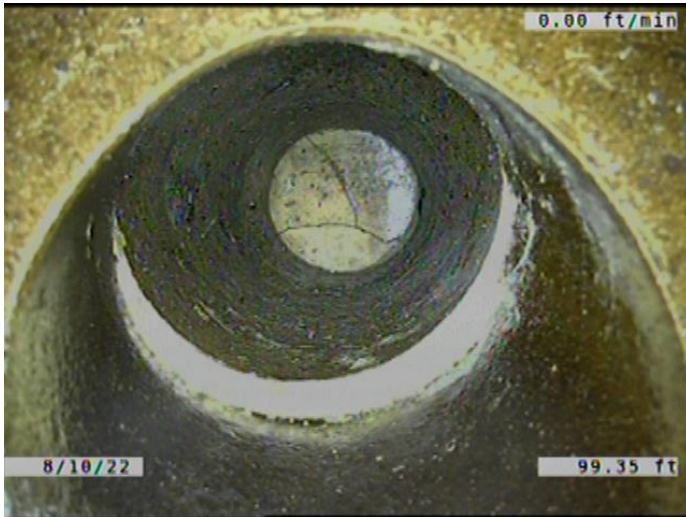
Code: **TFD**
 Description: **Tap Factory Defective**

Distance (ft): **99.4**
 Structural Grade: **0**
 O&M Grade: **3**
 Clock Start/From: **1**
 Clock To:
 1st Value: **6.000**

2nd Value:
 Value Percent:
 Continuous Index:
 Within 8" of Joint: **YES**
 Remarks: **SERVICE OFFSET. CAPPED. CAP BROKEN.**

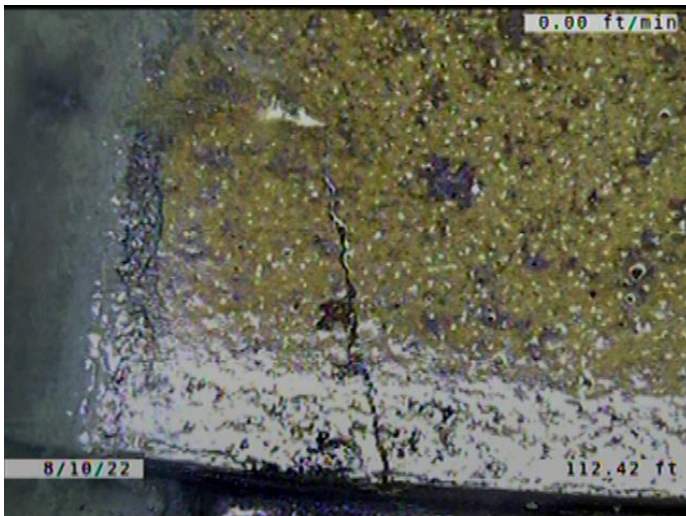
Code: **CS**
 Description: **Crack Spiral**

Distance (ft): **112.4**
 Structural Grade: **2**
 O&M Grade: **0**
 Clock Start/From: **3**
 Clock To: **4**

1st Value:
 2nd Value:
 Value Percent:
 Continuous Index:
 Within 8" of Joint: **YES**
 Remarks:

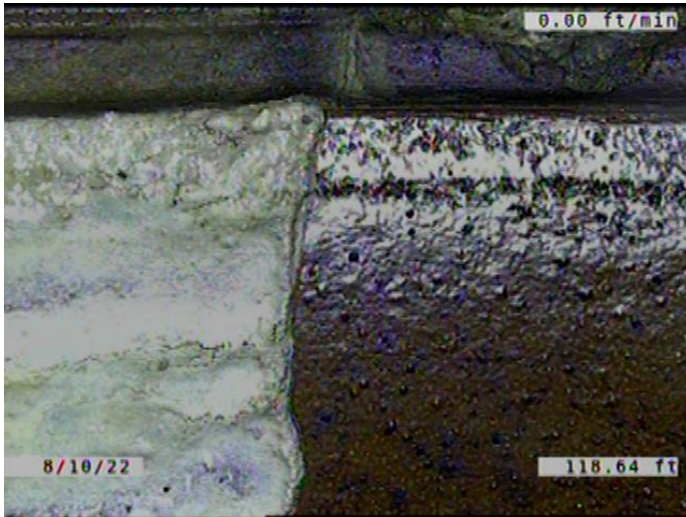
Code: **CL**
 Description: **Crack Longitudinal**

Distance (ft): **118.6**
 Structural Grade: **2**
 O&M Grade: **0**
 Clock Start/From: **11**
 Clock To:
 1st Value:
 2nd Value:
 Value Percent:
 Continuous Index:
 Within 8" of Joint: **YES**
 Remarks:

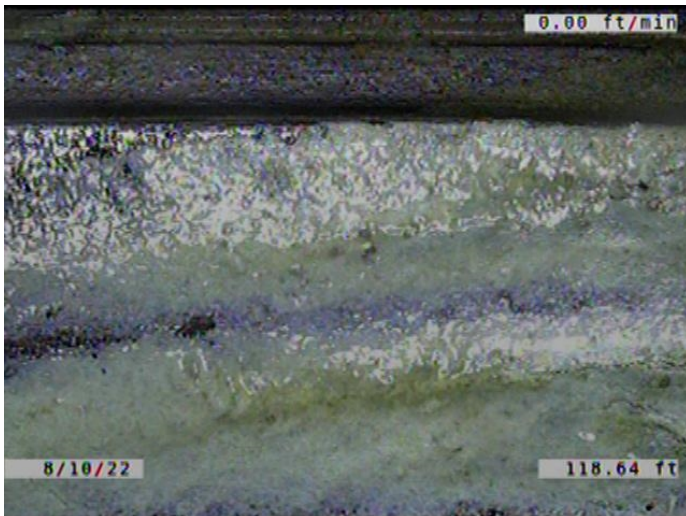
Code: **DAE**
 Description: **Deposits Attached Encrustation**

Distance (ft): **118.6**
 Structural Grade: **0**
 O&M Grade: **2**
 Clock Start/From: **8**
 Clock To: **11**
 1st Value:
 2nd Value:
 Value Percent: **5.000**
 Continuous Index:
 Within 8" of Joint: **YES**
 Remarks:

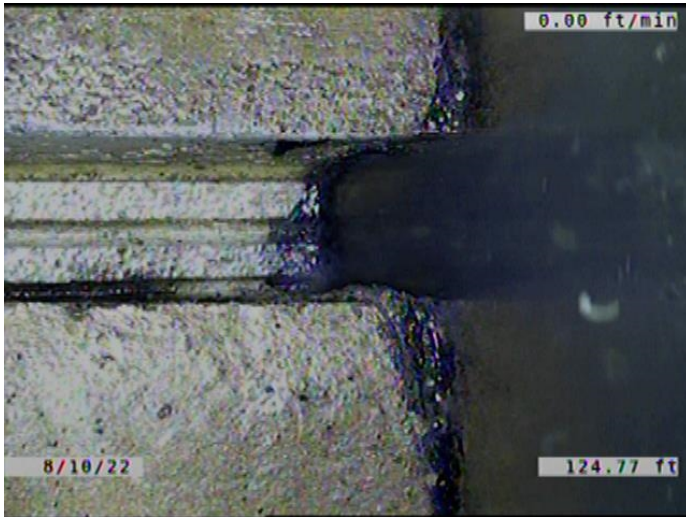
Code: **JAM**
 Description: **Joint Angular Medium**

Distance (ft): **124.8**
 Structural Grade: **3**
 O&M Grade: **0**
 Clock Start/From:
 Clock To:
 1st Value:
 2nd Value:
 Value Percent:
 Continuous Index:
 Within 8" of Joint: **NO**
 Remarks:

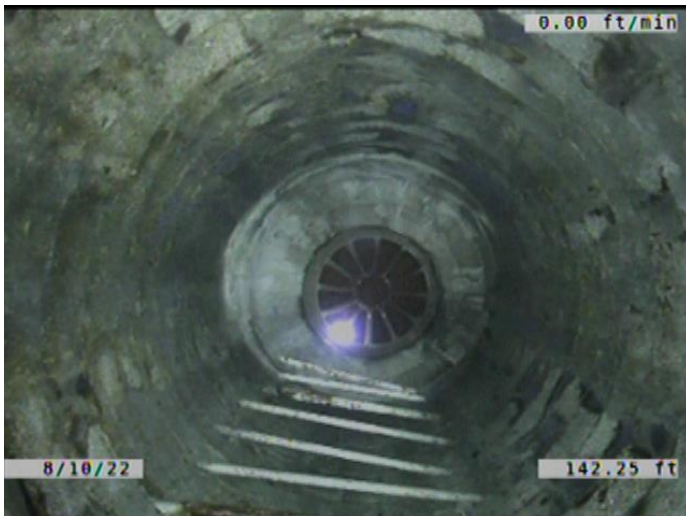
Code: **AMH**
 Description: **Manhole**

Distance (ft): **142.2**
 Structural Grade: **0**
 O&M Grade: **0**
 Clock Start/From:
 Clock To:
 1st Value:
 2nd Value:
 Value Percent:
 Continuous Index:
 Within 8" of Joint: **NO**
 Remarks: **M-504-071**
