RedZone
ROBOTICS

Total Length Surveyed (ft): **207.1**

M-504-072

M-504-101

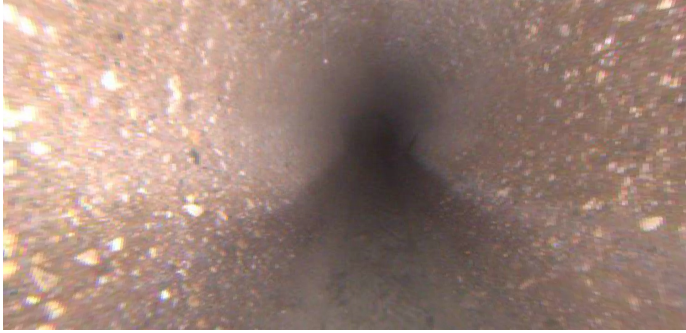
Code: **SAP**
Description: **Surface Aggregate Projecting**

Distance (ft): **.0**
Structural Grade: **3**
O&M Grade: **0**
Clock Start/From: **7**
Clock To: **5**
1st Value:
2nd Value:
Value Percent:
Continuous Index: **S01**
Within 8" of Joint: **YES**
Remarks: **WANDER**

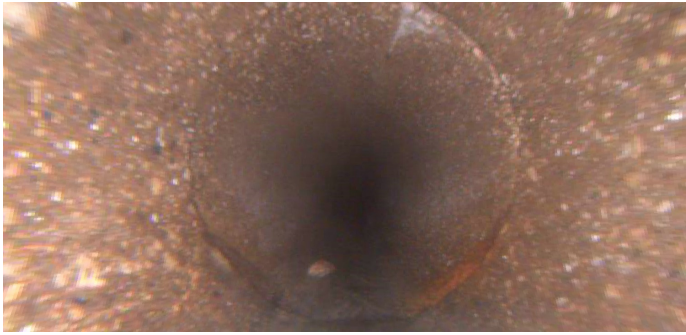
Code: **IS**
Description: **Infil Stain**

Distance (ft): **24.4**
Structural Grade: **0**
O&M Grade: **0**
Clock Start/From: **4**
Clock To: **5**
1st Value:
2nd Value:
Value Percent:
Continuous Index:
Within 8" of Joint: **YES**
Remarks:

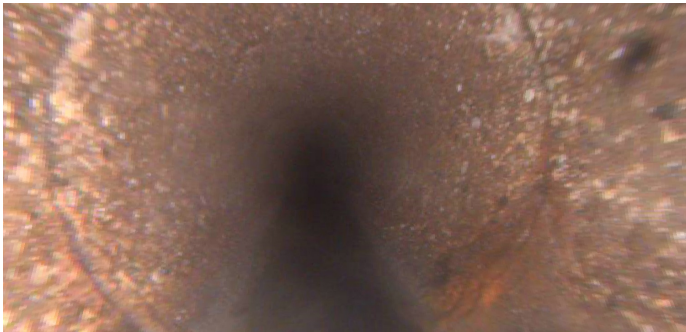
Code: **IS**
Description: **Infil Stain**

Distance (ft): **27.6**
Structural Grade: **0**
O&M Grade: **0**
Clock Start/From: **4**
Clock To: **5**
1st Value:
2nd Value:
Value Percent:
Continuous Index:
Within 8" of Joint: **YES**
Remarks:

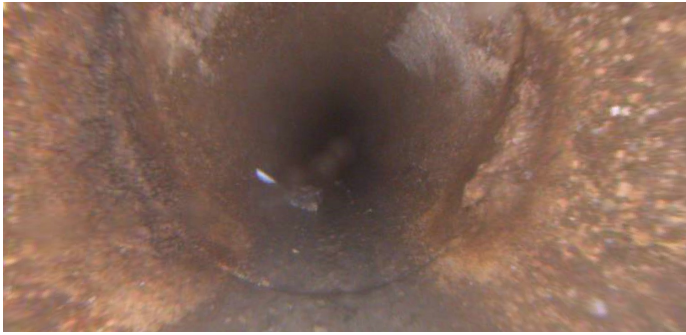
Code: **IS**
Description: **Infil Stain**

Distance (ft): **63.2**
Structural Grade: **0**
O&M Grade: **0**
Clock Start/From: **8**
Clock To: **4**
1st Value:
2nd Value:
Value Percent:
Continuous Index:
Within 8" of Joint: **YES**
Remarks:

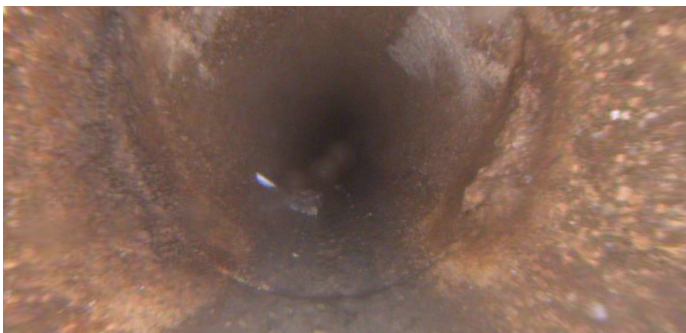
Code: **DAE**
Description: **Deposits Attached Encrustation**

Distance (ft): **63.2**
Structural Grade: **0**
O&M Grade: **2**
Clock Start/From: **3**
Clock To: **5**
1st Value:
2nd Value:
Value Percent: **5.000**
Continuous Index:
Within 8" of Joint: **YES**
Remarks:

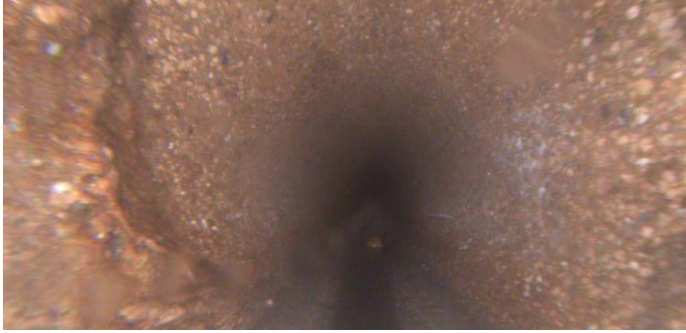
Code: **DAE**
Description: **Deposits Attached Encrustation**

Distance (ft): **66.2**
Structural Grade: **0**
O&M Grade: **2**
Clock Start/From: **7**
Clock To: **9**
1st Value:
2nd Value:
Value Percent: **5.000**
Continuous Index:
Within 8" of Joint: **YES**
Remarks:

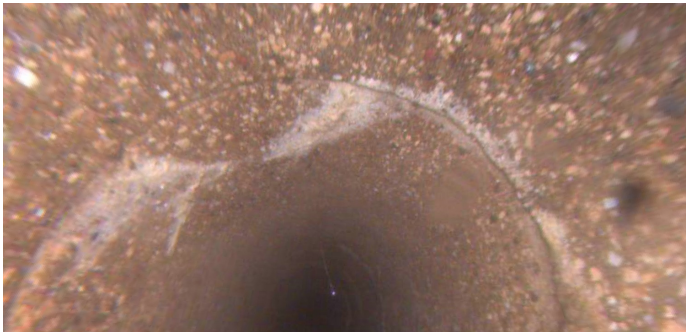
Code: **CS**
Description: **Crack Spiral**

Distance (ft): **69.2**
Structural Grade: **2**
O&M Grade: **0**
Clock Start/From: **10**
Clock To: **12**
1st Value:
2nd Value:
Value Percent:
Continuous Index:
Within 8" of Joint: **YES**
Remarks:

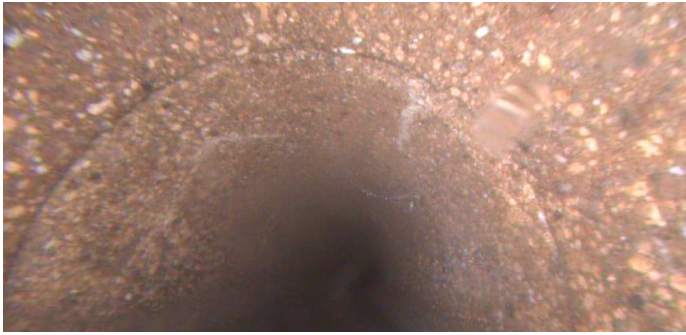
Code: **CM**
Description: **Crack Multiple**

Distance (ft): **84.1**
Structural Grade: **3**
O&M Grade: **0**
Clock Start/From: **9**
Clock To: **2**
1st Value:
2nd Value:
Value Percent:
Continuous Index:
Within 8" of Joint: **YES**
Remarks:

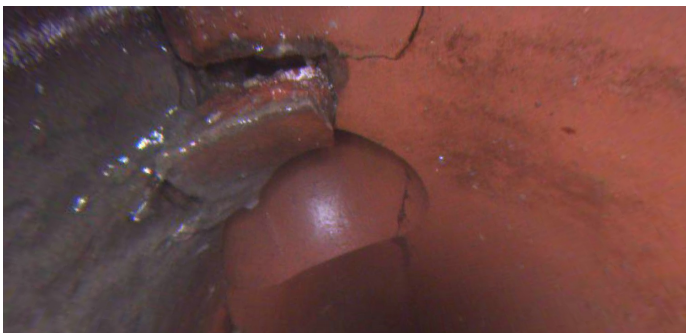
Code: **IR**
Description: **Infil Runner**

Distance (ft): **99.4**
Structural Grade: **0**
O&M Grade: **4**
Clock Start/From: **11**
Clock To:
1st Value:
2nd Value:
Value Percent:
Continuous Index:
Within 8" of Joint:
Remarks:

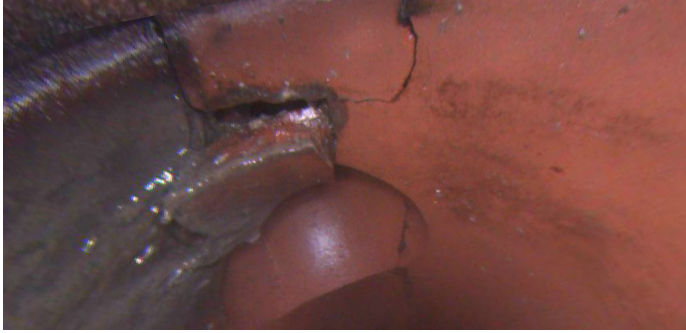
Code: **FS**
Description: **Fracture Spiral**

Distance (ft): **99.4**
Structural Grade: **3**
O&M Grade: **0**
Clock Start/From: **10**
Clock To: **12**
1st Value:
2nd Value:
Value Percent:
Continuous Index:
Within 8" of Joint: **YES**
Remarks:

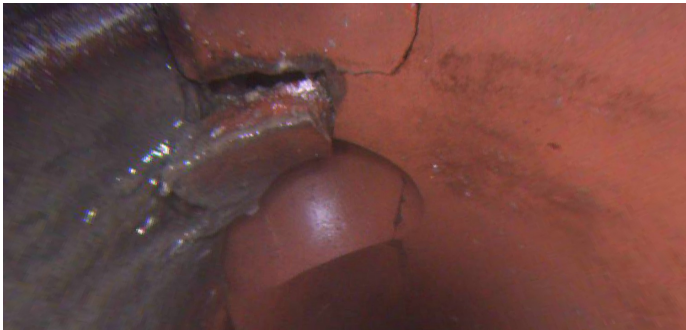
Code: **B**
Description: **Broken**

Distance (ft): **99.4**
Structural Grade: **3**
O&M Grade: **0**
Clock Start/From: **10**
Clock To:
1st Value:
2nd Value:
Value Percent:
Continuous Index:
Within 8" of Joint:
Remarks:

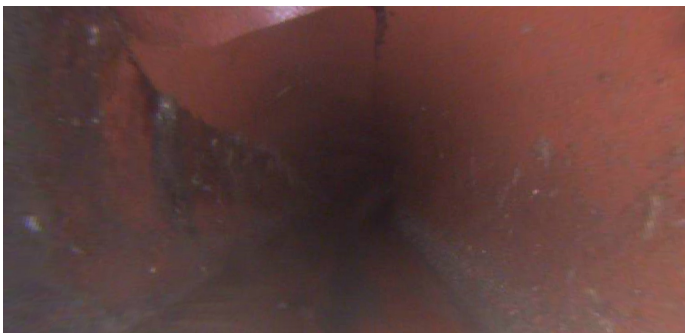
Code: **IW**
Description: **Infil Weeper**

Distance (ft): **99.6**
Structural Grade: **0**
O&M Grade: **2**
Clock Start/From: **8**
Clock To: **12**
1st Value:
2nd Value:
Value Percent:
Continuous Index:
Within 8" of Joint:
Remarks:

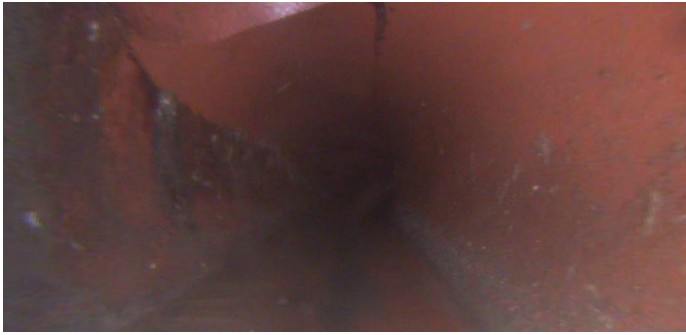
Code: **CM**
Description: **Crack Multiple**

Distance (ft): **99.6**
Structural Grade: **3**
O&M Grade: **0**
Clock Start/From: **9**
Clock To: **12**
1st Value:
2nd Value:
Value Percent:
Continuous Index:
Within 8" of Joint:
Remarks:

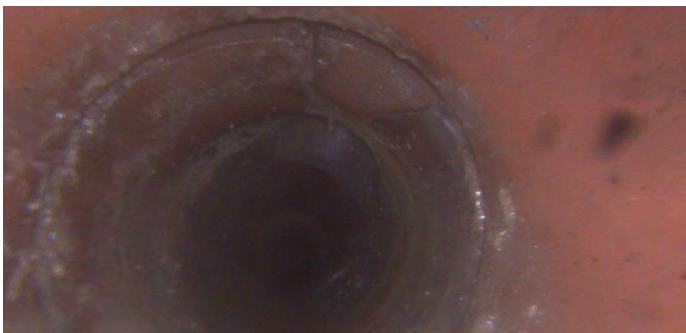
Code: **FS**
Description: **Fracture Spiral**

Distance (ft): **101.8**
Structural Grade: **3**
O&M Grade: **0**
Clock Start/From: **12**
Clock To: **2**
1st Value:
2nd Value:
Value Percent:
Continuous Index:
Within 8" of Joint: **YES**
Remarks:

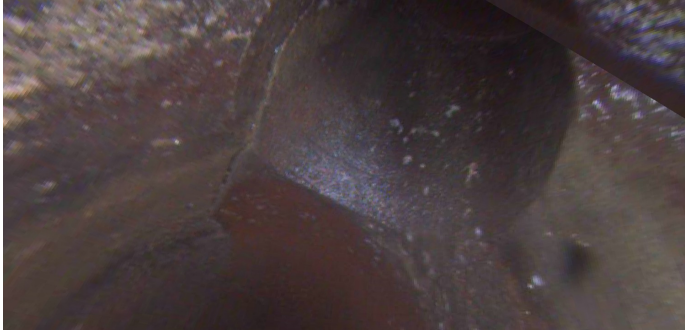
Code: **TFD**
Description: **Tap Factory Defective**

Distance (ft): **102.6**
Structural Grade: **0**
O&M Grade: **2**
Clock Start/From: **1**
Clock To:
1st Value: **4.000**
2nd Value:
Value Percent:
Continuous Index:
Within 8" of Joint:
Remarks: **fractured**

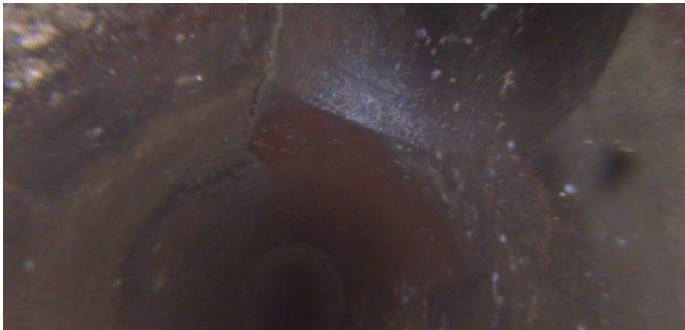
Code: **FL**
Description: **Fracture Longitudinal**

Distance (ft): **102.6**
Structural Grade: **3**
O&M Grade: **0**
Clock Start/From: **12**
Clock To:
1st Value:
2nd Value:
Value Percent:
Continuous Index:
Within 8" of Joint:
Remarks:

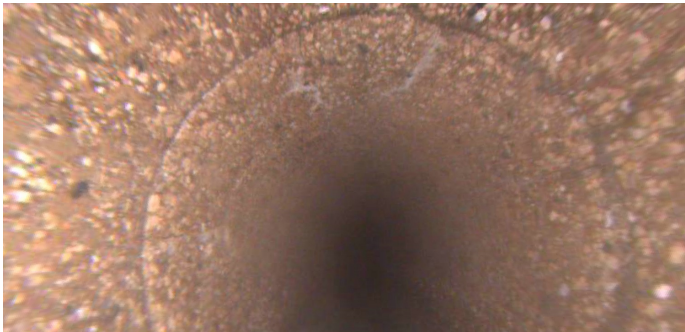
Code: **CM**
Description: **Crack Multiple**

Distance (ft): **113.3**
Structural Grade: **3**
O&M Grade: **0**
Clock Start/From: **11**
Clock To: **12**
1st Value:
2nd Value:
Value Percent:
Continuous Index:
Within 8" of Joint: **YES**
Remarks:

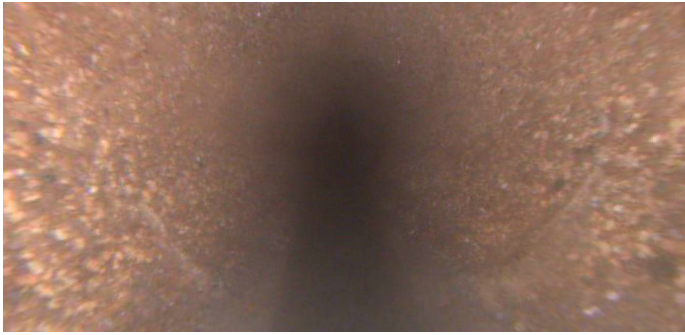
Code: **CC**
Description: **Crack Circumferential**

Distance (ft): **140.0**
Structural Grade: **1**
O&M Grade: **0**
Clock Start/From: **3**
Clock To: **9**
1st Value:
2nd Value:
Value Percent:
Continuous Index:
Within 8" of Joint:
Remarks:

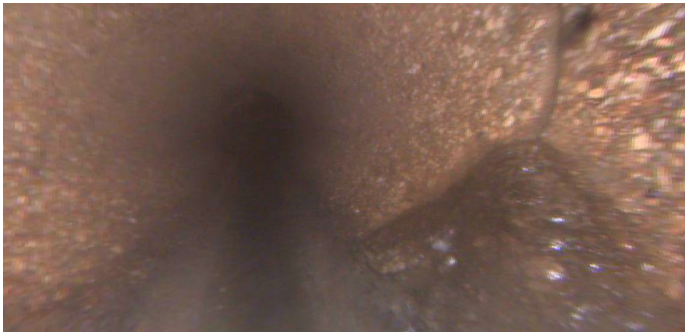
Code: **IS**
Description: **Infil Stain**

Distance (ft): **142.3**
Structural Grade: **0**
O&M Grade: **0**
Clock Start/From: **4**
Clock To: **5**
1st Value:
2nd Value:
Value Percent:
Continuous Index:
Within 8" of Joint: **YES**
Remarks:

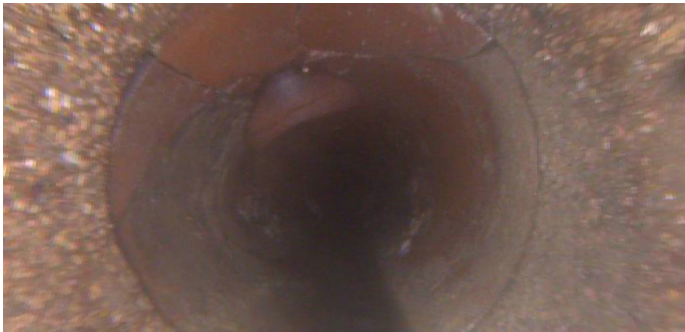
Code: **FM**
Description: **Fracture Multiple**

Distance (ft): **145.0**
Structural Grade: **4**
O&M Grade: **0**
Clock Start/From: **10**
Clock To: **2**
1st Value:
2nd Value:
Value Percent:
Continuous Index:
Within 8" of Joint: **YES**
Remarks:

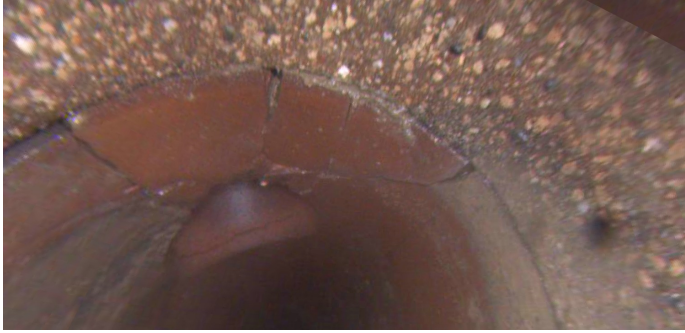
Code: **FM**
Description: **Fracture Multiple**

Distance (ft): **145.1**
Structural Grade: **4**
O&M Grade: **0**
Clock Start/From: **11**
Clock To: **1**
1st Value:
2nd Value:
Value Percent:
Continuous Index:
Within 8" of Joint: **YES**
Remarks:

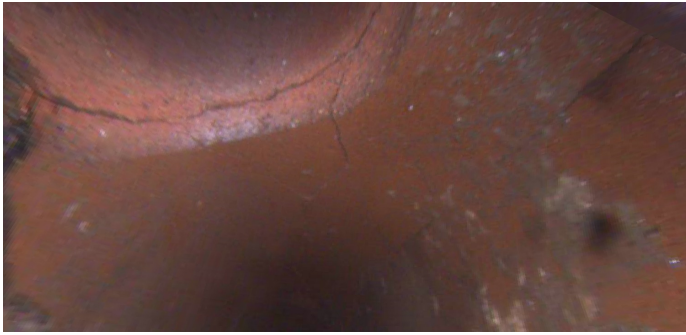
Code: **CM**
Description: **Crack Multiple**

Distance (ft): **146.0**
Structural Grade: **3**
O&M Grade: **0**
Clock Start/From: **12**
Clock To: **2**
1st Value:
2nd Value:
Value Percent:
Continuous Index:
Within 8" of Joint:
Remarks:

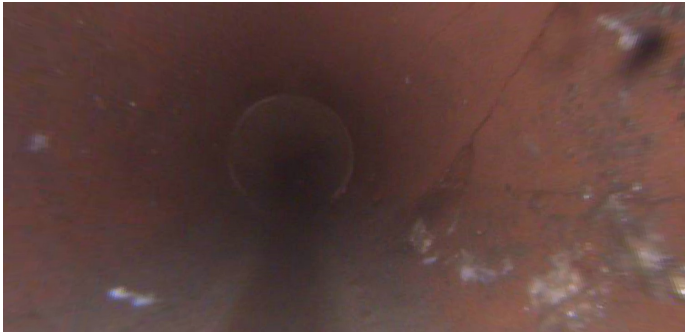
Code: **FS**
Description: **Fracture Spiral**

Distance (ft): **149.7**
Structural Grade: **3**
O&M Grade: **0**
Clock Start/From: **1**
Clock To: **4**
1st Value:
2nd Value:
Value Percent:
Continuous Index:
Within 8" of Joint: **YES**
Remarks:

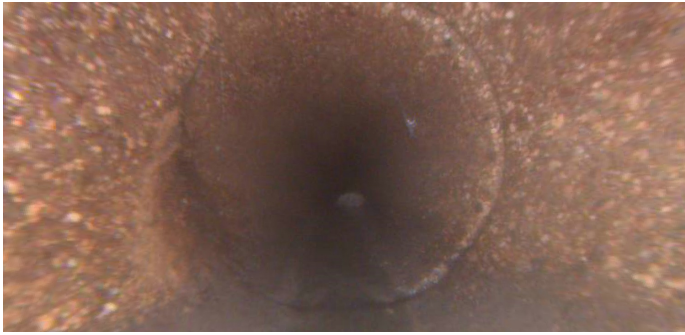
Code: **IW**
Description: **Infil Weeper**

Distance (ft): **153.8**
Structural Grade: **0**
O&M Grade: **2**
Clock Start/From: **7**
Clock To: **9**
1st Value:
2nd Value:
Value Percent:
Continuous Index:
Within 8" of Joint: **YES**
Remarks:

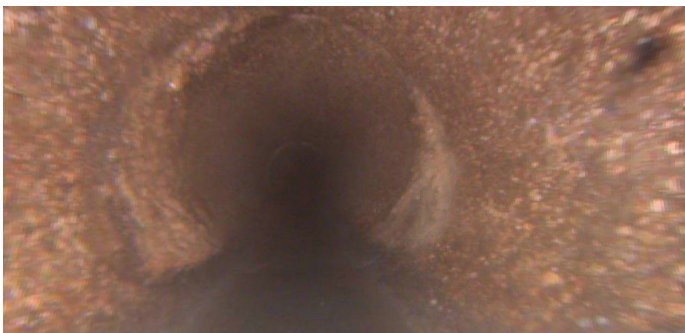
Code: **DAE**
Description: **Deposits Attached Encrustation**

Distance (ft): **159.6**
Structural Grade: **0**
O&M Grade: **2**
Clock Start/From: **7**
Clock To: **5**
1st Value:
2nd Value:
Value Percent: **5.000**
Continuous Index: **S03**
Within 8" of Joint: **YES**
Remarks: **WANDER**

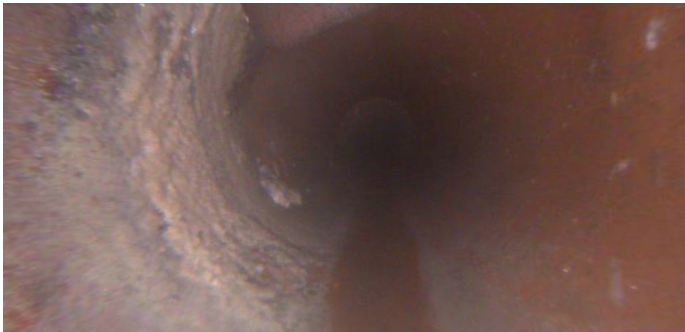
Code: **DAGS**
Description: **Deposits Attached Grease**

Distance (ft): **178.3**
Structural Grade: **0**
O&M Grade: **2**
Clock Start/From: **7**
Clock To: **11**
1st Value:
2nd Value:
Value Percent: **5.000**
Continuous Index:
Within 8" of Joint: **NO**
Remarks:

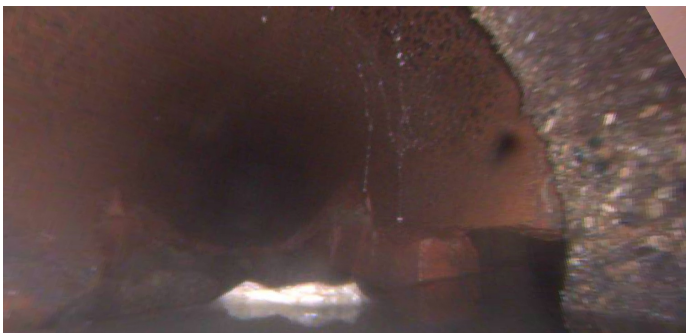
Code: **HSV**
Description: **Hole Soil Visible**

Distance (ft): **205.2**
Structural Grade: **5**
O&M Grade: **0**
Clock Start/From: **5**
Clock To:
1st Value:
2nd Value:
Value Percent:
Continuous Index:
Within 8" of Joint: **YES**
Remarks:

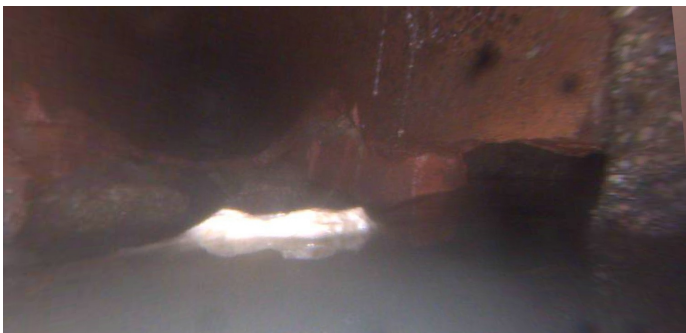
Code: **HVV**
Description: **Hole Void Visible**

Distance (ft): **205.3**
Structural Grade: **5**
O&M Grade: **0**
Clock Start/From: **3**
Clock To: **4**
1st Value:
2nd Value:
Value Percent:
Continuous Index:
Within 8" of Joint: **YES**
Remarks:

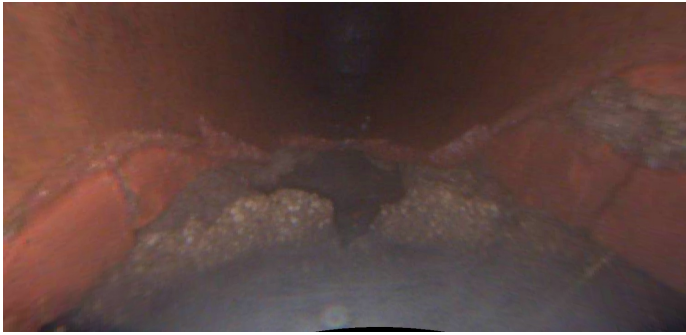
Code: **B**
Description: **Broken**

Distance (ft): **206.0**
Structural Grade: **5**
O&M Grade: **0**
Clock Start/From: **3**
Clock To: **7**
1st Value:
2nd Value:
Value Percent:
Continuous Index:
Within 8" of Joint:
Remarks:

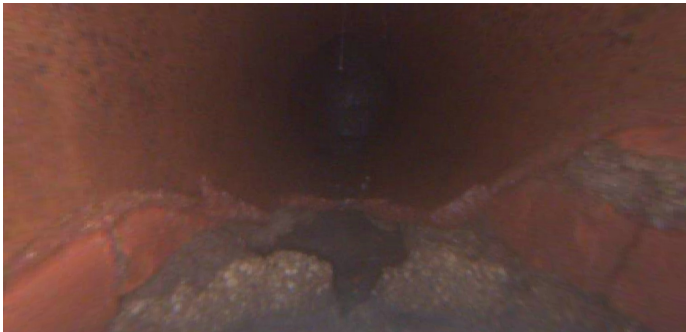
Code: **DSC**
Description: **Deposits Settled Compacted**

Distance (ft): **206.0**
Structural Grade: **0**
O&M Grade: **2**
Clock Start/From: **6**
Clock To:
1st Value:
2nd Value:
Value Percent: **5.000**
Continuous Index:
Within 8" of Joint: **NO**
Remarks:

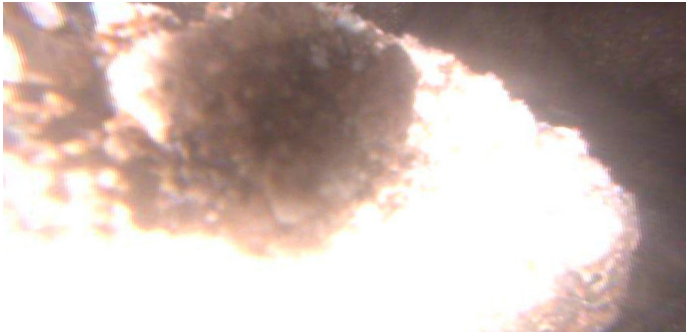
Code: **SAP**
Description: **Surface Aggregate Projecting**

Distance (ft): **207.1**
Structural Grade: **3**
O&M Grade: **0**
Clock Start/From: **7**
Clock To: **5**
1st Value:
2nd Value:
Value Percent:
Continuous Index: **F01**
Within 8" of Joint: **YES**
Remarks: **WANDER**

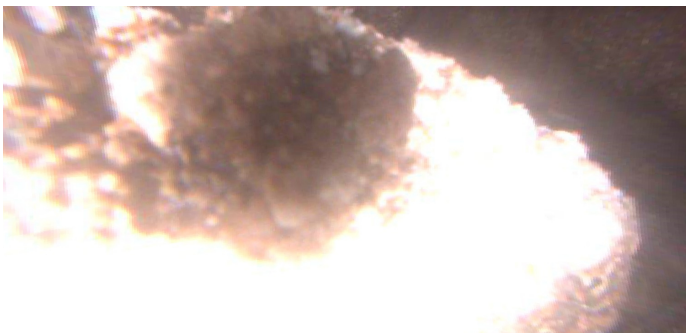
Code: **MSA**
Description: **Abandoned Survey**

Distance (ft): **207.1**
Structural Grade: **0**
O&M Grade: **0**
Clock Start/From:
Clock To:
1st Value:
2nd Value:
Value Percent:
Continuous Index:
Within 8" of Joint: **NO**
Remarks: **Robot stopped at external drop connection**

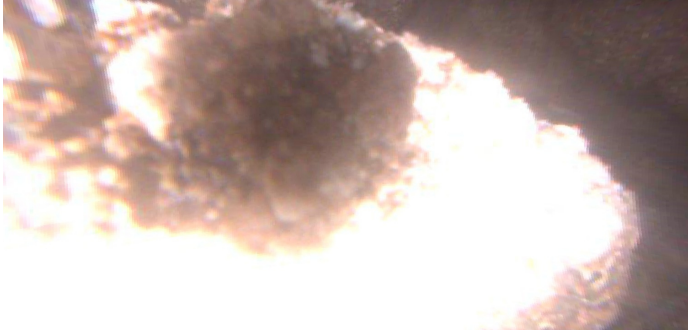
Code:	DAE
Description:	Deposits Attached Encrustation
Distance (ft):	207.1
Structural Grade:	0
O&M Grade:	2
Clock Start/From:	7
Clock To:	5
1st Value:	
2nd Value:	
Value Percent:	5.000
Continuous Index:	F03
Within 8" of Joint:	YES
Remarks:	WANDER
