Profile/Photo Observation Report

Date:	04/17/2018	Weather:		Coding:	PACP 6.0
Pipe Length (ft):	208.7	Owner:	NA	Pre Clean:	Not Known
P.O.#:		Surveyor:	Justin Gonzales	PSR:	P-504-101-072
Customer:		Clean Date:	01/01/1900	Shape:	C

Street:	Summerlin	Flow Control:	Not Controlled
City:	Hobart, IN	Year Renewed:	
Location:	Light Highway	Tape/Media #:	
Purpose:	Not Known	Dia/Height:	10"
Use:	Sanitary	Material:	CP
Drain Area:	NA	Lining:	
Category:	NA		
Comment:			
Location Details:		Direction of Survey:	Downstream
US MH:	M-504-072	DS MH:	M-504-101
		Total Length Surveyed (ft):	207.1

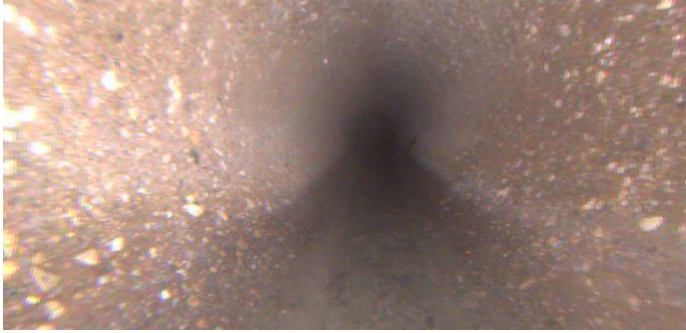
Code: **SAP**
Description: **Surface Aggregate Projecting**

Distance (ft): **.0**
Structural Grade: **3**
O&M Grade: **0**
Clock Start/From: **7**
Clock To: **5**
1st Value:
2nd Value:
Value Percent:
Continuous Index: **S01**
Within 8" of Joint: **YES**
Remarks: **WANDER**

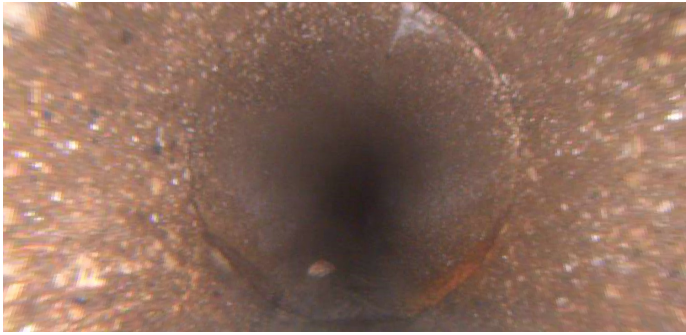
Code: **IS**
Description: **Infil Stain**

Distance (ft): **24.4**
Structural Grade: **0**
O&M Grade: **0**
Clock Start/From: **4**
Clock To: **5**
1st Value:
2nd Value:
Value Percent:
Continuous Index:
Within 8" of Joint: **YES**
Remarks:

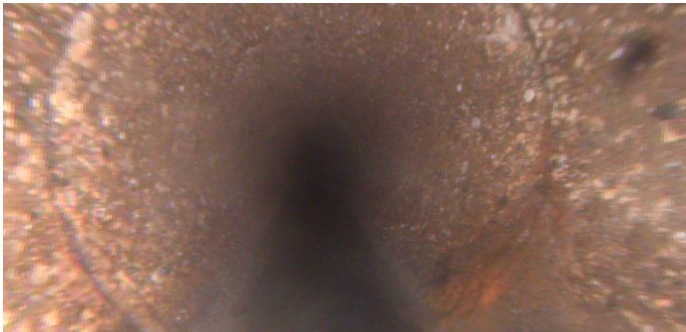
Code: **IS**
Description: **Infil Stain**

Distance (ft): **27.6**
Structural Grade: **0**
O&M Grade: **0**
Clock Start/From: **4**
Clock To: **5**
1st Value:
2nd Value:
Value Percent:
Continuous Index:
Within 8" of Joint: **YES**
Remarks:

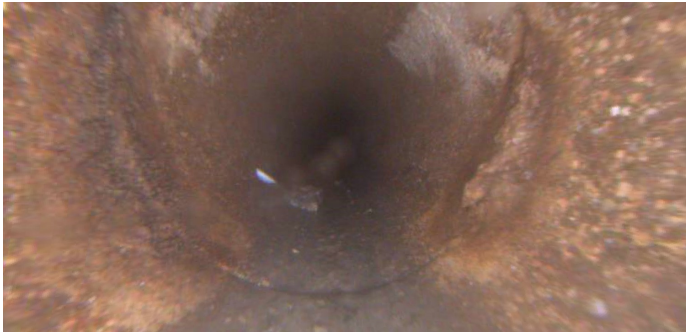
Code: **IS**
Description: **Infil Stain**

Distance (ft): **63.2**
Structural Grade: **0**
O&M Grade: **0**
Clock Start/From: **8**
Clock To: **4**
1st Value:
2nd Value:
Value Percent:
Continuous Index:
Within 8" of Joint: **YES**
Remarks:

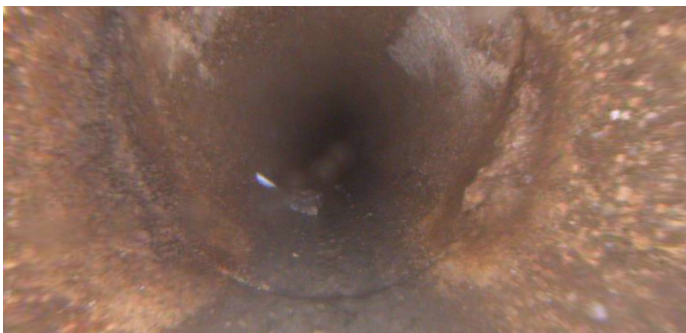
Code: **DAE**
Description: **Deposits Attached Encrustation**

Distance (ft): **63.2**
Structural Grade: **0**
O&M Grade: **2**
Clock Start/From: **3**
Clock To: **5**
1st Value:
2nd Value:
Value Percent: **5.000**
Continuous Index:
Within 8" of Joint: **YES**
Remarks:

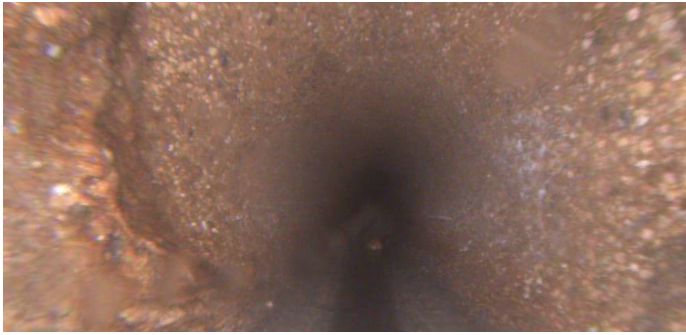
Code: **DAE**
Description: **Deposits Attached Encrustation**

Distance (ft): **66.2**
Structural Grade: **0**
O&M Grade: **2**
Clock Start/From: **7**
Clock To: **9**
1st Value:
2nd Value:
Value Percent: **5.000**
Continuous Index:
Within 8" of Joint: **YES**
Remarks:

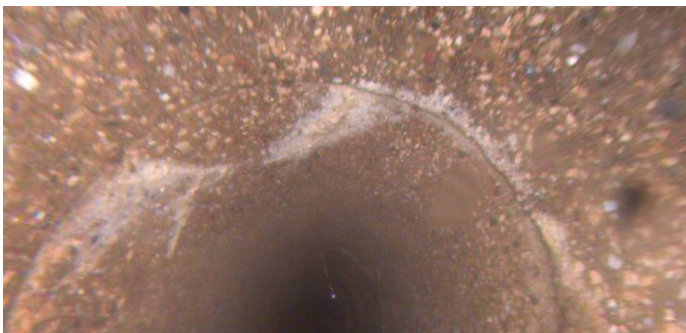
Code: **CS**
Description: **Crack Spiral**

Distance (ft): **69.2**
Structural Grade: **2**
O&M Grade: **0**
Clock Start/From: **10**
Clock To: **12**
1st Value:
2nd Value:
Value Percent:
Continuous Index:
Within 8" of Joint: **YES**
Remarks:

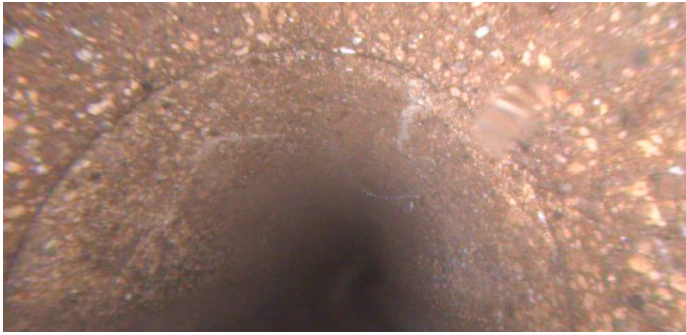
Code: **CM**
Description: **Crack Multiple**

Distance (ft): **84.1**
Structural Grade: **3**
O&M Grade: **0**
Clock Start/From: **9**
Clock To: **2**
1st Value:
2nd Value:
Value Percent:
Continuous Index:
Within 8" of Joint: **YES**
Remarks:

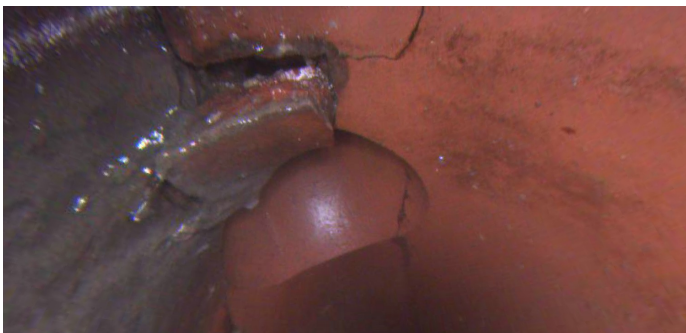
Code: **IR**
Description: **Infil Runner**

Distance (ft): **99.4**
Structural Grade: **0**
O&M Grade: **4**
Clock Start/From: **11**
Clock To:
1st Value:
2nd Value:
Value Percent:
Continuous Index:
Within 8" of Joint:
Remarks:

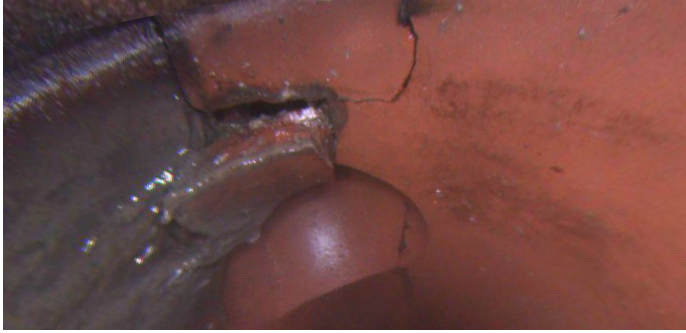
Code: **FS**
Description: **Fracture Spiral**

Distance (ft): **99.4**
Structural Grade: **3**
O&M Grade: **0**
Clock Start/From: **10**
Clock To: **12**
1st Value:
2nd Value:
Value Percent:
Continuous Index:
Within 8" of Joint: **YES**
Remarks:

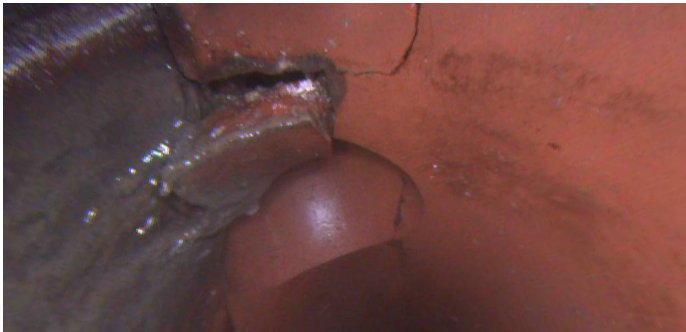
Code: **B**
Description: **Broken**

Distance (ft): **99.4**
Structural Grade: **3**
O&M Grade: **0**
Clock Start/From: **10**
Clock To:
1st Value:
2nd Value:
Value Percent:
Continuous Index:
Within 8" of Joint:
Remarks:

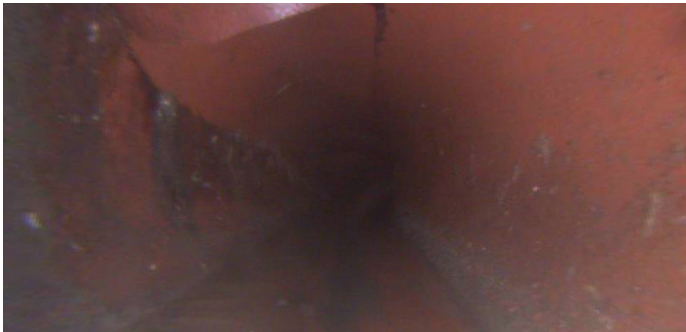
Code: **IW**
Description: **Infil Weeper**

Distance (ft): **99.6**
Structural Grade: **0**
O&M Grade: **2**
Clock Start/From: **8**
Clock To: **12**
1st Value:
2nd Value:
Value Percent:
Continuous Index:
Within 8" of Joint:
Remarks:

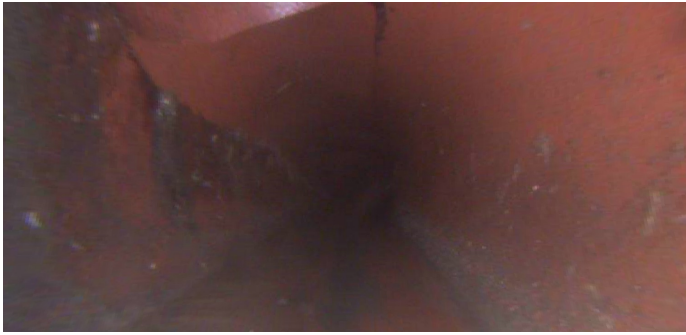
Code: **CM**
Description: **Crack Multiple**

Distance (ft): **99.6**
Structural Grade: **3**
O&M Grade: **0**
Clock Start/From: **9**
Clock To: **12**
1st Value:
2nd Value:
Value Percent:
Continuous Index:
Within 8" of Joint:
Remarks:

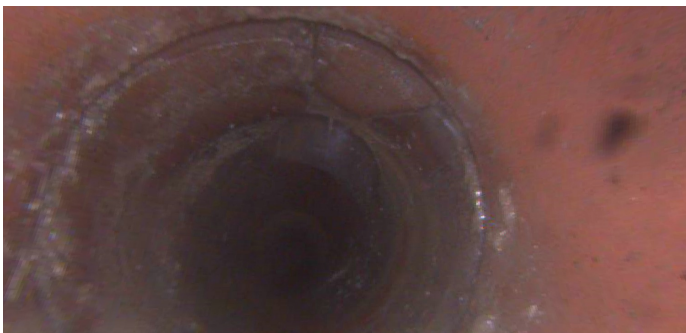
Code: **FS**
Description: **Fracture Spiral**

Distance (ft): **101.8**
Structural Grade: **3**
O&M Grade: **0**
Clock Start/From: **12**
Clock To: **2**
1st Value:
2nd Value:
Value Percent:
Continuous Index:
Within 8" of Joint: **YES**
Remarks:

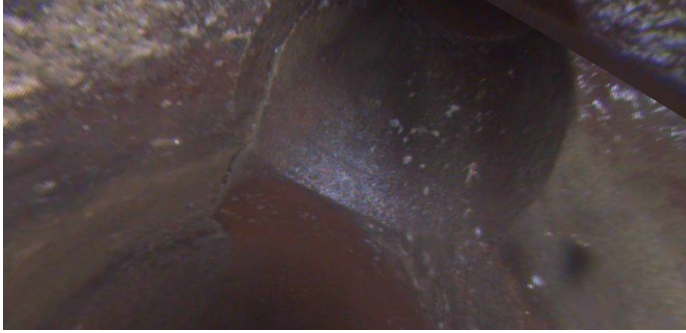
Code: **TFD**
Description: **Tap Factory Defective**

Distance (ft): **102.6**
Structural Grade: **0**
O&M Grade: **2**
Clock Start/From: **1**
Clock To:
1st Value: **4.000**
2nd Value:
Value Percent:
Continuous Index:
Within 8" of Joint:
Remarks: **fractured**

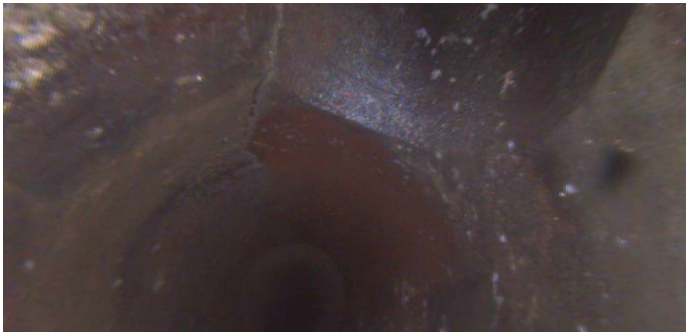
Code: **FL**
Description: **Fracture Longitudinal**

Distance (ft): **102.6**
Structural Grade: **3**
O&M Grade: **0**
Clock Start/From: **12**
Clock To:
1st Value:
2nd Value:
Value Percent:
Continuous Index:
Within 8" of Joint:
Remarks:

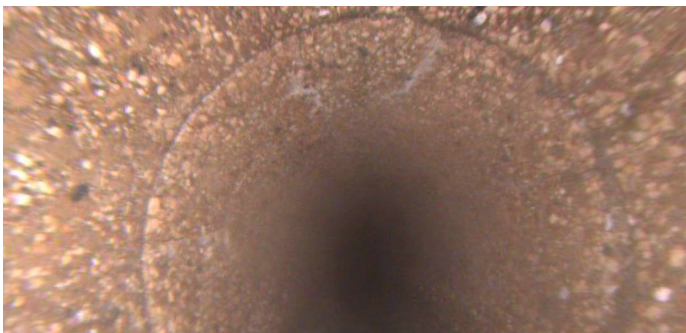
Code: **CM**
Description: **Crack Multiple**

Distance (ft): **113.3**
Structural Grade: **3**
O&M Grade: **0**
Clock Start/From: **11**
Clock To: **12**
1st Value:
2nd Value:
Value Percent:
Continuous Index:
Within 8" of Joint: **YES**
Remarks:

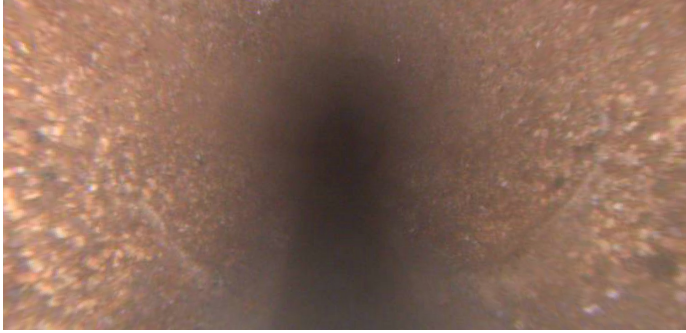
Code: **CC**
Description: **Crack Circumferential**

Distance (ft): **140.0**
Structural Grade: **1**
O&M Grade: **0**
Clock Start/From: **3**
Clock To: **9**
1st Value:
2nd Value:
Value Percent:
Continuous Index:
Within 8" of Joint:
Remarks:

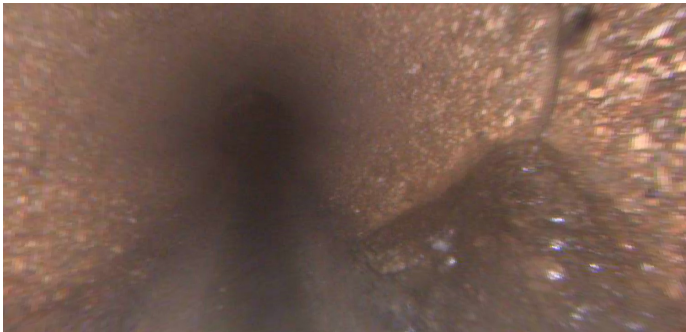
Code: **IS**
Description: **Infil Stain**

Distance (ft): **142.3**
Structural Grade: **0**
O&M Grade: **0**
Clock Start/From: **4**
Clock To: **5**
1st Value:
2nd Value:
Value Percent:
Continuous Index:
Within 8" of Joint: **YES**
Remarks:

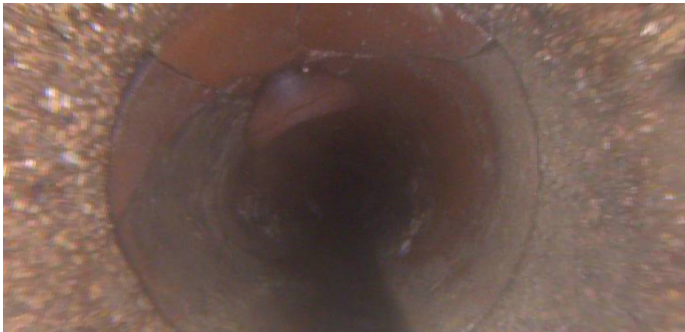
Code: **FM**
Description: **Fracture Multiple**

Distance (ft): **145.0**
Structural Grade: **4**
O&M Grade: **0**
Clock Start/From: **10**
Clock To: **2**
1st Value:
2nd Value:
Value Percent:
Continuous Index:
Within 8" of Joint: **YES**
Remarks:

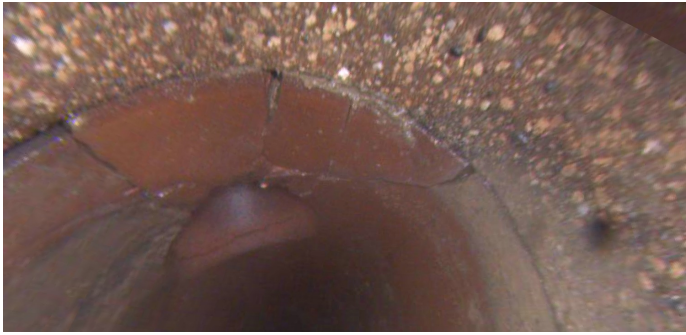
Code: **FM**
Description: **Fracture Multiple**

Distance (ft): **145.1**
Structural Grade: **4**
O&M Grade: **0**
Clock Start/From: **11**
Clock To: **1**
1st Value:
2nd Value:
Value Percent:
Continuous Index:
Within 8" of Joint: **YES**
Remarks:

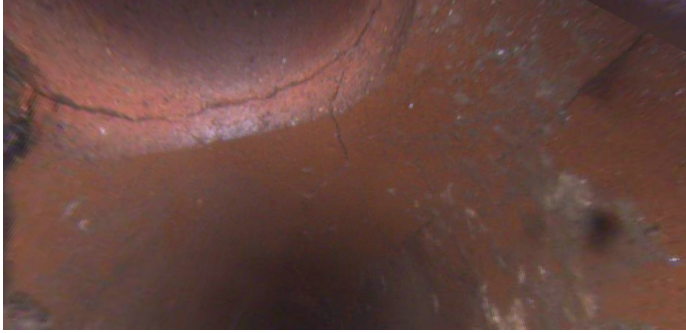
Code: **CM**
Description: **Crack Multiple**

Distance (ft): **146.0**
Structural Grade: **3**
O&M Grade: **0**
Clock Start/From: **12**
Clock To: **2**
1st Value:
2nd Value:
Value Percent:
Continuous Index:
Within 8" of Joint:
Remarks:

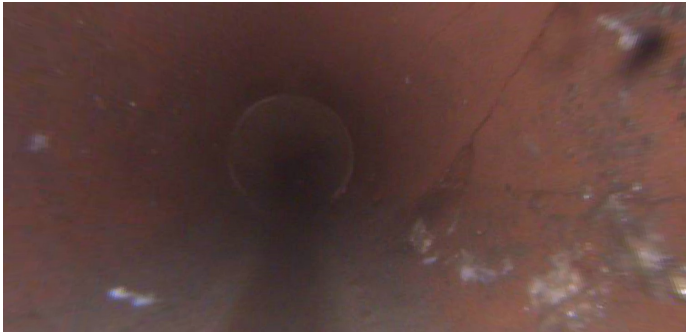
Code: **FS**
Description: **Fracture Spiral**

Distance (ft): **149.7**
Structural Grade: **3**
O&M Grade: **0**
Clock Start/From: **1**
Clock To: **4**
1st Value:
2nd Value:
Value Percent:
Continuous Index:
Within 8" of Joint: **YES**
Remarks:

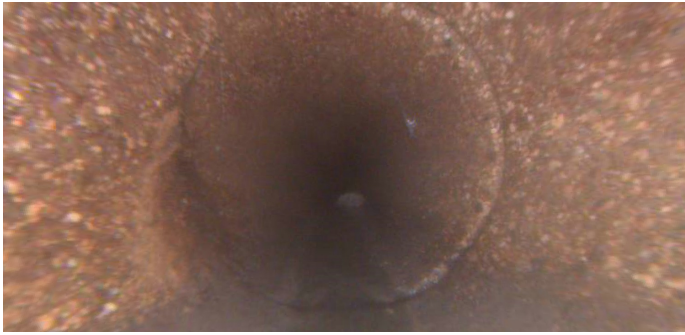
Code: **IW**
Description: **Infil Weeper**

Distance (ft): **153.8**
Structural Grade: **0**
O&M Grade: **2**
Clock Start/From: **7**
Clock To: **9**
1st Value:
2nd Value:
Value Percent:
Continuous Index:
Within 8" of Joint: **YES**
Remarks:

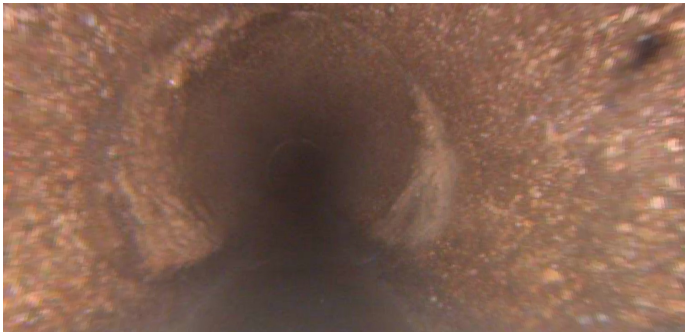
Code: **DAE**
Description: **Deposits Attached Encrustation**

Distance (ft): **159.6**
Structural Grade: **0**
O&M Grade: **2**
Clock Start/From: **7**
Clock To: **5**
1st Value:
2nd Value:
Value Percent: **5.000**
Continuous Index: **S03**
Within 8" of Joint: **YES**
Remarks: **WANDER**

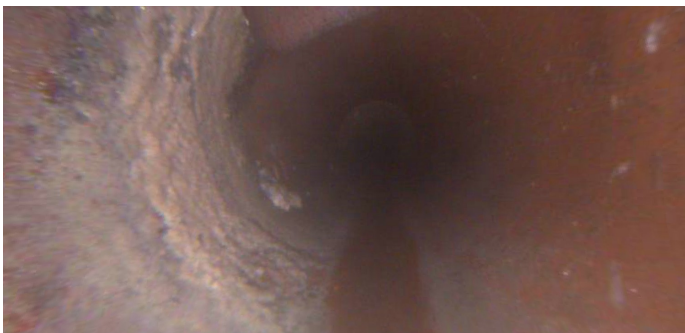
Code: **DAGS**
Description: **Deposits Attached Grease**

Distance (ft): **178.3**
Structural Grade: **0**
O&M Grade: **2**
Clock Start/From: **7**
Clock To: **11**
1st Value:
2nd Value:
Value Percent: **5.000**
Continuous Index:
Within 8" of Joint: **NO**
Remarks:

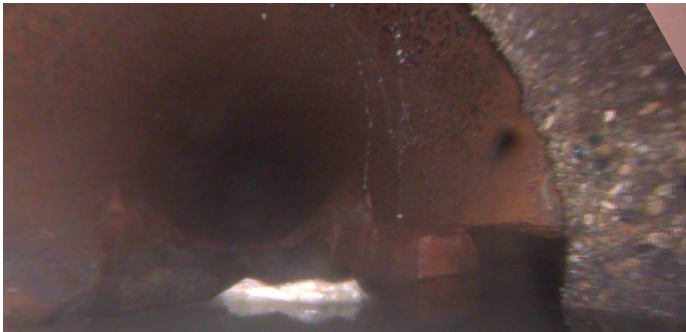
Code: **HSV**
Description: **Hole Soil Visible**

Distance (ft): **205.2**
Structural Grade: **5**
O&M Grade: **0**
Clock Start/From: **5**
Clock To:
1st Value:
2nd Value:
Value Percent:
Continuous Index:
Within 8" of Joint: **YES**
Remarks:

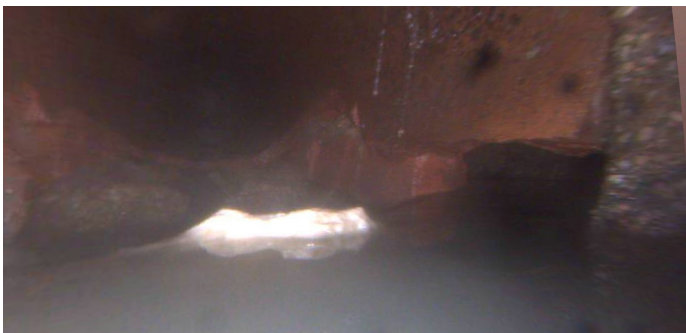
Code: **HVV**
Description: **Hole Void Visible**

Distance (ft): **205.3**
Structural Grade: **5**
O&M Grade: **0**
Clock Start/From: **3**
Clock To: **4**
1st Value:
2nd Value:
Value Percent:
Continuous Index:
Within 8" of Joint: **YES**
Remarks:

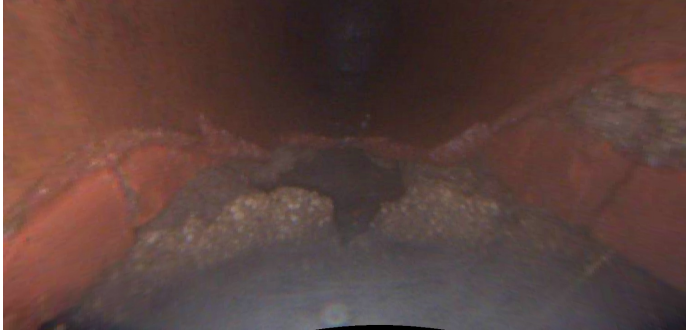
Code: **B**
Description: **Broken**

Distance (ft): **206.0**
Structural Grade: **5**
O&M Grade: **0**
Clock Start/From: **3**
Clock To: **7**
1st Value:
2nd Value:
Value Percent:
Continuous Index:
Within 8" of Joint:
Remarks:

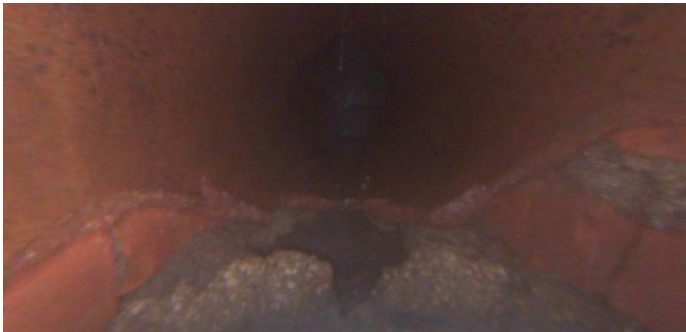
Code: **DSC**
Description: **Deposits Settled Compacted**

Distance (ft): **206.0**
Structural Grade: **0**
O&M Grade: **2**
Clock Start/From: **6**
Clock To:
1st Value:
2nd Value:
Value Percent: **5.000**
Continuous Index:
Within 8" of Joint: **NO**
Remarks:

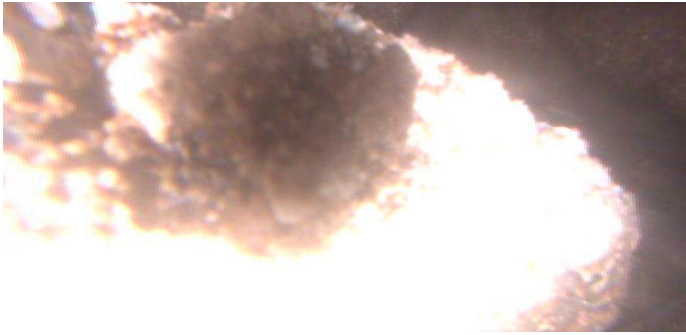
Code: **SAP**
Description: **Surface Aggregate Projecting**

Distance (ft): **207.1**
Structural Grade: **3**
O&M Grade: **0**
Clock Start/From: **7**
Clock To: **5**
1st Value:
2nd Value:
Value Percent:
Continuous Index: **F01**
Within 8" of Joint: **YES**
Remarks: **WANDER**

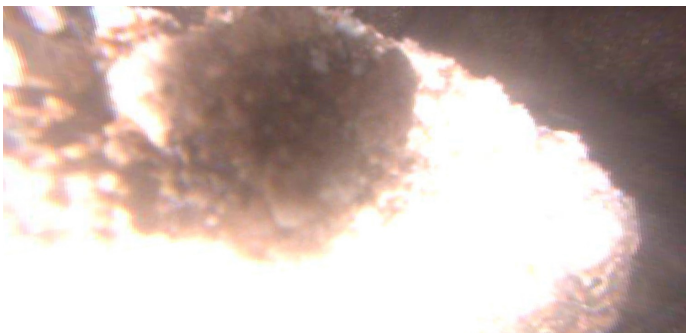
Code: **MSA**
Description: **Abandoned Survey**

Distance (ft): **207.1**
Structural Grade: **0**
O&M Grade: **0**
Clock Start/From:
Clock To:
1st Value:
2nd Value:
Value Percent:
Continuous Index:
Within 8" of Joint: **NO**
Remarks: **Robot stopped at external drop connection**

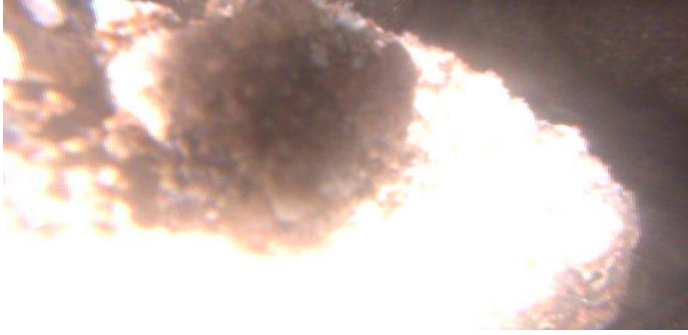
Code:	DAE
Description:	Deposits Attached Encrustation
Distance (ft):	207.1
Structural Grade:	0
O&M Grade:	2
Clock Start/From:	7
Clock To:	5
1st Value:	
2nd Value:	
Value Percent:	5.000
Continuous Index:	F03
Within 8" of Joint:	YES
Remarks:	WANDER
