## Profile/Photo Observation Report

Date:	<b>09/11/2021</b>	Weather:		Coding:	<b>PACP 7.0</b>
Pipe Length (ft):	<b>135.0</b>	Owner:	<b>City of Hobart</b>	Pre Clean:	<b>Heavy Cleaning</b>
P.O.#:	<b>YES502259</b>	Surveyor:	<b>S. Bucklin</b>	PSR:	<b>P-504-103-074</b>
Customer:	<b>City of Hobart</b>	Clean Date:	<b>08/27/2021</b>	Shape:	<b>C</b>

Location Details:		Direction of Survey:	<b>Downstream</b>
US MH:	<b>M-504-074</b>	DS MH:	<b>M-504-103</b>
		Total Length Surveyed (ft):	<b>110.5</b>

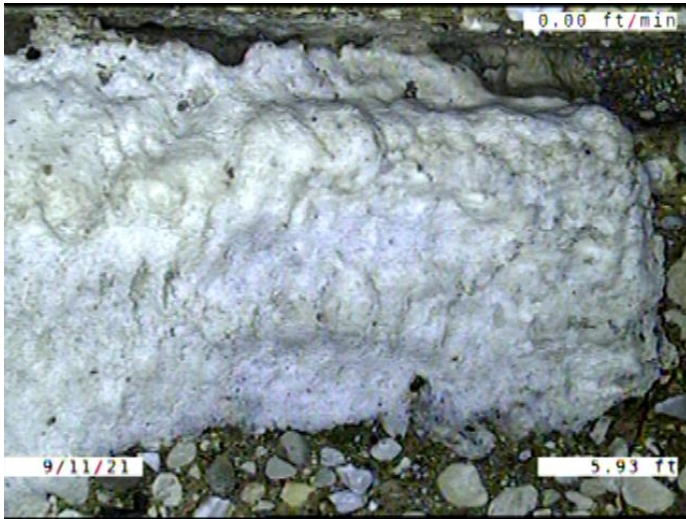
Code: **DAE**  
 Description: **Deposits Attached Encrustation**

Distance (ft): **5.9**  
 Structural Grade: **0**  
 O&M Grade: **2**  
 Clock Start/From: **9**  
 Clock To: **11**  
 1st Value:  
 2nd Value:  
 Value Percent: **5.000**  
 Continuous Index:  
 Within 8" of Joint: **YES**  
 Remarks:

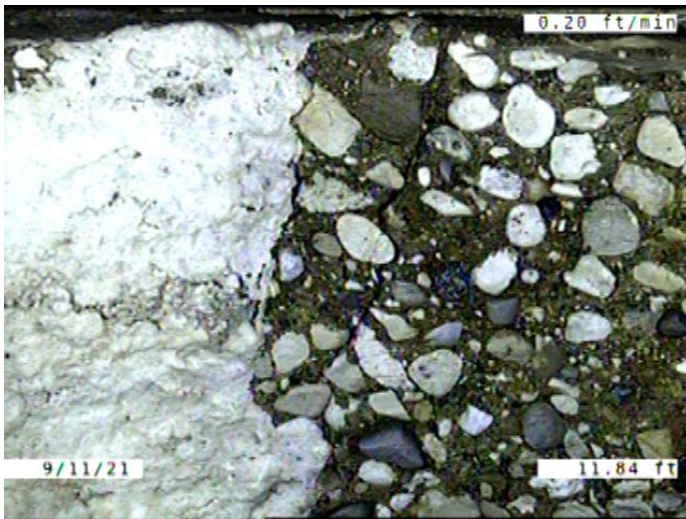
Code: **CM**  
 Description: **Crack Multiple**

Distance (ft): **11.8**  
 Structural Grade: **3**  
 O&M Grade: **0**  
 Clock Start/From: **10**  
 Clock To: **3**  
 1st Value:  
 2nd Value:  
 Value Percent:  
 Continuous Index:  
 Within 8" of Joint: **YES**  
 Remarks:

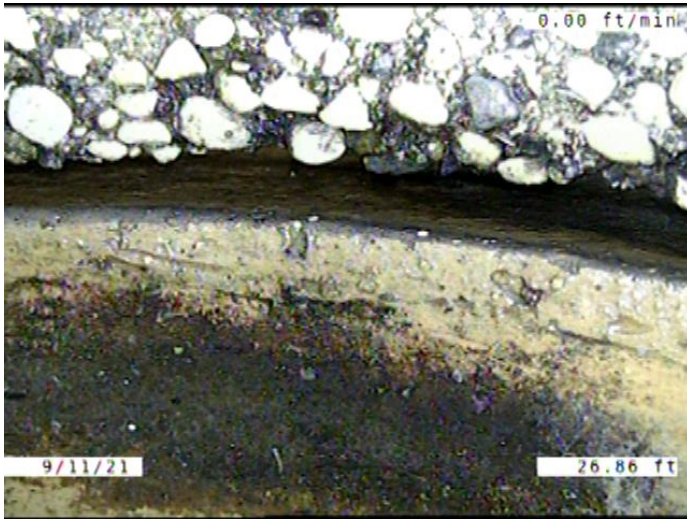
Code: **MMC**  
 Description: **Miscellaneous Material Change**

Distance (ft): **26.9**  
 Structural Grade: **0**  
 O&M Grade: **0**  
 Clock Start/From:  
 Clock To:  
 1st Value:  
 2nd Value:  
 Value Percent:  
 Continuous Index:  
 Within 8" of Joint: **NO**  
 Remarks: **CONCRETE TO VCP**

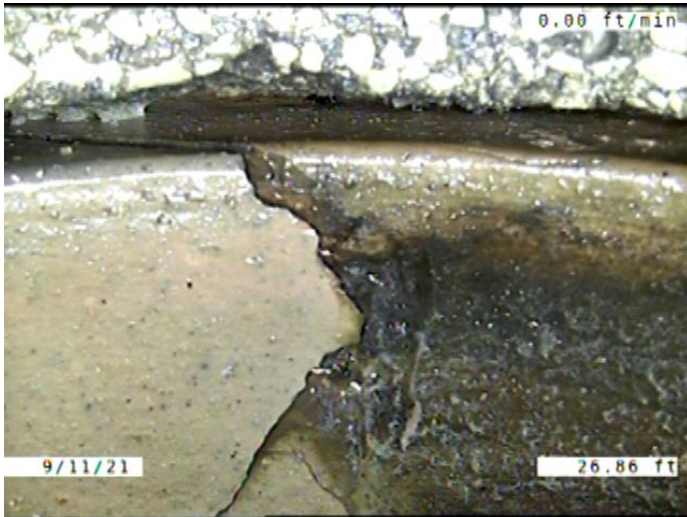
Code: **B**  
 Description: **Broken**

Distance (ft): **26.9**  
 Structural Grade: **4**  
 O&M Grade: **0**  
 Clock Start/From: **8**  
 Clock To: **2**  
 1st Value:  
 2nd Value:  
 Value Percent:  
 Continuous Index:  
 Within 8" of Joint: **YES**  
 Remarks:

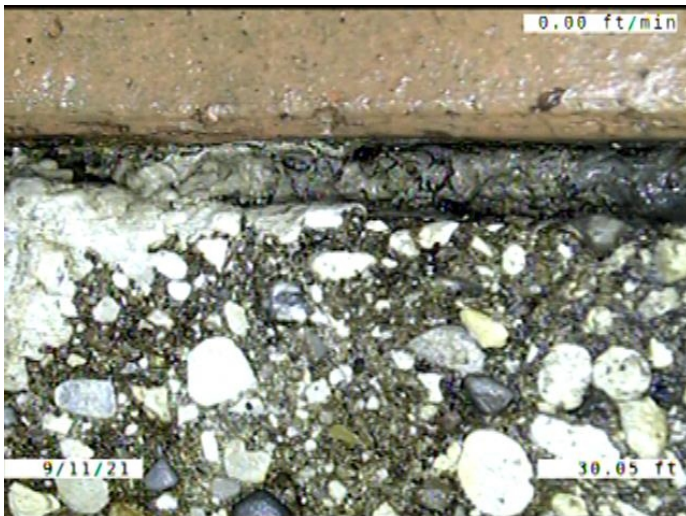
Code: **MMC**  
Description: **Miscellaneous Material Change**

Distance (ft): **30.0**  
Structural Grade: **0**  
O&M Grade: **0**  
Clock Start/From:  
Clock To:  
1st Value:  
2nd Value:  
Value Percent:  
Continuous Index:  
Within 8" of Joint: **NO**  
Remarks: **VCP TO CONCRETE**

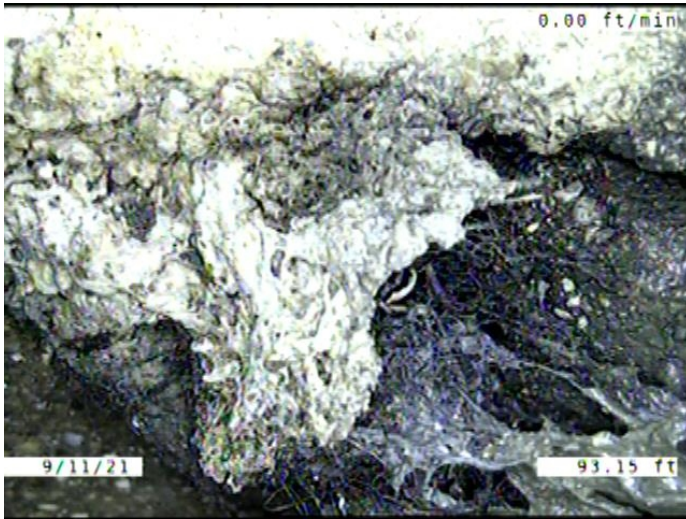
Code: **RMJ**  
 Description: **Roots Medium Joint**

Distance (ft): **93.2**  
 Structural Grade: **0**  
 O&M Grade: **3**  
 Clock Start/From: **12**  
 Clock To: **4**  
 1st Value:  
 2nd Value:  
 Value Percent: **5.000**  
 Continuous Index:  
 Within 8" of Joint: **YES**  
 Remarks:

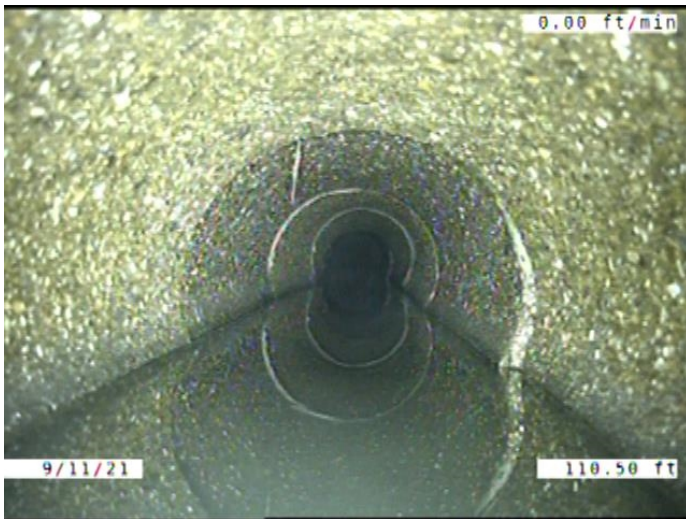
Code: **DSF**  
 Description: **Deposits Settled Fine**

Distance (ft): **110.5**  
 Structural Grade: **0**  
 O&M Grade: **2**  
 Clock Start/From: **5**  
 Clock To: **7**  
 1st Value:  
 2nd Value:  
 Value Percent: **5.000**  
 Continuous Index: **F01**  
 Within 8" of Joint: **YES**  
 Remarks:

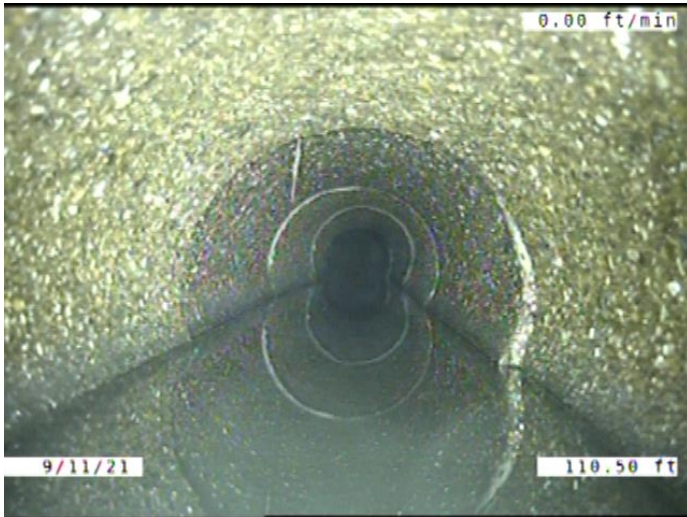
Code: **DAE**  
 Description: **Deposits Attached Encrustation**

Distance (ft): **110.5**  
 Structural Grade: **0**  
 O&M Grade: **2**  
 Clock Start/From: **8**  
 Clock To: **4**  
 1st Value:  
 2nd Value:  
 Value Percent: **5.000**  
 Continuous Index: **F03**  
 Within 8" of Joint: **YES**  
 Remarks:

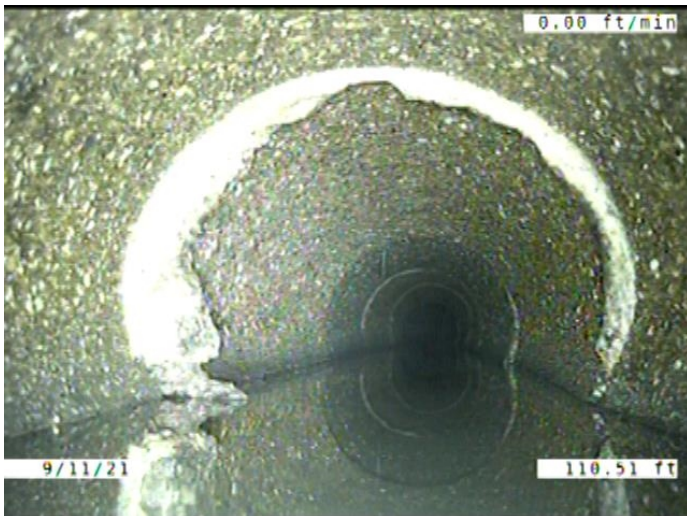
Code: **MSA**  
 Description: **Miscellaneous Survey Abandoned**

Distance (ft): **110.5**  
 Structural Grade: **0**  
 O&M Grade: **0**  
 Clock Start/From:  
 Clock To:  
 1st Value:  
 2nd Value:  
 Value Percent:  
 Continuous Index:  
 Within 8" of Joint: **NO**  
 Remarks: **CAMERA CANT MAKE IT PAST ENCRUSTATION**
